San Mateo County Harbor District Pillar Point Harbor Marina Facility Condition Survey

December 2014

The purpose of this report is to provide a summary of the facility condition survey (FCS) performed at Pillar Point Marina (Pillar Point) located in Half Moon Bay, California. San Mateo County Harbor District (SMCHD) asked Moffatt & Nichol (M&N) to visually inspect and evaluate the conditions of the waterside and shoreside structures at the facility. This report identifies the components that require repairs, a prioritized schedule for repair and maintenance of each survey component (i.e., docks, hoists, buildings, etc.), and costs for repair.

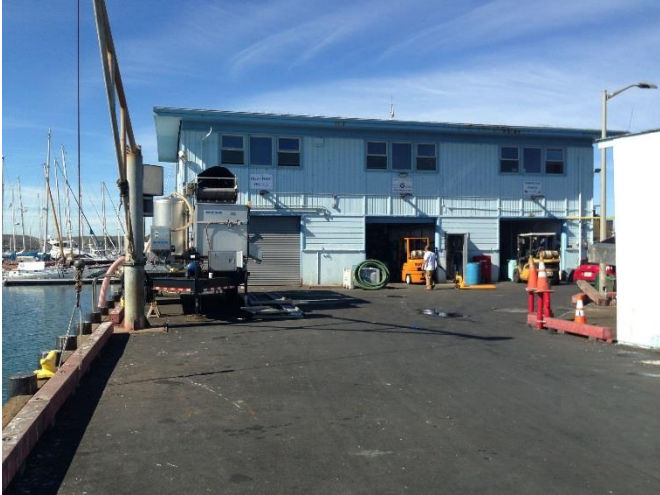
Photograph 1: Fish Buyer Building

This is a two story building with 2,200 square foot lower floor and 1,600 square foot upper floor at the west end of Johnson Pier. No information was provided on the age of construction. This building appears to be in fair condition structurally. The roof and second floor are plywood over wood framing and the walls are wood studs over four feet high reinforced concrete stem walls. The walls are sheathed with plywood and there are interior walls between the three tenant spaces and large roll up doors at the front and back of each space. The floor is the concrete pier deck which is supported by concrete piles. The finishes consist of built up roofing, exterior wood siding and interior gypsum board. This building services commercial fisheries and we observed several tenant modifications to the building (Photograph 1). It was reported that there had been a fire on the west side of the second floor between the northern tenant's space and the center tenant's space and repair work done (Photograph 2).

The condition of the exterior is generally fair to worn. The siding and exterior paint are in fair condition. The paint is consistent and shows little signs of wear. The exterior windows seem to be in fair condition and do not show excessive signs of leaking or wear. Several exterior man-doors are showing signs of moderate to severe corrosion around the door and the frame. Some of the man-doors have had their operating hardware removed, possibly due to excessive corrosion. Gutters and downspouts look to be in fair condition, with the exception of one downspout on the northeast corner of the building which has separated from the gutter. The roll-up doors are in good condition and may have been recently replaced.

1. Replace all exterior man-doors and frames
2. Repair gutter and downspout on the northeast side
3. Patch and paint small areas of corrosion on exterior

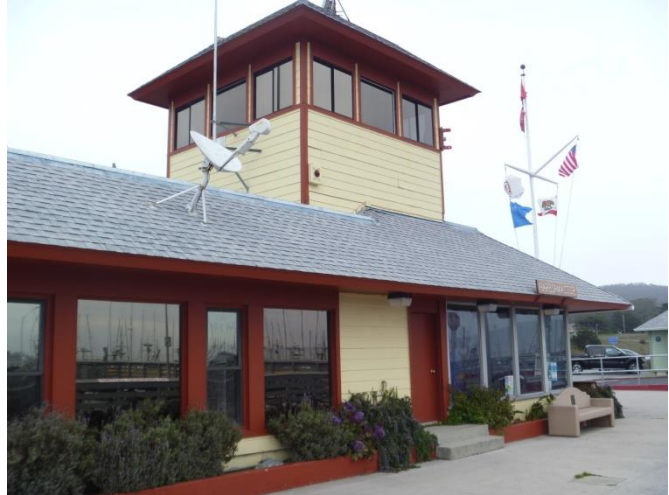
Photograph 4: Harbor Office Building

This is a one story 2,300 square foot building with a 200 square foot second story observation tower estimated to have been constructed in late 1950s or early 1960s. Structurally this building appears to be in fair condition. The roofing is asphalt shingle over the sloped portions of the wood framed mansard roof and built-up roofing on the flat portions. The observation tower has wood framed walls and the first floor walls are a mix of masonry and conventional wood framing (Photograph 4). The foundation consists of a raised reinforced concrete slab on grade. The finishes consist of exterior wood siding and interior gypsum board. Based on the estimated age of the original construction we suspect that the anchorage of the masonry walls to the roof framing is not adequate for earthquake loading.

Exterior siding looks to be in good condition. The paint overall is consistent and shows no signs of leaks or cracking. There is some cracking and peeling on the southern face of the observation tower.

The roof also looks to be in good condition. The north side of the roof has moss growing in between the shingles. The eaves and soffits look to have been recently painted and are in good condition. Gutters and downspout look new and are in good condition. Exterior windows are in good condition and show no signs of leaking or corrosion.

1. Replace restroom and shower finishes
2. Upgrade and standardize floor finishes throughout the building
3. Install new ADA compliant service counter
4. Repair lighting controls throughout the building
5. Repair ceiling grid in copy area

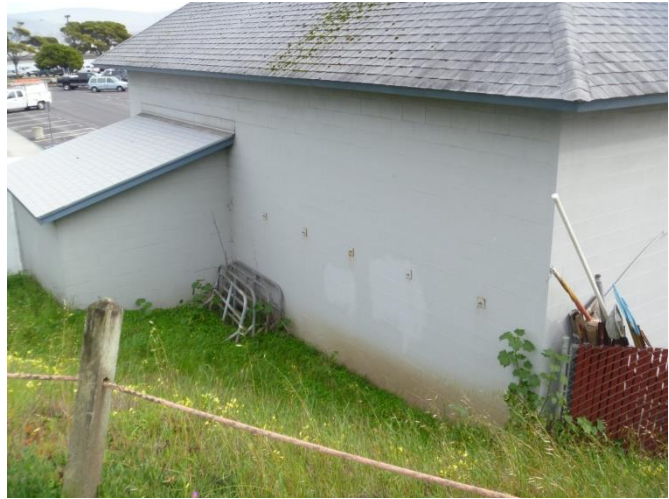
Photograph 5: Maintenance Shop

This building was originally constructed as a one story 1,000 square foot warehouse in the late 1960s and appears to be in fair condition structurally. The mansard roof consists of 1/2" plywood over 2x wood rafters at 24" supported by 2x12 joists at 16". The exterior walls are reinforced concrete masonry over a reinforced concrete spread footing foundation. The anchorage of the masonry walls to the roof framing appears to not be adequate for earthquake loading. The north side of the building is built into the hill side below Capistrano Road. The floor is concrete slab on grade. A wood framed mezzanine has been added to the west end of the building. The mezzanine's wood framing is supported by wood ledgers bolted through the masonry walls. At the northeast side of the building, there appears to be a 120 square foot addition with a lower roof height (Photograph 5). This appears to be constructed of similar material. The finishes consist of asphalt shingle on the sloped portions of the roof and build-up roofing on the flat portions.

between the shingles on the north side. Bolts visible on the west exterior facade above the door are corroding and staining the wall.

The gutters and downspouts look to be in fair condition. The soffit vents and fascia board, however, are beginning to deteriorate.

The exterior man-doors are showing signs of moderate to severe corrosion. The frames and door hardware are showing similar signs of corrosion and are beginning to fail. The exterior windows on the south side of the building are in fair condition. There are few signs of corrosion. Two of the windows have been boarded up with plywood and painted the same color as the rest of the building.

Conduit running along the exterior of the building is in worn condition. Most of it is showing signs of corrosion moderate corrosion. Some areas have begun to detach from their mountings to the wall. In places, there is exposed romex cable that should be enclosed in conduit.

1. Replace exterior conduit
2. Replace exterior soffits and fascia board
3. Address areas of corrosion
4. Replace corroded doors and frames
5. Repair/replace (2) boarded up windows
6. Replace interior finishes in upstairs locker room
7. Improve heating and ventilation in upstairs locker room

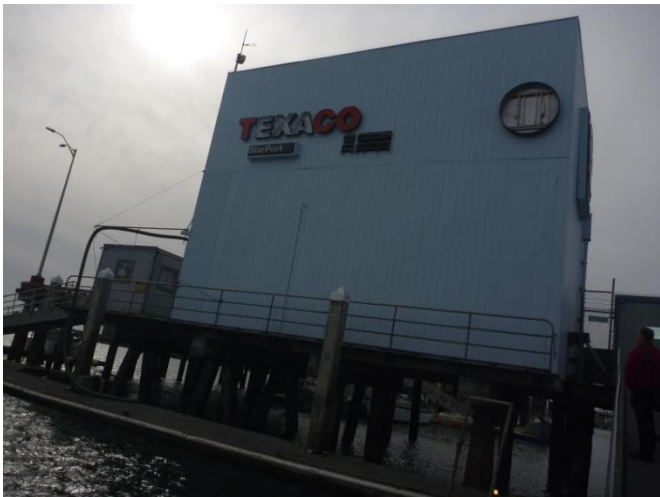
Photograph 3: Ice House

This is a two story building with a 600 square foot upper floor which houses the ice generating equipment and the lower floor stores the ice. No information was provided on the age of construction. This building appears to be in fair condition structurally. The roof consists of built-up roofing over plywood supported by 2x roof rafters slightly sloped to the west side of the building. The walls are conventionally frame stud walls with plywood sheathing with aluminum siding over rigid foam board insulation. The building is built over a concrete pile supported reinforced concrete deck adjacent to the southeast side of Johnson Pier (Photograph 3). Adjacent to the ice building is a 130 square foot modular building which serves as the ice plant and fueling office.

The exterior paint and siding are mostly in good condition. Areas near the base of the building show signs of damage from equipment and corrosion from resulting damage.

Conduit cover box on the north side of the building is severely corroded and needs to be replaced.

1. Minor repairs to the damaged siding
2. Replace corroded conduit cover
4. Install downspouts on the west side

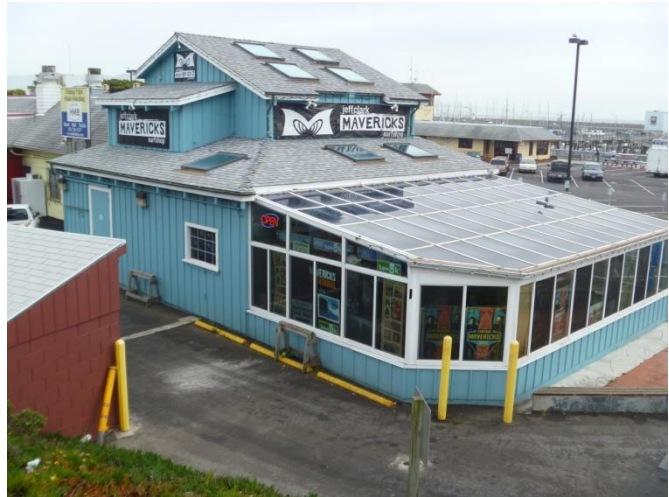
Photograph 6: Tenant Row

portions of the roof and build-up roofing on the flat portions. On the west side a portion of the building is two stories and there is a large enclosed glass sun room (Photograph 6). On the northwest side of the building there is a two story portion of the building that extends to an upper parking lot (Photograph 7). The south wall has several large openings with timber header above (Photograph 8). Based on the estimated age of the original construction, the anchorage of the masonry walls to the roof framing is most likely inadequate for earthquake loads. Portions of the exterior masonry walls have been covered by wood siding. Interior walls appear to be wood framed with gypsum board.

Most of the exterior finishes are in good condition. Exterior paint and siding is in good condition and show no unexpected signs of wear. Soffits look recently painted and are in good condition. Gutters and downspouts are in good condition. The roof overall is in good condition. The north side of the roof has spots where water from other parts of the roof are draining onto them and moss is growing in between the shingles.

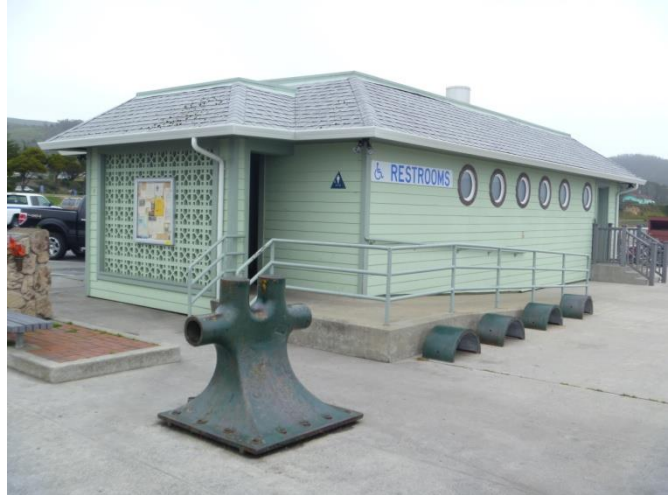
Photograph 10: Restroom #2 & Sidewalk

Restroom #2 is a one story 900 square foot building with wood framed mansard roof and masonry exterior walls with exterior wood siding in fair condition (Photograph 10). Similar to the other buildings with masonry walls, we suspect that the anchorage of the masonry walls to the roof framing is not adequate.

There is a ramp leading to the main entrance of the restrooms, however they are on the other side of the building from the two H.C. accessible parking spaces. This ramp and handrails do not meet current ADA standards. The condition of the ramp and handrails is fair. There is some paint wear on the handrail. The showers do not have a H.C. accessible route. There was ponding in front of the building at the time of the survey.

The exterior doors to the showers show moderate to severe corrosion on the doors, hardware and frames. The door vents are the most severely and the hardware is beginning to fail. The exterior windows look to be in good condition. The hardware on the exterior restroom doors is failing and should be replaced with lever-style handles.

1. Replace corroded exterior doors, frames and hardware
2. Address ponding issue in front of restroom entrance
3. Repair/replace worn tile in shower areas

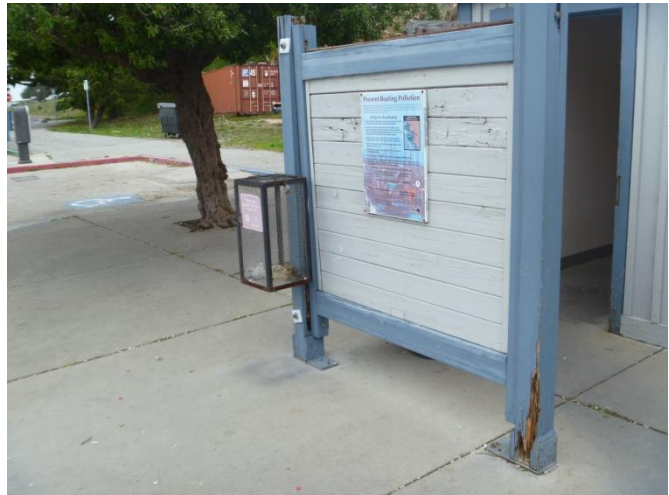
Photograph 11: Restroom #3 & Sidewalk

Restroom #3 is a one story 350 square foot building with conventional wood framed gable roof and stud walls with wood exterior siding in a worn condition (Photograph 11). The foundations are concrete slab on grade. The roofing consists of asphalt shingle on sloped roof and built-up roofing on the flat portions of the mansard roofs.

There is one H.C. accessible space with proper signage but no access aisle. The exterior overall is worn. Siding is deteriorating in several places. There is damage on privacy screens in front of the entrances to the restrooms. The roof looks to be in fair condition. There are no gutters.

Exterior doors to the restrooms are showing severe signs of corrosion. The door hardware is beginning to fail. Exterior conduit for lighting is showing moderate signs of corrosion.

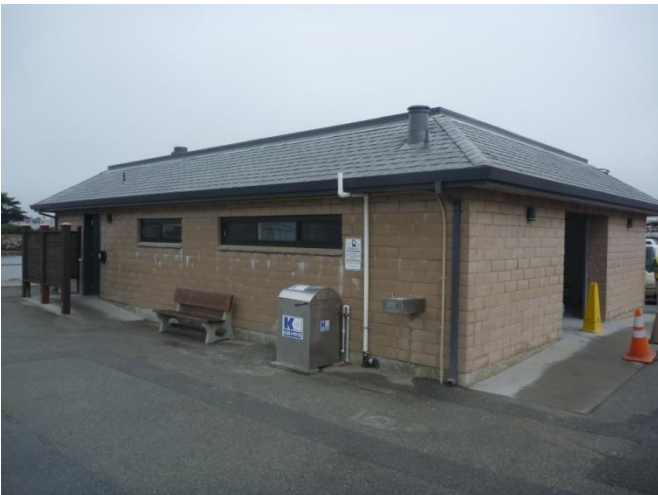
Photograph 9: Restroom #1

Restroom #1 is a one story 1,200 square foot building with wood framed mansard roof and masonry exterior walls in fair condition (Photograph 9).

There is one H.C. accessible space outside this restroom. The accessible route from this space is in worn condition. There is alligating in the asphalt. The ramps leading to the showers are too steep and do not have compliant handrails.

The exterior block walls are in fair condition. There are areas of efflorescence on the southern face. The soffits and fascia board are in good condition. The roof looks to be in good condition and shows little signs of wear. The windows have metal grates which are in good condition. Exterior doors, also, look to be in good condition. There is some patching of the concrete block over the main entrances to the men's and women's restrooms.

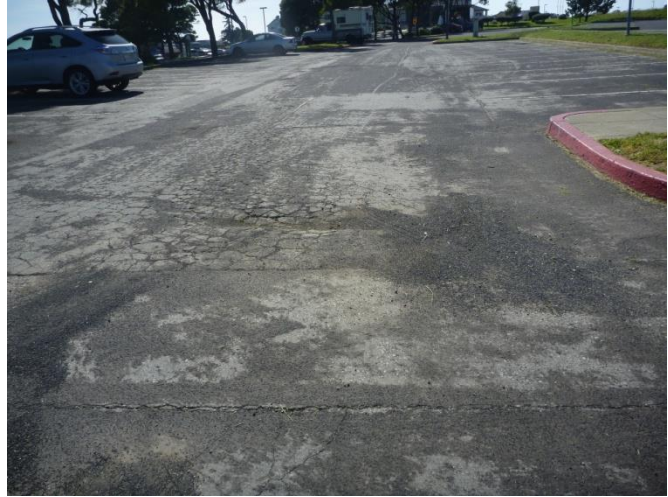
Photograph 14: Alligator Cracking North Parking Lot

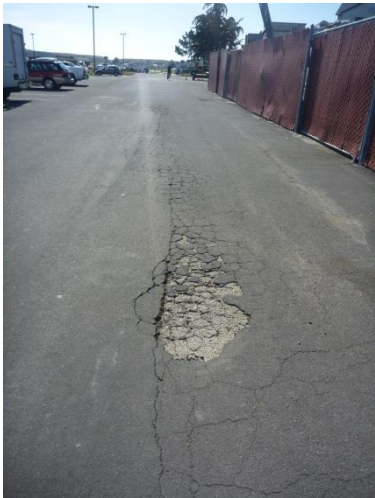
Photograph 13: Potholes & Alligator Cracking West Parking Lot
