SAN MATEO COUNTY HARBOR DISTRICT

ADA Self-Evaluation and Transition Plan

August 2018

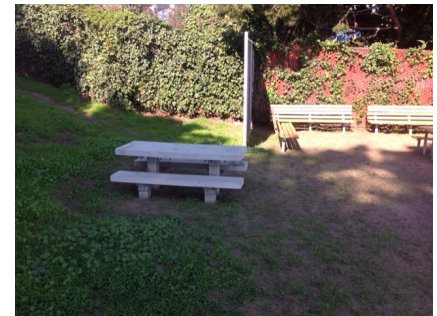
| 72 | <ul style="list-style-type: none"> <i>As-Built Description:</i> Knee clearance at minimums 27" high, 30" wide, and 19" deep is not provided. <i>As-Built:</i> 24" high knee 14" deep <i>Proposed Solution:</i> Modify picnic table as required to provide knee clearance. | <p>PCODE NH11A ADAAG 91 16.5.4. ADA 2010 306.3 CBC 2007 1132B.1 CBC 2016 11B-306.3</p> <p>Priority 1 Severity 2</p> | 1 | JOB | \$850 | \$850 |

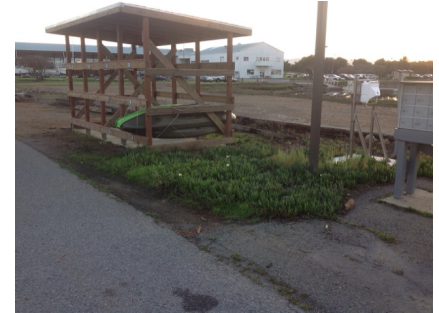
| Item No. and Name | Existing Architectural Barrier and Proposed Solution | Codes / Mitigation Info | Qty | Unit | Cost | Total |
|---|---|--|---|---|---|---|
| 196 | <ul style="list-style-type: none"> <i>As-Built Description:</i> No walk / sidewalk provided to connect accessible facilities or elements that are on the same site. <i>Proposed Solution:</i> Provide new 48" wide walk / sidewalk. | PCODE EF13 ADAAG 91 4.3.2 ADA 2010 206.1 CBC 2007 1114B.1.2 CBC 2016 11B-206.1 Priority 4 Severity 3 | 120 | LF | \$45 | \$5,400 |

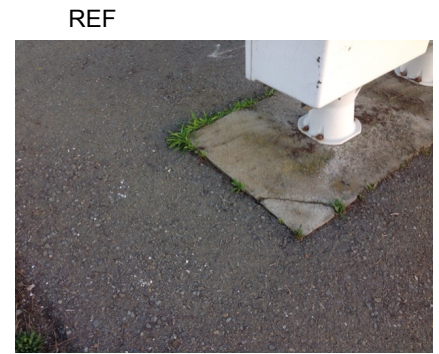
Changes in Level

| 194 | <ul style="list-style-type: none"> <i>As-Built Description:</i> Walk: Pavement dislocation creates abrupt change in level exceeding 1/2" in accessible route. <i>As-Built:</i> 0.5" <i>Proposed Solution:</i> Remove, replace or repair area of pavement sufficient to correct abrupt change in level. | PCODE EF03REF ADAAG 91 4.3.8 ADA 2010 403.4 CBC 2007 1133B.7.4 CBC 2016 11B-403.4 Priority 4 Severity 4 | | | | |

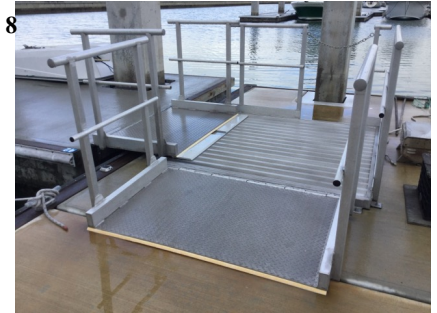
| Item No. and Name | Existing Architectural Barrier and Proposed Solution | Codes / Mitigation Info | Qty | Unit | Cost | Total |
|---|--|--|---|---|---|---|
| 460 | <ul style="list-style-type: none"> <i>As-Built Description:</i> Dislocation creates abrupt change in level exceeding 1/2" on the accessible route along the gangway ramp. <i>As-Built:</i> 1" lip at transition to gangway ramps <i>Proposed Solution:</i> Modify gangway ramp to smooth or ramp abrupt portion. | <p>PCODE NZ01B</p> <p>ADA 2010 1003.2.1 Exception 8</p> <p>CBC 2016 11B-1003.2.1 Exception 8</p> <p>Priority 2</p> <p>Severity 3</p> | 1 | JOB | \$500 | \$500 |

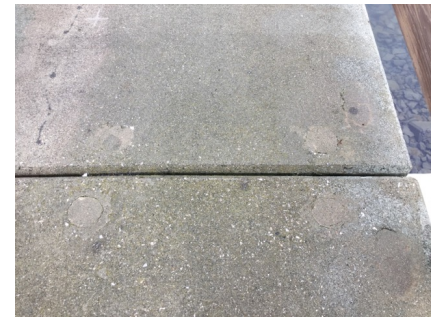
Walkway Surface

| 455 | <ul style="list-style-type: none"> <i>As-Built Description:</i> The sidewalk has a highly irregular pavement surface due to excessive cracks and gaps along path of travel. <i>As-Built:</i> Gap in pavement <i>Proposed Solution:</i> Smooth pavement surface as necessary, by grinding, filling, or refinishing. | <p>PCODE PR18A</p> <p>ADAAG 91 4.5.2</p> <p>PROW R302.7.1</p> <p>CBC 2007 1133B.7.1</p> <p>CBC 2016 11B-303.2</p> <p>Priority 2</p> <p>Severity 4</p> | 10 | SF | \$10 | \$100 |

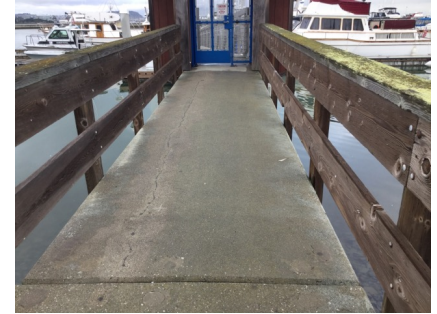
| 454 | <ul style="list-style-type: none"> • <i>As-Built Description:</i> Cross slope more than 1":48" (2.083%). • <i>As-Built:</i> 4.5-5.3% to slip entrance • <i>Proposed Solution:</i> Modify cross slope. | <p>PCODE EF07</p> <p>ADAAG 91 4.3.7</p> <p>ADA 2010 403.3</p> <p>CBC 2007 1133B.7.1.3</p> <p>CBC 2016 11B-403.3</p> <p>Priority 2</p> <p>Severity 3</p> | 100 | SF | \$25 | \$2,500 |

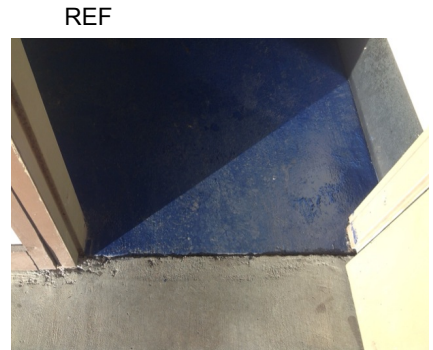
| 166 | <ul style="list-style-type: none"> <i>As-Built Description:</i> Walk: Pavement dislocation creates abrupt change in level exceeding 1/2" in accessible route. <i>As-Built:</i> 0.5" <i>Proposed Solution:</i> Remove, replace or repair area of pavement sufficient to correct abrupt change in level. | <p><i>PCODE</i> EF03REF</p> <p><i>ADAAG 91</i> 4.3.8</p> <p><i>ADA 2010</i> 403.4</p> <p><i>CBC 2007</i> 1133B.7.4</p> <p><i>CBC 2016</i> 11B-403.4</p> <p>Priority 3</p> <p>Severity 4</p> | | | | |

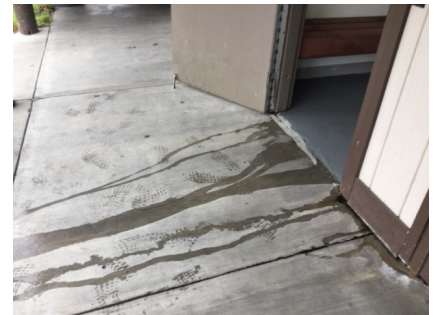
| 294 | <ul style="list-style-type: none"> <i>As-Built Description:</i> Surface of required maneuvering clearance at door slopes more than 1/4":12" (2.0%). <i>As-Built:</i> 6.6% <i>Proposed Solution:</i> Modify surface slope at door. | PCODE ID11REF ADAAG 91 4.13.6 ADA 2010 404.2.4.4 CBC 2007 1133B.2.4 CBC 2016 11B-404.2.4 Priority 3 Severity 3 | REF | | | |

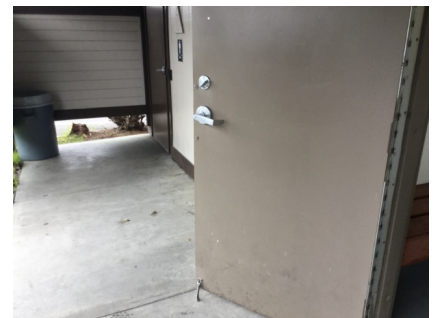
| 292 | <ul style="list-style-type: none"> <i>As-Built Description:</i> Door lock or latch less than 34" or more than 48" above the floor (CA only: 34" to 44"). <i>As-Built:</i> 48" high <i>Proposed Solution:</i> Relocate or replace existing hardware. Notes: Compliant with past code | PCODE ID17REF ADAAG 91 4.13.9 ADA 2010 404.2.7 CBC 2007 1133B.2.5.2 CBC 2016 11B-404.2.7 Priority 3 Severity 4 | REF | | | |

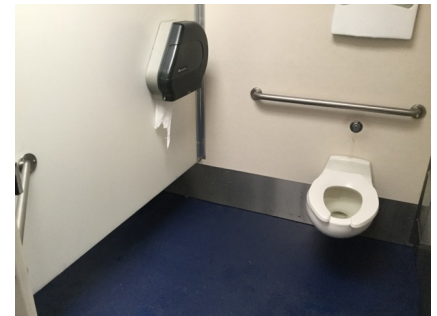
| 334 | <ul style="list-style-type: none"> <i>As-Built Description:</i> Toilet stall less than 60" wide. <i>As-Built:</i> 57.5" wide <i>Proposed Solution:</i> Provide new accessible stall. Notes: Bar in corner reduces stall width | PCODE WB06 ADAAG 91 4.17.3 ADA 2010 604.8.1.1 CBC 2007 1115B.3.1.4.1 CBC 2016 11B-604.8.1.1 Priority 3 Severity 4 | 1 | JOB | \$1,500 | \$1,500 |

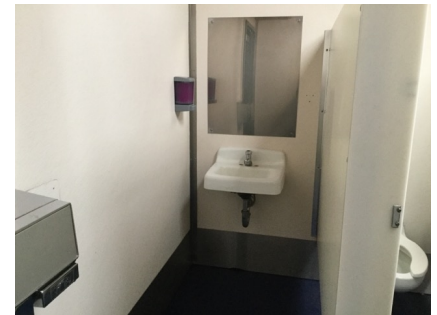
Wheelchair Clearance

| 327 | <ul style="list-style-type: none"> <i>As-Built Description:</i> Clear passage width (except doorways) from rest room entry to lavatory less than 36" (CA only: 44" wide). <i>As-Built:</i> 35.5" wide to lavatory <i>Proposed Solution:</i> Modify facility passage to be min. 44" wide. Demolish existing partition and replace. | PCODE WC02ANT ADAAG 91 4.3.3 ADA 2010 403.5.1 CBC 2007 1115B.3.2.4 CBC 2016 11B-403.5.1 Priority 3 Severity 2 | 5 | LF | \$170 | \$850 |

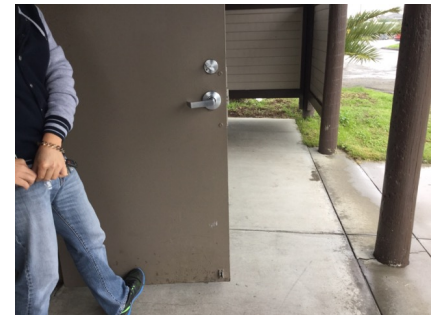
| 352 | <ul style="list-style-type: none"> • <i>As-Built Description:</i> Door lock or latch less than 34" or more than 48" above the floor (CA only: 34" to 44"). • <i>As-Built:</i> 48" high • <i>Proposed Solution:</i> Relocate or replace existing hardware. | <p><i>PCODE</i> ID17 <i>ADAAG 91</i> 4.13.9 <i>ADA 2010</i> 404.2.7 <i>CBC 2007</i> 1133B.2.5.2 <i>CBC 2016</i> 11B-404.2.7</p> <p>Priority 3 Severity 4</p> | 1 | JOB | \$300 | \$300 |

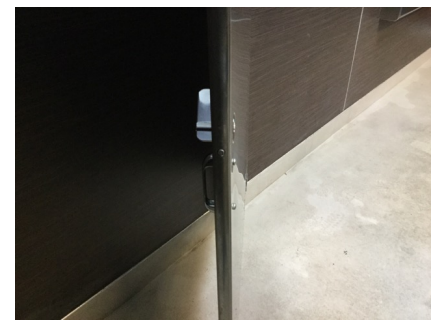
| 382 | <ul style="list-style-type: none"> As-Built Description: Stall door does not have accessible operating hardware (U-pulls on both sides, flip-over or sliding lock). As-Built: U-pull only on one side Proposed Solution: Provide new accessible locking hardware that does not require grasping, pinching, or twisting and U-pulls on both sides. | <p>PCODE WB05C</p> <p>ADAAG 91 4.17.5</p> <p>ADA 2010 604.8.1.2</p> <p>CBC 2007 1115B.3.1.4.5</p> <p>CBC 2016 11B-604.8.1.2</p> <p>Priority 3</p> <p>Severity 3</p> | 1 | JOB | \$100 | \$100 |

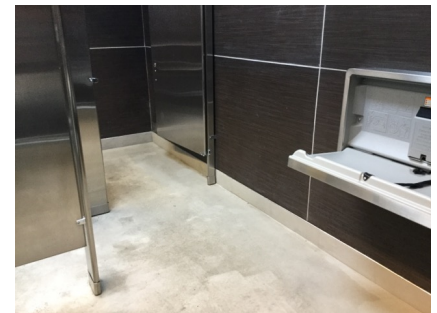
Wheelchair Clearance

| 385 | <ul style="list-style-type: none"> As-Built Description: Clear passage width (except doorways) from rest room entry to accessible water closet compartment less than 36" (CA only: 44" wide). As-Built: 39" wide when changing station is down Proposed Solution: Modify facility passage to be min. 44" wide. Demolish existing partition and replace. Notes: Ensure changing station remains closed when not in use via self closer. | <p>PCODE WC02AREF</p> <p>ADAAG 91 4.3.3</p> <p>ADA 2010 403.5.1</p> <p>CBC 2007 1115B.3.2.4</p> <p>CBC 2016 11B-403.5.1</p> <p>Priority 3</p> <p>Severity 2</p> | REF | | | |

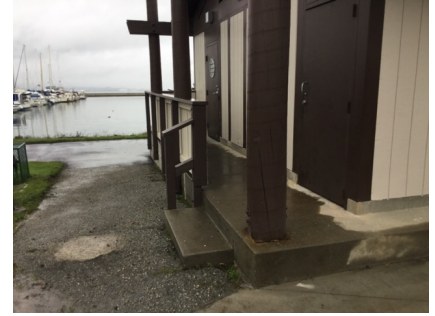
| 396 | <ul style="list-style-type: none"> <i>As-Built Description:</i> Ramp needed to provide disabled access at steps or change of level along path of travel. <i>As-Built:</i> Access to laundry room only by stairs <i>Proposed Solution:</i> Provide new concrete ramp with handrails [slope more than 1:20 (5.0%) needed]. <i>Notes:</i> Replace stairs with ramp or relocate laundry room | <p><i>PCODE</i> EB01A <i>ADAAG 91</i> 4.1.1 <i>ADA 2010</i> 303.4 <i>CBC 2007</i> 1127B.1 <i>CBC 2016</i> 11B-303.4</p> <p>Priority 3 Severity 3</p> | 80 | SF | \$100 | \$8,000 |

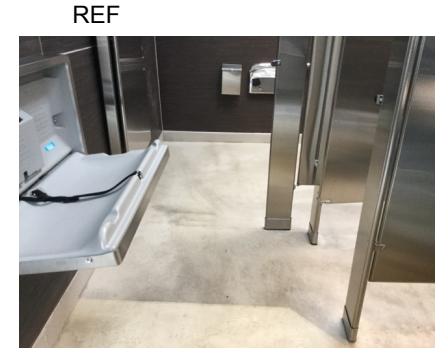
| 410 | <ul style="list-style-type: none"> <i>As-Built Description:</i> Clear passage width (except doorways) from rest room entry to accessible water closet compartment less than 36" (CA only: 44" wide). <i>As-Built:</i> 33" wide when changing station is down <i>Proposed Solution:</i> Modify facility passage to be min. 44" wide. Demolish existing partition and replace. <i>Notes:</i> Ensure changing station remains closed when not in use via self closer. | <p>PCODE WC02AREF</p> <p>ADAAG 91 4.3.3</p> <p>ADA 2010 403.5.1</p> <p>CBC 2007 1115B.3.2.4</p> <p>CBC 2016 11B-403.5.1</p> <p>Priority 3</p> <p>Severity 2</p> | | | | |

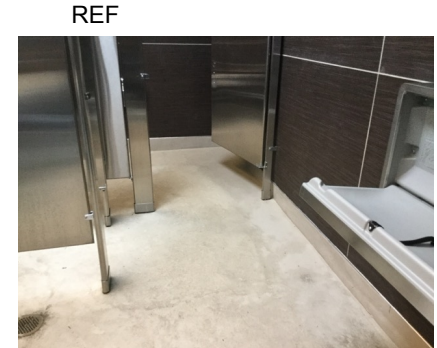
| 417 | <ul style="list-style-type: none"> • <i>As-Built Description:</i> Clear passage width (except doorways) from rest room entry to accessible water closet compartment less than 36" (CA only: 44" wide). • <i>As-Built:</i> 39" wide with changing station down • <i>Proposed Solution:</i> Modify facility passage to be min. 44" wide. Demolish existing partition and replace. • <i>Notes:</i> Ensure changing station remains closed when not in use via self closer. | <p>PCODE WC02AREF ADAAG 91 4.3.3 ADA 2010 403.5.1 CBC 2007 1115B.3.2.4 CBC 2016 11B-403.5.1</p> <p>Priority 3 Severity 2</p> | | | | |

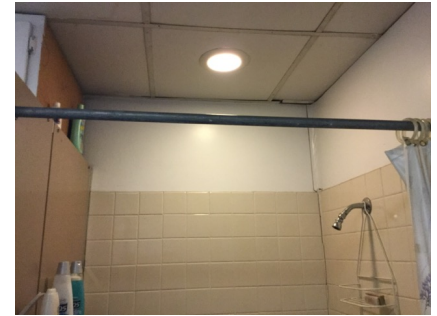
| 503 | <ul style="list-style-type: none"> • <i>As-Built Description:</i> Overhead clearance less than 80" above finished floor. • <i>As-Built:</i> 78.5" high curtain rod • <i>Proposed Solution:</i> Modify overhead clearance. | <p>PCODE EG01 ADAAG 91 4.4.2 ADA 2010 307.4 CBC 2007 1133B.8.6.2 CBC 2016 11B-307.4</p> <p>Priority 4 Severity 2</p> | 1 | JOB | \$100 | \$100 |

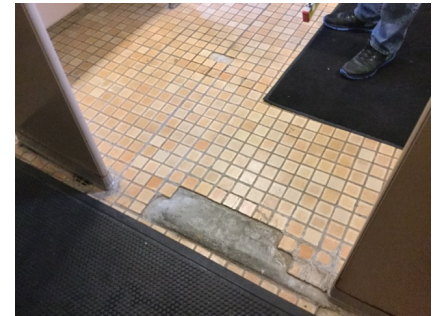
Door

| 507 | <ul style="list-style-type: none"> • <i>As-Built Description:</i> Surface of required maneuvering clearance at door slopes more than 1/4":12" (2.0%). • <i>As-Built:</i> 3.7-4.6% at shower entrance • <i>Proposed Solution:</i> Modify surface slope at door. • Notes: Repair damaged tiles in threshold area | <p>PCODE ID11NT ADAAG 91 4.13.6 ADA 2010 404.2.4.4 CBC 2007 1133B.2.4 CBC 2016 11B-404.2.4</p> <p>Priority 4 Severity 3</p> | 12 | SF | \$40 | \$480 |

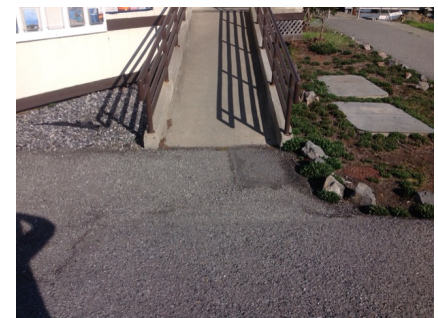
| 12 | <ul style="list-style-type: none"> As-Built Description: Level 2% max. landing for ramp not provided. As-Built: Highly irregular surface Proposed Solution: Rebuild ramp to provide landings for each ramp run with slopes no greater than 2% | PCODE EB05ANT | 30 | SF | \$100 | \$3,000 |

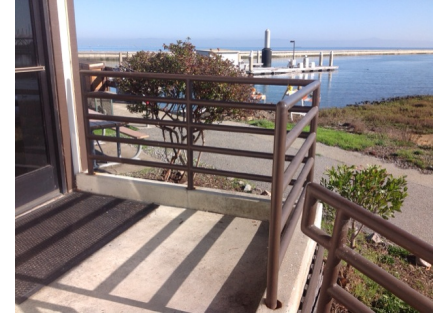
| 16 | <ul style="list-style-type: none"> • <i>As-Built Description:</i> Open guards does not have balusters or ornamental patterns such that a 4-inch-diameter (102 mm) sphere cannot pass through any opening. • <i>As-Built:</i> 5.5" • <i>Proposed Solution:</i> Provide new guards which do not allow passage of an 4 inch sphere at any opening. | <p><i>PCODE</i> ED08A <i>ADA 2010</i> 405.9.2 <i>CBC 2007</i> 1013.3 <i>CBC 2016</i> 11B-405.9.2</p> <p>Priority 1 Severity 4</p> <p>Mitigation Project: <i>Replace Harbormaster Building</i></p> <p>Estimated Completion Date: <i>2020-2021</i></p> | 15 | LF | \$120 | \$1,800 |

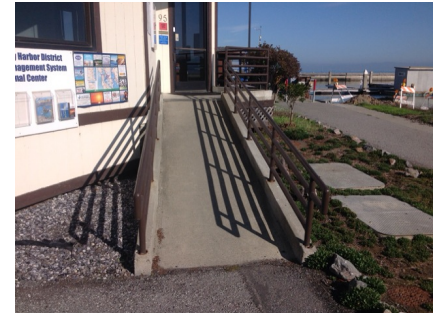
Height

| 14 | <ul style="list-style-type: none"> • <i>As-Built Description:</i> Handrail gripping surface top not mounted between 34" and 38" above ramp surface or stair nosings. • <i>As-Built:</i> 32.5" • <i>Proposed Solution:</i> Remove existing and provide new handrail. | <p><i>PCODE</i> ED02 <i>ADAAG 91</i> 4.9.4(5) <i>ADA 2010</i> 505.4 <i>CBC 2007</i> 1133B.4.2.1 & B.5.5.1 <i>CBC 2016</i> 11B-505.4</p> <p>Priority 1 Severity 3</p> <p>Mitigation Project: <i>Replace Harbormaster Building</i></p> <p>Estimated Completion Date: <i>2020-2021</i></p> | 120 | LF | \$75 | \$9,000 |

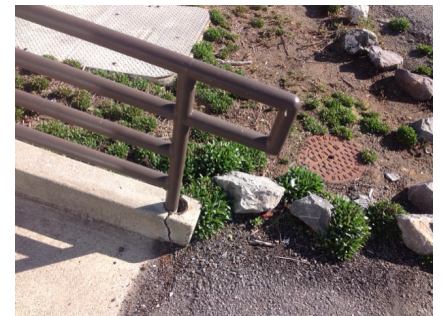
Top and Bottom Extension at

| 13 | <ul style="list-style-type: none"> • <i>As-Built Description:</i> Ramp handrail does not extend horizontally 12" past top and / or bottom of ramp. • <i>As-Built:</i> 0 to 10" • <i>Proposed Solution:</i> Provide ramp handrail extension (cost for each extension piece). | <p><i>PCODE</i> ED05REF <i>ADAAG 91</i> 4.8.5(2) <i>ADA 2010</i> 505.10.1 <i>CBC 2007</i> 1133B.4.2.2 & 1133B.5.5.1 <i>CBC 2016</i> 11B-505.10.1</p> <p>Priority 1 Severity 2</p> <p>Mitigation Project: <i>Replace Harbormaster Building</i></p> <p>Estimated Completion Date: <i>2020-2021</i></p> | REF | | | |

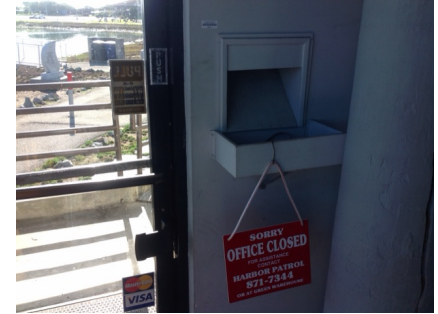
| 19 | <ul style="list-style-type: none"> • <i>As-Built Description:</i> Protruding objects more than 4" from wall, when bottom of object more than 27" or less than 80" above finished floor. • <i>As-Built:</i> 7" at 45.25" high • <i>Proposed Solution:</i> Remove/relocate protruding object. Patch existing surface. | <p>PCODE EG04 ADAAG 91 4.4.1 ADA 2010 307.2 CBC 2007 1133B.8.6.1 CBC 2016 11B-307.2</p> <p>Priority 1 Severity 3</p> <p>Mitigation Project: Replace Harbormaster Building</p> <p>Estimated Completion Date: 2020-2021</p> | 1 | JOB | \$100 | \$100 |

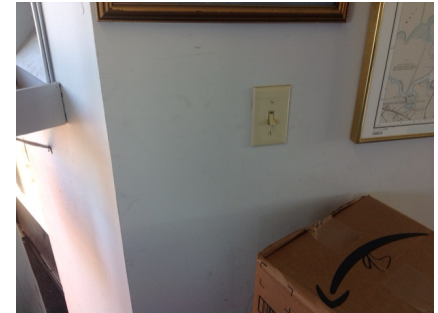
Electrical

| 24 | <ul style="list-style-type: none"> • <i>As-Built Description:</i> Electric switch or control mounted less than 15" measured to the bottom of the outlet box or greater than 48 inches measured to the top of the outlet box. • <i>As-Built:</i> 49" • <i>Proposed Solution:</i> Relocate light switches or control to between 15" and 48" height. | <p>PCODE IC01 ADAAG 91 4.2.5 & 6 ADA 2010 308.2.1 & 308.2.2 CBC 2007 1117B.6.3 CBC 2016 11B-308.2.1 & 11B-308.2.2</p> <p>Priority 1 Severity 4</p> <p>Mitigation Project: Replace Harbormaster Building</p> <p>Estimated Completion Date: 2020-2021</p> | 1 | JOB | \$300 | \$300 |

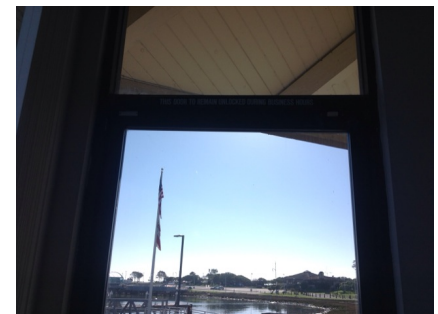
Door Closer

| 18 | <ul style="list-style-type: none"> • <i>As-Built Description:</i> Excessive force required to open door. • <i>As-Built:</i> 15 lbs • <i>Proposed Solution:</i> Adjust regular door closer to accessible standards (5 lbs. max). | <p>PCODE ID03 ADAAG 91 4.13.11 ADA 2010 404.2.9 CBC 2007 1133B.2.5 CBC 2016 11B-404.2.9</p> <p>Priority 1 Severity 3</p> <p>Mitigation Project: Replace Harbormaster Building</p> <p>Estimated Completion Date: 2020-2021</p> | 1 | JOB | \$25 | \$25 |

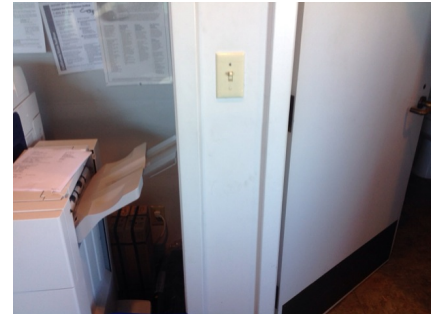
| 32 | <ul style="list-style-type: none"> <i>As-Built Description:</i> Electric switch or control mounted less than 15" measured to the bottom of the outlet box or greater than 48 inches measured to the top of the outlet box. <i>As-Built:</i> 49" <i>Proposed Solution:</i> Relocate light switches or control to between 15" and 48" height. | <p>PCODE IC01 ADAAG 91 4.2.5 & 6 ADA 2010 308.2.1 & 308.2.2 CBC 2007 1117B.6.3 CBC 2016 11B-308.2.1 & 11B-308.2.2</p> <p>Priority 4 Severity 4</p> <p>Mitigation Project: Replace Harbormaster Building</p> <p>Estimated Completion Date: 2020-2021</p> | 1 | JOB | \$300 | \$300 |

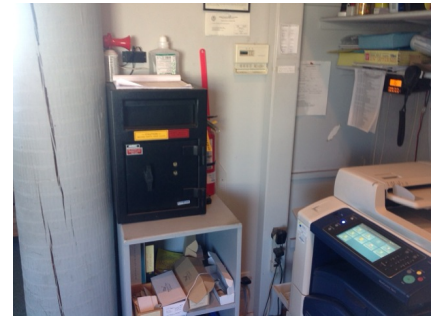
| 52 | <ul style="list-style-type: none"> <i>As-Built Description:</i> Electric switch or control mounted less than 15" measured to the bottom of the outlet box or greater than 48 inches measured to the top of the outlet box. <i>As-Built:</i> Thermostat: 60" high <i>Proposed Solution:</i> Relocate light switches or control to between 15" and 48" height. Notes: No clear space in front of thermostat, relocate furniture | <p>PCODE IC01 ADAAG 91 4.2.5 & 6 ADA 2010 308.2.1 & 308.2.2 CBC 2007 1117B.6.3 CBC 2016 11B-308.2.1 & 11B-308.2.2</p> <p>Priority 4 Severity 3</p> <p>Mitigation Project: Replace Harbormaster Building</p> <p>Estimated Completion Date: 2020-2021</p> | 1 | JOB | \$300 | \$300 |

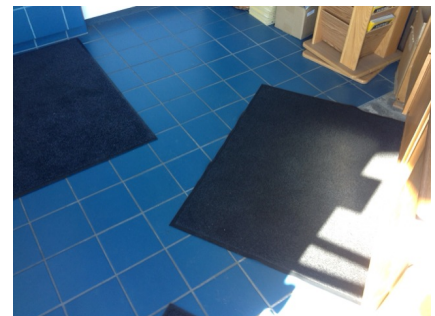
Carpet/Doormat

| 56 | <ul style="list-style-type: none"> <i>As-Built Description:</i> Doormat not securely attached to ground or floor structure. <i>Proposed Solution:</i> Attach doormat to floor surface or remove doormat. | <p>PCODE ID05A ADAAG 91 4.5.3 ADA 2010 302.2 CBC 2007 1124B.3 CBC 2016 11B-302.2</p> <p>Priority 4 Severity 3</p> <p>Mitigation Project: Replace Harbormaster Building</p> <p>Estimated Completion Date: 2020-2021</p> | 1 | JOB | \$75 | \$75 |

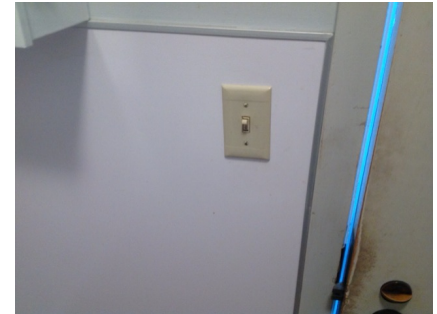
| 47 | <ul style="list-style-type: none"> <i>As-Built Description:</i> Electric switch or control mounted less than 15" measured to the bottom of the outlet box or greater than 48 inches measured to the top of the outlet box. <i>As-Built:</i> 49.5" high <i>Proposed Solution:</i> Relocate light switches or control to between 15" and 48" height. | <p>PCODE IC01 ADAAG 91 4.2.5 & 6 ADA 2010 308.2.1 & 308.2.2 CBC 2007 1117B.6.3 CBC 2016 11B-308.2.1 & 11B-308.2.2</p> <p>Priority 4 Severity 4</p> <p>Mitigation Project: Replace Harbormaster Building</p> <p>Estimated Completion Date: 2020-2021</p> | 1 | JOB | \$300 | \$300 |

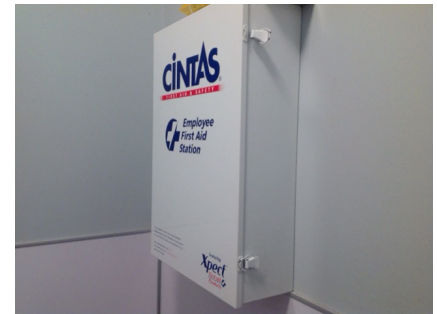
Reach Range

| 48 | <ul style="list-style-type: none"> <i>As-Built Description:</i> Reach height to control or access point, exceeds 48" or is less than 15". <i>As-Built:</i> First aid kit: 56-72" high <i>Proposed Solution:</i> Modify equipment or mounting. | <p>PCODE IE01 ADAAG 91 4.2.5 ADA 2010 308.2.1 CBC 2007 1118B.5 CBC 2016 11B-308.2.1</p> <p>Priority 4 Severity 1</p> <p>Mitigation Project: Replace Harbormaster Building</p> <p>Estimated Completion Date: 2020-2021</p> | 1 | JOB | \$100 | \$100 |

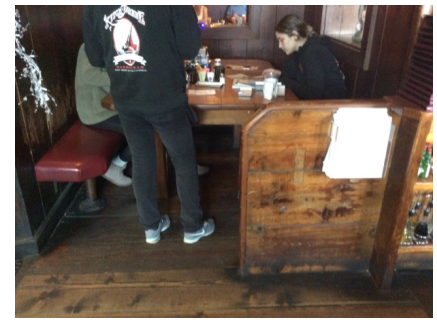
| 60 | <ul style="list-style-type: none"> <i>As-Built Description:</i> Recommended only: Accessible non-fixed table or desk (top 28" to 34" high; knee space at least 27" high x 19" deep x 30" wide) not provided. <i>As-Built:</i> Potential accessible seat blocked by partition <i>Proposed Solution:</i> Provide table or desk with accessible dimensions when purchasing new furniture. Notes: <p>At large table for 6 seats</p> | PCODE IN02AREF ADAAG 91 4.32.3 & .4 ADA 2010 306.1 CBC 2007 1122B.3 & 4 CBC 2016 11B-306.1 & 11B-902.3 Priority 2 Severity 2 | REF | | | |
