SAN MATEO COUNTY HARBOR DISTRICT  
STRATEGIC BUSINESS PLAN  
**EXISTING INFRASTRUCTURE &  
FACILITIES ASSESSMENT**  
DRAFT, DECEMBER 2014

**A.3. MARINE INFRASTRUCTURE & HARBOR FACILITIES ASSESSMENT –  
PILLAR POINT HARBOR**

**A.4. MARINE INFRASTRUCTURE & HARBOR FACILITIES ASSESSMENT –  
OYSTER POINT MARINA PARK**

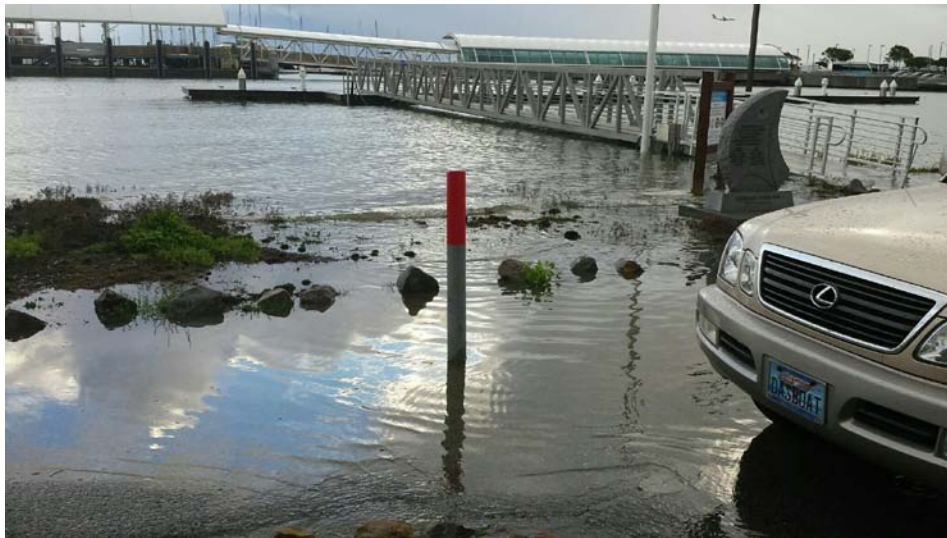
Photograph 1-Flooding at Oyster Pt.

There is frequent flooding of the parking lot between the East and West Basins at the Harbormaster's office now (see Figure 1 and cover photo), which is caused by high tides. The flooding will only get more frequent in the next 10 years. The harbor office should be moved to higher ground as placing fill to raise the ground will increase surcharge and induce settlement on the compressible landfill below.

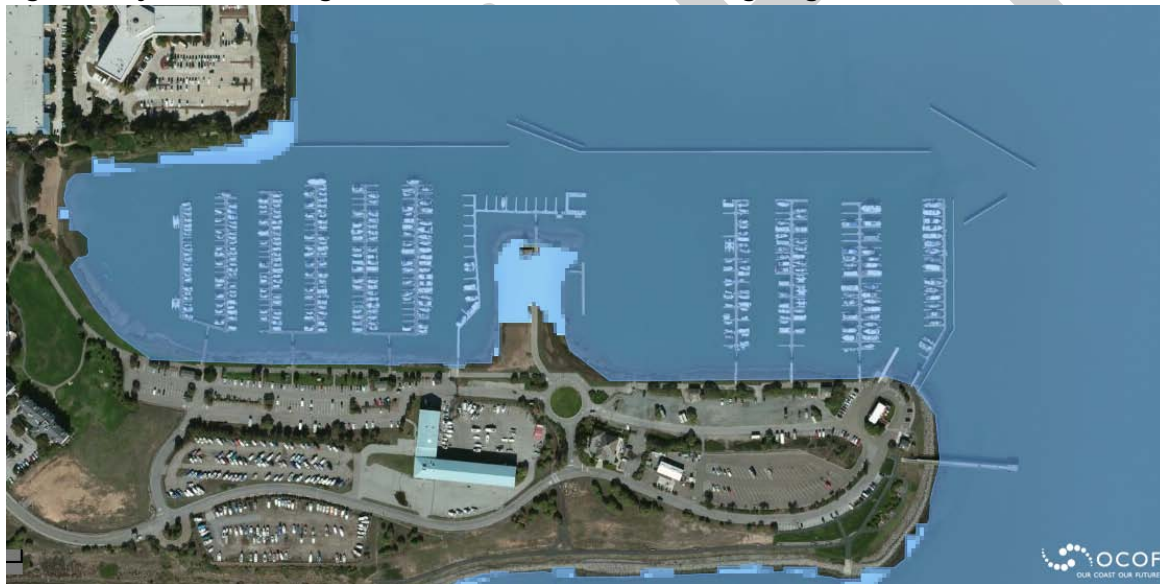
Figure 1-Oyster Pt, Existing Water Level (blue shade) During King Tides

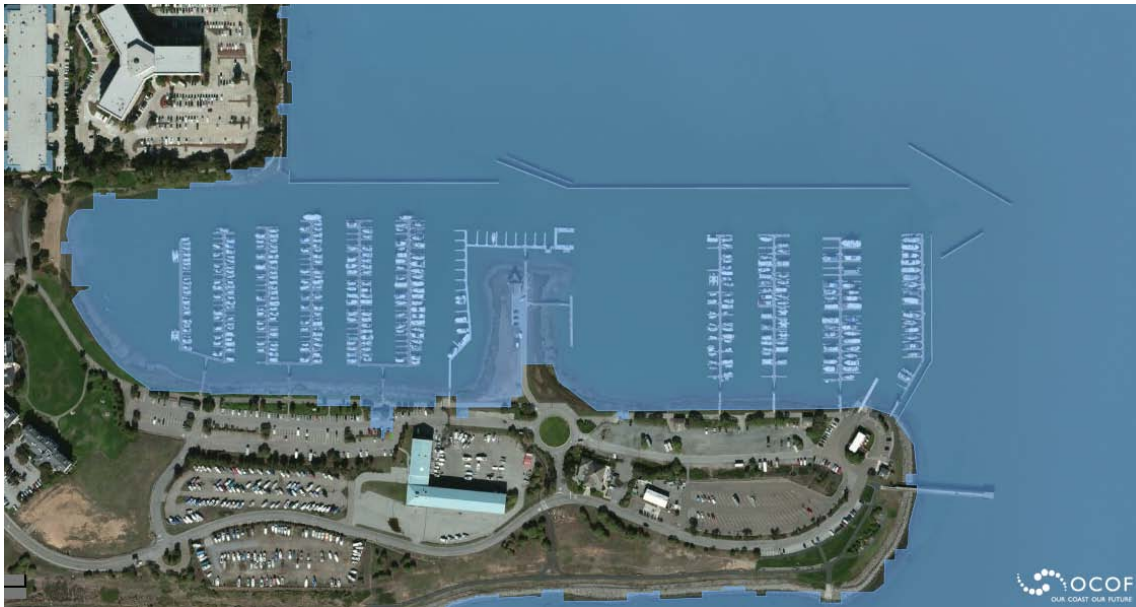
Other features that will be affected further into the future are the access gates to all the docks. Figures 2 and 3 show flooding in these areas with sea level rise from the table above. The tops of guide piles may need to be extended if they are not replaced by 2050. The elevations need to be confirmed to ensure the docks will still be restrained. The breakwater is an item of concern as well as it has been "overtopped" during combination high tides and storm surges.

Figure 2-Oyster Pt, Water Level (blue shade) During King Tides with 12 inches SLR

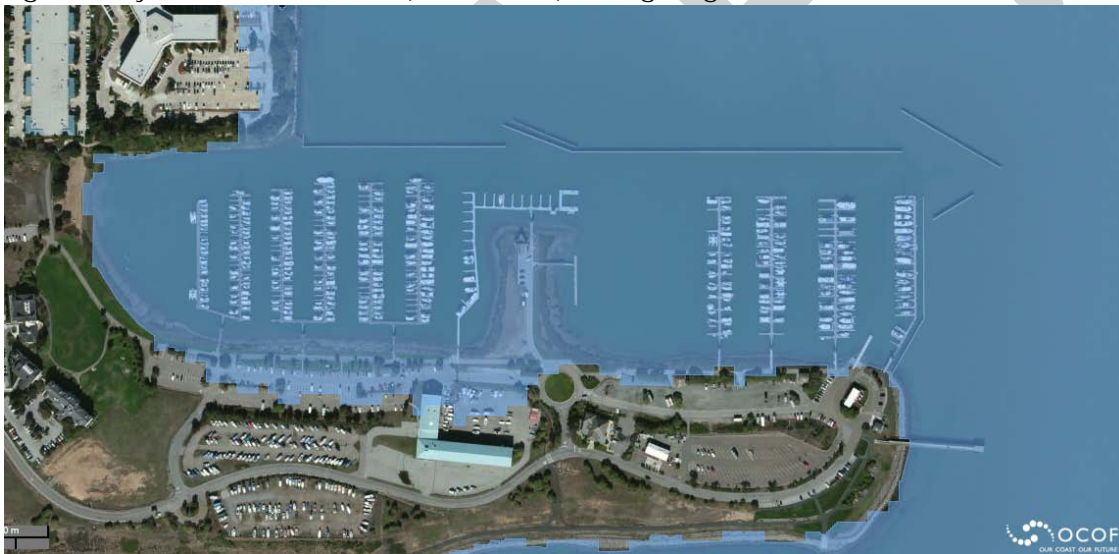
Figure 3-Oyster Pt, Water Level (blue shade) During King Tides with 36 inches SLR

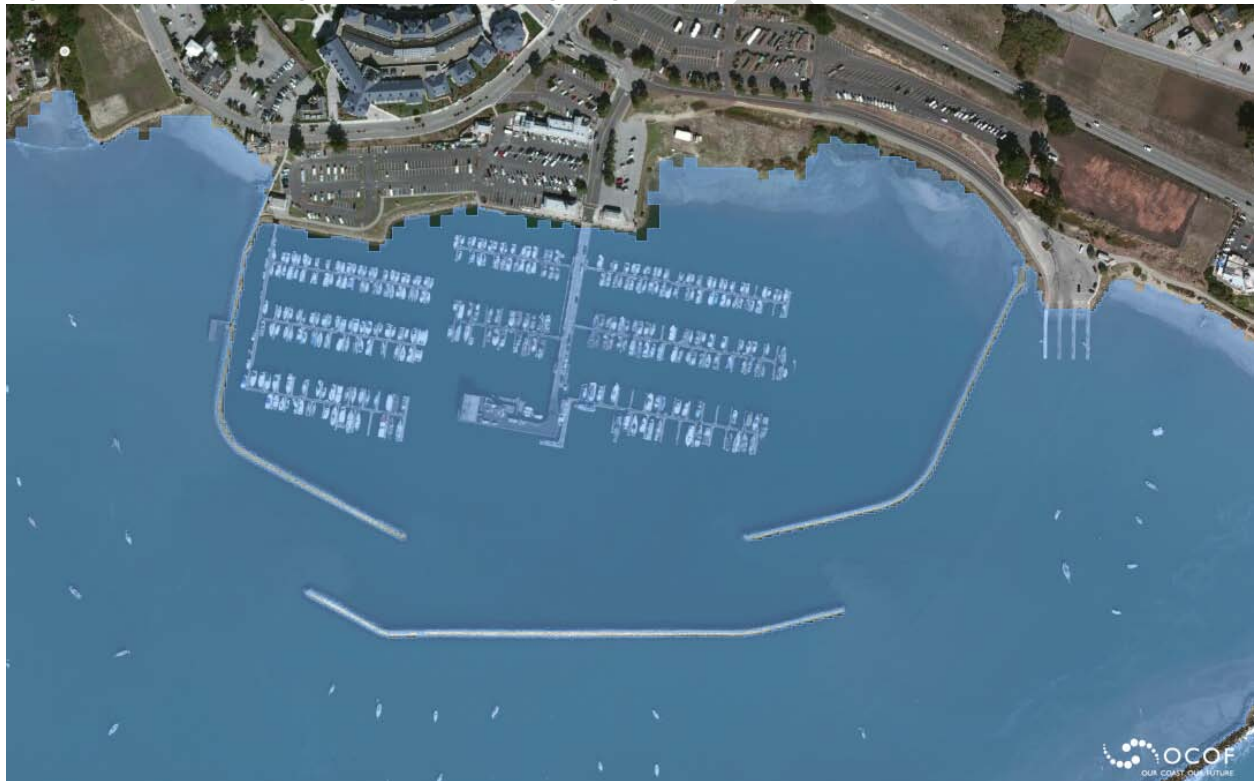
The current western slope within the harbor is sloughing down into the harbor, resulting in the rip rap falling and the soil being exposed. With SLR this will expose the bare slope to greater erosion and cutting back of the soil. The rip rap protection should be repaired or a seawall installed similar to the portion at the Harbormaster Building and East Basin.

Figure 4-Pillar Pt, Existing Water Level During King Tides

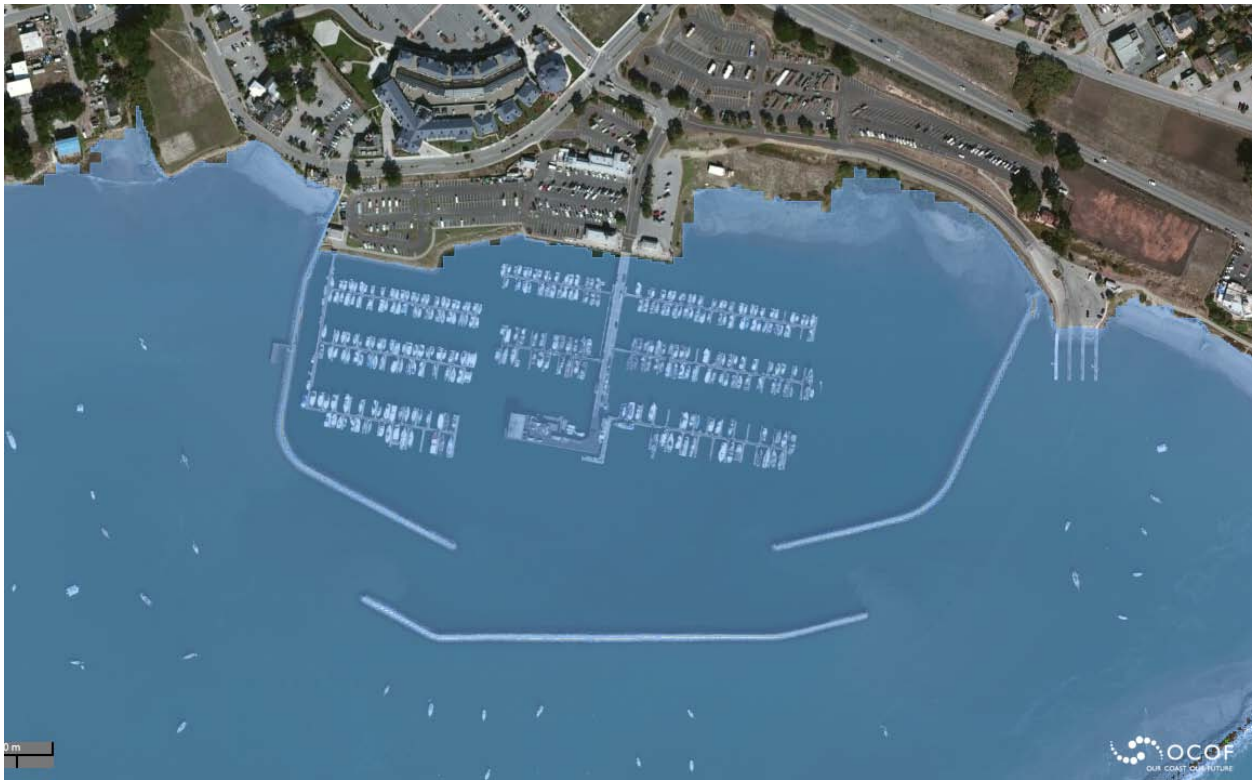
Figure 5-Pillar Pt, Existing Water Level During King Tides with 36 inches SLR

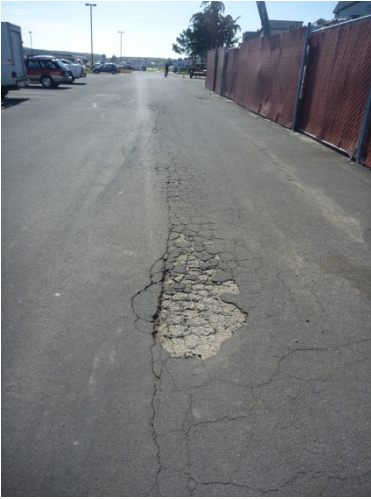
*PHOTOGRAPH 13: POTHOLES & ALLIGATOR CRACKING WEST PARKING LOT*

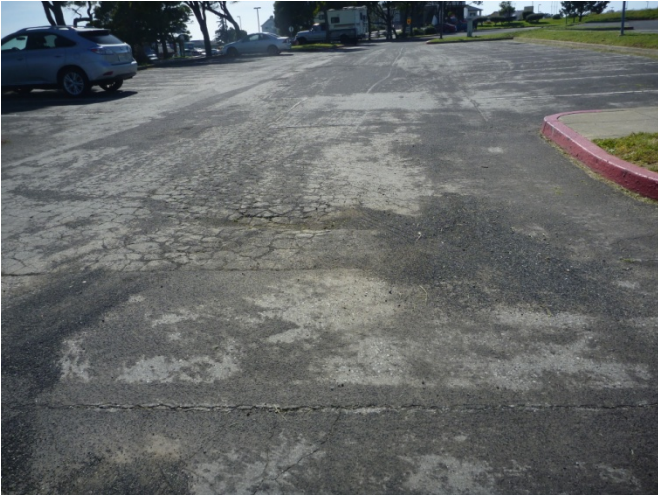
*PHOTOGRAPH 14: ALLIGATOR CRACKING NORTH PARKING LOT*

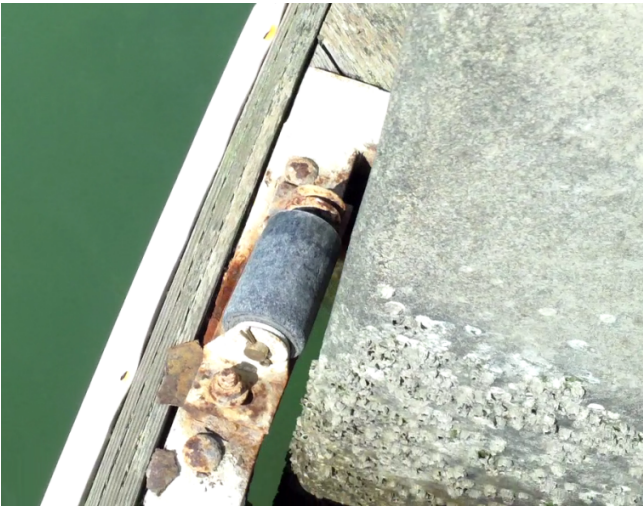
PHOTOGRAPH 1: TYPICAL PILE GUIDE -GOOD  
CONDITION (DOCK)

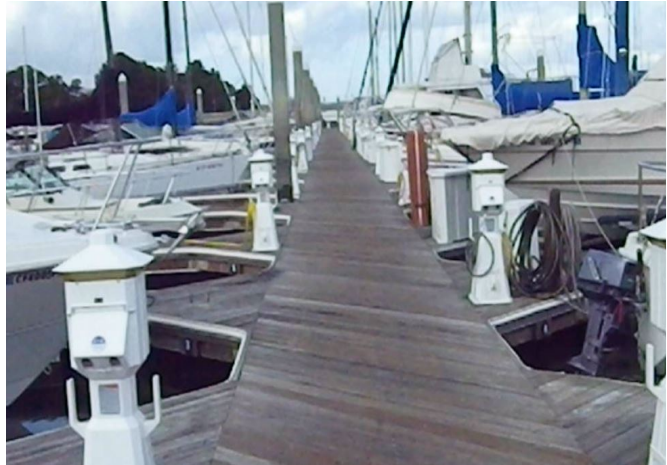
PHOTOGRAPH 2: PILE GUIDE DAMAGE – DOCK 1,  
SLIP 6-8

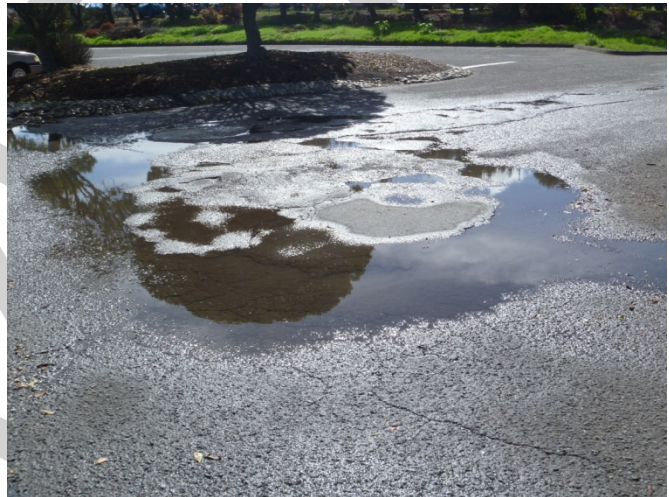
PHOTOGRAPH 9: POTHoles & ALLIGATOR  
CRACKING

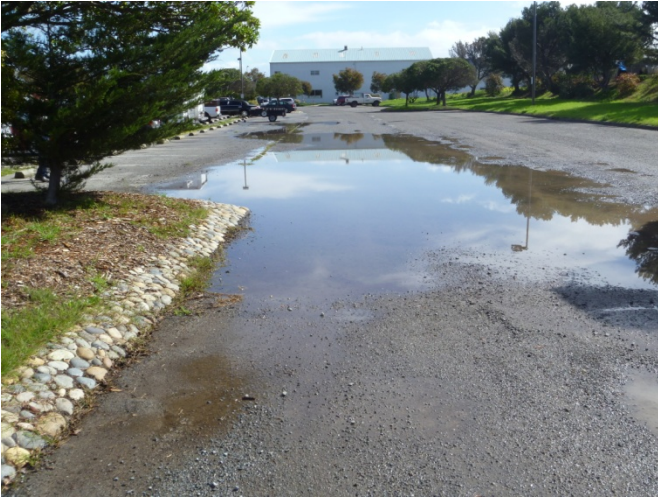
PHOTOGRAPH 10: STANDING WATER

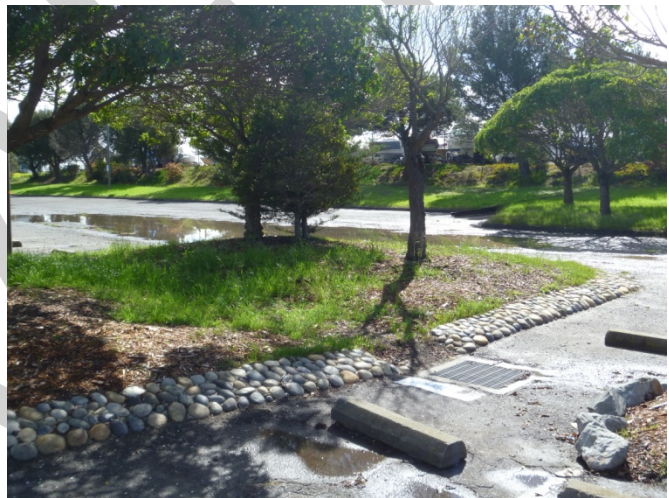
PHOTOGRAPH 14: STORM DRAIN AND STANDING WATER IN OYSTER POINT PARKING LOT
