San Mateo County Harbor District Oyster Point Marina & Park Marina Facility Condition Survey

November 2014

The purpose of this report is to provide a summary of the facility condition surveys (FCS) performed at the Oyster Point Marina & Park (Oyster Point) located on the San Francisco Bay in the City of South San Francisco, California. San Mateo County Harbor District (SMCHD) asked Moffatt & Nichol (M&N) to visually inspect and evaluate the conditions of the waterside and shoreside structures at the facility. This report identifies the components that require repairs, a prioritized schedule for repair and maintenance of each survey component (i.e., docks, hoists, buildings, etc.), and costs for repair.

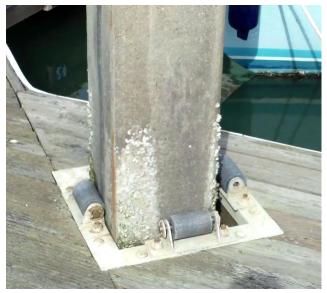
Photograph 1: Typical Pile Guide -Good Condition (Dock1)

The pile guides at all the docks consist of steel angles bolted to the dock surface. Photograph 1 in Attachment A shows a typical pile guide in good condition. The pile guides are generally in good condition, with a few exceptions. The following pile guides should be replaced within the next two years due to missing bolts or corrosion, four pile guides at Dock 1 (Photograph 1 and Photograph 2,) one at Dock 2, and one at Dock 3.

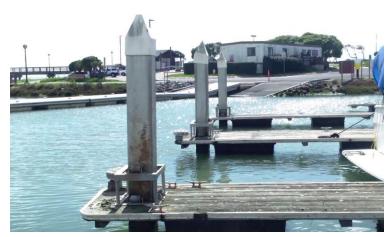
Photograph 2b-Dock 13 Fingers

The condition of docks 12 through 14 is to the point where it would not be worthwhile to repair; it would be better to replace the entire dock (except for the new concrete end portions).

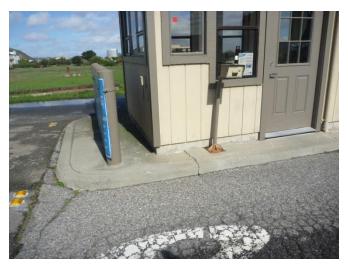
Photograph 4: Kiosk Building

This is a small one story 100 square foot building constructed in the early 1980s and structurally appears to be in fair condition. The roof consists of conventional wood framing over stud walls with a 4" thick slab on grade. The finishes consist of wood shake roofing, exterior T1-11wood siding and interior gypsum board. The raised concrete pad beyond the kiosk's foundation appears to have settlement cracks (Photograph 4).

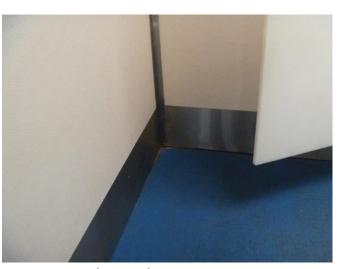
Photograph 7: Restroom #4

These one story 440 square foot buildings appear to be in fair condition structurally. No information was provided on the age of construction. They are conventionally framed wood buildings with similar dimensions and layout. The roofing is asphalt shingle over 2x decking over 2x stud bearing walls. They have a slab on grade foundation. The exterior finish is T1-11 siding and the interior is finished fiberglass panels over particle board. The particle board was installed between the wall framing making it difficult to remove. The exterior of the building has ornamental timber poles and roof outriggers. It was reported that the interior particle board has been replaced in some areas due to swelling and moisture damage. Swelling of the wall panels was observed in the men's restroom at a few locations (Photograph 7).

Both restrooms have non-compliant ramp approaches to the restroom facilities. Siding and other exterior finishes are in worn condition with some areas of the trim beginning to separate from the building. The exterior doors are also worn and have handles and hardware that are beginning to fail.

The interior finishes are generally worn. The floors throughout are fading and cracked. The toilet partitions show signs of abuse and the fixtures need to be updated and replaced. The metal base trim around the walls is separating in some areas and showing signs of corrosion. Benches in the shower areas are worn and show signs of rot.

- 1. Replacing floors throughout
- 2. Upgrading fixtures; including partitions
- 3. Repairing walls and metal wall trim
- 4. Replacing exterior doors and hardware

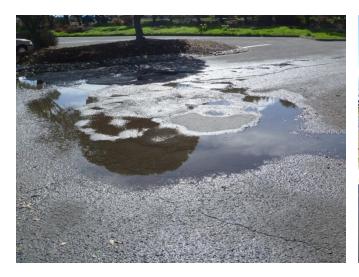
Photograph 9: Potholes & Alligator Cracking

The roads appear to be in a worn condition with the exception of the new asphalt concrete pavement in the east basin. Potholes and alligator cracking (Photograph 9) were observed as well as standing water due to inadequate drainage (Photograph 10).

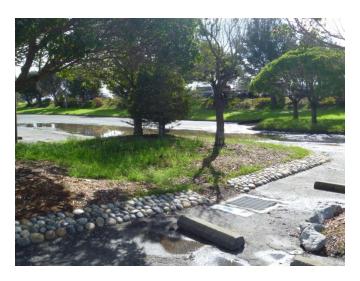
Photograph 14: Storm Drain and Standing Water in Oyster
Point Parking Lot

The parking lot appeared to have a storm drain system with drop inlets near the landscaping areas but standing water was observed in the parking area (Photograph 14). It may be prudent to have further investigation of the underground storm drain system.

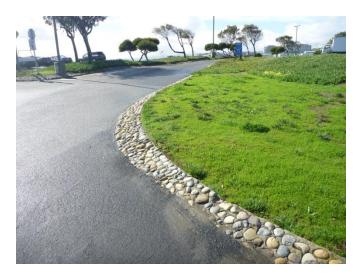
Photograph 15: Landscaping

The landscaping area by the boat launch ramp consisted of trimmed lawn in good condition. The landscaping near the fishing pier appeared to be native foliage in worn condition. The landscaping near the parking lots appeared to be in fair condition (Photograph 15) and well maintained.
