SAN MATEO
RESOURCE
CONSERVATION
DISTRICT

PPH Water Quality Assistance Update

First Flush 2021 Water Quality Results

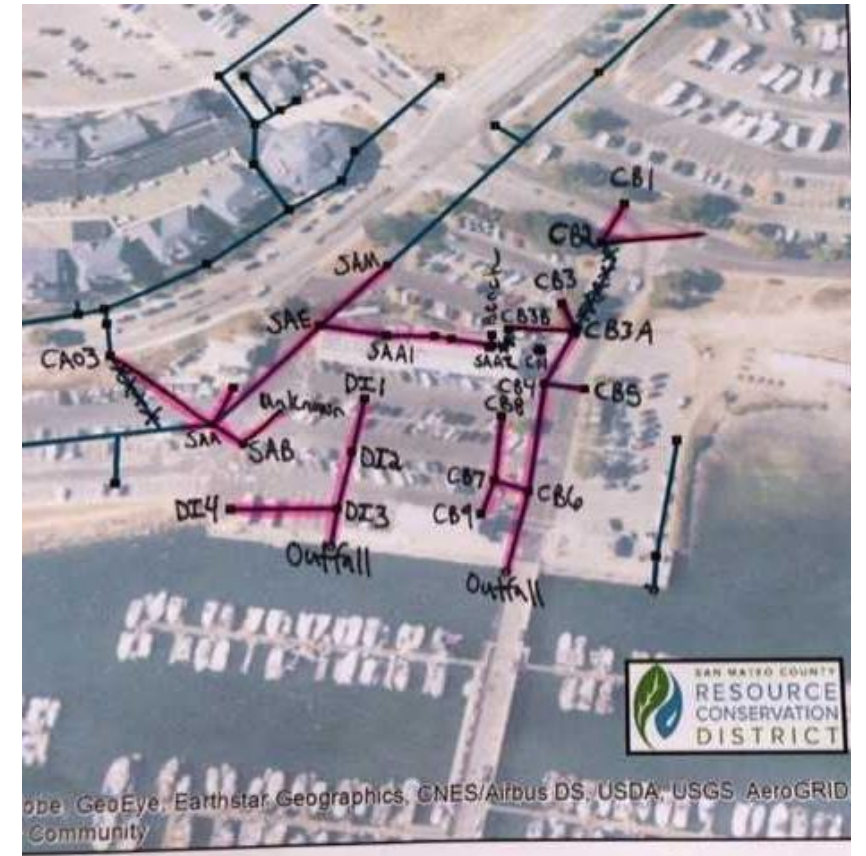
South Stormwater Lines

- TMDL Implementation Actions:
 1. “Inspect sewer and stormwater laterals and all other components connecting facilities at Pilar Point Harbor to the sanitary sewer system”
 2. “Evaluate effectiveness and proper performance of sewage collection systems (sewage dump stations, sewage pumpout stations, sewer lines, etc.) for the harbor marine and harbor amenities”
- Re-inspect stormwater lines with #4 rating
 - DI1 → DI2: drains to Inner Harbor Outfall
 - DI3 → Outfall (First Flush Site)
 - CB3B → CB31
 - SAB → Unknown

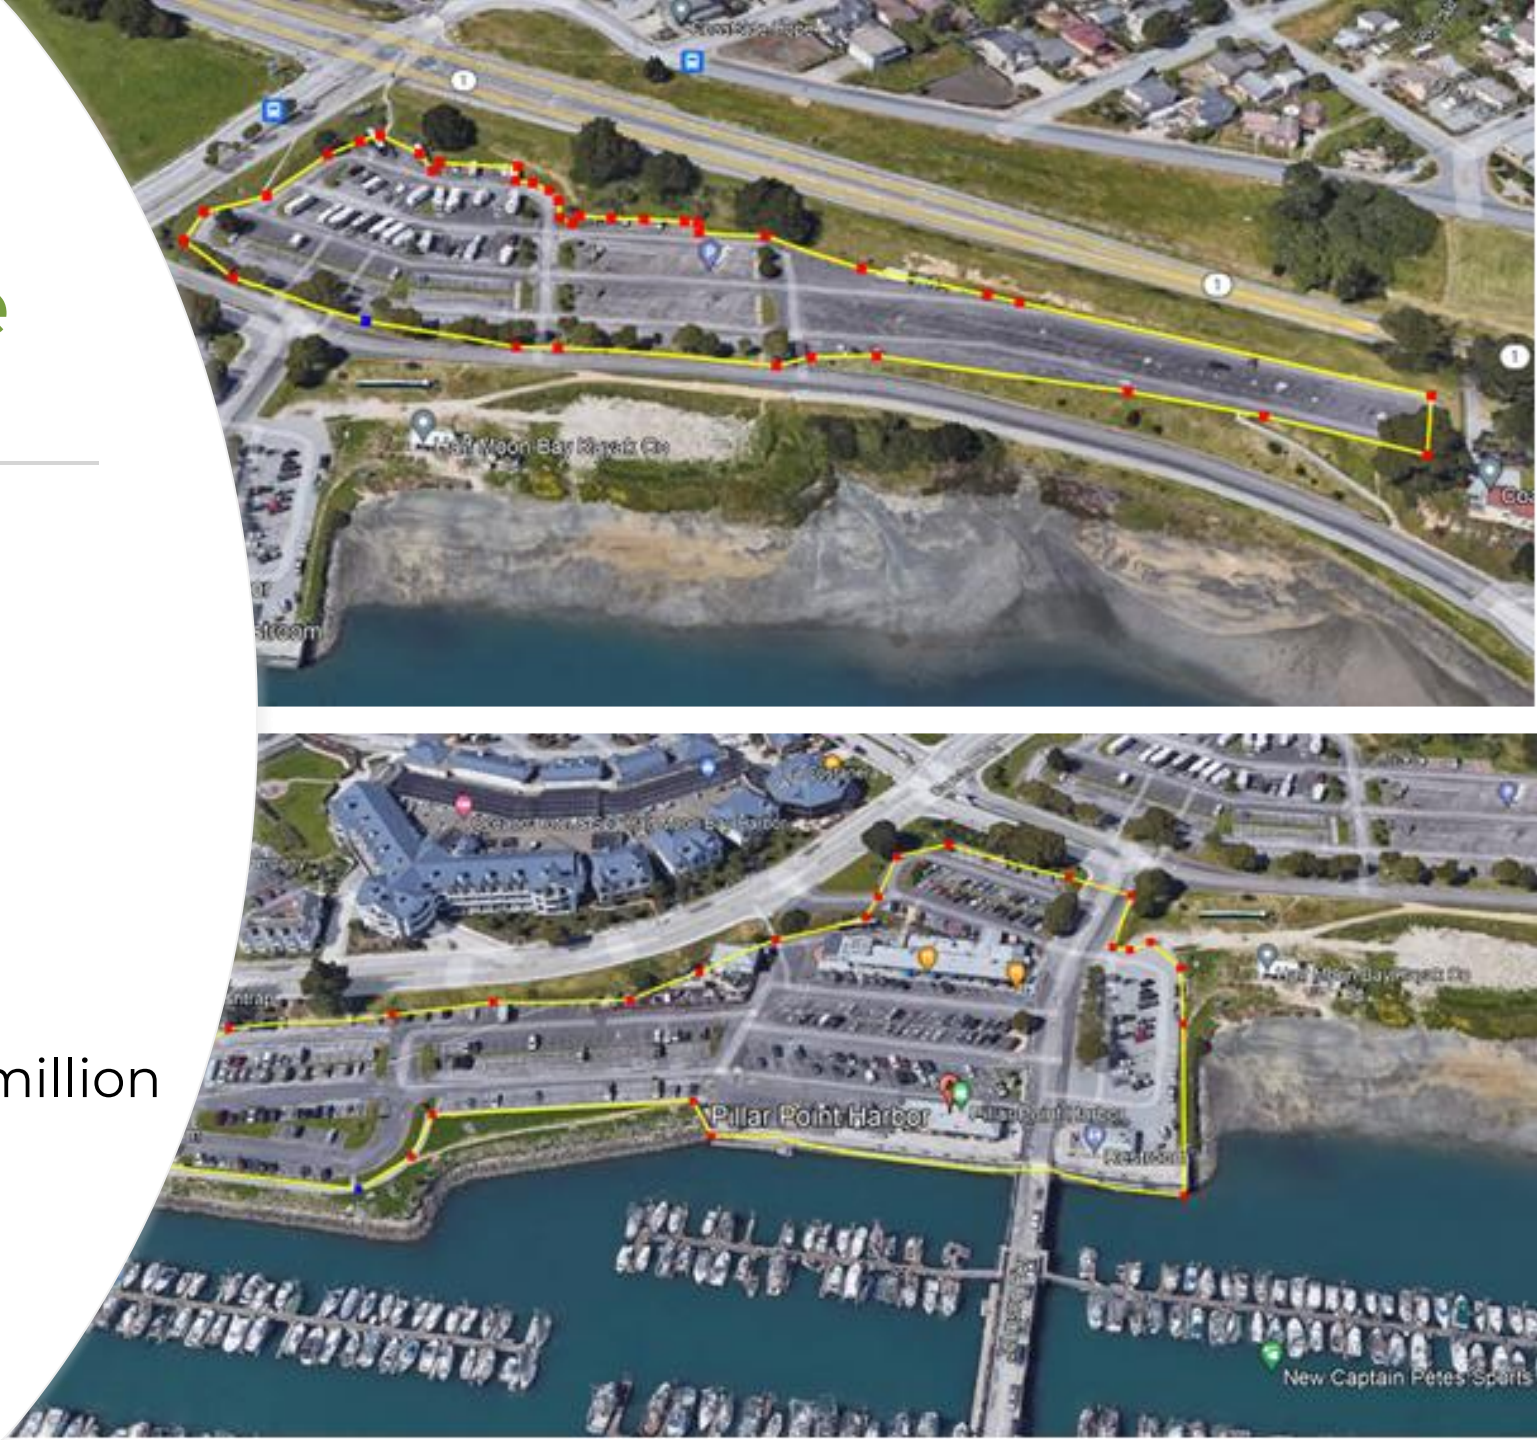
- DWR Grant submitted
- Water resources project
- Co-benefits:
 - Water quality
 - Water security
 - Beautification/greening
- Lot Area = ~435,000 sq ft
- Average capture potential = ~5-million gallons*
- Usage offset potential = 86%

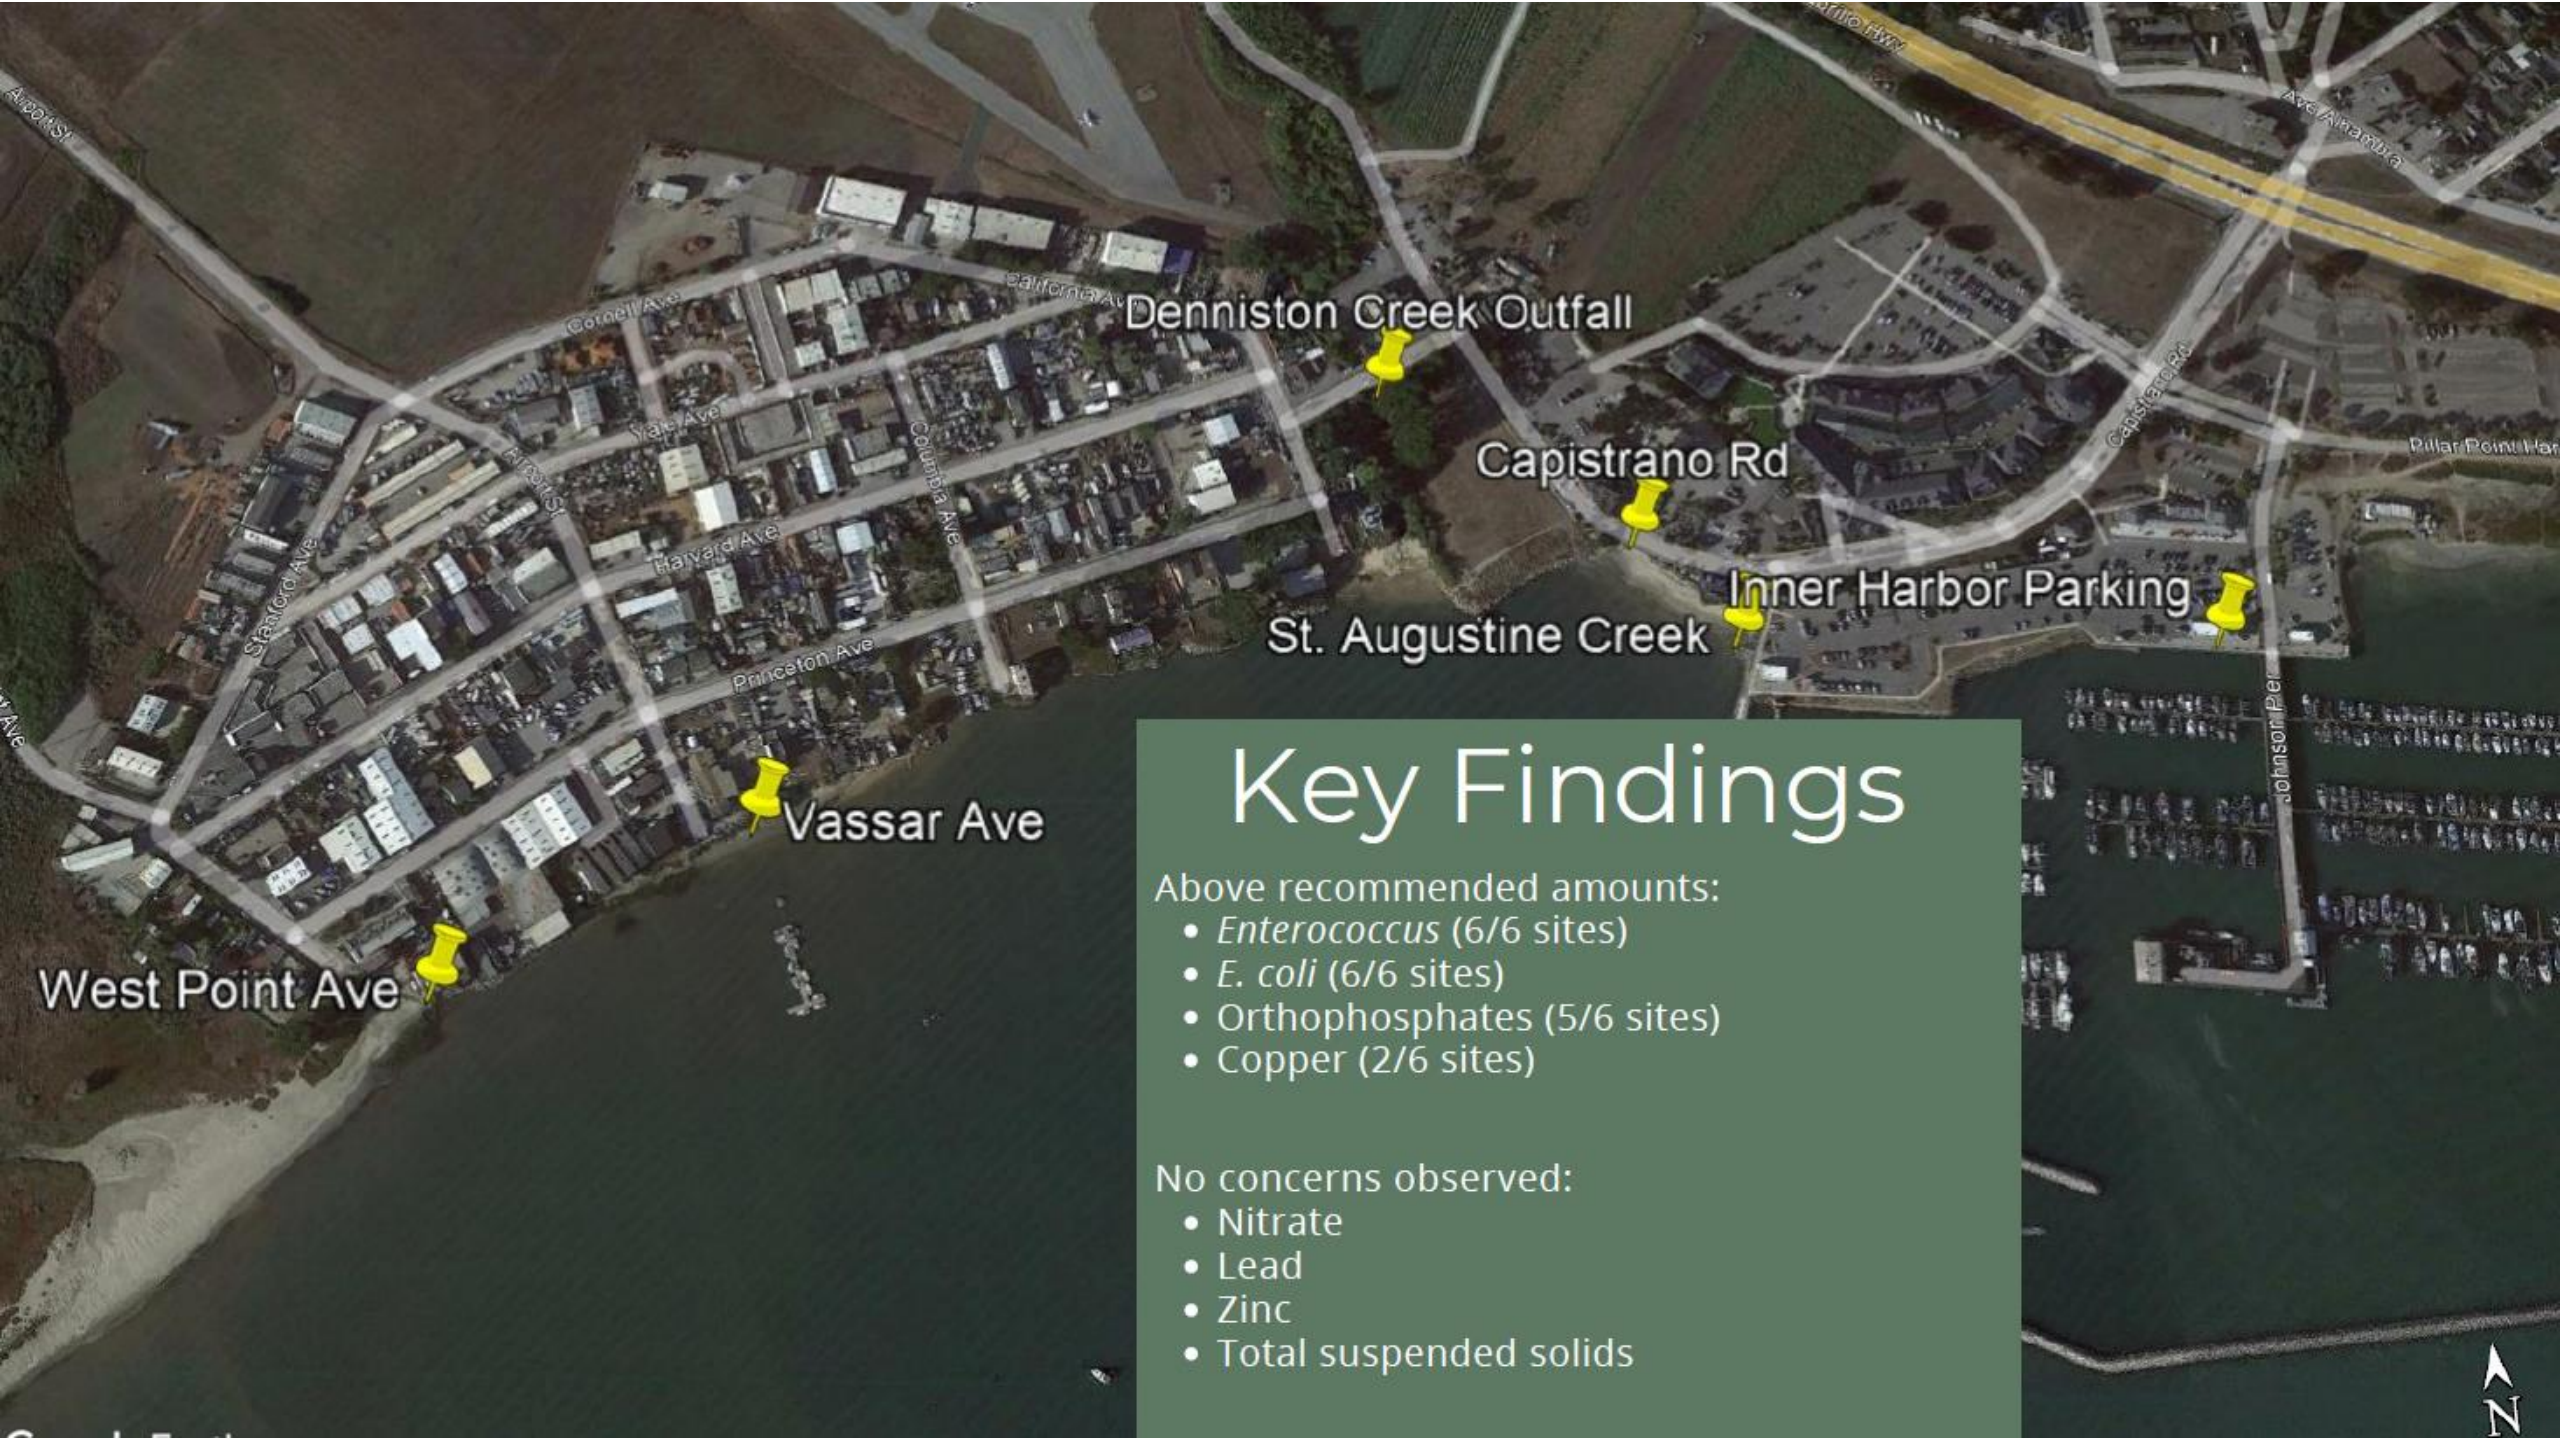
Denniston Creek Outfall

Capistrano Rd

Inner Harbor Parking

St. Augustine Creek

Vassar Ave

West Point Ave

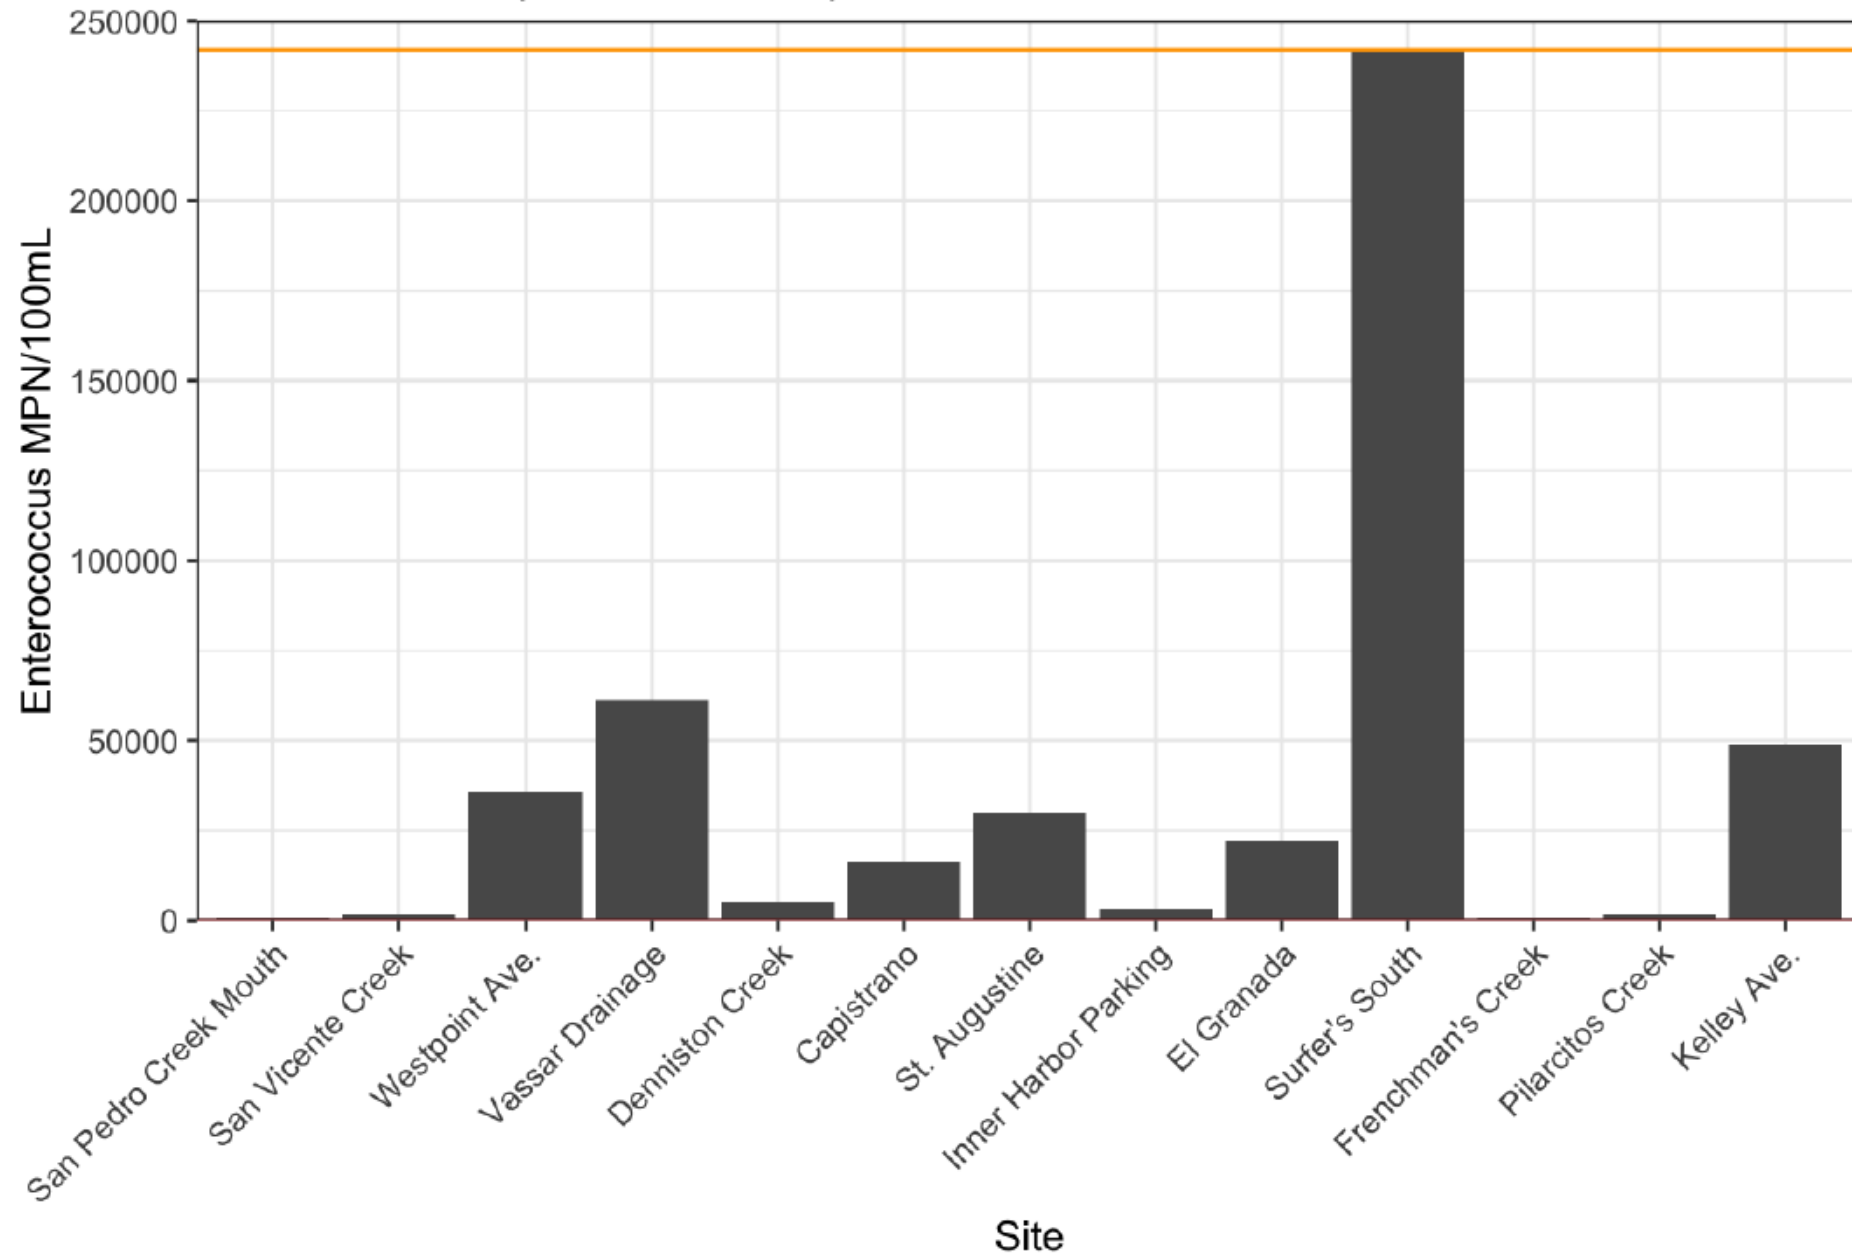
Enterococcus (1:100 Dilution)

Key Findings

Above recommended amounts:

- *Enterococcus* (6/6 sites)
- *E. coli* (6/6 sites)
- Orthophosphates (5/6 sites)
- Copper (2/6 sites)
