San Mateo County Harbor District Pillar Point Harbor Marina Facility Condition Survey

December 2014

The purpose of this report is to provide a summary of the facility condition survey (FCS) performed at Pillar Point Marina (Pillar Point) located in Half Moon Bay, California. San Mateo County Harbor District (SMCHD) asked Moffatt & Nichol (M&N) to visually inspect and evaluate the conditions of the waterside and shoreside structures at the facility. This report identifies the components that require repairs, a prioritized schedule for repair and maintenance of each survey component (i.e., docks, hoists, buildings, etc.), and costs for repair.

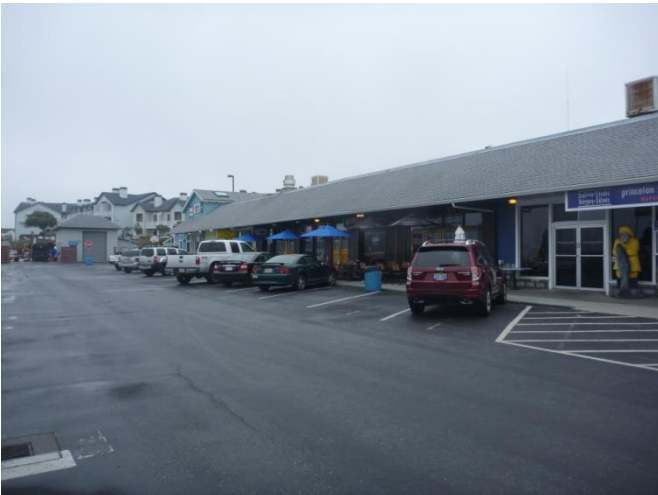
Photograph 8: Tenant Row & Parking

The sidewalks appear to be in good condition, however the sidewalk at the tenant building is not ADA compliant (Photograph 8).

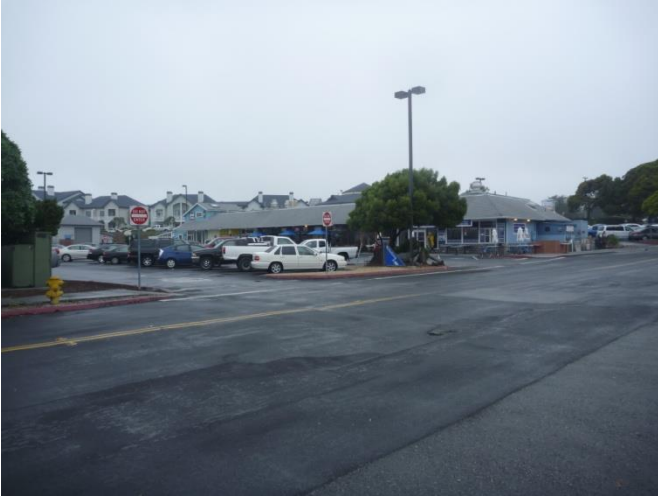
Photograph 12: Roads

The roads appear to be in fair condition (Photograph 12) with some alligator cracking in the asphalt pavement.

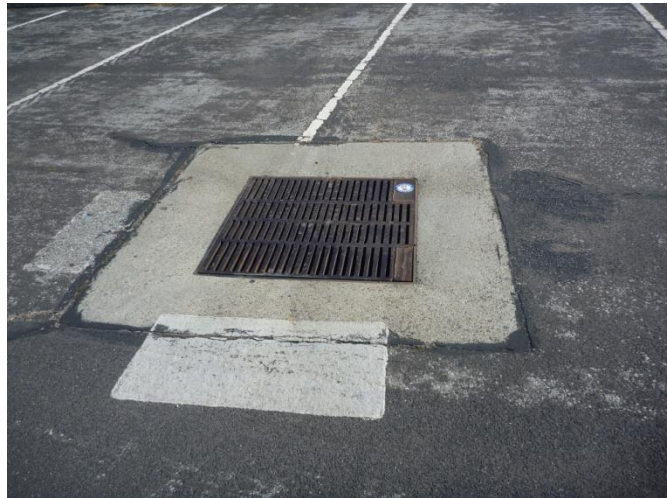
Photograph 15: Storm Drain Drop Inlet

The parking lot storm drain system appeared to be in good condition with drop inlets in the roadway (Photograph 15). It may be prudent to have testing and further investigation of the underground storm drain system.

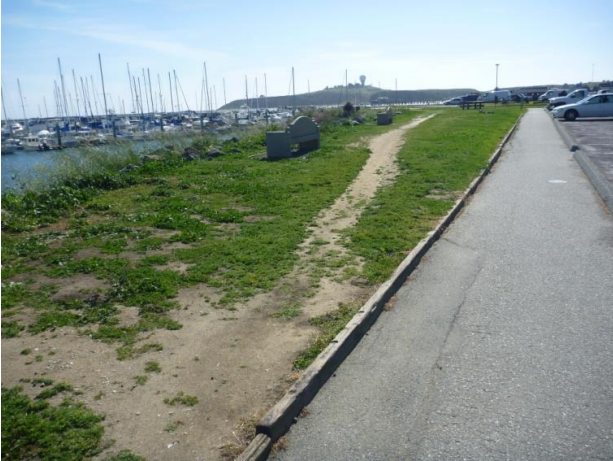
Photograph 16: Landscaped Area Between Parking Lot & Harbor Waters

Landscaping is minimal since most of the site is paved. The area between the parking lot and the harbor waters had ground cover that was mowed but appeared natural with a pathway (Photograph 16) The parking lots had landscaped areas with miscellaneous nautical themed items displayed (Photograph 17). The trees located in the parking lot appear to be in good condition. There is a small area that has been recently improved located behind Tenant Row and is in new
