SAN MATEO COUNTY HARBOR DISTRICT

ADA Self-Evaluation and Transition Plan

August 2018

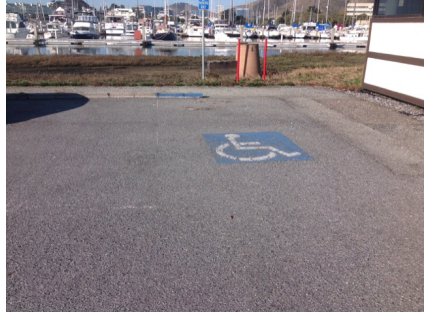
| 4 | <ul style="list-style-type: none"> <i>As-Built Description:</i> Accessible parking space smaller than 8' wide (CA only: 9' x 18'). <i>As-Built:</i> Parking spaces are not clearly defined <i>Proposed Solution:</i> Modify parking space(s) to create accessible space. <i>Notes:</i> Striping is faded | <p>PCODE EA02AREF ADAAG 91 4.6.3 ADA 2010 502.2 CBC 2007 1129B.3.1 CBC 2016 11B-502.2</p> <p>Priority 1 Severity 2</p> | | | | REF |

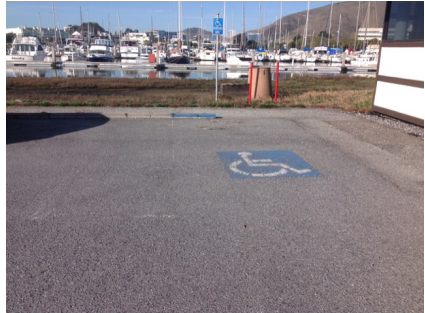
| 7 | <ul style="list-style-type: none"> <i>As-Built Description:</i> Accessible parking space does not have 5' wide access aisle; 8' wide for van accessible aisle. <i>As-Built:</i> 4' wide aisle <i>Proposed Solution:</i> Modify parking aisle(s) to create accessible space by restriping. <i>Notes:</i> Based on stripings of a past aisle. Provide a new 8' wide aisle on passenger side of van accessible space when remodeling area. | <p>PCODE EA02BREF ADAAG 91 4.6.3 ADA 2010 502.3 CBC 2007 1129B.3.1 CBC 2016 11B-502.2; 11B-502.3.1</p> <p>Priority 1 Severity 1</p> | | | | REF |

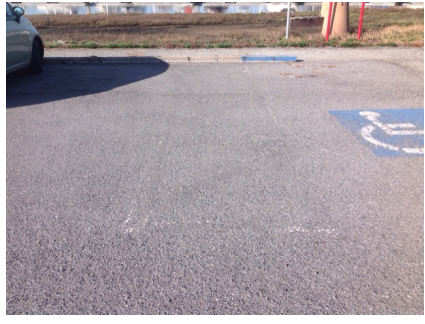
| 6 | <ul style="list-style-type: none"> <i>As-Built Description:</i> International Symbol of Accessibility (36" square, in white on blue) is not painted on the pavement near the rear end of the parking space (required in CA only). <i>As-Built:</i> Not located near the rear end of parking space <i>Proposed Solution:</i> Apply symbol on parking space pavement when altering area. | <p>PCODE EA04A CBC 2007 1129B.4 CBC 2016 11B-502.6.4.1</p> <p>Priority 1 Severity 4</p> | 1 | JOB | \$120 | \$120 |

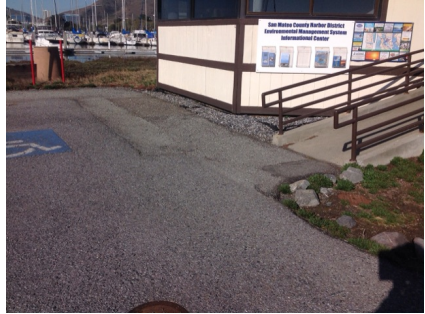
| Item No. and Name | Existing Architectural Barrier and Proposed Solution | Codes / Mitigation Info | Qty | Unit | Cost | Total |
|---|--|---|---|---|---|---|
| 10 | <ul style="list-style-type: none"> <i>As-Built Description:</i> 36" wide band of truncated domes not provided at walkway or crossing adjoining a vehicular way, if surfaces are not separated by a curb, railing, or other element. <i>Proposed Solution:</i> Provide 36" wide, contrasting color, band of truncated domes between pedestrian and vehicular area. <i>Notes:</i> Provide at bottom of ramp serving Harbor Master office | PCODE EG09 ADAAG 91 4.29.5 CBC 2007 1133B.8.5 CBC 2016 11B-705.1.2.5 Priority 1 Severity 3 | 5 | LF | \$27 | \$135 |

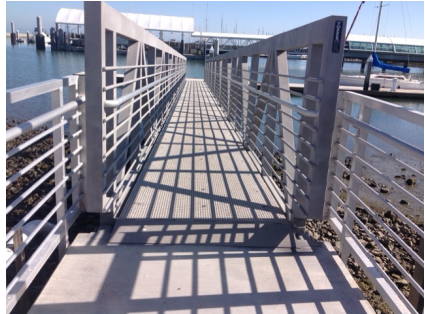
| <u>Recreational Boating Facilities</u> | | | | | | |
|---|---|--|---|--|--|--|
| 59 | <ul style="list-style-type: none"> <i>As-Built Description:</i> Barriers identified along the gangway ramp are compliant per meeting one or more of the exceptions specified for recreational boating facilities. <i>As-Built:</i> 90' long gangway ramp meets exceptions <i>Proposed Solution:</i> No changes necessary. <i>Notes:</i> 8% slope at transition from gangway ramp to boat slip | PCODE NZ01 ADA 2010 1003.2 CBC 2016 11B-1003.2 Priority 2 - | REF | | | |

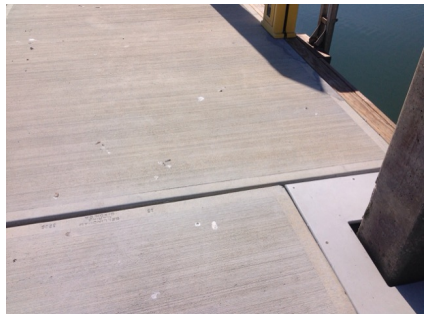
| <u>Walkway Surface</u> | | | | | | |
|---|--|--|---|---|---|---|
| 61 | <ul style="list-style-type: none"> <i>As-Built Description:</i> The sidewalk has a highly irregular pavement surface due to excessive cracks and gaps along path of travel. <i>As-Built:</i> Occurs at concrete joints <i>Proposed Solution:</i> Smooth pavement surface as necessary, by grinding, filling, or refinishing. | PCODE PR18A ADAAG 91 4.5.2 PROW R302.7.1 CBC 2007 1133B.7.1 CBC 2016 11B-303.2 Priority 2 Severity 4 | 45 | SF | \$10 | \$450 |

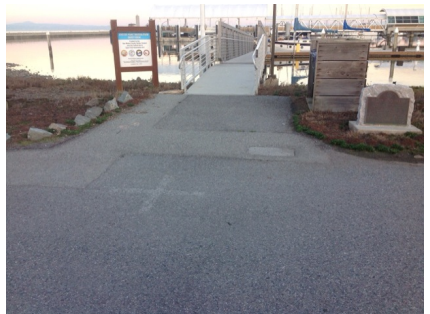
| Item No. and Name | Existing Architectural Barrier and Proposed Solution | Codes / Mitigation Info | Qty | Unit | Cost | Total |
|---|--|--|---|---|---|---|
| 192 | <ul style="list-style-type: none"> <i>As-Built Description:</i> 36" wide band of truncated domes not provided at walkway or crossing adjoining a vehicular way, if surfaces are not separated by a curb, railing, or other element. <i>Proposed Solution:</i> Provide 36" wide, contrasting color, band of truncated domes between pedestrian and vehicular area. | <p><i>PCODE</i> EG09 <i>ADAAG 91</i> 4.29.5 <i>CBC 2007</i> 1133B.8.5 <i>CBC 2016</i> 11B-705.1.2.5</p> <p>Priority 2 Severity 3</p> | 10 | LF | \$27 | \$270 |

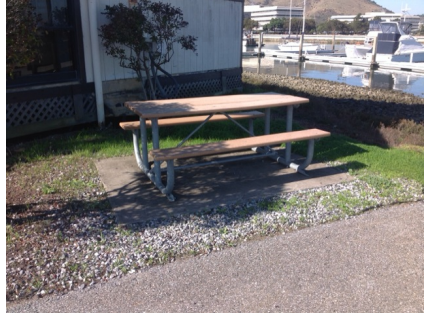
| Item No. and Name | Existing Architectural Barrier and Proposed Solution | Codes / Mitigation Info | Qty | Unit | Cost | Total |
|---|---|---|---|---|---|---|
| 63 | <ul style="list-style-type: none"> <i>As-Built Description:</i> Single fixed picnic table is not connected to an outdoor recreation access route. <i>Proposed Solution:</i> Provide connection to recreation access route. | <p>PCODE NH02 ADAAG 91 16.5.1.1. ADA 2010 206.2.2 CBC 2007 1132B.1 CBC 2016 11B-206.2.2</p> <p>Priority 2 Severity 2</p> | 10 | LF | \$45 | \$450 |

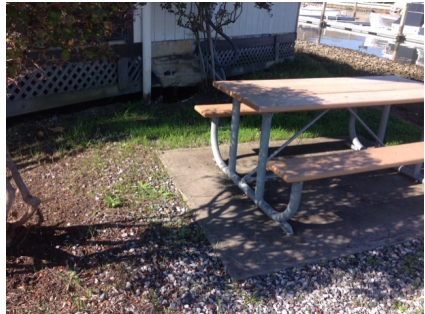
| Item No. and Name | Existing Architectural Barrier and Proposed Solution | Codes / Mitigation Info | Qty | Unit | Cost | Total |
|---|---|---|---|---|---|---|
| 64 | <ul style="list-style-type: none"> <i>As-Built Description:</i> Knee clearance at minimums 27" high, 30" wide, and 19" deep is not provided. <i>As-Built:</i> 4" deep <i>Proposed Solution:</i> Modify picnic table as required to provide knee clearance. | <p>PCODE NH11A ADAAG 91 16.5.4. ADA 2010 306.3 CBC 2007 1132B.1 CBC 2016 11B-306.3</p> <p>Priority 2 Severity 2</p> | 1 | JOB | \$850 | \$850 |

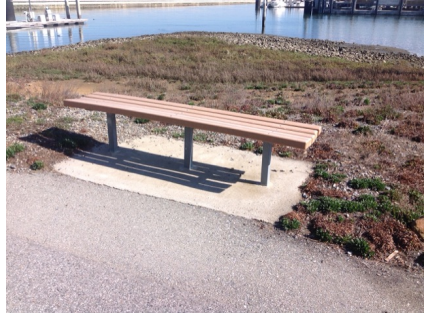
| Item No. and Name | Existing Architectural Barrier and Proposed Solution | Codes / Mitigation Info | Qty | Unit | Cost | Total |
|---|---|---|---|---|---|---|
| 62 | <ul style="list-style-type: none"> <i>As-Built Description:</i> Clear and level floor or ground space (30" x 48") not overlapping with other clear space requirements, is not provided at at least one end of the bench. <i>Proposed Solution:</i> Provide and position a clear and level floor or ground space to allow wheelchair users to be seated shoulder-to-shoulder with an individual seated on the bench. | <p>PCODE N007 ADAAG 91 4.32.2 ADA 2010 903.2 CBC 2007 1118B.4 CBC 2016 11B-903.2</p> <p>Priority 2 Severity 3</p> | 1 | JOB | \$500 | \$500 |

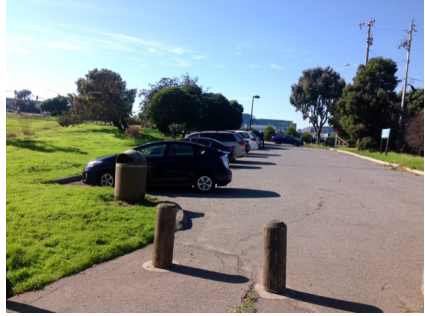
| Item No. and Name | Existing Architectural Barrier and Proposed Solution | Codes / Mitigation Info | Qty | Unit | Cost | Total |
|---|---|---|---|---|---|---|
| 66 | <ul style="list-style-type: none"> <i>As-Built Description:</i> At parking lot with 1-25 spaces, the number of accessible spaces is less than required by code; 1 space required <i>Proposed Solution:</i> Provide required accessible parking space with sign including a minimum of one van space. <i>Notes:</i> 13 total spaces 0 accessible spaces | PCODE EA01A ADAAG 91 4.1.2(5) ADA 2010 208.2 CBC 2007 Tbl. 11B-6 CBC 2016 11B-208.2 Tbl. 11B-208.2 Priority 1 Severity 3 | 1 | JOB | \$300 | \$300 |

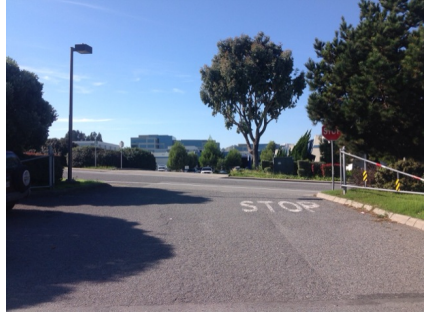
| 65 | <ul style="list-style-type: none"> <i>As-Built Description:</i> No "Tow Away" sign at parking lot entrance (required in CA only). <i>As-Built:</i> No tow away sign provided <i>Proposed Solution:</i> Provide "Tow Away" sign at parking lot entrance when altering area. | PCODE EA04C CBC 2007 1129B.4 CBC 2016 11B-502.8.2 Priority 1 Severity 4 | 1 | JOB | \$325 | \$325 |

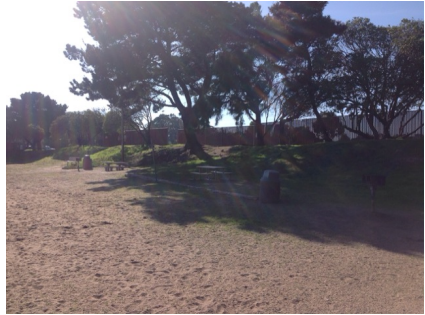
| 71 | <ul style="list-style-type: none"> <i>As-Built Description:</i> Ramp needed to provide disabled access at steps or change of level along path of travel. <i>Proposed Solution:</i> Provide new concrete ramp with handrails [slope more than 1:20 (5.0%) needed]. <i>Notes:</i> Install ramp close to all picnic elements | PCODE EB01A ADAAG 91 4.1.1 ADA 2010 303.4 CBC 2007 1127B.1 CBC 2016 11B-303.4 Priority 1 Severity 3 | 500 | SF | \$100 | \$50,000 |

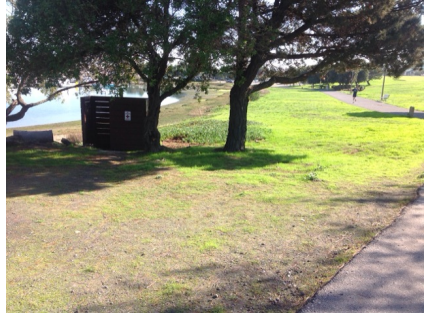
| Item No. and Name | Existing Architectural Barrier and Proposed Solution | Codes / Mitigation Info | Qty | Unit | Cost | Total |
|---|--|--|---|---|---|---|
| 74 | <ul style="list-style-type: none"> • <i>As-Built Description:</i> No walk / sidewalk provided to connect accessible facilities or elements that are on the same site. • <i>As-Built:</i> To outdoor rinse station • <i>Proposed Solution:</i> Provide new 48" wide walk / sidewalk. | <p>PCODE EF13 ADAAG 91 4.3.2 ADA 2010 206.1 CBC 2007 1114B.1.2 CBC 2016 11B-206.1</p> <p>Priority 1 Severity 3</p> | 120 | LF | \$45 | \$5,400 |

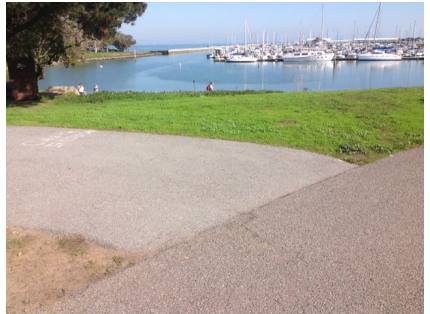
| Item No. and Name | Existing Architectural Barrier and Proposed Solution | Codes / Mitigation Info | Qty | Unit | Cost | Total |
|---|--|--|---|---|---|---|
| 69 | <ul style="list-style-type: none"> • <i>As-Built Description:</i> Walk: Slope greater than 1:20 (5.0%), and walk does not comply with requirements for ramps. • <i>As-Built:</i> 6.0% to 9.3% • <i>Proposed Solution:</i> Modify walk/sidewalk slope to 1:20 or less. | <p>PCODE EF01 ADAAG 91 4.3.7 ADA 2010 403.3 CBC 2007 1133B.7.3 CBC 2016 11B-403.3</p> <p>Priority 1 Severity 3</p> | 60 | SF | \$25 | \$1,500 |

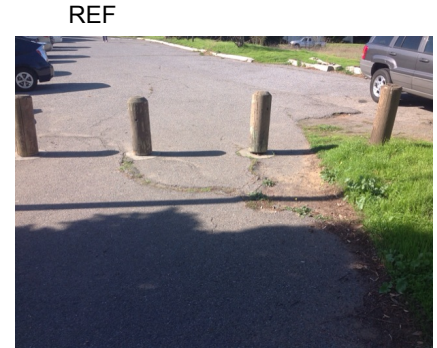
| Item No. and Name | Existing Architectural Barrier and Proposed Solution | Codes / Mitigation Info | Qty | Unit | Cost | Total |
|---|--|---|---|---|---|---|
| 67 | <ul style="list-style-type: none"> <i>As-Built Description:</i> Walk: Irregular surface in pavement. <i>Proposed Solution:</i> Smooth pavement surface; grind or refinish surface. | <p>PCODE EF10REF ADAAG 91 4.5.2 ADA 2010 303.1; 302.1 CBC 2007 1133B.7.1 CBC 2016 11B-303.1; 11B-302.1</p> <p>Priority 1 Severity 3</p> | | | | |

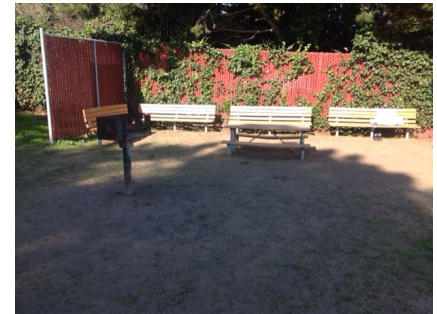
| 73 | <ul style="list-style-type: none"> <i>As-Built Description:</i> No hard-surfaced accessible spaces at picnic table, B.B.Q. grill and/or bench. <i>Proposed Solution:</i> Provide paved accessible spaces for sitting and turning at picnic table, B.B.Q. grill and/or bench. | <p>PCODE NA07 CBC 2007 1132B.1 CBC 2016 11B-246.5</p> <p>Priority 1 Severity 3</p> | 150 | SF | \$6 | \$900 |

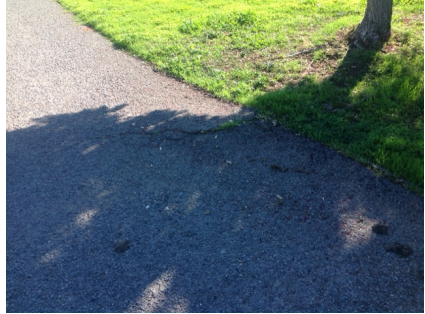
| 80 | <ul style="list-style-type: none"> <i>As-Built Description:</i> Walk: Pavement dislocation creates abrupt change in level exceeding 1/2" in accessible route. <i>Proposed Solution:</i> Remove, replace or repair area of pavement sufficient to correct abrupt change in level. | <p>PCODE EF03 ADAAG 91 4.3.8 ADA 2010 403.4 CBC 2007 1133B.7.4 CBC 2016 11B-403.4</p> <p>Priority 1 Severity 4</p> | 20 | SF | \$21 | \$420 | |

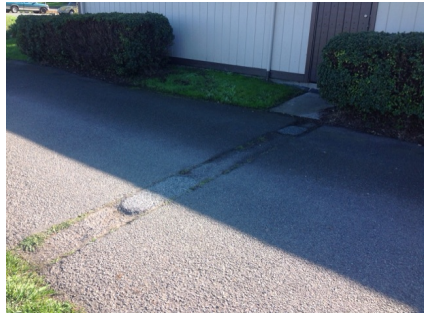
| 86 | <ul style="list-style-type: none"> <i>As-Built Description:</i> Walk: Pavement dislocation creates abrupt change in level exceeding 1/2" in accessible route. <i>As-Built:</i> 1" <i>Proposed Solution:</i> Remove, replace or repair area of pavement sufficient to correct abrupt change in level. | <p>PCODE EF03 ADAAG 91 4.3.8 ADA 2010 403.4 CBC 2007 1133B.7.4 CBC 2016 11B-403.4</p> <p>Priority 1 Severity 4</p> | 50 | SF | \$21 | \$1,050 | |

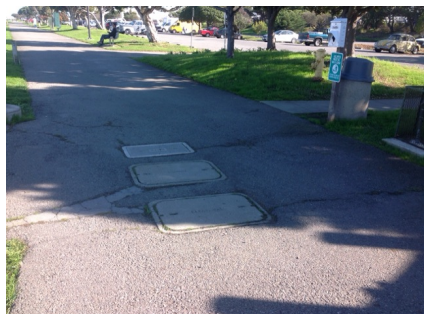
| 87 | <ul style="list-style-type: none"> <i>As-Built Description:</i> Walk: Pavement dislocation creates abrupt change in level exceeding 1/2" in accessible route. <i>As-Built:</i> 1.5" <i>Proposed Solution:</i> Remove, replace or repair area of pavement sufficient to correct abrupt change in level. | <p>PCODE EF03 ADAAG 91 4.3.8 ADA 2010 403.4 CBC 2007 1133B.7.4 CBC 2016 11B-403.4</p> <p>Priority 1 Severity 4</p> | 150 | SF | \$21 | \$3,150 | |

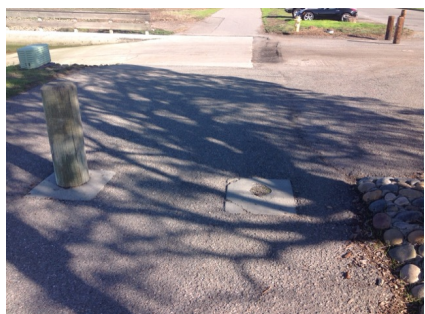
| 91 | <ul style="list-style-type: none"> <i>As-Built Description:</i> Walk: Pavement dislocation creates abrupt change in level exceeding 1/2" in accessible route. <i>Proposed Solution:</i> Remove, replace or repair area of pavement sufficient to correct abrupt change in level. | <p>PCODE EF03 ADAAG 91 4.3.8 ADA 2010 403.4 CBC 2007 1133B.7.4 CBC 2016 11B-403.4</p> <p>Priority 1 Severity 4</p> | 5 | SF | \$21 | \$105 | |

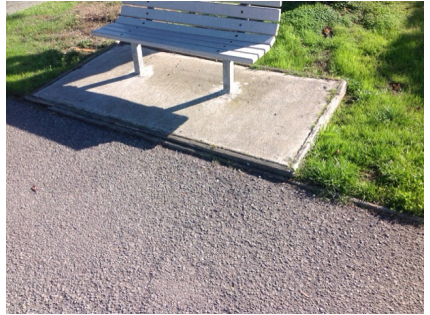
| Item No. and Name | Existing Architectural Barrier and Proposed Solution | Codes / Mitigation Info | Qty | Unit | Cost | Total |
|---|--|--|--|---|---|---|
| 89 | <ul style="list-style-type: none"> <i>As-Built Description:</i> Walk: Pavement dislocation creates abrupt change in level exceeding 1/2" in accessible route. <i>As-Built:</i> 1.5" to 2" <i>Proposed Solution:</i> Remove, replace or repair area of pavement sufficient to correct abrupt change in level. | <p>PCODE EF03REF ADAAG 91 4.3.8 ADA 2010 403.4 CBC 2007 1133B.7.4 CBC 2016 11B-403.4</p> <p>Priority 1 Severity 4</p> | | | | |

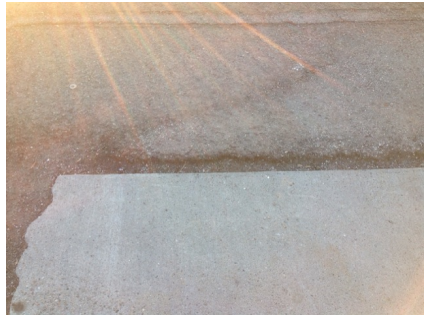
| Item No. and Name | Existing Architectural Barrier and Proposed Solution | Codes / Mitigation Info | Qty | Unit | Cost | Total |
|---|--|--|--|---|---|---|
| 184 | <ul style="list-style-type: none"> <i>As-Built Description:</i> Walk: Pavement dislocation creates abrupt change in level exceeding 1/2" in accessible route. <i>As-Built:</i> 1.5" to 2" <i>Proposed Solution:</i> Remove, replace or repair area of pavement sufficient to correct abrupt change in level. | <p>PCODE EF03REF ADAAG 91 4.3.8 ADA 2010 403.4 CBC 2007 1133B.7.4 CBC 2016 11B-403.4</p> <p>Priority 1 Severity 3</p> | | | | |

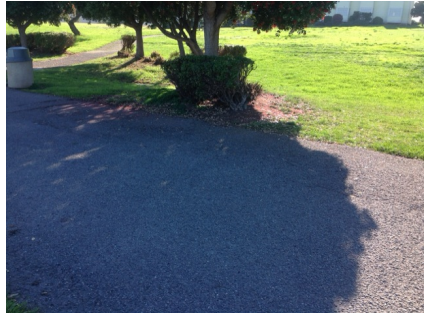
| Item No. and Name | Existing Architectural Barrier and Proposed Solution | Codes / Mitigation Info | Qty | Unit | Cost | Total |
|---|--|---|---|---|---|---|
| 83 | <ul style="list-style-type: none"> <i>As-Built Description:</i> Walk: Irregular surface in pavement. <i>Proposed Solution:</i> Smooth pavement surface; grind or refinish surface. | PCODE EF10 ADAAG 91 4.5.2 ADA 2010 303.1; 302.1 CBC 2007 1133B.7.1 CBC 2016 11B-303.1; 11B-302.1 Priority 1 Severity 3 | 120 | SF | \$5 | \$600 |

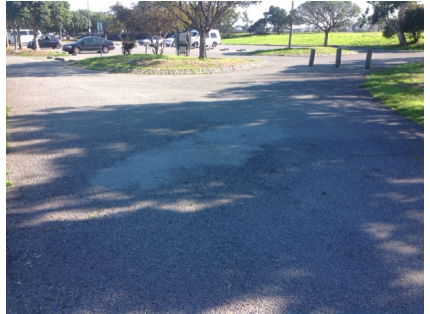
| Item No. and Name | Existing Architectural Barrier and Proposed Solution | Codes / Mitigation Info | Qty | Unit | Cost | Total |
|---|--|---|---|---|---|---|
| 84 | <ul style="list-style-type: none"> <i>As-Built Description:</i> Walk: Irregular surface in pavement. <i>Proposed Solution:</i> Smooth pavement surface; grind or refinish surface. | PCODE EF10 ADAAG 91 4.5.2 ADA 2010 303.1; 302.1 CBC 2007 1133B.7.1 CBC 2016 11B-303.1; 11B-302.1 Priority 1 Severity 3 | 150 | SF | \$5 | \$750 |

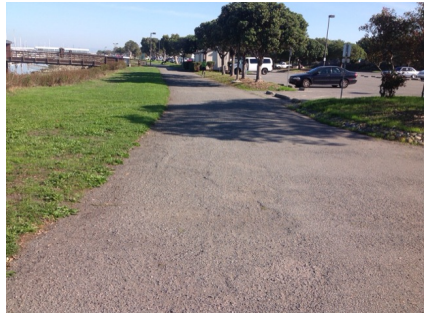
| Item No. and Name | Existing Architectural Barrier and Proposed Solution | Codes / Mitigation Info | Qty | Unit | Cost | Total |
|---|--|---|---|---|---|---|
| 85 | <ul style="list-style-type: none"> <i>As-Built Description:</i> Walk: Irregular surface in pavement. <i>Proposed Solution:</i> Smooth pavement surface; grind or refinish surface. | PCODE EF10 ADAAG 91 4.5.2 ADA 2010 303.1; 302.1 CBC 2007 1133B.7.1 CBC 2016 11B-303.1; 11B-302.1 Priority 1 Severity 3 | 1500 | SF | \$5 | \$7,500 |

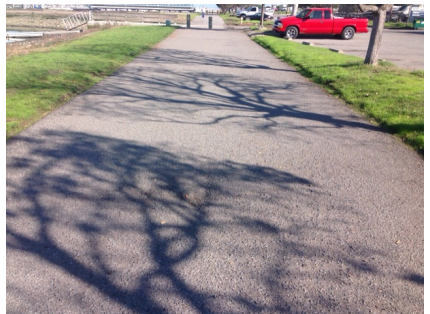
| Item No. and Name | Existing Architectural Barrier and Proposed Solution | Codes / Mitigation Info | Qty | Unit | Cost | Total |
|---|--|---|---|---|---|---|
| 90 | <ul style="list-style-type: none"> <i>As-Built Description:</i> Walk: Irregular surface in pavement. <i>Proposed Solution:</i> Smooth pavement surface; grind or refinish surface. | PCODE EF10 ADAAG 91 4.5.2 ADA 2010 303.1; 302.1 CBC 2007 1133B.7.1 CBC 2016 11B-303.1; 11B-302.1 Priority 1 Severity 3 | 50 | SF | \$5 | \$250 |

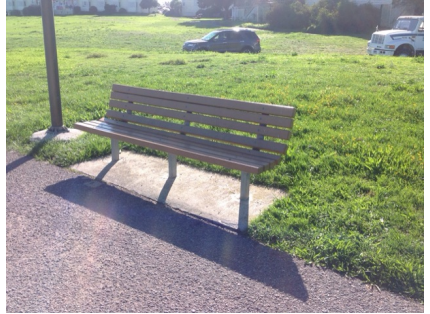
| Item No. and Name | Existing Architectural Barrier and Proposed Solution | Codes / Mitigation Info | Qty | Unit | Cost | Total |
|---|---|---|---|---|---|---|
| 82 | <ul style="list-style-type: none"> <i>As-Built Description:</i> Clear and level floor or ground space (30" x 48") not overlapping with other clear space requirements, is not provided at at least one end of the bench. <i>Proposed Solution:</i> Provide and position a clear and level floor or ground space to allow wheelchair users to be seated shoulder-to-shoulder with an individual seated on the bench. | <p>PCODE N007</p> <p>ADAAG 91 4.32.2</p> <p>ADA 2010 903.2</p> <p>CBC 2007 1118B.4</p> <p>CBC 2016 11B-903.2</p> <p>Priority 1</p> <p>Severity 3</p> | 6 | JOB | \$500 | \$3,000 |

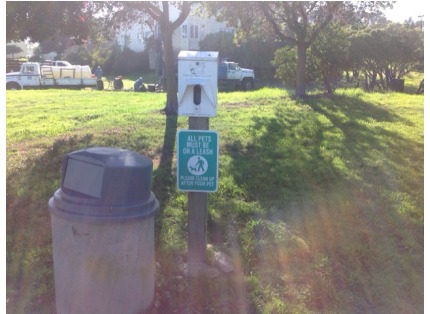
| Item No. and Name | Existing Architectural Barrier and Proposed Solution | Codes / Mitigation Info | Qty | Unit | Cost | Total |
|---|---|---|---|---|---|---|
| 79 | <ul style="list-style-type: none"> <i>As-Built Description:</i> Reach height to control or access point, where side approach is available, exceeds 48" or is less than 15" in height, or exceeds 10" in depth. <i>As-Built:</i> 57" high 29" deep <i>Proposed Solution:</i> Modify equipment or mounting. | <p>PCODE IE02</p> <p>ADAAG 91 4.2.6</p> <p>ADA 2010 308.3.1</p> <p>CBC 2007 1118B.6</p> <p>CBC 2016 11B-308.3</p> <p>Priority 1</p> <p>Severity 3</p> | 1 | JOB | \$100 | \$100 |

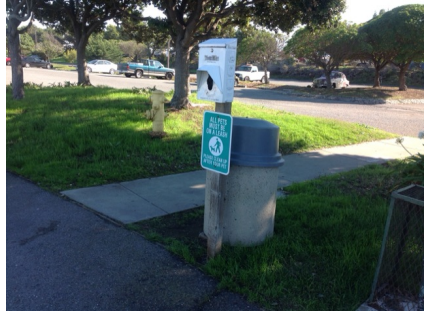
| Item No. and Name | Existing Architectural Barrier and Proposed Solution | Codes / Mitigation Info | Qty | Unit | Cost | Total |
|---|---|---|---|---|---|---|
| 88 | <ul style="list-style-type: none"> <i>As-Built Description:</i> Reach height to control or access point, where side approach is available, exceeds 48" or is less than 15" in height, or exceeds 10" in depth. <i>As-Built:</i> 58" <i>Proposed Solution:</i> Modify equipment or mounting. | <p>PCODE IE02</p> <p>ADAAG 91 4.2.6</p> <p>ADA 2010 308.3.1</p> <p>CBC 2007 1118B.6</p> <p>CBC 2016 11B-308.3</p> <p>Priority 1</p> <p>Severity 3</p> | 2 | JOB | \$100 | \$200 |

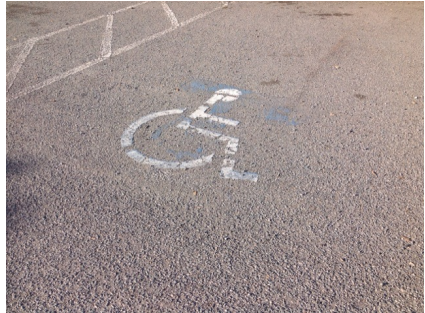
| Item No. and Name | Existing Architectural Barrier and Proposed Solution | Codes / Mitigation Info | Qty | Unit | Cost | Total |
|---|--|--|---|---|---|---|
| 106 | <ul style="list-style-type: none"> <i>As-Built Description:</i> International Symbol of Accessibility (36" square, in white on blue) is not painted on the pavement near the rear end of the parking space (required in CA only). <i>As-Built: ISA fading</i> <i>Proposed Solution:</i> Apply symbol on parking space pavement when altering area. | <p>PCODE EA04A</p> <p>CBC 2007 1129B.4</p> <p>CBC 2016 11B-502.6.4.1</p> <p>Priority 1</p> <p>Severity 4</p> | 4 | JOB | \$120 | \$480 |

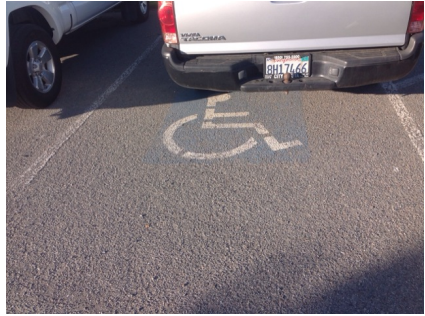
| Item No. and Name | Existing Architectural Barrier and Proposed Solution | Codes / Mitigation Info | Qty | Unit | Cost | Total |
|---|--|--|---|---|---|---|
| 120 | <ul style="list-style-type: none"> <i>As-Built Description:</i> International Symbol of Accessibility (36" square, in white on blue) is not painted on the pavement near the rear end of the parking space (required in CA only). <i>As-Built: ISA fading</i> <i>Proposed Solution:</i> Apply symbol on parking space pavement when altering area. | <p>PCODE EA04A</p> <p>CBC 2007 1129B.4</p> <p>CBC 2016 11B-502.6.4.1</p> <p>Priority 1</p> <p>Severity 4</p> | 1 | JOB | \$120 | \$120 |

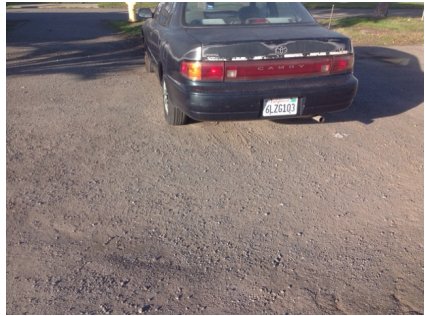
| Item No. and Name | Existing Architectural Barrier and Proposed Solution | Codes / Mitigation Info | Qty | Unit | Cost | Total |
|---|--|--|---|---|---|---|
| 129 | <ul style="list-style-type: none"> <i>As-Built Description:</i> International Symbol of Accessibility (36" square, in white on blue) is not painted on the pavement near the rear end of the parking space (required in CA only). <i>Proposed Solution:</i> Apply symbol on parking space pavement when altering area. | <p>PCODE EA04A</p> <p>CBC 2007 1129B.4</p> <p>CBC 2016 11B-502.6.4.1</p> <p>Priority 1</p> <p>Severity 4</p> | 1 | JOB | \$120 | \$120 |

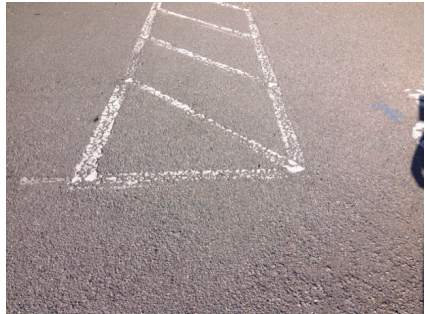
| Item No. and Name | Existing Architectural Barrier and Proposed Solution | Codes / Mitigation Info | Qty | Unit | Cost | Total |
|---|--|--|---|---|---|---|
| 95 | <ul style="list-style-type: none"> <i>As-Built Description:</i> The words "NO PARKING" not painted on the ground within loading and unloading access aisle (12" min high white letters), located so that it is visible to traffic enforcement officials (required in CA only). <i>Proposed Solution:</i> Provide the words "NO PARKING" in each access aisle, painted in 12" high letters, when altering area. | <p>PCODE EA04D</p> <p>ADA 2010 502.3.3</p> <p>CBC 2007 1129B.3.1</p> <p>CBC 2016 11B-502.3.3</p> <p>Priority 1</p> <p>Severity 4</p> | 2 | JOB | \$100 | \$200 |

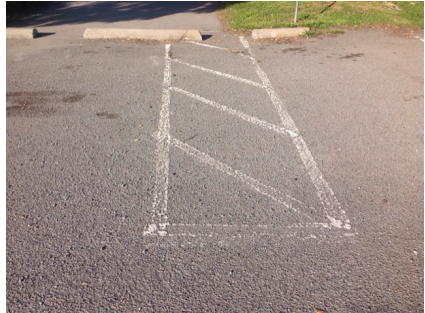
| Item No. and Name | Existing Architectural Barrier and Proposed Solution | Codes / Mitigation Info | Qty | Unit | Cost | Total |
|---|--|---|---|---|---|---|
| 105 | <ul style="list-style-type: none"> As-Built Description: The words "NO PARKING" not painted on the ground within loading and unloading access aisle (12" min high white letters), located so that it is visible to traffic enforcement officials (required in CA only). Proposed Solution: Provide the words "NO PARKING" in each access aisle, painted in 12" high letters, when altering area. | PCODE EA04D ADA 2010 502.3.3 CBC 2007 1129B.3.1 CBC 2016 11B-502.3.3 Priority 1 Severity 4 | 2 | JOB | \$100 | \$200 |

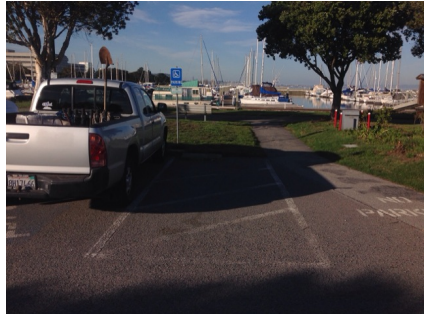
| Item No. and Name | Existing Architectural Barrier and Proposed Solution | Codes / Mitigation Info | Qty | Unit | Cost | Total |
|---|--|---|---|---|---|---|
| 119 | <ul style="list-style-type: none"> As-Built Description: The words "NO PARKING" not painted on the ground within loading and unloading access aisle (12" min high white letters), located so that it is visible to traffic enforcement officials (required in CA only). Proposed Solution: Provide the words "NO PARKING" in each access aisle, painted in 12" high letters, when altering area. | PCODE EA04D ADA 2010 502.3.3 CBC 2007 1129B.3.1 CBC 2016 11B-502.3.3 Priority 1 Severity 4 | 1 | JOB | \$100 | \$100 |

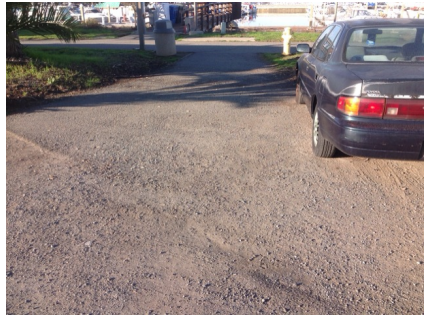
| Item No. and Name | Existing Architectural Barrier and Proposed Solution | Codes / Mitigation Info | Qty | Unit | Cost | Total |
|---|--|---|---|---|---|---|
| 128 | <ul style="list-style-type: none"> As-Built Description: The words "NO PARKING" not painted on the ground within loading and unloading access aisle (12" min high white letters), located so that it is visible to traffic enforcement officials (required in CA only). Proposed Solution: Provide the words "NO PARKING" in each access aisle, painted in 12" high letters, when altering area. | PCODE EA04D ADA 2010 502.3.3 CBC 2007 1129B.3.1 CBC 2016 11B-502.3.3 Priority 1 Severity 4 | 1 | JOB | \$100 | \$100 |

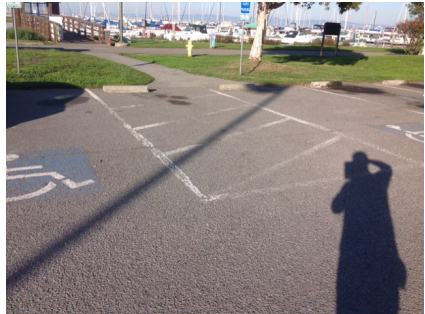
| Item No. and Name | Existing Architectural Barrier and Proposed Solution | Codes / Mitigation Info | Qty | Unit | Cost | Total |
|---|--|---|---|---|---|---|
| 115 | <ul style="list-style-type: none"> As-Built Description: CA only: The area within the blue borderlines not marked with hatched lines a maximum of 36" on center. As-Built: 44" Proposed Solution: Restripe to provide hatched lines at 36" on center within access aisle. | PCODE EA04I CBC 2007 1129B.3.1 CBC 2016 11B-502.3.3 Priority 1 Severity 4 | 1 | JOB | \$100 | \$100 |

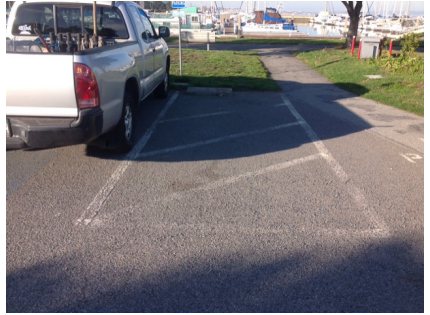
| Item No. and Name | Existing Architectural Barrier and Proposed Solution | Codes / Mitigation Info | Qty | Unit | Cost | Total |
|---|---|--|---|---|---|---|
| 123 | <ul style="list-style-type: none"> <i>As-Built Description:</i> CA only: The area within the blue borderlines not marked with hatched lines a maximum of 36" on center. <i>As-Built:</i> 44" <i>Proposed Solution:</i> Restripe to provide hatched lines at 36" on center within access aisle. | <p>PCODE EA04I</p> <p>CBC 2007 1129B.3.1</p> <p>CBC 2016 11B-502.3.3</p> <p>Priority 1</p> <p>Severity 4</p> | 1 | JOB | \$100 | \$100 |

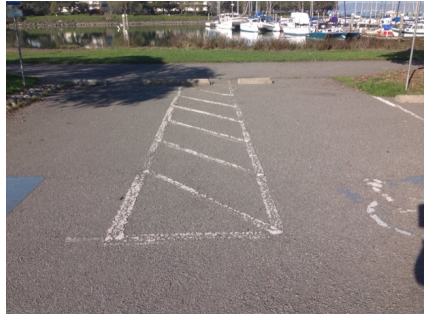
| Item No. and Name | Existing Architectural Barrier and Proposed Solution | Codes / Mitigation Info | Qty | Unit | Cost | Total |
|---|---|--|---|---|---|---|
| 96 | <ul style="list-style-type: none"> <i>As-Built Description:</i> Access aisles and parking space not marked with a blue painted borderline around perimeter (required in CA only). <i>Proposed Solution:</i> Provide access aisle marked with blue borderline. (Hatch lines shall contrast with the aisle surface in blue or white). | <p>PCODE EA04KREF</p> <p>CBC 2016 11B-502.6</p> <p>Priority 1</p> <p>Severity 4</p> | | REF | | |

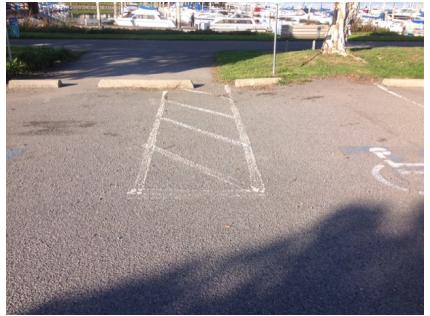
| Item No. and Name | Existing Architectural Barrier and Proposed Solution | Codes / Mitigation Info | Qty | Unit | Cost | Total |
|---|---|--|---|---|---|---|
| 114 | <ul style="list-style-type: none"> <i>As-Built Description:</i> Access aisles and parking space not marked with a blue painted borderline around perimeter (required in CA only). <i>Proposed Solution:</i> Provide access aisle marked with blue borderline. (Hatch lines shall contrast with the aisle surface in blue or white). | <p>PCODE EA04KREF</p> <p>CBC 2016 11B-502.6</p> <p>Priority 1</p> <p>Severity 4</p> | | REF | | |

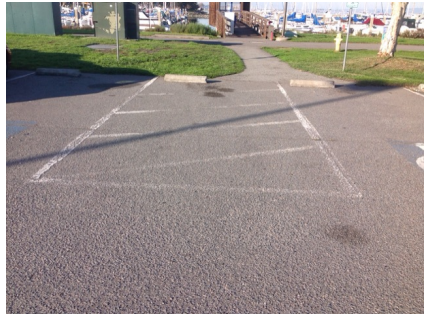
| Item No. and Name | Existing Architectural Barrier and Proposed Solution | Codes / Mitigation Info | Qty | Unit | Cost | Total |
|---|---|--|---|---|---|---|
| 117 | <ul style="list-style-type: none"> <i>As-Built Description:</i> Access aisles and parking space not marked with a blue painted borderline around perimeter (required in CA only). <i>Proposed Solution:</i> Provide access aisle marked with blue borderline. (Hatch lines shall contrast with the aisle surface in blue or white). | <p>PCODE EA04KREF</p> <p>CBC 2016 11B-502.6</p> <p>Priority 1</p> <p>Severity 4</p> | | REF | | |

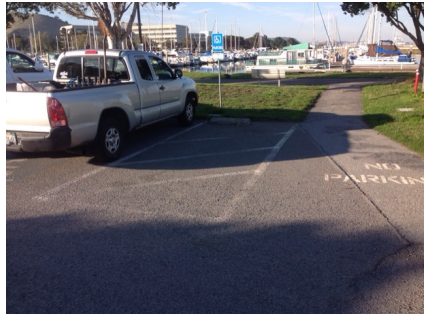
| Item No. and Name | Existing Architectural Barrier and Proposed Solution | Codes / Mitigation Info | Qty | Unit | Cost | Total |
|---|---|--|---|---|---|---|
| 126 | <ul style="list-style-type: none"> <i>As-Built Description:</i> Access aisles and parking space not marked with a blue painted borderline around perimeter (required in CA only). <i>Proposed Solution:</i> Provide access aisle marked with blue borderline. (Hatch lines shall contrast with the aisle surface in blue or white). | PCODE EA04KREF CBC 2016 11B-502.6 Priority 1 Severity 4 | | | | |

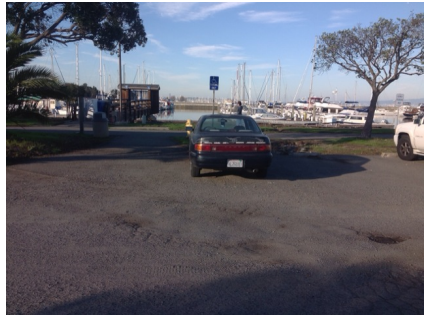
| 133 | <ul style="list-style-type: none"> <i>As-Built Description:</i> Accessible parking aisle is not located on the passenger side (required in CA only). <i>Proposed Solution:</i> Modify parking aisle(s) to create accessible space by restriping. | PCODE EA02C ADA 2010 502.3.4 CBC 2007 1129B.3.1 CBC 2016 11B-502.3.4 Priority 1 Severity 3 | 1 | JOB | \$200 | \$200 |

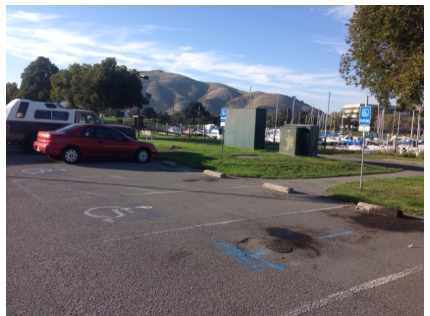
| 118 | <ul style="list-style-type: none"> <i>As-Built Description:</i> Accessible parking aisle is not located on the passenger side (required in CA only). <i>As-Built:</i> Aisle serving van accessible space must be on passenger side <i>Proposed Solution:</i> Remove van sign on right space. | PCODE EA02CNT ADA 2010 502.3.4 CBC 2007 1129B.3.1 CBC 2016 11B-502.3.4 Priority 1 Severity 3 | 1 | JOB | \$200 | \$200 |

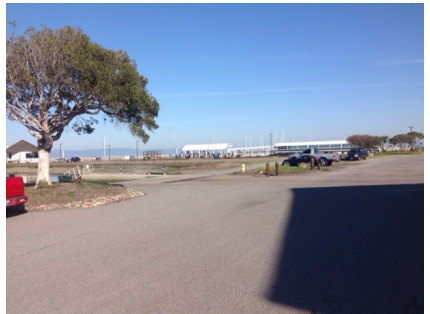
| 93 | <ul style="list-style-type: none"> <i>As-Built Description:</i> No "Tow Away" sign at parking lot entrance (required in CA only). <i>As-Built:</i> No tow away sign provided <i>Proposed Solution:</i> Provide "Tow Away" sign at parking lot entrance when altering area. <i>Notes:</i> Provide a tow-away sign at each separate lot entry | PCODE EA04C CBC 2007 1129B.4 CBC 2016 11B-502.8.2 Priority 1 Severity 4 | 3 | JOB | \$325 | \$975 |

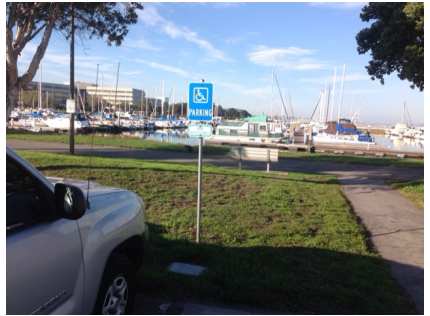
| Item No. and Name | Existing Architectural Barrier and Proposed Solution | Codes / Mitigation Info | Qty | Unit | Cost | Total |
|---|--|--|---|---|---|---|
| 121 | <ul style="list-style-type: none"> <i>As-Built Description:</i> CA only: Additional Sign or additional language below the symbol of accessibility stating "Minimum Fine \$250" not provided. <i>Proposed Solution:</i> Provide compliant parking signage that includes fine information. | <p>PCODE EA04G</p> <p>CBC 2007 1129B.4</p> <p>CBC 2016 11B-502.6.2</p> <p>Priority 1</p> <p>Severity 4</p> | 1 | JOB | \$100 | \$100 |

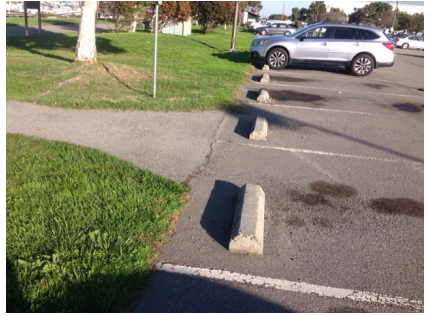
| Item No. and Name | Existing Architectural Barrier and Proposed Solution | Codes / Mitigation Info | Qty | Unit | Cost | Total |
|---|---|---|---|---|---|---|
| 116 | <ul style="list-style-type: none"> <i>As-Built Description:</i> 36" wide band of truncated domes not provided at walkway or crossing adjoining a vehicular way, if surfaces are not separated by a curb, railing, or other element. <i>Proposed Solution:</i> Provide 36" wide, contrasting color, band of truncated domes between pedestrian and vehicular area. | PCODE EG09 ADAAG 91 4.29.5 CBC 2007 1133B.8.5 CBC 2016 11B-705.1.2.5 Priority 1 Severity 3 | 5 | LF | \$27 | \$135 |

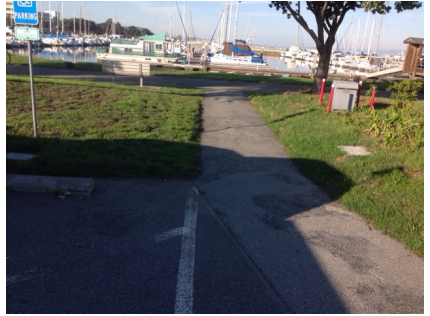
| Item No. and Name | Existing Architectural Barrier and Proposed Solution | Codes / Mitigation Info | Qty | Unit | Cost | Total |
|---|---|---|---|---|---|---|
| 124 | <ul style="list-style-type: none"> <i>As-Built Description:</i> 36" wide band of truncated domes not provided at walkway or crossing adjoining a vehicular way, if surfaces are not separated by a curb, railing, or other element. <i>Proposed Solution:</i> Provide 36" wide, contrasting color, band of truncated domes between pedestrian and vehicular area. | PCODE EG09 ADAAG 91 4.29.5 CBC 2007 1133B.8.5 CBC 2016 11B-705.1.2.5 Priority 1 Severity 3 | 5 | LF | \$27 | \$135 |

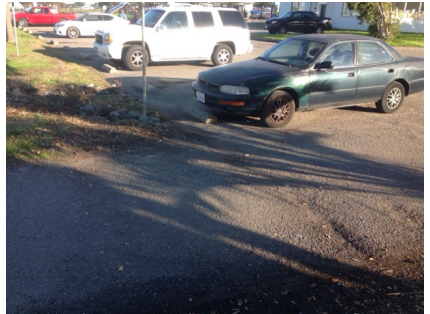
| Item No. and Name | Existing Architectural Barrier and Proposed Solution | Codes / Mitigation Info | Qty | Unit | Cost | Total |
|---|---|---|---|---|---|---|
| 134 | <ul style="list-style-type: none"> <i>As-Built Description:</i> 36" wide band of truncated domes not provided at walkway or crossing adjoining a vehicular way, if surfaces are not separated by a curb, railing, or other element. <i>Proposed Solution:</i> Provide 36" wide, contrasting color, band of truncated domes between pedestrian and vehicular area. | PCODE EG09 ADAAG 91 4.29.5 CBC 2007 1133B.8.5 CBC 2016 11B-705.1.2.5 Priority 1 Severity 3 | 10 | LF | \$27 | \$270 |

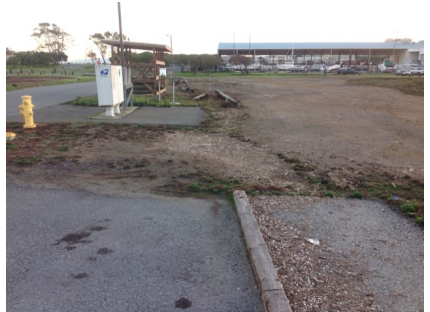
| 193 | <ul style="list-style-type: none"> <i>As-Built Description:</i> No walk / sidewalk provided to connect accessible facilities or elements that are on the same site. <i>As-Built:</i> Direct path to mailbox not provided <i>Proposed Solution:</i> Provide new 48" wide walk / sidewalk. | PCODE EF13 ADAAG 91 4.3.2 ADA 2010 206.1 CBC 2007 1114B.1.2 CBC 2016 11B-206.1 Priority 4 Severity 3 | 100 | LF | \$45 | \$4,500 |

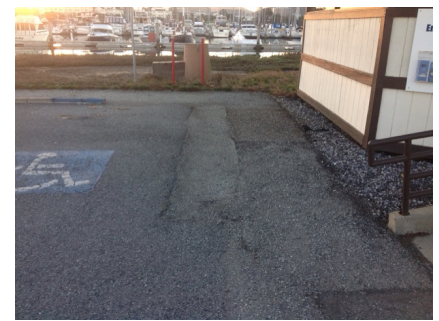
| 190 | <ul style="list-style-type: none"> <i>As-Built Description:</i> Walk: Irregular surface in pavement. <i>Proposed Solution:</i> Smooth pavement surface; grind or refinish surface. | PCODE EF10 ADAAG 91 4.5.2 ADA 2010 303.1; 302.1 CBC 2007 1133B.7.1 CBC 2016 11B-303.1; 11B-302.1 Priority 4 Severity 3 | 50 | SF | \$5 | \$250 |

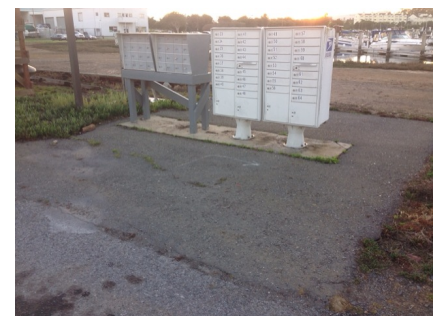
| 195 | <ul style="list-style-type: none"> <i>As-Built Description:</i> Walk: Irregular surface in pavement. <i>Proposed Solution:</i> Smooth pavement surface; grind or refinish surface. | PCODE EF10 ADAAG 91 4.5.2 ADA 2010 303.1; 302.1 CBC 2007 1133B.7.1 CBC 2016 11B-303.1; 11B-302.1 Priority 4 Severity 3 | 100 | SF | \$5 | \$500 |

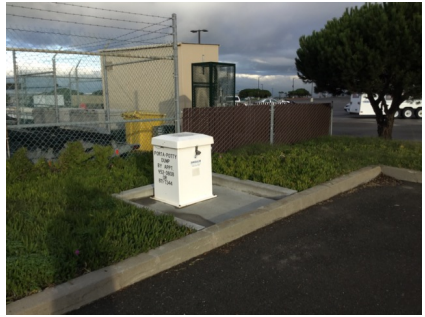
| Item No. and Name | Existing Architectural Barrier and Proposed Solution | Codes / Mitigation Info | Qty | Unit | Cost | Total |
|---|---|--|---|---|---|---|
| 520 | <ul style="list-style-type: none"> <i>As-Built Description:</i> No walk / sidewalk provided to connect accessible facilities or elements that are on the same site. <i>As-Built:</i> Raised curb to access <i>Proposed Solution:</i> Provide new 48" wide walk / sidewalk. <i>Notes:</i> Dump station made by appointment | <p><i>PCODE</i> EF13 <i>ADAAG 91</i> 4.3.2 <i>ADA 2010</i> 206.1 <i>CBC 2007</i> 1114B.1.2 <i>CBC 2016</i> 11B-206.1</p> <p>Priority 2 Severity 3</p> | 4 | LF | \$45 | \$180 |

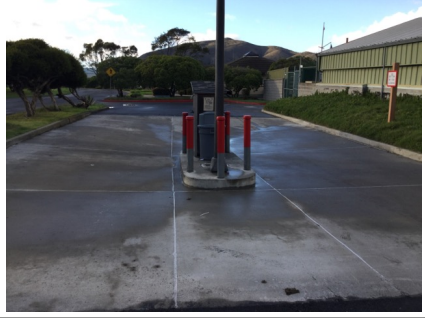
| Item No. and Name | Existing Architectural Barrier and Proposed Solution | Codes / Mitigation Info | Qty | Unit | Cost | Total |
|---|---|--|---|---|---|---|
| 519 | <ul style="list-style-type: none"> <i>As-Built Description:</i> Cross slope more than 1":48" (2.083%). <i>As-Built:</i> 4.3-9.6% <i>Proposed Solution:</i> Modify cross slope. <i>Notes:</i> Throughout wash area | <p><i>PCODE</i> EF07 <i>ADAAG 91</i> 4.3.7 <i>ADA 2010</i> 403.3 <i>CBC 2007</i> 1133B.7.1.3 <i>CBC 2016</i> 11B-403.3</p> <p>Priority 2 Severity 2</p> | 1500 | SF | \$25 | \$37,500 |

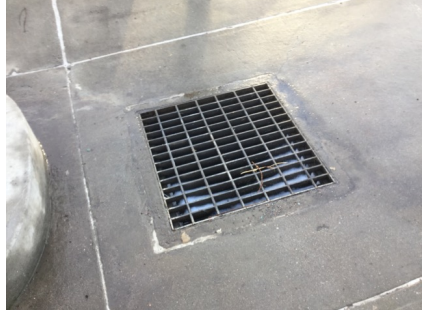
| Item No. and Name | Existing Architectural Barrier and Proposed Solution | Codes / Mitigation Info | Qty | Unit | Cost | Total |
|---|---|--|---|---|---|---|
| 518 | <ul style="list-style-type: none"> <i>As-Built Description:</i> Walk: Grating has grid openings greater than 1/2" along the line of traffic flow. <i>As-Built:</i> 2" X 4" openings <i>Proposed Solution:</i> Provide new grating, with grid openings 1/2" max. along the line of traffic flow. | <p><i>PCODE</i> EF04 <i>ADAAG 91</i> 4.3.6; 4.5.4 <i>ADA 2010</i> 403.2; 302.3 <i>CBC 2007</i> 1133B.7.2 <i>CBC 2016</i> 11B-403.2; 11B-302.3</p> <p>Priority 2 Severity 2</p> | 4 | SF | \$80 | \$320 |

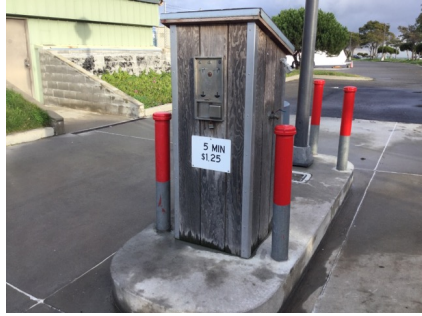
| Item No. and Name | Existing Architectural Barrier and Proposed Solution | Codes / Mitigation Info | Qty | Unit | Cost | Total |
|---|---|---|---|---|---|---|
| 521 | <ul style="list-style-type: none"> <i>As-Built Description:</i> Reach height to control or access point, exceeds 48" or is less than 15". <i>As-Built:</i> 58" high coin slot at 26" deep <i>Proposed Solution:</i> Modify equipment or mounting. | <p>PCODE IE01</p> <p>ADAAG 91 4.2.5</p> <p>ADA 2010 308.2.1</p> <p>CBC 2007 1118B.5</p> <p>CBC 2016 11B-308.2.1</p> <p>Priority 2</p> <p>Severity 3</p> | 1 | JOB | \$100 | \$100 |

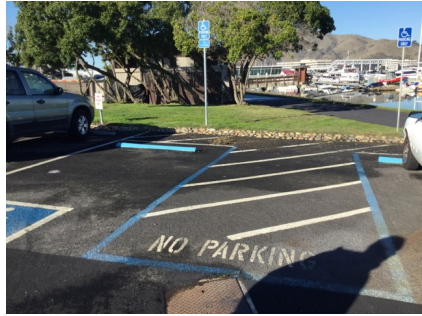
| Floor or Ground Surfaces | | | | | | |
|---|--|---|--|---|---|---|
| 525 | <ul style="list-style-type: none"> <i>As-Built Description:</i> Accessible parking space has slope greater than 1/4":12" (2%). <i>As-Built:</i> 3.0-4.3% <i>Proposed Solution:</i> Modify slope at accessible parking space. | <p>PCODE EA05</p> <p>ADAAG 91 4.6.3</p> <p>ADA 2010 502.4</p> <p>CBC 2007 1129B.3.3</p> <p>CBC 2016 11B-502.4</p> <p>Priority 1</p> <p>Severity 3</p> | 486 | SF | \$12 | \$5,832 |

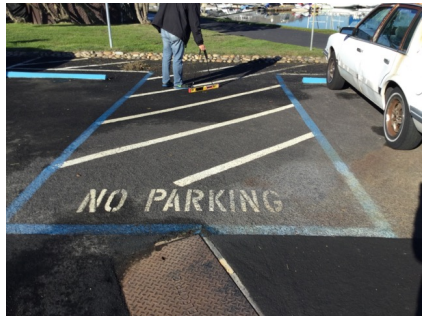
| Parking | | | | | | |
|---|--|---|---|---|---|---|
| 524 | <ul style="list-style-type: none"> <i>As-Built Description:</i> Accessible parking space does not have 5' wide access aisle; 8' wide for van accessible aisle. <i>As-Built:</i> 94" wide o.c. <i>Proposed Solution:</i> Modify parking aisle(s) to create accessible space by restriping. Notes: Compliant measured to edge to edge | <p>PCODE EA02B</p> <p>ADAAG 91 4.6.3</p> <p>ADA 2010 502.3</p> <p>CBC 2007 1129B.3.1</p> <p>CBC 2016 11B-502.2; 11B-502.3.1</p> <p>Priority 1</p> <p>Severity 3</p> | 1 | JOB | \$200 | \$200 |

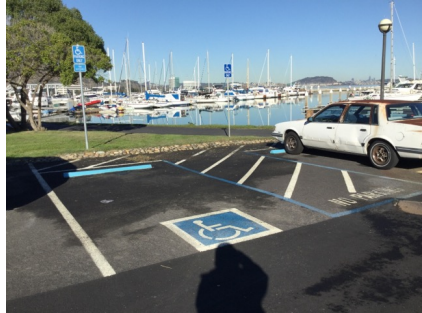
| Item No. and Name | Existing Architectural Barrier and Proposed Solution | Codes / Mitigation Info | Qty | Unit | Cost | Total |
|---|--|--|---|---|---|---|
| 523 | <ul style="list-style-type: none"> <i>As-Built Description:</i> No "Tow Away" sign at parking lot entrance (required in CA only). <i>Proposed Solution:</i> Provide "Tow Away" sign at parking lot entrance when altering area. | <p>PCODE EA04C</p> <p>CBC 2007 1129B.4</p> <p>CBC 2016 11B-502.8.2</p> <p>Priority 1</p> <p>Severity 4</p> | 1 | JOB | \$325 | \$325 |

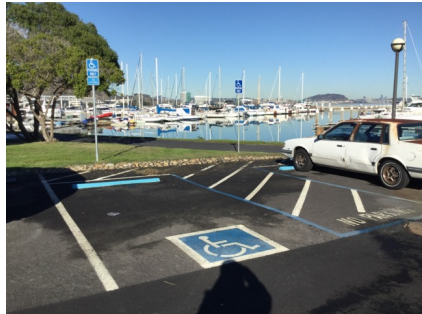
| Item No. and Name | Existing Architectural Barrier and Proposed Solution | Codes / Mitigation Info | Qty | Unit | Cost | Total |
|---|--|--|---|---|---|---|
| 522 | <ul style="list-style-type: none"> <i>As-Built Description:</i> CA only: Additional Sign or additional language below the symbol of accessibility stating "Minimum Fine \$250" not provided. <i>Proposed Solution:</i> Provide compliant parking signage that includes fine information. | <p>PCODE EA04G</p> <p>CBC 2007 1129B.4</p> <p>CBC 2016 11B-502.6.2</p> <p>Priority 1</p> <p>Severity 4</p> | 2 | JOB | \$100 | \$200 |

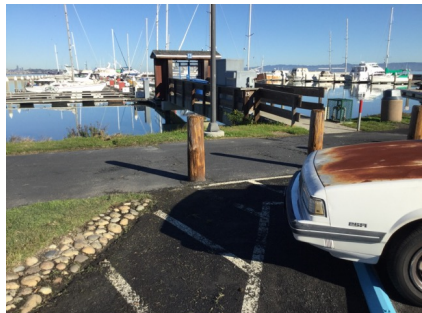
| Item No. and Name | Existing Architectural Barrier and Proposed Solution | Codes / Mitigation Info | Qty | Unit | Cost | Total |
|---|--|--|---|---|---|---|
| 526 | <ul style="list-style-type: none"> <i>As-Built Description:</i> 36" wide band of truncated domes not provided at walkway or crossing adjoining a vehicular way, if surfaces are not separated by a curb, railing, or other element. <i>As-Built:</i> Provide domes at transition from aisle to walkway <i>Proposed Solution:</i> Provide 36" wide, contrasting color, band of truncated domes between pedestrian and vehicular area. | <p>PCODE EG09</p> <p>ADAAG 91 4.29.5</p> <p>CBC 2007 1133B.8.5</p> <p>CBC 2016 11B-705.1.2.5</p> <p>Priority 1</p> <p>Severity 3</p> | 4 | LF | \$27 | \$108 |

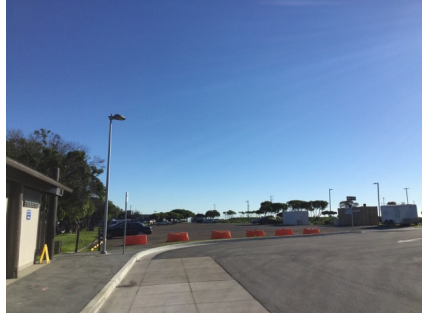
| Item No. and Name | Existing Architectural Barrier and Proposed Solution | Codes / Mitigation Info | Qty | Unit | Cost | Total |
|---|---|---|---|---|---|---|
| 527 | <ul style="list-style-type: none"> <i>As-Built Description:</i> At parking lot with 76-100 spaces, the number of accessible spaces is less than required by code; 4 spaces required. <i>As-Built:</i> No accessible parking provided <i>Proposed Solution:</i> Provide required accessible parking spaces with signs including a minimum of one van space. <i>Notes:</i> Accessible parking is provided west in a lot maintained by a private department and also further east directly serving launch ramp and restroom. | <p>PCODE EA01DREF</p> <p>ADAAG 91 4.1.2(5)*</p> <p>ADA 2010 208.2</p> <p>CBC 2007 Tbl. 11B-6</p> <p>CBC 2016 11B-208.2 Tbl. 11B-208.2</p> <p>Priority 1</p> <p>Severity 2</p> | | | | |

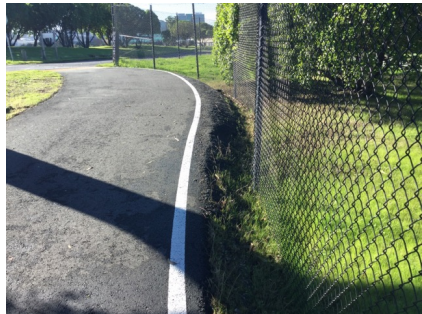
| Item No. and Name | Existing Architectural Barrier and Proposed Solution | Codes / Mitigation Info | Qty | Unit | Cost | Total |
|---|---|--|---|---|---|--|
| 536 | <ul style="list-style-type: none"> <i>As-Built Description:</i> An abrupt change in level exceeding 4" vertically, except between a walk/sidewalk and an adjacent street or driveway, is not identified by a 6" minimum high warning curb above the potential drop off (CA requirement only) . <i>As-Built:</i> Drop adjacent to walk potential tripping hazard <i>Proposed Solution:</i> Provide a 6" minimum high warning curb or guardrail centered at 3" above the pedestrian access route or fill in the drop off with soil or gravel. | <p>PCODE PR30A</p> <p>ADAAG 91 4.3.8</p> <p>ADA 2010 303.2</p> <p>CBC 2007 1133B.8.1</p> <p>CBC 2016 11B-303.5</p> <p>Priority 1</p> <p>Severity 2</p> | 30 | LF | \$45 | \$1,350 |

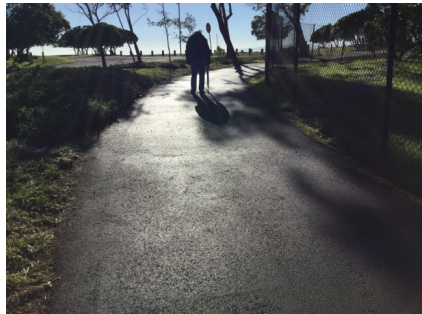
| Item No. and Name | Existing Architectural Barrier and Proposed Solution | Codes / Mitigation Info | Qty | Unit | Cost | Total |
|---|---|---|---|---|---|---|
| 529 | <ul style="list-style-type: none"> <i>As-Built Description:</i> Walk: Slope greater than 1:20 (5.0%), and walk does not comply with requirements for ramps. <i>As-Built:</i> 5.4-7.2% <i>Proposed Solution:</i> Modify walk/sidewalk slope to 1:20 or less. | <p>PCODE EF01</p> <p>ADAAG 91 4.3.7</p> <p>ADA 2010 403.3</p> <p>CBC 2007 1133B.7.3</p> <p>CBC 2016 11B-403.3</p> <p>Priority 1</p> <p>Severity 4</p> | 160 | SF | \$25 | \$4,000 |

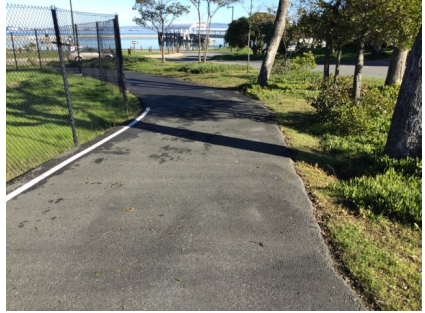
| Item No. and Name | Existing Architectural Barrier and Proposed Solution | Codes / Mitigation Info | Qty | Unit | Cost | Total |
|---|---|--|---|---|---|---|
| 530 | <ul style="list-style-type: none"> • <i>As-Built Description:</i> Walk: Slope greater than 1:20 (5.0%), and walk does not comply with requirements for ramps. • <i>As-Built:</i> 6.3-6.7% • <i>Proposed Solution:</i> Modify walk/sidewalk slope to 1:20 or less. | <p>PCODE EF01 ADAAG 91 4.3.7 ADA 2010 403.3 CBC 2007 1133B.7.3 CBC 2016 11B-403.3</p> <p>Priority 1 Severity 4</p> | 60 | SF | \$25 | \$1,500 |

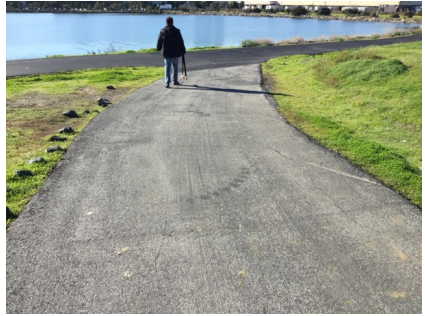
| Item No. and Name | Existing Architectural Barrier and Proposed Solution | Codes / Mitigation Info | Qty | Unit | Cost | Total |
|---|---|--|---|---|---|---|
| 535 | <ul style="list-style-type: none"> • <i>As-Built Description:</i> Walk: Slope greater than 1:20 (5.0%), and walk does not comply with requirements for ramps. • <i>As-Built:</i> 6.5-6.9% • <i>Proposed Solution:</i> Modify walk/sidewalk slope to 1:20 or less. | <p>PCODE EF01 ADAAG 91 4.3.7 ADA 2010 403.3 CBC 2007 1133B.7.3 CBC 2016 11B-403.3</p> <p>Priority 1 Severity 4</p> | 100 | SF | \$25 | \$2,500 |

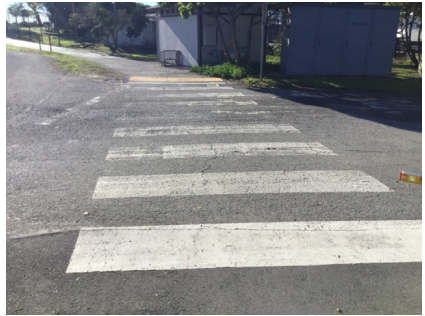
| Item No. and Name | Existing Architectural Barrier and Proposed Solution | Codes / Mitigation Info | Qty | Unit | Cost | Total |
|---|---|--|---|---|---|---|
| 528 | <ul style="list-style-type: none"> • <i>As-Built Description:</i> Walk: Irregular surface in pavement. • <i>As-Built:</i> At crossings • <i>Proposed Solution:</i> Smooth pavement surface; grind or refinish surface. • Notes: Crosswalk marking faded also | <p>PCODE EF10 ADAAG 91 4.5.2 ADA 2010 303.1; 302.1 CBC 2007 1133B.7.1 CBC 2016 11B-303.1; 11B-302.1</p> <p>Priority 1 Severity 3</p> | 160 | SF | \$5 | \$800 |

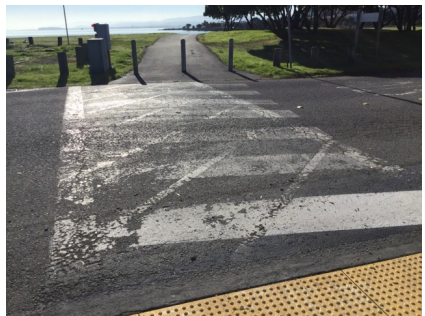
| Item No. and Name | Existing Architectural Barrier and Proposed Solution | Codes / Mitigation Info | Qty | Unit | Cost | Total |
|---|---|--|---|---|---|---|
| 531 | <ul style="list-style-type: none"> • <i>As-Built Description:</i> Walk: Irregular surface in pavement. • <i>As-Built:</i> On crossing • <i>Proposed Solution:</i> Smooth pavement surface; grind or refinish surface. • Notes: Crosswalk markings also faded | <p>PCODE EF10 ADAAG 91 4.5.2 ADA 2010 303.1; 302.1 CBC 2007 1133B.7.1 CBC 2016 11B-303.1; 11B-302.1</p> <p>Priority 1 Severity 3</p> | 250 | SF | \$5 | \$1,250 |

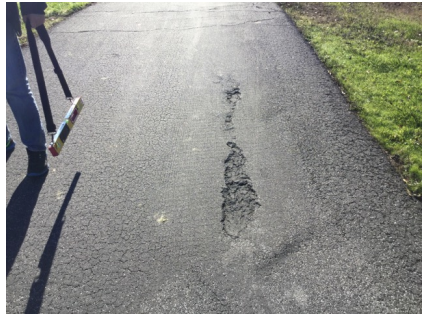
| Item No. and Name | Existing Architectural Barrier and Proposed Solution | Codes / Mitigation Info | Qty | Unit | Cost | Total |
|---|---|--|---|---|---|---|
| 533 | <ul style="list-style-type: none"> <i>As-Built Description:</i> Walk: Irregular surface in pavement. <i>As-Built:</i> Damaged pavement <i>Proposed Solution:</i> Smooth pavement surface; grind or refinish surface. <i>Notes:</i> Path is negotiable | PCODE EF10REF ADAAG 91 4.5.2 ADA 2010 303.1; 302.1 CBC 2007 1133B.7.1 CBC 2016 11B-303.1; 11B-302.1 Priority 1 Severity 3 | | REF | | |

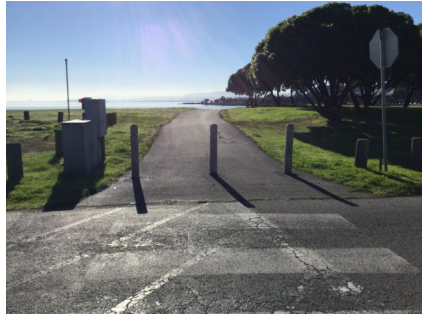
| 532 | <ul style="list-style-type: none"> <i>As-Built Description:</i> 36" wide band of truncated domes not provided at walkway or crossing adjoining a vehicular way, if surfaces are not separated by a curb, railing, or other element. <i>Proposed Solution:</i> Provide 36" wide, contrasting color, band of truncated domes between pedestrian and vehicular area. | PCODE EG09 ADAAG 91 4.29.5 CBC 2007 1133B.8.5 CBC 2016 11B-705.1.2.5 Priority 1 Severity 3 | 10 | LF | \$27 | \$270 |

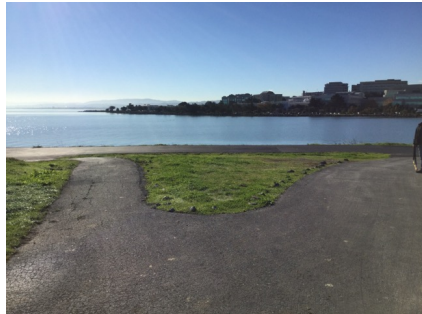
| 534 | <ul style="list-style-type: none"> <i>As-Built Description:</i> No sign by inaccessible route directing persons to an accessible route. <i>Proposed Solution:</i> Provide directional sign. <i>Notes:</i> Create one compliant route and direct to that route | PCODE SA20 ADAAG 91 35.163(b) ADA 2010 216.3 CBC 2007 1127B.3 CBC 2016 11B-216.3 Priority 1 Severity 3 | 1 | JOB | \$170 | \$170 |

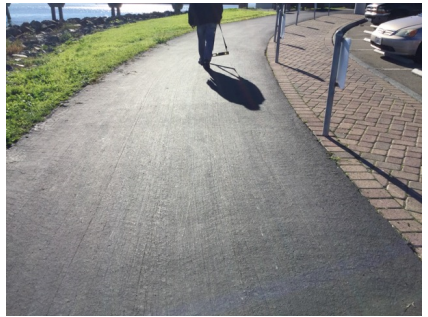
| 556 | <ul style="list-style-type: none"> <i>As-Built Description:</i> Cross slope more than 1":48" (2.083%). <i>As-Built:</i> 2.5-3.4% <i>Proposed Solution:</i> Modify cross slope. | <p>PCODE EF07</p> <p>ADAAG 91 4.3.7</p> <p>ADA 2010 403.3</p> <p>CBC 2007 1133B.7.1.3</p> <p>CBC 2016 11B-403.3</p> <p>Priority 3</p> <p>Severity 4</p> | 600 | SF | \$25 | \$15,000 |

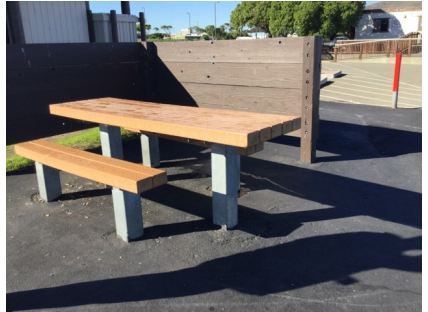
| 557 | <ul style="list-style-type: none"> <i>As-Built Description:</i> Knee clearance at minimums 27" high, 30" wide, and 19" deep is not provided. <i>As-Built:</i> 2.6% slope in wheelchair space at table 36" high table 16" deep knee space <i>Proposed Solution:</i> Modify picnic table as required to provide knee clearance. | <p>PCODE NH11A</p> <p>ADAAG 91 16.5.4.</p> <p>ADA 2010 306.3</p> <p>CBC 2007 1132B.1</p> <p>CBC 2016 11B-306.3</p> <p>Priority 3</p> <p>Severity 2</p> | 1 | JOB | \$850 | \$850 |

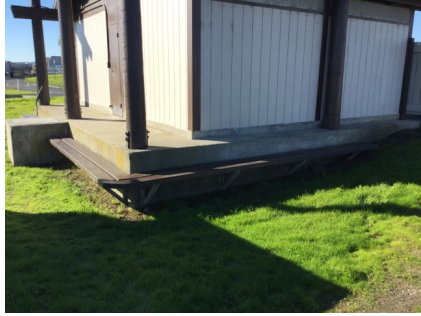
| Item No. and Name | Existing Architectural Barrier and Proposed Solution | Codes / Mitigation Info | Qty | Unit | Cost | Total |
|---|---|---|---|---|---|---|
| 558 | <ul style="list-style-type: none"> <i>As-Built Description:</i> Clear and level floor or ground space (30" x 48") not overlapping with other clear space requirements, is not provided at at least one end of the bench. <i>Proposed Solution:</i> Provide and position a clear and level floor or ground space to allow wheelchair users to be seated shoulder-to-shoulder with an individual seated on the bench. | PCODE N007 ADAAG 91 4.32.2 ADA 2010 903.2 CBC 2007 1118B.4 CBC 2016 11B-903.2 Priority 3 Severity 3 | 1 | JOB | \$500 | \$500 |
