SAN MATEO COUNTY HARBOR DISTRICT

ADA Self-Evaluation and Transition Plan

August 2018

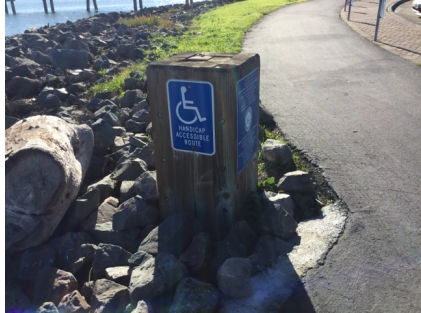
| 555 | <ul style="list-style-type: none"> <i>As-Built Description:</i> Sign directing disabled persons to an accessible route is non-compliant. <i>Proposed Solution:</i> Provide compliant signage that does not contain the word "handicapped". | PCODE SA20A CBC 2007 VC §22511.9. CBC 2016 11B-502.6 Priority 3 Severity 4 | 1 | JOB | \$100 | \$100 |

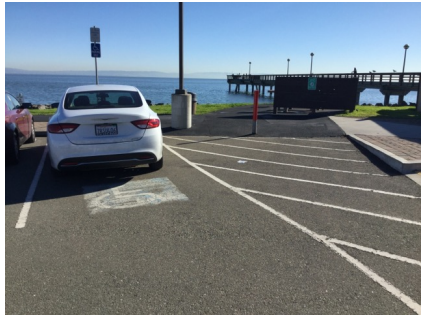
| Floor or Ground Surfaces | | | | | | |
|---|--|--|---|---|---|---|
| 564 | <ul style="list-style-type: none"> <i>As-Built Description:</i> Accessible parking space has slope greater than 1/4":12" (2%). <i>As-Built:</i> 3.4-5.3% <i>Proposed Solution:</i> Modify slope at accessible parking space. | PCODE EA05 ADAAG 91 4.6.3 ADA 2010 502.4 CBC 2007 1129B.3.3 CBC 2016 11B-502.4 Priority 1 Severity 3 | 162 | SF | \$12 | \$1,944 |

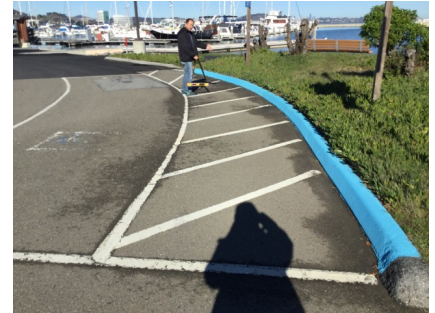
| Item No. and Name | Existing Architectural Barrier and Proposed Solution | Codes / Mitigation Info | Qty | Unit | Cost | Total |
|---|---|---|---|---|---|---|
| 570 | <ul style="list-style-type: none"> <i>As-Built Description:</i> Access aisle at accessible parking space has slope greater than 1/4":12" (2%). <i>As-Built:</i> 3.0-4.6% in aisle <i>Proposed Solution:</i> Modify slope at accessible parking space aisle. | PCODE EA05B ADAAG 91 4.6.3 ADA 2010 502.4 CBC 2007 1129B.3.3 CBC 2016 11B-502.4 Priority 1 Severity 3 | 200 | SF | \$12 | \$2,400 |

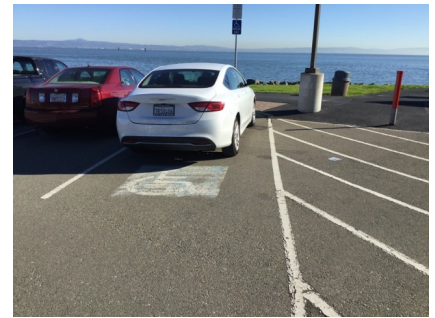
| 559 | <ul style="list-style-type: none"> <i>As-Built Description:</i> International Symbol of Accessibility (36" square, in white on blue) is not painted on the pavement near the rear end of the parking space (required in CA only). <i>As-Built:</i> Faded <i>Proposed Solution:</i> Apply symbol on parking space pavement when altering area. | PCODE EA04A CBC 2007 1129B.4 CBC 2016 11B-502.6.4.1 Priority 1 Severity 4 | 1 | JOB | \$120 | \$120 |

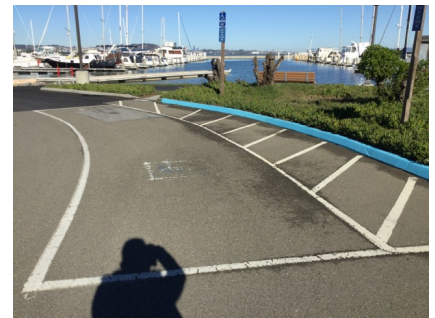
| 566 | <ul style="list-style-type: none"> <i>As-Built Description:</i> International Symbol of Accessibility (36" square, in white on blue) is not painted on the pavement near the rear end of the parking space (required in CA only). <i>As-Built:</i> Faded <i>Proposed Solution:</i> Apply symbol on parking space pavement when altering area. Notes: Accessible trailer parking | PCODE EA04A CBC 2007 1129B.4 CBC 2016 11B-502.6.4.1 Priority 1 Severity 4 | 1 | JOB | \$120 | \$120 |

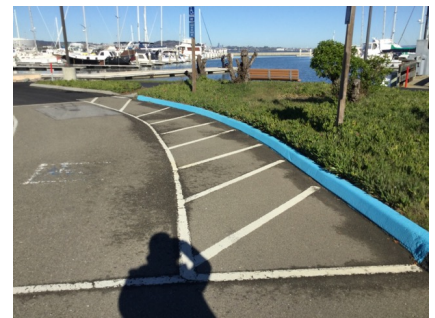
| 567 | <ul style="list-style-type: none"> <i>As-Built Description:</i> The words "NO PARKING" not painted on the ground within loading and unloading access aisle (12" min high white letters), located so that it is visible to traffic enforcement officials (required in CA only). <i>Proposed Solution:</i> Provide the words "NO PARKING" in each access aisle, painted in 12" high letters, when altering area. | PCODE EA04D ADA 2010 502.3.3 CBC 2007 1129B.3.1 CBC 2016 11B-502.3.3 Priority 1 Severity 4 | 1 | JOB | \$100 | \$100 |

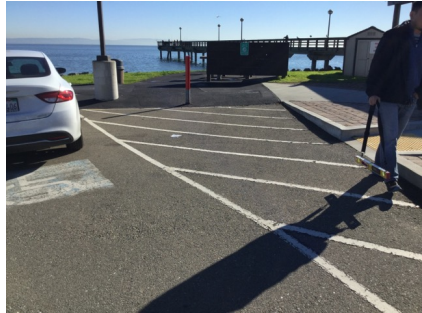
| Item No. and Name | Existing Architectural Barrier and Proposed Solution | Codes / Mitigation Info | Qty | Unit | Cost | Total |
|---|--|---|---|---|---|---|
| 563 | <ul style="list-style-type: none"> <i>As-Built Description:</i> The words "NO PARKING" not painted on the ground within loading and unloading access aisle (12" min high white letters), located so that it is visible to traffic enforcement officials (required in CA only). <i>Proposed Solution:</i> Provide the words "NO PARKING" in each access aisle, painted in 12" high letters, when altering area. Notes: Unusual aisle | PCODE EA04DREF ADA 2010 502.3.3 CBC 2007 1129B.3.1 CBC 2016 11B-502.3.3 Priority 1 Severity 4 | | | | REF |

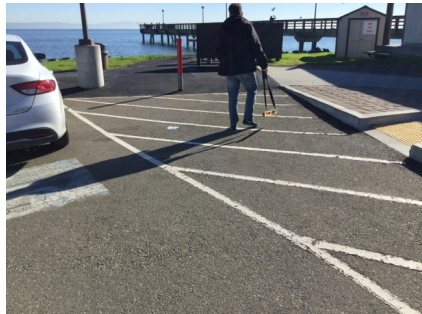
| Item No. and Name | Existing Architectural Barrier and Proposed Solution | Codes / Mitigation Info | Qty | Unit | Cost | Total |
|---|--|---|---|---|---|---|
| 562 | <ul style="list-style-type: none"> <i>As-Built Description:</i> CA only: The area within the blue borderlines not marked with hatched lines a maximum of 36" on center. <i>As-Built:</i> No blue border <i>Proposed Solution:</i> Restripe to provide hatched lines at 36" on center within access aisle. | PCODE EA04I CBC 2007 1129B.3.1 CBC 2016 11B-502.3.3 Priority 1 Severity 4 | 1 | JOB | \$100 | \$100 |

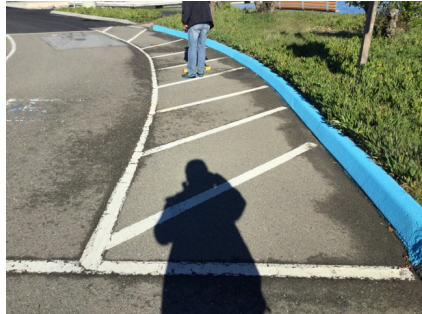
| Item No. and Name | Existing Architectural Barrier and Proposed Solution | Codes / Mitigation Info | Qty | Unit | Cost | Total |
|---|--|---|---|---|---|---|
| 569 | <ul style="list-style-type: none"> <i>As-Built Description:</i> CA only: The area within the blue borderlines not marked with hatched lines a maximum of 36" on center. <i>As-Built:</i> No blue border <i>Proposed Solution:</i> Restripe to provide hatched lines at 36" on center within access aisle. | PCODE EA04I CBC 2007 1129B.3.1 CBC 2016 11B-502.3.3 Priority 1 Severity 4 | 1 | JOB | \$100 | \$100 |

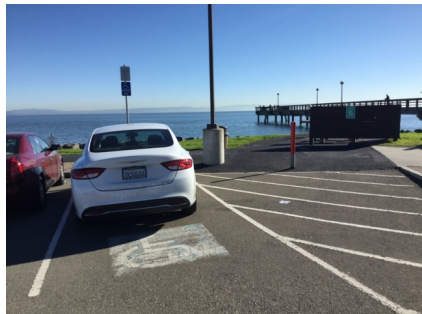
| Item No. and Name | Existing Architectural Barrier and Proposed Solution | Codes / Mitigation Info | Qty | Unit | Cost | Total |
|---|--|---|---|---|---|---|
| 565 | <ul style="list-style-type: none"> <i>As-Built Description:</i> No van parking provided (one in every 6 or fraction of 6 accessible spaces, but not less than one). <i>As-Built:</i> No Van space <i>Proposed Solution:</i> Provide van parking space(s) by restriping; provide van sign. | PCODE EA07 ADAAG 91 4.1.2(5)(b) ADA 2010 208.2; 502.1 CBC 2007 1129B.3.2 CBC 2016 11B-208.2.4 Priority 1 Severity 2 | 1 | JOB | \$350 | \$350 |

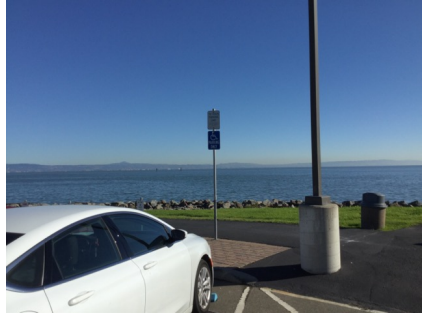
| Item No. and Name | Existing Architectural Barrier and Proposed Solution | Codes / Mitigation Info | Qty | Unit | Cost | Total |
|---|--|--|---|---|---|---|
| 561 | <ul style="list-style-type: none"> <i>As-Built Description:</i> No "Tow Away" sign at parking lot entrance (required in CA only). <i>Proposed Solution:</i> Provide "Tow Away" sign at parking lot entrance when altering area. | <p><i>PCODE</i> EA04C</p> <p><i>CBC 2007</i> 1129B.4</p> <p><i>CBC 2016</i> 11B-502.8.2</p> <p>Priority 1</p> <p>Severity 4</p> | 1 | JOB | \$325 | \$325 |

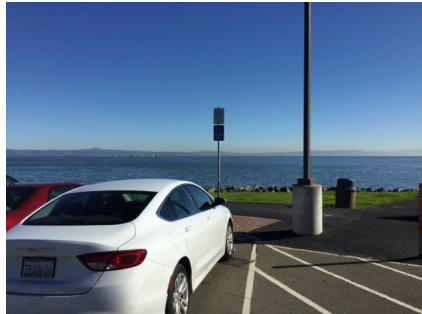
| Item No. and Name | Existing Architectural Barrier and Proposed Solution | Codes / Mitigation Info | Qty | Unit | Cost | Total |
|---|--|--|---|---|---|---|
| 560 | <ul style="list-style-type: none"> <i>As-Built Description:</i> CA only: Additional Sign or additional language below the symbol of accessibility stating "Minimum Fine \$250" not provided. <i>Proposed Solution:</i> Provide compliant parking signage that includes fine information. | <p><i>PCODE</i> EA04G</p> <p><i>CBC 2007</i> 1129B.4</p> <p><i>CBC 2016</i> 11B-502.6.2</p> <p>Priority 1</p> <p>Severity 4</p> | 1 | JOB | \$100 | \$100 |

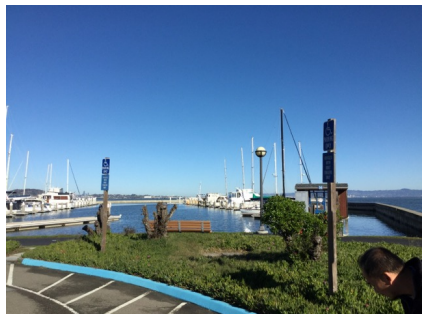
| Item No. and Name | Existing Architectural Barrier and Proposed Solution | Codes / Mitigation Info | Qty | Unit | Cost | Total |
|---|--|--|---|---|---|---|
| 568 | <ul style="list-style-type: none"> <i>As-Built Description:</i> CA only: Additional Sign or additional language below the symbol of accessibility stating "Minimum Fine \$250" not provided. <i>Proposed Solution:</i> Provide compliant parking signage that includes fine information. | <p><i>PCODE</i> EA04G</p> <p><i>CBC 2007</i> 1129B.4</p> <p><i>CBC 2016</i> 11B-502.6.2</p> <p>Priority 1</p> <p>Severity 4</p> | 1 | JOB | \$100 | \$100 |

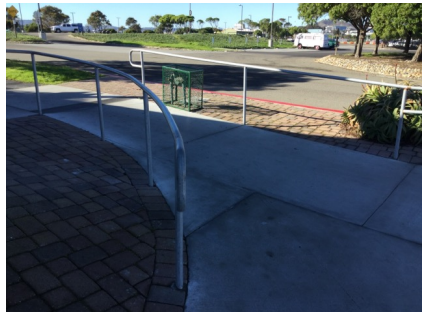
| Item No. and Name | Existing Architectural Barrier and Proposed Solution | Codes / Mitigation Info | Qty | Unit | Cost | Total |
|---|--|--|---|---|---|---|
| 574 | <ul style="list-style-type: none"> <i>As-Built Description:</i> No curb (2" minimum height) or wheel guide (centered approx. 3" above surface of ramp) at sides of ramp. <i>Proposed Solution:</i> Provide 2" minimum curb or wheel guide. | <p><i>PCODE</i> EB14</p> <p><i>ADAAG 91</i> 4.8.7</p> <p><i>ADA 2010</i> 405.9.2</p> <p><i>CBC 2007</i> 1133B.5.6</p> <p><i>CBC 2016</i> 11B-405.9.2</p> <p>Priority 1</p> <p>Severity 3</p> | 30 | LF | \$17 | \$510 |

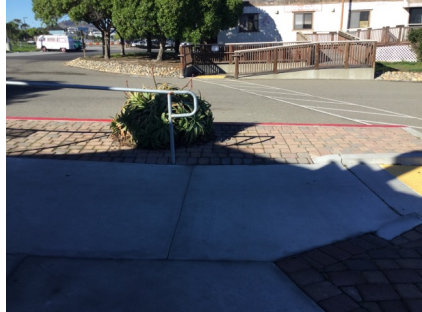
| 575 | <ul style="list-style-type: none"> • <i>As-Built Description:</i> Level 2% max. landing for ramp not provided. • <i>As-Built:</i> 2.5% BL for ramp • <i>Proposed Solution:</i> Rebuild ramp to provide landings for each ramp run with slopes no greater than 2% | <p><i>PCODE</i> EB05A <i>ADAAG 91</i> 4.8.4 <i>ADA 2010</i> 405.7.1 <i>CBC 2007</i> 1133B.5.4.1 <i>CBC 2016</i> 11B-405.7.1</p> <p>Priority 1 Severity 4</p> | 30 | SF | \$100 | \$3,000 |

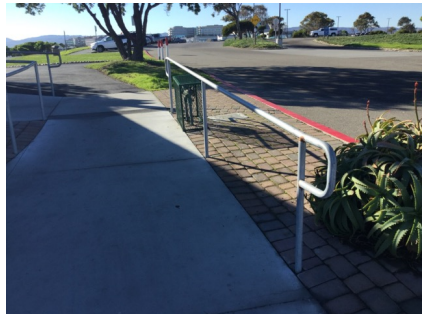
| 576 | <ul style="list-style-type: none"> • <i>As-Built Description:</i> Ramp handrail does not extend horizontally 12" past top and / or bottom of ramp. • <i>As-Built:</i> 8" extensions • <i>Proposed Solution:</i> Provide ramp handrail extension (cost for each extension piece). | <p><i>PCODE</i> ED05 <i>ADAAG 91</i> 4.8.5(2) <i>ADA 2010</i> 505.10.1 <i>CBC 2007</i> 1133B.4.2.2 & 1133B.5.5.1 <i>CBC 2016</i> 11B-505.10.1</p> <p>Priority 1 Severity 3</p> | 6 | JOB | \$170 | \$1,020 |

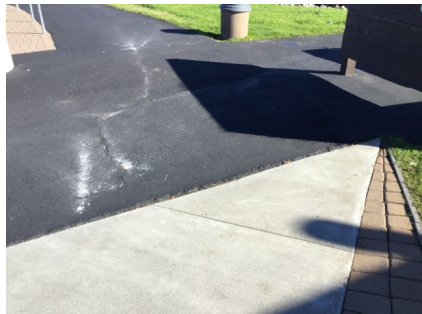
| 578 | <ul style="list-style-type: none"> • <i>As-Built Description:</i> Walk: Pavement dislocation creates abrupt change in level exceeding 1/2" in accessible route. • <i>As-Built:</i> 0.5" lip • <i>Proposed Solution:</i> Remove, replace or repair area of pavement sufficient to correct abrupt change in level. | <p><i>PCODE</i> EF03 <i>ADAAG 91</i> 4.3.8 <i>ADA 2010</i> 403.4 <i>CBC 2007</i> 1133B.7.4 <i>CBC 2016</i> 11B-403.4</p> <p>Priority 1 Severity 4</p> | 20 | SF | \$21 | \$420 |

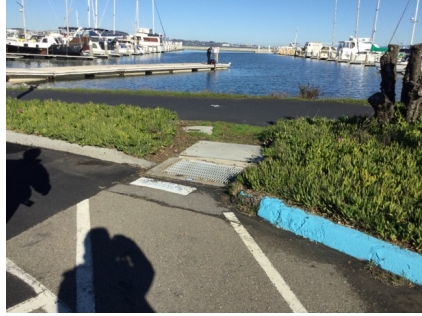
| Item No. and Name | Existing Architectural Barrier and Proposed Solution | Codes / Mitigation Info | Qty | Unit | Cost | Total |
|---|---|---|---|---|---|---|
| 571 | <ul style="list-style-type: none"> <i>As-Built Description:</i> 36" wide band of truncated domes not provided at walkway or crossing adjoining a vehicular way, if surfaces are not separated by a curb, railing, or other element. <i>Proposed Solution:</i> Provide 36" wide, contrasting color, band of truncated domes between pedestrian and vehicular area. | PCODE EG09 ADAAG 91 4.29.5 CBC 2007 1133B.8.5 CBC 2016 11B-705.1.2.5 Priority 1 Severity 3 | 4 | LF | \$27 | \$108 |

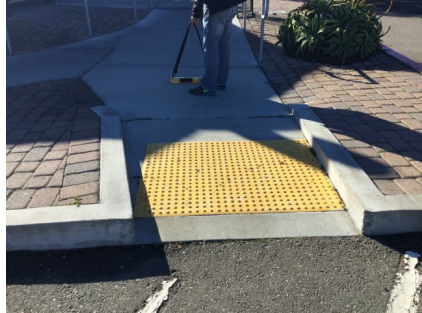
| 573 | <ul style="list-style-type: none"> <i>As-Built Description:</i> Detectable warning not provided where pedestrian crosses vehicular area. <i>As-Built:</i> Not entire width <i>Proposed Solution:</i> Provide detectable warning surface (i.e. in-line truncated domes) at regular curb ramp. | PCODE EH07A ADAAG 91 4.7.7 ADA 2010 705.1 CBC 2007 1127B.5.7 CBC 2016 11B-705.1.2.2 Priority 1 Severity 3 | 1 | JOB | \$250 | \$250 |

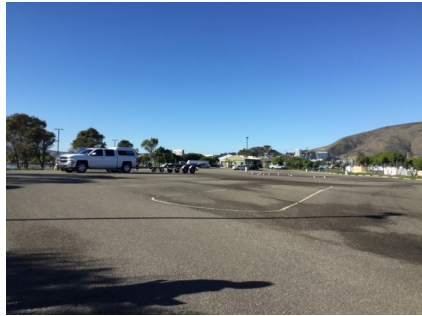
| 580 | <ul style="list-style-type: none"> <i>As-Built Description:</i> At parking lot with 51-75 spaces, the number of accessible spaces is less than required by code; 3 spaces required. <i>As-Built:</i> No accessible parking provided <i>Proposed Solution:</i> Provide required accessible parking spaces with signs including a minimum of one van space. Notes: 56 total trailer parking spaces 0 accessible trailer spaces One accessible boat trailer provided near launch ramp Recommend providing at least 2 more accessible trailer spaces near the launch ramp. | PCODE EA01CNT ADAAG 91 4.1.2(5)* ADA 2010 208.2 CBC 2007 Tbl. 11B-6 CBC 2016 11B-208.2 Tbl. 11B-208.2 Priority 1 Severity 2 | 2 | JOB | \$300 | \$600 |

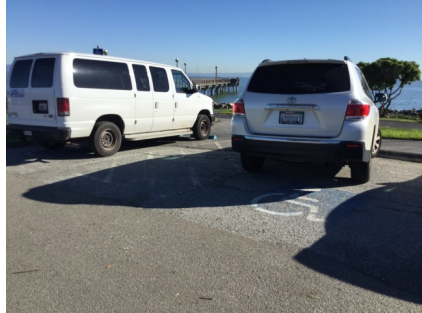
| Item No. and Name | Existing Architectural Barrier and Proposed Solution | Codes / Mitigation Info | Qty | Unit | Cost | Total |
|---|--|--|---|---|---|---|
| 585 | <ul style="list-style-type: none"> <i>As-Built Description:</i> Accessible parking space has slope greater than 1/4":12" (2%). <i>As-Built:</i> 2.6-7.2% <i>Proposed Solution:</i> Modify slope at accessible parking space. <i>Notes:</i> Highly irregular | PCODE EA05 ADAAG 91 4.6.3 ADA 2010 502.4 CBC 2007 1129B.3.3 CBC 2016 11B-502.4 Priority 1 Severity 2 | 486 | SF | \$12 | \$5,832 |

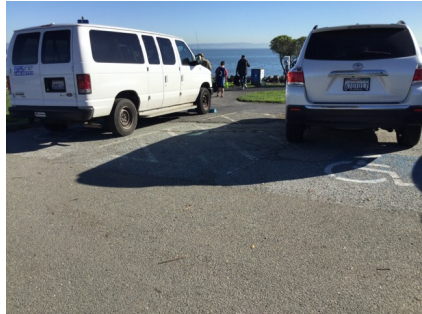
| Item No. and Name | Existing Architectural Barrier and Proposed Solution | Codes / Mitigation Info | Qty | Unit | Cost | Total |
|---|--|--|---|---|---|---|
| 581 | <ul style="list-style-type: none"> <i>As-Built Description:</i> International Symbol of Accessibility (36" square, in white on blue) is not painted on the pavement near the rear end of the parking space (required in CA only). <i>As-Built:</i> Faded <i>Proposed Solution:</i> Apply symbol on parking space pavement when altering area. | PCODE EA04A CBC 2007 1129B.4 CBC 2016 11B-502.6.4.1 Priority 1 Severity 4 | 2 | JOB | \$120 | \$240 |

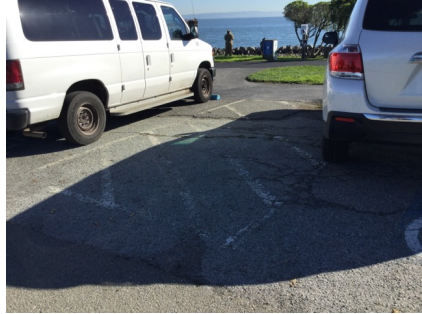
| Item No. and Name | Existing Architectural Barrier and Proposed Solution | Codes / Mitigation Info | Qty | Unit | Cost | Total |
|---|--|--|---|---|---|---|
| 583 | <ul style="list-style-type: none"> <i>As-Built Description:</i> The words "NO PARKING" not painted on the ground within loading and unloading access aisle (12" min high white letters), located so that it is visible to traffic enforcement officials (required in CA only). <i>Proposed Solution:</i> Provide the words "NO PARKING" in each access aisle, painted in 12" high letters, when altering area. | PCODE EA04D ADA 2010 502.3.3 CBC 2007 1129B.3.1 CBC 2016 11B-502.3.3 Priority 1 Severity 4 | 1 | JOB | \$100 | \$100 |

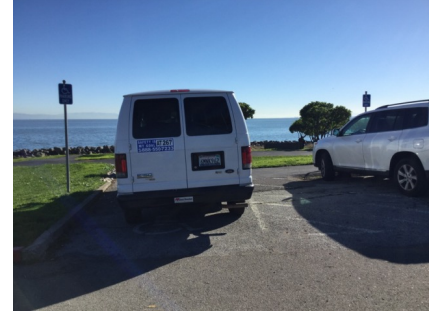
| Item No. and Name | Existing Architectural Barrier and Proposed Solution | Codes / Mitigation Info | Qty | Unit | Cost | Total |
|---|--|---|---|---|---|---|
| 586 | <ul style="list-style-type: none"> <i>As-Built Description:</i> No van parking provided (one in every 6 or fraction of 6 accessible spaces, but not less than one). <i>As-Built:</i> No van space designated <i>Proposed Solution:</i> Provide van parking space(s) by restriping; provide van sign. | PCODE EA07 ADAAG 91 4.1.2(5)(b) ADA 2010 208.2; 502.1 CBC 2007 1129B.3.2 CBC 2016 11B-208.2.4 Priority 1 Severity 2 | 1 | JOB | \$350 | \$350 |

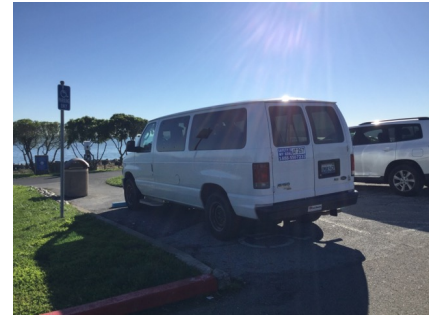
Parking Signage

| 588 | <ul style="list-style-type: none"> <i>As-Built Description:</i> No "Tow Away" sign at parking lot entrance (required in CA only). <i>Proposed Solution:</i> Provide "Tow Away" sign at parking lot entrance when altering area. | PCODE EA04C CBC 2007 1129B.4 CBC 2016 11B-502.8.2 Priority 1 Severity 4 | 1 | JOB | \$325 | \$325 |

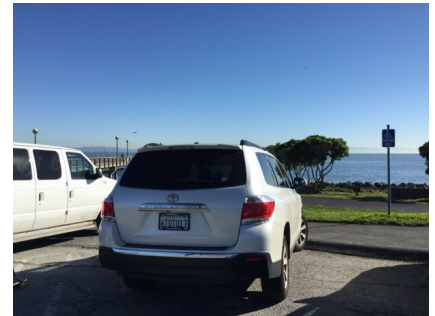
| 582 | <ul style="list-style-type: none"> <i>As-Built Description:</i> CA only: Additional Sign or additional language below the symbol of accessibility stating "Minimum Fine \$250" not provided. <i>Proposed Solution:</i> Provide compliant parking signage that includes fine information. | PCODE EA04G CBC 2007 1129B.4 CBC 2016 11B-502.6.2 Priority 1 Severity 4 | 2 | JOB | \$100 | \$200 |

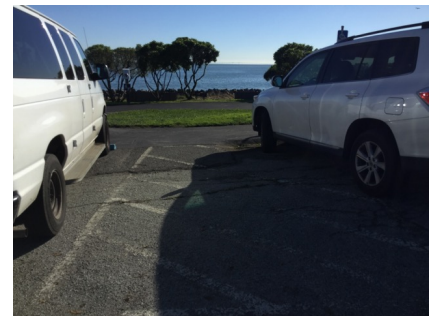
Detectable Warning

| 587 | <ul style="list-style-type: none"> <i>As-Built Description:</i> 36" wide band of truncated domes not provided at walkway or crossing adjoining a vehicular way, if surfaces are not separated by a curb, railing, or other element. <i>Proposed Solution:</i> Provide 36" wide, contrasting color, band of truncated domes between pedestrian and vehicular area. | PCODE EG09 ADAAG 91 4.29.5 CBC 2007 1133B.8.5 CBC 2016 11B-705.1.2.5 Priority 1 Severity 3 | 8 | LF | \$27 | \$216 |

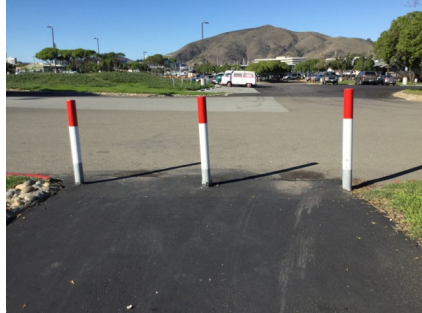
Detectable Warning

| 589 | <ul style="list-style-type: none"> <i>As-Built Description:</i> 36" wide band of truncated domes not provided at walkway or crossing adjoining a vehicular way, if surfaces are not separated by a curb, railing, or other element. <i>Proposed Solution:</i> Provide 36" wide, contrasting color, band of truncated domes between pedestrian and vehicular area. <i>Notes:</i> To parking lot | <p>PCODE EG09 ADAAG 91 4.29.5 CBC 2007 1133B.8.5 CBC 2016 11B-705.1.2.5</p> <p>Priority 1 Severity 3</p> | 10 | LF | \$27 | \$270 |

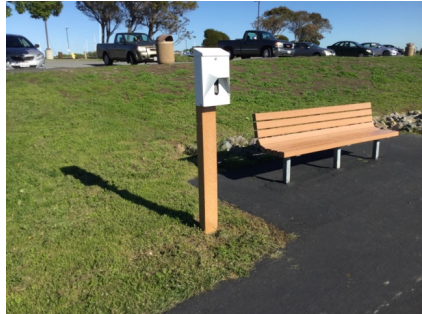
Reach Range

| 603 | <ul style="list-style-type: none"> <i>As-Built Description:</i> Reach height to control or access point, where only forward approach is available, exceeds 48" or is less than 15". <i>As-Built:</i> Dog waste bin: 50" high <i>Proposed Solution:</i> Modify equipment or mounting. <i>Notes:</i> Compliant with past code for recreational areas. | <p>PCODE IE01REF ADAAG 91 4.2.5 ADA 2010 308.2.1 CBC 2007 1118B.5 CBC 2016 11B-308.2.1</p> <p>Priority 1 Severity 4</p> | REF | | | |

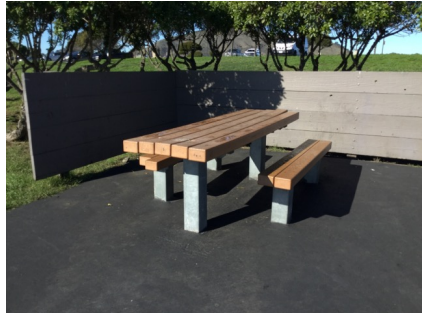
Picnic Area

| 594 | <ul style="list-style-type: none"> <i>As-Built Description:</i> Knee clearance at minimums 27" high, 30" wide, and 19" deep is not provided. <i>As-Built:</i> 2.6% slope in wheelchair space 15" deep knee space <i>Proposed Solution:</i> Modify picnic table as required to provide knee clearance. <i>Notes:</i> 4 picnic tables | <p>PCODE NH11A ADAAG 91 16.5.4. ADA 2010 306.3 CBC 2007 1132B.1 CBC 2016 11B-306.3</p> <p>Priority 2 Severity 2</p> | 1 | JOB | \$850 | \$850 |

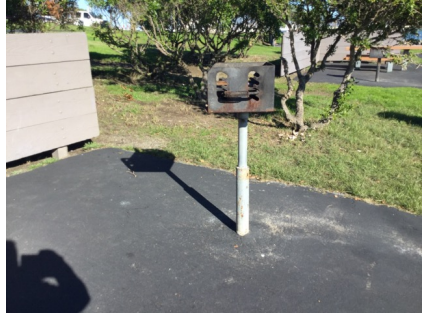
| Item No. and Name | Existing Architectural Barrier and Proposed Solution | Codes / Mitigation Info | Qty | Unit | Cost | Total |
|---|--|---|---|---|---|---|
| <u>Cooking and Grills</u> | | | | | | |

| Item No. and Name | Existing Architectural Barrier and Proposed Solution | Codes / Mitigation Info | Qty | Unit | Cost | Total |
|---|--|---|---|---|---|---|
| 595 | <ul style="list-style-type: none"> <i>As-Built Description:</i> Single cook surface height is not between 28" and 34" above ground surface. <i>As-Built:</i> 40" high grill <i>Proposed Solution:</i> Replace with new cook surface. | <p>PCODE NJ01A ADAAG 91 16.7.3 ADA 2010 804.3.2 CBC 2007 1132B.1 CBC 2016 11B-306.1 & 11B-902.3</p> <p>Priority 2 Severity 3</p> | 1 | JOB | \$200 | \$200 |

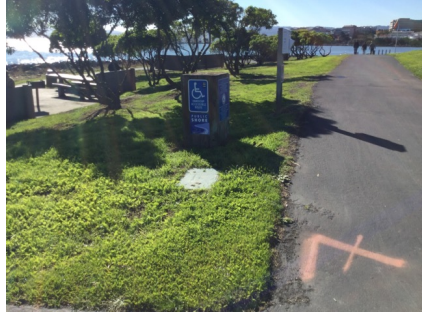
| <u>Route Sign</u> | | | | | | |

| 592 | <ul style="list-style-type: none"> <i>As-Built Description:</i> Sign directing disabled persons to an accessible route is non-compliant. <i>Proposed Solution:</i> Provide compliant signage that does not contain the word "handicapped". | <p>PCODE SA20A CBC 2007 VC §22511.9. CBC 2016 11B-502.6</p> <p>Priority 2 Severity 4</p> | 1 | JOB | \$100 | \$100 |

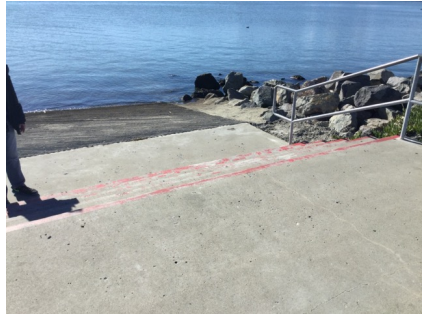
| <u>Tread Surface</u> | | | | | | |

| 600 | <ul style="list-style-type: none"> <i>As-Built Description:</i> The leading 2" of the tread does not have visual contrast of dark-on-light or light-on-dark from the remainder of the tread. <i>Proposed Solution:</i> Provide contrasting color strips at all exterior stair treads. | <p>PCODE EC02 ADA 2010 504.4 CBC 2007 1133B.4.4 CBC 2016 11B-504.4.1</p> <p>Priority 2 Severity 4</p> | 75 | LF | \$9 | \$675 |

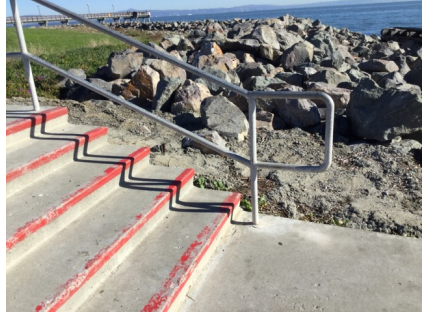
Top & Bottom Extension at Stairs

| 601 | <ul style="list-style-type: none"> <i>As-Built Description:</i> Stair handrail does not extend horizontally 12" minimum beyond top nosing, and one tread width sloped, plus 12" minimum horizontally beyond the bottom nosing. <i>As-Built:</i> Lacks one tread width extending passed bottom <i>Proposed Solution:</i> Extend stair handrail at top and bottom (cost for each extension piece). | <p>PCODE ED06 ADAAG 91 4.9.4(2) ADA 2010 505.10.2; 505.10.3 CBC 2007 1133B.4.2.2 CBC 2016 11B-505.10.2; 11B-505.10.3</p> <p>Priority 2 Severity 4</p> | 2 | JOB | \$170 | \$340 |

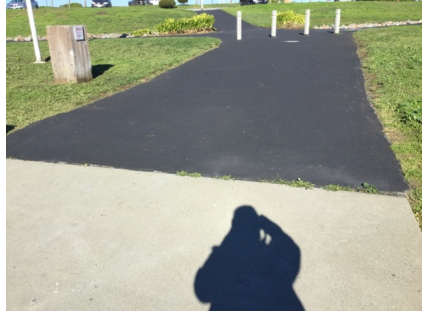
Changes in Level

| 599 | <ul style="list-style-type: none"> <i>As-Built Description:</i> Walk: Pavement dislocation creates abrupt change in level exceeding 1/2" in accessible route. <i>As-Built:</i> 0.5" lip at transition to asphalt and concrete <i>Proposed Solution:</i> Remove, replace or repair area of pavement sufficient to correct abrupt change in level. | <p>PCODE EF03 ADAAG 91 4.3.8 ADA 2010 403.4 CBC 2007 1133B.7.4 CBC 2016 11B-403.4</p> <p>Priority 2 Severity 4</p> | 15 | SF | \$21 | \$315 |

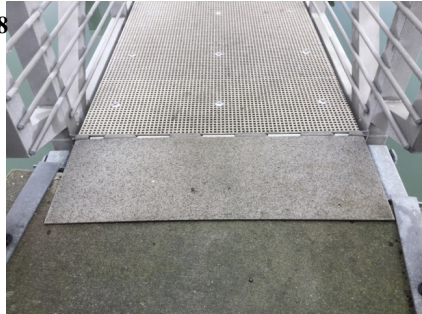
Recreational Boating Facilities

| 459 | <ul style="list-style-type: none"> <i>As-Built Description:</i> Dislocation creates abrupt change in level exceeding 1/2" on the accessible route along the gangway ramp. <i>As-Built:</i> Transition plate moves and creates a lip <i>Proposed Solution:</i> Modify gangway ramp to smooth or ramp abrupt portion. Notes: Replace transition plate with one that is less susceptible to movement. | <p>PCODE NZ01B ADA 2010 1003.2.1 Exception 8 CBC 2016 11B-1003.2.1 Exception 8</p> <p>Priority 2 Severity 3</p> | 1 | JOB | \$500 | \$500 |

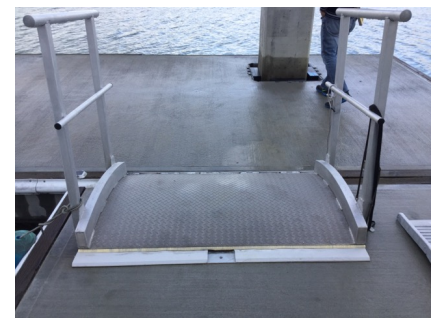
| 461 | <ul style="list-style-type: none"> <i>As-Built Description:</i> Slope greater than 1:12 (8.3%). <i>As-Built:</i> 20% slope on gangway ramp <i>Proposed Solution:</i> Demolish existing and provide new ramp with handrails. Notes: Fluctuates with tide; gangway is not of sufficient length to meet exceptions. | <p>PCODE EB02</p> <p>ADAAG 91 4.8.2</p> <p>ADA 2010 405.2</p> <p>CBC 2007 1133B.5.3</p> <p>CBC 2016 11B-405.2</p> <p>Priority 2</p> <p>Severity 1</p> | 30 | SF | \$100 | \$3,000 |

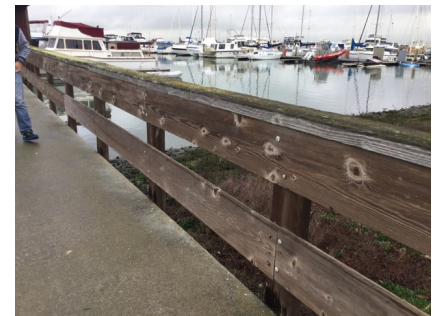
Handrail

| 453 | <ul style="list-style-type: none"> <i>As-Built Description:</i> Open guards does not have balusters or ornamental patterns such that a 4-inch-diameter (102 mm) sphere cannot pass through any opening. <i>As-Built:</i> 7.5-8.5" openings in railing <i>Proposed Solution:</i> Provide new guards which do not allow passage of an 4 inch sphere at any opening. | <p>PCODE ED08A</p> <p>ADA 2010 405.9.2</p> <p>CBC 2007 1013.3</p> <p>CBC 2016 11B-405.9.2</p> <p>Priority 2</p> <p>Severity 3</p> | 100 | LF | \$120 | \$12,000 |

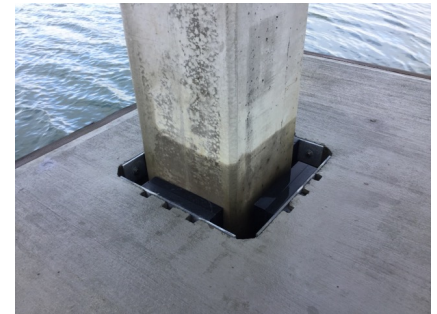
| 462 | <ul style="list-style-type: none"> • <i>As-Built Description:</i> Walk: Grating has grid openings greater than 1/2" along the line of traffic flow. • <i>As-Built:</i> Openings adjacent pillar create tripping hazard • <i>Proposed Solution:</i> Provide new grating, with grid openings 1/2" max. along the line of traffic flow. • Notes: Throughout boat slips. Check feasibility of addressing issue. | <p>PCODE EF04REF</p> <p>ADAAG 91 4.3.6; 4.5.4</p> <p>ADA 2010 403.2; 302.3</p> <p>CBC 2007 1133B.7.2</p> <p>CBC 2016 11B-403.2; 11B-302.3</p> <p>Priority 2</p> <p>Severity 2</p> | | | | |

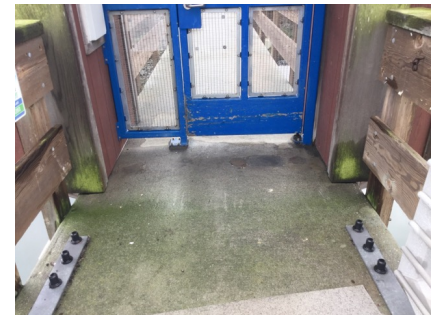
Door

| 458 | <ul style="list-style-type: none"> • <i>As-Built Description:</i> Surface of required maneuvering clearance at door slopes more than 1/4":12" (2.0%). • <i>As-Built:</i> 2.4-2.8% • <i>Proposed Solution:</i> Modify surface slope at door. | <p>PCODE ID11</p> <p>ADAAG 91 4.13.6</p> <p>ADA 2010 404.2.4.4</p> <p>CBC 2007 1133B.2.4</p> <p>CBC 2016 11B-404.2.4</p> <p>Priority 2</p> <p>Severity 4</p> | 25 | SF | \$40 | \$1,000 |

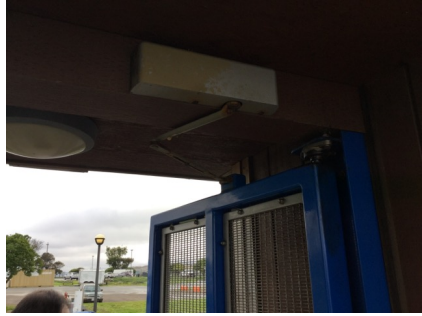
| Item No. and Name | Existing Architectural Barrier and Proposed Solution | Codes / Mitigation Info | Qty | Unit | Cost | Total |
|---|---|--|---|---|---|---|
| Door Closer | | | | | | |

| Item No. and Name | Existing Architectural Barrier and Proposed Solution | Codes / Mitigation Info | Qty | Unit | Cost | Total |
|---|---|--|---|---|---|---|
| 456 | <ul style="list-style-type: none"> <i>As-Built Description:</i> Excessive force required to open door. <i>As-Built:</i> 16 lbs <i>Proposed Solution:</i> Adjust regular door closer to accessible standards (5 lbs. max). | <p><i>PCODE</i> ID03</p> <p>ADAAG 91 4.13.11</p> <p>ADA 2010 404.2.9</p> <p>CBC 2007 1133B.2.5</p> <p>CBC 2016 11B-404.2.9</p> <p>Priority 2</p> <p>Severity 2</p> | 1 | JOB | \$25 | \$25 |

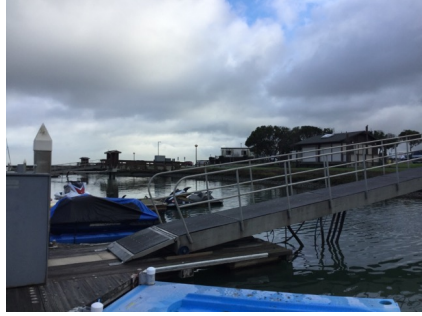
| Handrail | | | | | | | |

| 463 | <ul style="list-style-type: none"> <i>As-Built Description:</i> Open guards does not have balusters or ornamental patterns such that a 4-inch-diameter (102 mm) sphere cannot pass through any opening. <i>As-Built:</i> 19" openings in guardrail <i>Proposed Solution:</i> Provide new guards which do not allow passage of an 4 inch sphere at any opening. Notes: Occurs at Boat Slip 12, 13 and 14. Boat Slip 11 provides compliant gangway ramp with guardrails of sufficient protection; likely why the slip is designated accessible by staff. | <p><i>PCODE</i> ED08AREF</p> <p>ADA 2010 405.9.2</p> <p>CBC 2007 1013.3</p> <p>CBC 2016 11B-405.9.2</p> <p>Priority 2</p> <p>Severity 1</p> | REF | | | | |

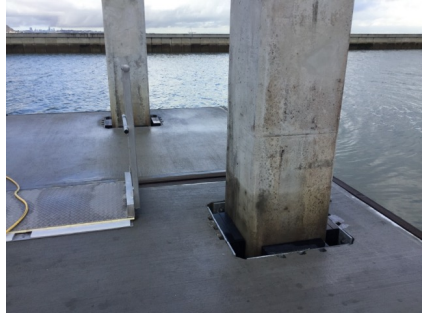
| Floor or Ground Surface | | | | | | | |

| 464 | <ul style="list-style-type: none"> <i>As-Built Description:</i> Walk: Grating has grid openings greater than 1/2" along the line of traffic flow. <i>As-Built:</i> Openings adjacent pillars create tripping hazard <i>Proposed Solution:</i> Provide new grating, with grid openings 1/2" max. along the line of traffic flow. | <p><i>PCODE</i> EF04REF</p> <p>ADAAG 91 4.3.6; 4.5.4</p> <p>ADA 2010 403.2; 302.3</p> <p>CBC 2007 1133B.7.2</p> <p>CBC 2016 11B-403.2; 11B-302.3</p> <p>Priority 2</p> <p>Severity 2</p> | REF | | | | |

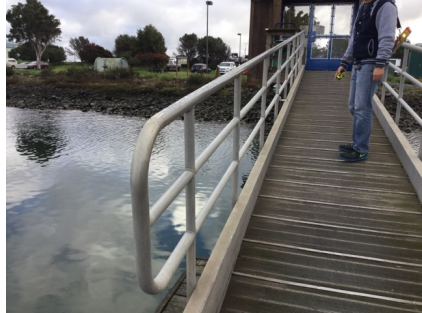
| Item No. and Name | Existing Architectural Barrier and Proposed Solution | Codes / Mitigation Info | Qty | Unit | Cost | Total |
|---|--|---|---|---|---|---|
| Handrail | | | | | | |

| Item No. and Name | Existing Architectural Barrier and Proposed Solution | Codes / Mitigation Info | Qty | Unit | Cost | Total |
|---|--|---|---|---|---|---|
| 467 | <ul style="list-style-type: none"> <i>As-Built Description:</i> Open guards does not have balusters or ornamental patterns such that a 4-inch-diameter (102 mm) sphere cannot pass through any opening. <i>As-Built:</i> 10" openings in guardrails <i>Proposed Solution:</i> Provide new guards which do not allow passage of an 4 inch sphere at any opening. <i>Notes:</i> 60' long gangway ramps Noncompliant guardrails occurs at three gangway ramps in the area. Recommend designating and providing an accessible boat slip amongst Boat Slips 1 to 6 to provide an accessible slip in the west. | <p><i>PCODE</i> ED08A <i>ADA 2010</i> 405.9.2 <i>CBC 2007</i> 1013.3 <i>CBC 2016</i> 11B-405.9.2</p> <p>Priority 2 Severity 2</p> | 60 | LF | \$120 | \$7,200 |

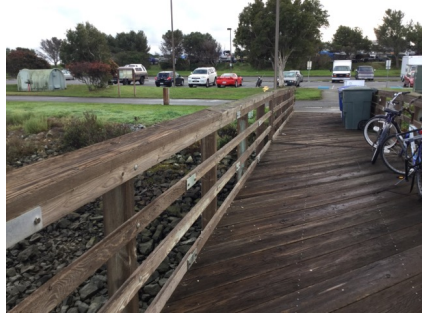
| Item No. and Name | Existing Architectural Barrier and Proposed Solution | Codes / Mitigation Info | Qty | Unit | Cost | Total |
|---|--|---|---|---|---|---|
| 469 | <ul style="list-style-type: none"> <i>As-Built Description:</i> Open guards does not have balusters or ornamental patterns such that a 4-inch-diameter (102 mm) sphere cannot pass through any opening. <i>As-Built:</i> 9" openings <i>Proposed Solution:</i> Provide new guards which do not allow passage of an 4 inch sphere at any opening. <i>Notes:</i> At entrance to boat slips. | <p><i>PCODE</i> ED08A <i>ADA 2010</i> 405.9.2 <i>CBC 2007</i> 1013.3 <i>CBC 2016</i> 11B-405.9.2</p> <p>Priority 2 Severity 3</p> | 100 | LF | \$120 | \$12,000 |

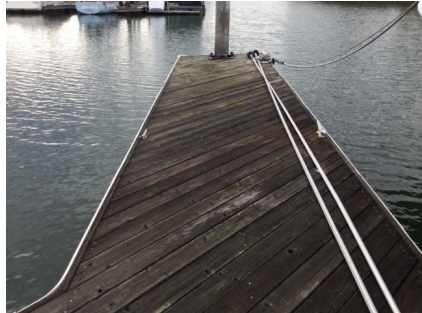
| Item No. and Name | Existing Architectural Barrier and Proposed Solution | Codes / Mitigation Info | Qty | Unit | Cost | Total |
|---|--|---|---|---|---|---|
| Cross Slope | | | | | | |

| Item No. and Name | Existing Architectural Barrier and Proposed Solution | Codes / Mitigation Info | Qty | Unit | Cost | Total |
|---|--|---|---|---|---|---|
| 465 | <ul style="list-style-type: none"> <i>As-Built Description:</i> Cross slope more than 1":48" (2.083%). <i>As-Built:</i> Various cross slope issues at ends of boat slips 2-6 <i>Proposed Solution:</i> Modify cross slope. <i>Notes:</i> Sufficient space for an accessible boat slip is provided at ends of slips 2-6. Recommend designating and providing an accessible boat slip amongst Boat Slips 1 to 6 to provide an accessible slip in the west. Resolve slope issues and other access issues for boat slip designated accessible. | <p><i>PCODE</i> EF07 <i>ADAAG 91</i> 4.3.7 <i>ADA 2010</i> 403.3 <i>CBC 2007</i> 1133B.7.1.3 <i>CBC 2016</i> 11B-403.3</p> <p>Priority 2 Severity 4</p> | 200 | SF | \$25 | \$5,000 |

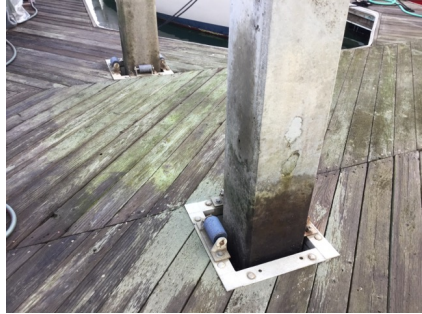
| Item No. and Name | Existing Architectural Barrier and Proposed Solution | Codes / Mitigation Info | Qty | Unit | Cost | Total |
|---|--|---|---|---|---|---|
| 466 | <ul style="list-style-type: none"> <i>As-Built Description:</i> Walk: Grating has grid openings greater than 1/2" along the line of traffic flow. <i>As-Built:</i> Openings near pillars create tripping hazard <i>Proposed Solution:</i> Provide new grating, with grid openings 1/2" max. along the line of traffic flow. <i>Notes:</i> Throughout area, determine if feasible to address barrier. | <p>PCODE EF04REF</p> <p>ADAAG 91 4.3.6; 4.5.4</p> <p>ADA 2010 403.2; 302.3</p> <p>CBC 2007 1133B.7.2</p> <p>CBC 2016 11B-403.2; 11B-302.3</p> <p>Priority 2</p> <p>Severity 2</p> | | | | |

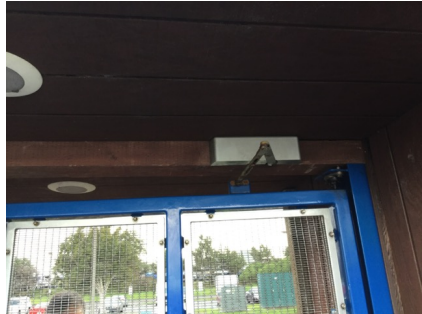
| <u>Door Closer</u> | | | | | | |

| 468 | <ul style="list-style-type: none"> <i>As-Built Description:</i> Excessive force required to open door. <i>As-Built:</i> 12 lbs <i>Proposed Solution:</i> Adjust regular door closer to accessible standards (5 lbs. max). <i>Notes:</i> At entrance door to boat slips. | <p>PCODE ID03</p> <p>ADAAG 91 4.13.11</p> <p>ADA 2010 404.2.9</p> <p>CBC 2007 1133B.2.5</p> <p>CBC 2016 11B-404.2.9</p> <p>Priority 2</p> <p>Severity 3</p> | 3 | JOB | \$25 | \$75 |

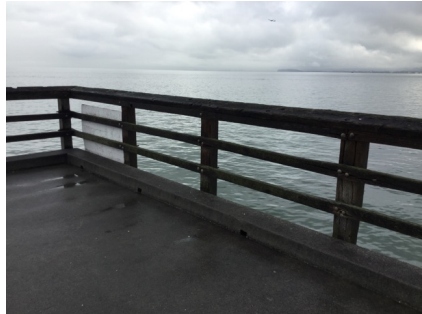
| <u>Fishing Piers and Platforms</u> | | | | | | |

| 448 | <ul style="list-style-type: none"> <i>As-Built Description:</i> Less than 25% of the railings, guards, or handrails are accessible. <i>As-Built:</i> 46" high fishing pier railing <i>Proposed Solution:</i> Replace at least 25% of the railings, guards, or hand rails and insure that they are a max. 34" above the ground or deck surface. <i>Notes:</i> Curb on inside of pier prevents wheelchairs from accessing the fishing pier, recommend removing and providing a 12" edge protection passed the fishing pier. | <p>PCODE NZ02</p> <p>ADA 2010 1005.2.1</p> <p>CBC 2016 11B-1005.2.1</p> <p>Priority 2</p> <p>Severity 3</p> | 125 | LF | \$250 | \$31,250 |

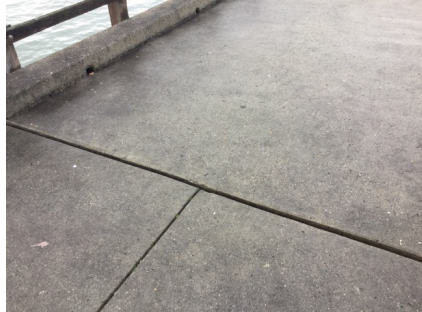
Walkway Surface

| 452 | <ul style="list-style-type: none"> <i>As-Built Description:</i> The sidewalk has a highly irregular pavement surface due to excessive cracks and gaps along path of travel. <i>As-Built:</i> 1.25" gap <i>Proposed Solution:</i> Smooth pavement surface as necessary, by grinding, filling, or refinishing. | <p><i>PCODE</i> PR18A <i>ADAAG 91</i> 4.5.2 <i>PROW</i> R302.7.1 <i>CBC 2007</i> 1133B.7.1 <i>CBC 2016</i> 11B-303.2</p> <p>Priority 2 Severity 4</p> | 10 | SF | \$10 | \$100 |

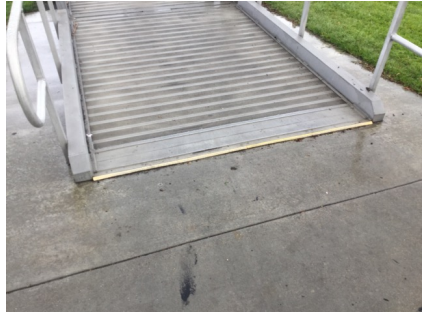
| 445 | <ul style="list-style-type: none"> <i>As-Built Description:</i> Slope greater than 1:12 (8.3%). <i>As-Built:</i> 10.7% at transition <i>Proposed Solution:</i> Demolish existing and provide new ramp with handrails. | <p><i>PCODE</i> EB02 <i>ADAAG 91</i> 4.8.2 <i>ADA 2010</i> 405.2 <i>CBC 2007</i> 1133B.5.3 <i>CBC 2016</i> 11B-405.2</p> <p>Priority 2 Severity 4</p> | 6 | SF | \$100 | \$600 |

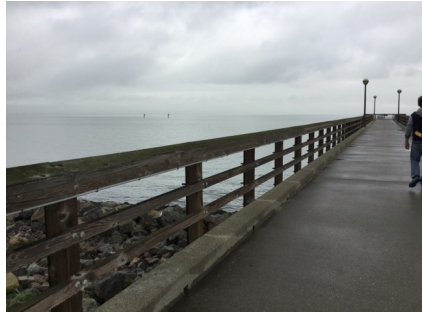
Handrail

| 446 | <ul style="list-style-type: none"> <i>As-Built Description:</i> Open guards does not have balusters or ornamental patterns such that a 4-inch-diameter (102 mm) sphere cannot pass through any opening. <i>As-Built:</i> 9" opening in railing <i>Proposed Solution:</i> Provide new guards which do not allow passage of an 4 inch sphere at any opening. | <p><i>PCODE</i> ED08A <i>ADA 2010</i> 405.9.2 <i>CBC 2007</i> 1013.3 <i>CBC 2016</i> 11B-405.9.2</p> <p>Priority 2 Severity 3</p> | 500 | LF | \$120 | \$60,000 |

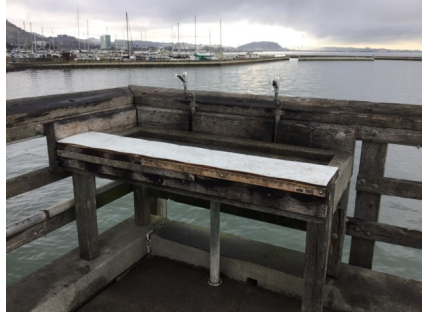
Reach Range

| 451 | <ul style="list-style-type: none"> • <i>As-Built Description:</i> Reach height to control or access point, where side approach is available, exceeds 48" or is less than 15" in height, or exceeds 10" in depth. • <i>As-Built:</i> 51" high at 29" deep sink control • <i>Proposed Solution:</i> Modify equipment or mounting. | <p>PCODE IE02 ADAAG 91 4.2.6 ADA 2010 308.3.1 CBC 2007 1118B.6 CBC 2016 11B-308.3</p> <p>Priority 2 Severity 4</p> | 1 | JOB | \$100 | \$100 |

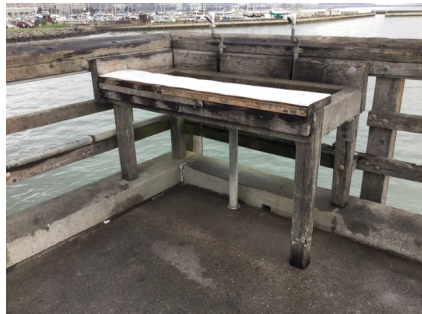
| 449 | <ul style="list-style-type: none"> • <i>As-Built Description:</i> Sink rim higher than 34" above floor. • <i>As-Built:</i> 37.25" high sink • <i>Proposed Solution:</i> Remodel sink cabinet to lower sink. | <p>PCODE IN06 ADAAG 91 4.24.2 ADA 2010 606.3 CBC 2007 1115B.4.7.1 CBC 2016 11B-606.3</p> <p>Priority 2 Severity 4</p> | 1 | JOB | \$1,750 | \$1,750 |

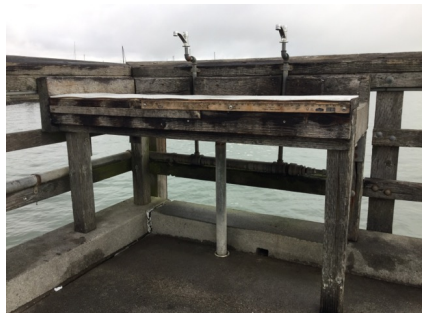
| 450 | <ul style="list-style-type: none"> • <i>As-Built Description:</i> Sink does not have knee space min. 27" high x 19" deep x 30" wide. • <i>As-Built:</i> 17" deep knee space • <i>Proposed Solution:</i> Remodel sink cabinet. | <p>PCODE IN06AREF ADAAG 91 4.24.3 ADA 2010 606.2 CBC 2007 1115B.4.7.1 CBC 2016 11B-606.2</p> <p>Priority 2 Severity 2</p> | REF | | | |

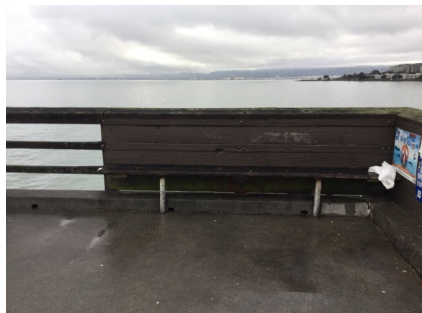
Disabled Seating

| 447 | <ul style="list-style-type: none"> • <i>As-Built Description:</i> Wheelchair space (33"x48") not provided at fixed seating with forward or rear approach. (NOTE: Space must be adjacent to regular seating; can provide easily removable fixed seat). • <i>Proposed Solution:</i> Remove fixed seating and provide wheelchair space plus necessary maneuvering clearance. • Notes: Provided but not directly adjacent | <p>PCODE GB01A ADAAG 91 4.1.3(19)(a) ADA 2010 221.2 CBC 2007 1104B.3.6 CBC 2016 11B-221.2</p> <p>Priority 2 Severity 4</p> | 1 | JOB | \$450 | \$450 |

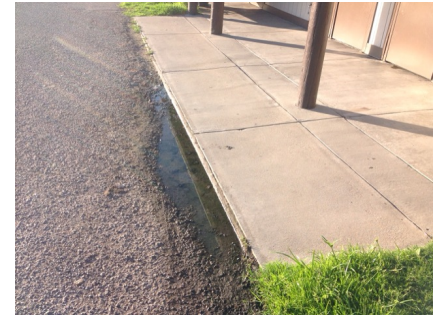
| 138 | <ul style="list-style-type: none"> <i>As-Built Description:</i> Walk: Pavement dislocation creates abrupt change in level exceeding 1/2" in accessible route. <i>As-Built:</i> 1" <i>Proposed Solution:</i> Remove, replace or repair area of pavement sufficient to correct abrupt change in level. | <i>PCODE</i> EF03REF | | | | |

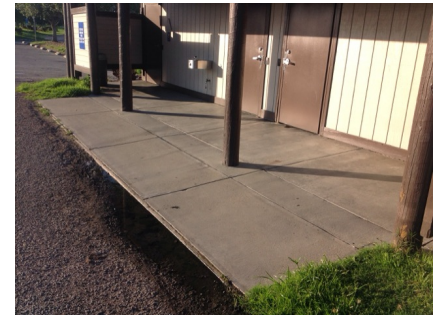
Walk

| 137 | <ul style="list-style-type: none"> <i>As-Built Description:</i> Walk: Slope greater than 1:20 (5.0%), and walk does not comply with requirements for ramps. <i>As-Built:</i> 4.3% to 6.2% <i>Proposed Solution:</i> Modify walk/sidewalk slope to 1:20 or less. | <i>PCODE</i> EF01 | 350 | SF | \$25 | \$8,750 |

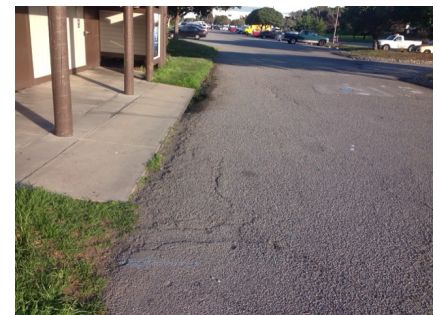
| 136 | <ul style="list-style-type: none"> <i>As-Built Description:</i> Walk: Irregular surface in pavement. <i>Proposed Solution:</i> Smooth pavement surface; grind or refinish surface. | <i>PCODE</i> EF10 | 100 | SF | \$5 | \$500 |

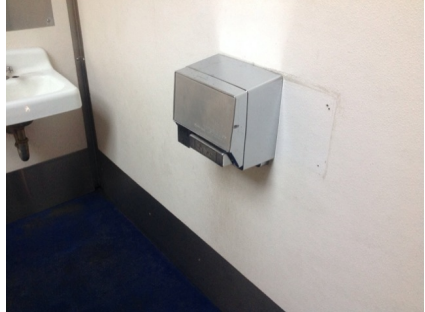
Protrusion Limits

| 147 | <ul style="list-style-type: none"> • <i>As-Built Description:</i> Protruding objects more than 4" from wall, when bottom of object more than 27" or less than 80" above finished floor. • <i>As-Built:</i> PTD: 8" at 34" high • <i>Proposed Solution:</i> Remove/relocate protruding object. Patch existing surface. | <p>PCODE EG04 ADAAG 91 4.4.1 ADA 2010 307.2 CBC 2007 1133B.8.6.1 CBC 2016 11B-307.2</p> <p>Priority 3 Severity 3</p> | 1 | JOB | \$100 | \$100 |

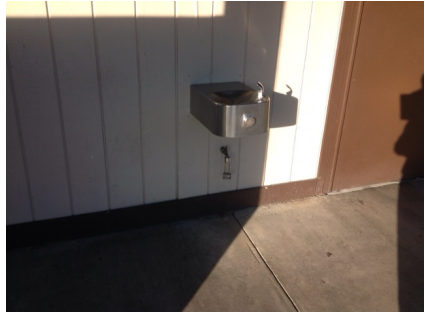
Drinking Fountain

| 139 | <ul style="list-style-type: none"> • <i>As-Built Description:</i> Drinking fountain lacks protection for visually impaired persons. • <i>Proposed Solution:</i> Provide cane-detectable rails. | <p>PCODE IA05C ADAAG 91 4.4.1 ADA 2010 307.2 CBC 2007 1115B.4.6.3 CBC 2016 11B-307.2</p> <p>Priority 3 Severity 3</p> | 1 | JOB | \$500 | \$500 |

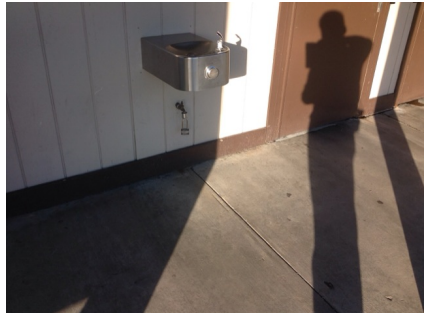
| 140 | <ul style="list-style-type: none"> • <i>As-Built Description:</i> 30" wide x 48" long clear floor space not provided at drinking fountain. • <i>As-Built:</i> 4.0% • <i>Proposed Solution:</i> Provide clear floor space at drinking fountain. | <p>PCODE IA06REF ADAAG 91 4.15.5(1)* ADA 2010 602.2 CBC 2007 1115B.4.6.3 CBC 2016 11B-602.2</p> <p>Priority 3 Severity 3</p> | REF | | | |

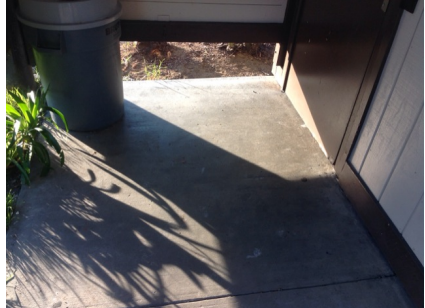
Door

| 144 | <ul style="list-style-type: none"> • <i>As-Built Description:</i> Surface of required maneuvering clearance at door slopes more than 1/4":12" (2.0%). • <i>As-Built:</i> 4.8% • <i>Proposed Solution:</i> Modify surface slope at door. | <p>PCODE ID11REF ADAAG 91 4.13.6 ADA 2010 404.2.4.4 CBC 2007 1133B.2.4 CBC 2016 11B-404.2.4</p> <p>Priority 3 Severity 3</p> | REF | | | |

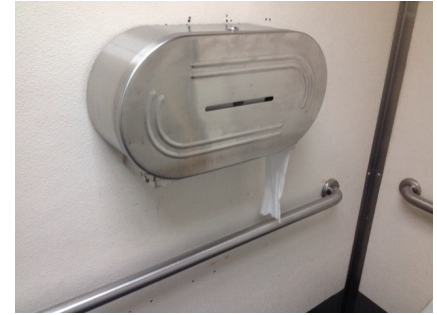
| Item No. and Name | Existing Architectural Barrier and Proposed Solution | Codes / Mitigation Info | Qty | Unit | Cost | Total |
|---|---|--|---|---|---|---|
| 161 | <ul style="list-style-type: none"> <i>As-Built Description:</i> Accessories/dispensers in accessible stall located closer than 1-1/2" below or 12" above grab bar impedes its use. <i>As-Built:</i> 10" <i>Proposed Solution:</i> Relocate accessories/dispensers to be no closer than 1-1/2" below and 12" above grab bars (except if accessories are recessed, flush with wall, and have no sharp edges). | <p>PCODE WB07I ADAAG 91 4.26.2 ADA 2010 609.3 CBC 2007 1133B.4.2.5 CBC 2016 11B-609.3</p> <p>Priority 3 Severity 4</p> | 1 | JOB | \$75 | \$75 |

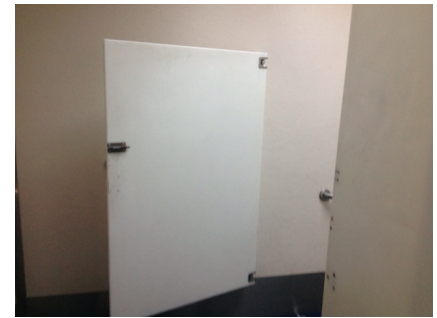
Stall Door

| 154 | <ul style="list-style-type: none"> <i>As-Built Description:</i> Stall door to accessible compartment not self closing. <i>Proposed Solution:</i> Adjust closer. | <p>PCODE WB05B ADAAG 91 4.22.4 ADA 2010 604.8.1.2 CBC 2007 1115B.3.1.4.4 CBC 2016 11B-604.8.1.2</p> <p>Priority 3 Severity 4</p> | 1 | JOB | \$25 | \$25 |

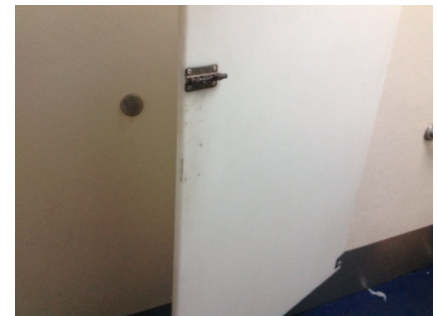
| 155 | <ul style="list-style-type: none"> <i>As-Built Description:</i> Stall door does not have accessible operating hardware (U-pulls on both sides, flip-over or sliding lock). <i>Proposed Solution:</i> Provide new accessible locking hardware that does not require grasping, pinching, or twisting and U-pulls on both sides. | <p>PCODE WB05C ADAAG 91 4.17.5 ADA 2010 604.8.1.2 CBC 2007 1115B.3.1.4.5 CBC 2016 11B-604.8.1.2</p> <p>Priority 3 Severity 3</p> | 1 | JOB | \$100 | \$100 |

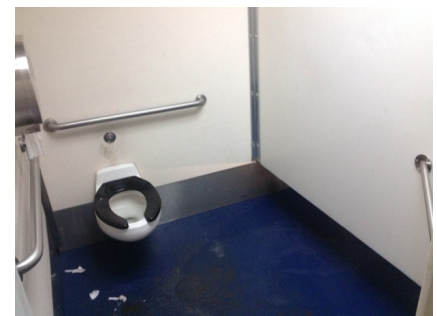
Toilet Stall

| 159 | <ul style="list-style-type: none"> <i>As-Built Description:</i> Toilet stall less than 60" wide. <i>As-Built:</i> 57.5" <i>Proposed Solution:</i> Provide new accessible stall. | <p>PCODE WB06 ADAAG 91 4.17.3 ADA 2010 604.8.1.1 CBC 2007 1115B.3.1.4.1 CBC 2016 11B-604.8.1.1</p> <p>Priority 3 Severity 4</p> | 1 | JOB | \$1,500 | \$1,500 |

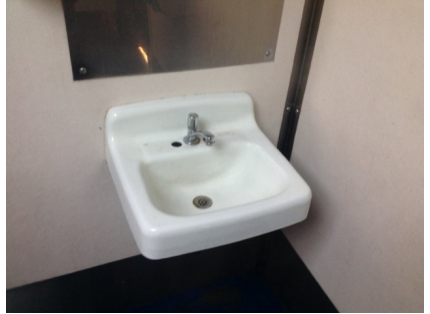
| Item No. and Name | Existing Architectural Barrier and Proposed Solution | Codes / Mitigation Info | Qty | Unit | Cost | Total |
|---|--|---|---|---|---|---|
| 149 | <ul style="list-style-type: none"> <i>As-Built Description:</i> Clear floor space, 30" x 48" in front of fixture, extending 19" max. under the lavatory, not provided (CA only: Less than 18" from side wall to centerline of lavatory). <i>As-Built:</i> 16.5" <i>Proposed Solution:</i> Provide new accessible lavatory. Remodel restroom as needed. | PCODE WD01 ADAAG 91 4.19.3 ADA 2010 606.2 CBC 2007 1115B.4.3 CBC 2016 11B-606.2, 11B-606.6 Priority 3 Severity 2 | 1 | JOB | \$3,400 | \$3,400 |

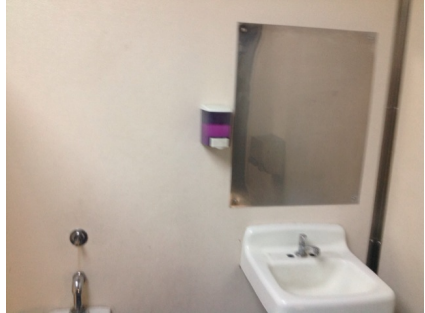
| Item No. and Name | Existing Architectural Barrier and Proposed Solution | Codes / Mitigation Info | Qty | Unit | Cost | Total |
|---|---|---|---|---|---|---|
| 153 | <ul style="list-style-type: none"> <i>As-Built Description:</i> Dispensers in sanitary facilities, such as for towels, soap, sanitary napkins, seat covers, etc., and waste receptacles more than 48" (CA only: 40") from floor to highest operating slot or control. <i>As-Built:</i> SD: 52" high <i>Proposed Solution:</i> Relocate existing restroom accessories. | PCODE WG01A ADAAG 91 4.23.7 ADA 2010 308.2.1 CBC 2007 1115B.8.3 CBC 2016 11B-603.5 Priority 3 Severity 2 | 1 | JOB | \$100 | \$100 |

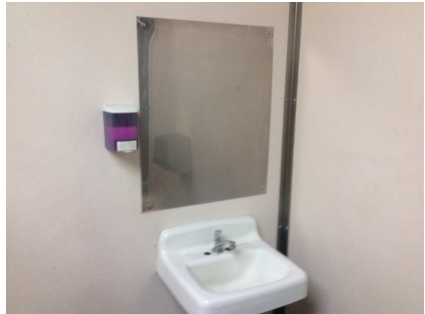
| Item No. and Name | Existing Architectural Barrier and Proposed Solution | Codes / Mitigation Info | Qty | Unit | Cost | Total |
|---|---|---|---|---|---|---|
| 148 | <ul style="list-style-type: none"> <i>As-Built Description:</i> Bottom of flat, not tilted mirror located above lavatories or countertops more than 40" above floor. <i>As-Built:</i> 40.25" <i>Proposed Solution:</i> Relocate or provide new accessible mirror. | PCODE WG03 ADAAG 91 4.19.6 ADA 2010 603.3 CBC 2007 1115B.8.1 CBC 2016 11B-603.3 Priority 3 Severity 4 | 1 | JOB | \$150 | \$150 |

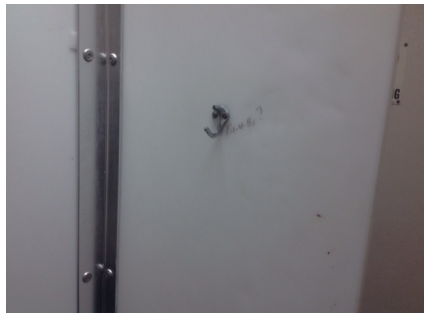
| Item No. and Name | Existing Architectural Barrier and Proposed Solution | Codes / Mitigation Info | Qty | Unit | Cost | Total |
|---|---|---|---|---|---|---|
| 158 | <ul style="list-style-type: none"> <i>As-Built Description:</i> Accessible coat hook not within reach range. <i>As-Built:</i> 60" high <i>Proposed Solution:</i> Adjust existing or provide new coat hook at maximum 48" height. | PCODE WG03A ADAAG 91 4.2.5 ADA 2010 603.4 CBC 2007 1118B.5 CBC 2016 11B-603.4 Priority 3 Severity 2 | 1 | JOB | \$50 | \$50 |

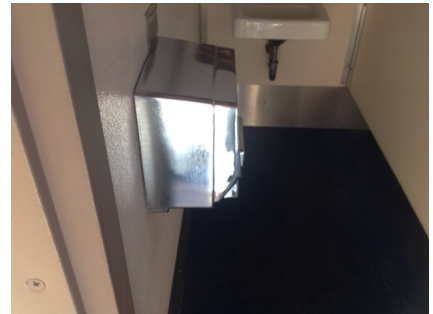
Protrusion Limits

| 168 | <ul style="list-style-type: none"> <i>As-Built Description:</i> Protruding objects more than 4" from wall, when bottom of object more than 27" or less than 80" above finished floor. <i>As-Built:</i> PTD: 7" at 34" high <i>Proposed Solution:</i> Remove/relocate protruding object. Patch existing surface. | <p><i>PCODE</i> EG04</p> <p><i>ADAAG 91</i> 4.4.1</p> <p><i>ADA 2010</i> 307.2</p> <p><i>CBC 2007</i> 1133B.8.6.1</p> <p><i>CBC 2016</i> 11B-307.2</p> <p>Priority 3</p> <p>Severity 3</p> | 1 | JOB | \$100 | \$100 |

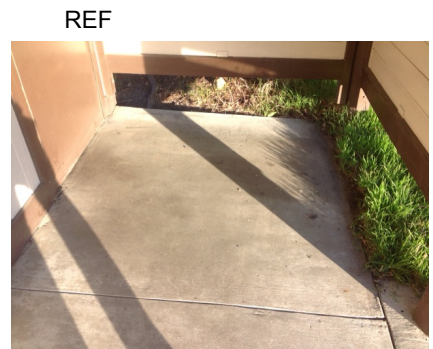
Door

| 164 | <ul style="list-style-type: none"> <i>As-Built Description:</i> Surface of required maneuvering clearance at door slopes more than 1/4":12" (2.0%). <i>As-Built:</i> 5.9% <i>Proposed Solution:</i> Modify surface slope at door. | <p><i>PCODE</i> ID11REF</p> <p><i>ADAAG 91</i> 4.13.6</p> <p><i>ADA 2010</i> 404.2.4.4</p> <p><i>CBC 2007</i> 1133B.2.4</p> <p><i>CBC 2016</i> 11B-404.2.4</p> <p>Priority 3</p> <p>Severity 3</p> | | | | |

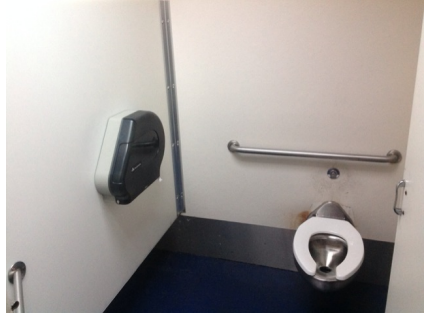
| Item No. and Name | Existing Architectural Barrier and Proposed Solution | Codes / Mitigation Info | Qty | Unit | Cost | Total |
|---|--|--|---|---|---|---|
| 178 | <ul style="list-style-type: none"> • <i>As-Built Description:</i> Toilet stall less than 60" wide. • <i>As-Built:</i> 57.5" • <i>Proposed Solution:</i> Provide new accessible stall. | <p><i>PCODE</i> WB06</p> <p><i>ADAAG 91</i> 4.17.3</p> <p><i>ADA 2010</i> 604.8.1.1</p> <p><i>CBC 2007</i> 1115B.3.1.4.1</p> <p><i>CBC 2016</i> 11B-604.8.1.1</p> <p>Priority 3</p> <p>Severity 4</p> | 1 | JOB | \$1,500 | \$1,500 |

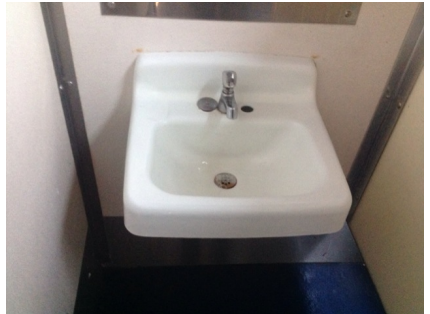
| Item No. and Name | Existing Architectural Barrier and Proposed Solution | Codes / Mitigation Info | Qty | Unit | Cost | Total |
|---|--|--|---|---|---|---|
| 174 | <ul style="list-style-type: none"> • <i>As-Built Description:</i> Clear floor space, 30" x 48" in front of fixture, extending 19" max. under the lavatory, not provided (CA only: Less than 18" from side wall to centerline of lavatory). • <i>As-Built:</i> 16" • <i>Proposed Solution:</i> Provide new accessible lavatory. Remodel restroom as needed. | <p><i>PCODE</i> WD01</p> <p><i>ADAAG 91</i> 4.19.3</p> <p><i>ADA 2010</i> 606.2</p> <p><i>CBC 2007</i> 1115B.4.3</p> <p><i>CBC 2016</i> 11B-606.2, 11B-606.6</p> <p>Priority 3</p> <p>Severity 2</p> | 1 | JOB | \$3,400 | \$3,400 |

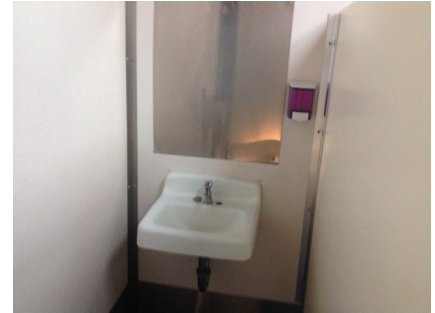
| Item No. and Name | Existing Architectural Barrier and Proposed Solution | Codes / Mitigation Info | Qty | Unit | Cost | Total |
|---|--|--|---|---|---|---|
| 170 | <ul style="list-style-type: none"> <i>As-Built Description:</i> Bottom of flat, not tilted mirror located above lavatories or countertops more than 40" above floor. <i>As-Built:</i> 40.5" <i>Proposed Solution:</i> Relocate or provide new accessible mirror. | PCODE WG03 ADAAG 91 4.19.6 ADA 2010 603.3 CBC 2007 1115B.8.1 CBC 2016 11B-603.3 Priority 3 Severity 4 | 1 | JOB | \$150 | \$150 |

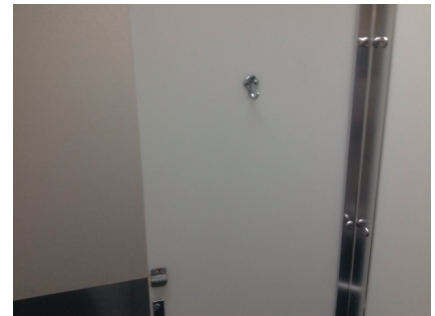
| 180 | <ul style="list-style-type: none"> <i>As-Built Description:</i> Accessible coat hook not within reach range. <i>As-Built:</i> 60" high <i>Proposed Solution:</i> Adjust existing or provide new coat hook at maximum 48" height. | PCODE WG03A ADAAG 91 4.2.5 ADA 2010 603.4 CBC 2007 1118B.5 CBC 2016 11B-603.4 Priority 3 Severity 2 | 1 | JOB | \$50 | \$50 |
