SAN MATEO COUNTY HARBOR DISTRICT

ADA Self-Evaluation and Transition Plan

August 2018

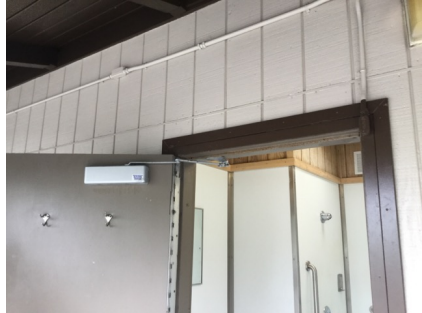
| Item No. and Name | Existing Architectural Barrier and Proposed Solution | Codes / Mitigation Info | Qty | Unit | Cost | Total |
|---|--|---|---|---|---|---|
| 290 | <ul style="list-style-type: none"> <i>As-Built Description:</i> Excessive force required to open door. <i>As-Built:</i> 10 lbs <i>Proposed Solution:</i> Adjust regular door closer to accessible standards (5 lbs. max). | <p><i>PCODE</i> ID03</p> <p>ADAAG 91 4.13.11</p> <p>ADA 2010 404.2.9</p> <p>CBC 2007 1133B.2.5</p> <p>CBC 2016 11B-404.2.9</p> <p>Priority 3</p> <p>Severity 4</p> | 1 | JOB | \$25 | \$25 |

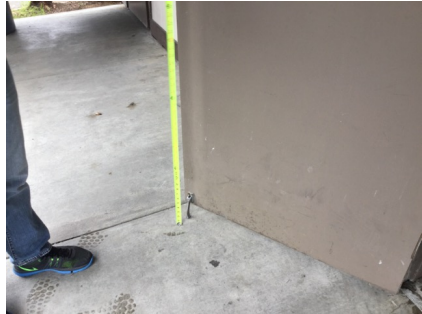
| Item No. and Name | Existing Architectural Barrier and Proposed Solution | Codes / Mitigation Info | Qty | Unit | Cost | Total |
|---|--|---|---|---|---|---|
| 291 | <ul style="list-style-type: none"> <i>As-Built Description:</i> At push side of door on accessible route, bottom 10" does not have a smooth, uninterrupted surface. <i>Proposed Solution:</i> Remove door stopper when altering area. Provide rubber wedge. | <p><i>PCODE</i> ID06A</p> <p>ADA 2010 404.2.10</p> <p>CBC 2007 1133B.2.6</p> <p>CBC 2016 11B-404.2.10</p> <p>Priority 3</p> <p>Severity 3</p> | 1 | JOB | \$25 | \$25 |

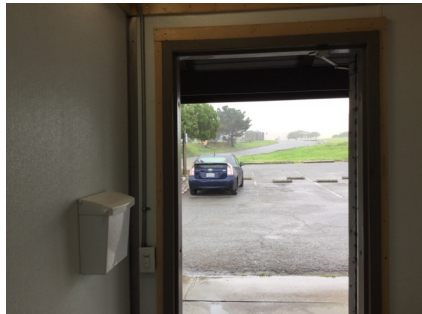
| Item No. and Name | Existing Architectural Barrier and Proposed Solution | Codes / Mitigation Info | Qty | Unit | Cost | Total |
|---|--|---|---|---|---|---|
| 299 | <ul style="list-style-type: none"> <i>As-Built Description:</i> Front approach: At push side, door does not have clear and level maneuvering space measuring door width x 48" (door width plus 12" if door has both, latch and closer). <i>As-Built:</i> 9.5" to wall <i>Proposed Solution:</i> Provide relocated new door and frame; remodel walls as needed. | <p><i>PCODE</i> ID24B</p> <p>ADAAG 91 Fig. 25(a)</p> <p>ADA 2010 404.2.4</p> <p>CBC 2007 11B-26A(a)</p> <p>CBC 2016 11B-404.2.4</p> <p>Priority 3</p> <p>Severity 3</p> | 1 | JOB | \$2,600 | \$2,600 |

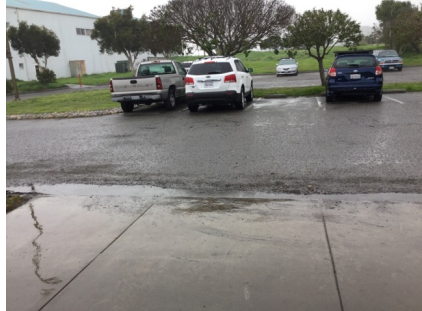
| Changes in Level | | | | | | |
|---|--|--|--|---|---|---|
| 302 | <ul style="list-style-type: none"> <i>As-Built Description:</i> Walk: Pavement dislocation creates abrupt change in level exceeding 1/2" in accessible route. <i>As-Built:</i> Water accumulates in ditch <i>Proposed Solution:</i> Remove, replace or repair area of pavement sufficient to correct abrupt change in level. | <p>PCODE EF03 ADAAG 91 4.3.8 ADA 2010 403.4 CBC 2007 1133B.7.4 CBC 2016 11B-403.4 Priority 3 Severity 3</p> | 50 | SF | \$21 | \$1,050 |

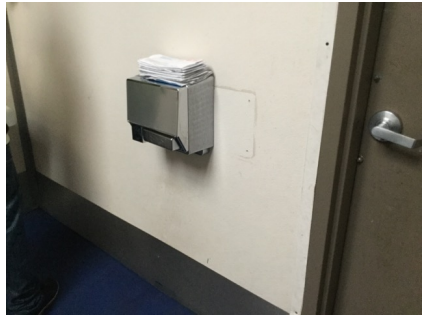
| Protrusion Limits | | | | | | |
|---|---|--|---|---|---|---|
| 309 | <ul style="list-style-type: none"> <i>As-Built Description:</i> Protruding objects more than 4" from wall, when bottom of object more than 27" or less than 80" above finished floor. <i>As-Built:</i> PTD: 7" at 34" high <i>Proposed Solution:</i> Remove/relocate protruding object. Patch existing surface. | <p>PCODE EG04 ADAAG 91 4.4.1 ADA 2010 307.2 CBC 2007 1133B.8.6.1 CBC 2016 11B-307.2 Priority 3 Severity 3</p> | 1 | JOB | \$100 | \$100 |

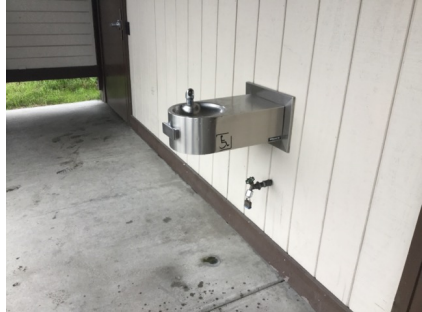
| 303 | <ul style="list-style-type: none"> <i>As-Built Description:</i> Drinking fountain lacks protection for visually impaired persons. <i>Proposed Solution:</i> Provide cane-detectable rails. | <p><i>PCODE</i> IA05C <i>ADAAG 91</i> 4.4.1 <i>ADA 2010</i> 307.2 <i>CBC 2007</i> 1115B.4.6.3 <i>CBC 2016</i> 11B-307.2</p> <p>Priority 3 Severity 3</p> | 1 | JOB | \$500 | \$500 |

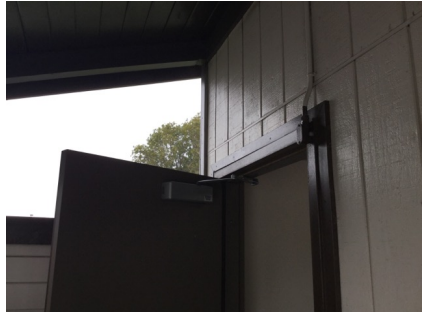
| 306 | <ul style="list-style-type: none"> <i>As-Built Description:</i> Excessive force required to open door. <i>As-Built:</i> 12 lbs <i>Proposed Solution:</i> Adjust regular door closer to accessible standards (5 lbs. max). | <p><i>PCODE</i> ID03 <i>ADAAG 91</i> 4.13.11 <i>ADA 2010</i> 404.2.9 <i>CBC 2007</i> 1133B.2.5 <i>CBC 2016</i> 11B-404.2.9</p> <p>Priority 3 Severity 3</p> | 1 | JOB | \$25 | \$25 |

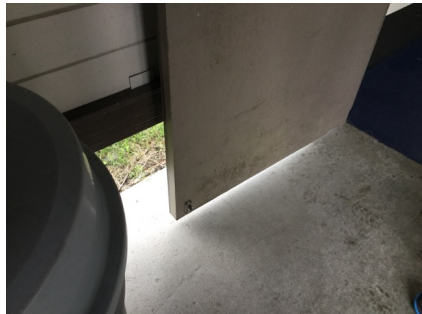
| 307 | <ul style="list-style-type: none"> <i>As-Built Description:</i> At push side of door on accessible route, bottom 10" does not have a smooth, uninterrupted surface. <i>Proposed Solution:</i> Remove door stopper when altering area. Provide rubber wedge. | <p><i>PCODE</i> ID06A <i>ADA 2010</i> 404.2.10 <i>CBC 2007</i> 1133B.2.6 <i>CBC 2016</i> 11B-404.2.10</p> <p>Priority 3 Severity 3</p> | 1 | JOB | \$25 | \$25 |

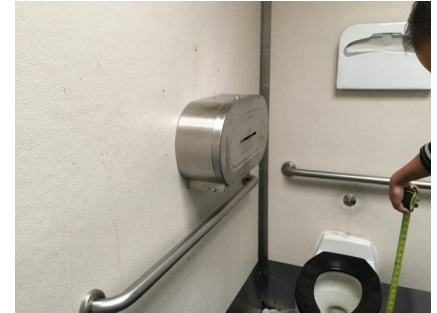
| Item No. and Name | Existing Architectural Barrier and Proposed Solution | Codes / Mitigation Info | Qty | Unit | Cost | Total |
|---|--|--|---|---|---|---|
| 314 | <ul style="list-style-type: none"> <i>As-Built Description:</i> Accessories/dispensers in accessible stall located closer than 1-1/2" below or 12" above grab bar impedes its use. <i>As-Built:</i> TPD 5" above SGB <i>Proposed Solution:</i> Relocate accessories/dispensers to be no closer than 1-1/2" below and 12" above grab bars (except if accessories are recessed, flush with wall, and have no sharp edges). | <p>PCODE WB07I ADAAG 91 4.26.2 ADA 2010 609.3 CBC 2007 1133B.4.2.5 CBC 2016 11B-609.3</p> <p>Priority 3 Severity 4</p> | 1 | JOB | \$75 | \$75 |

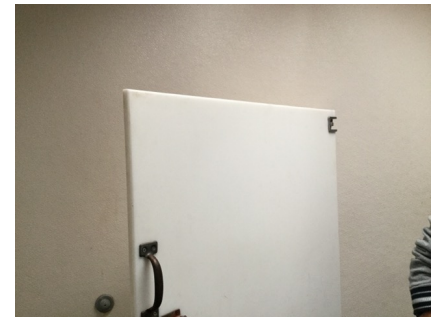
| 311 | <ul style="list-style-type: none"> <i>As-Built Description:</i> Stall door to accessible compartment not self closing. <i>Proposed Solution:</i> Adjust closer. | <p>PCODE WB05B ADAAG 91 4.22.4 ADA 2010 604.8.1.2 CBC 2007 1115B.3.1.4.4 CBC 2016 11B-604.8.1.2</p> <p>Priority 3 Severity 4</p> | 1 | JOB | \$25 | \$25 |

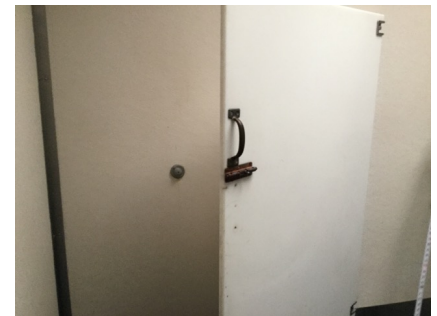
| 310 | <ul style="list-style-type: none"> <i>As-Built Description:</i> Stall door does not have accessible operating hardware (U-pulls on both sides, flip-over or sliding lock). <i>As-Built:</i> At 50" high <i>Proposed Solution:</i> Provide new accessible locking hardware that does not require grasping, pinching, or twisting and U-pulls on both sides. | <p>PCODE WB05C ADAAG 91 4.17.5 ADA 2010 604.8.1.2 CBC 2007 1115B.3.1.4.5 CBC 2016 11B-604.8.1.2</p> <p>Priority 3 Severity 3</p> | 1 | JOB | \$100 | \$100 |

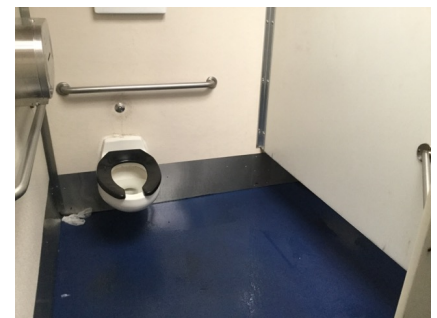
| 312 | <ul style="list-style-type: none"> <i>As-Built Description:</i> Toilet stall less than 60" wide. <i>As-Built:</i> 57.75" wide <i>Proposed Solution:</i> Provide new accessible stall. Notes: Bar in corner of stall reduces stall width less | <p>PCODE WB06 ADAAG 91 4.17.3 ADA 2010 604.8.1.1 CBC 2007 1115B.3.1.4.1 CBC 2016 11B-604.8.1.1</p> <p>Priority 3 Severity 4</p> | 1 | JOB | \$1,500 | \$1,500 |

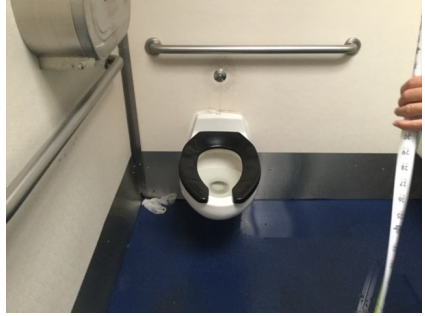
| 315 | <ul style="list-style-type: none"> <i>As-Built Description:</i> Water closet not 16"-18" (CA: 17"-18") from near side wall to center line of water closet (2010 ADAAG: 16"-18"). <i>As-Built:</i> 18.5" o.c. <i>Proposed Solution:</i> Relocate existing water closet and plumbing, remount with offset closet flange to provide 18" max. from side wall. | <p>PCODE WB02C ADAAG 91 Fig. 28 ADA 2010 604.2 CBC 2007 1115B.4.1.1 CBC 2016 11B-604.2</p> <p>Priority 3 Severity 4</p> | 1 | JOB | \$500 | \$500 |

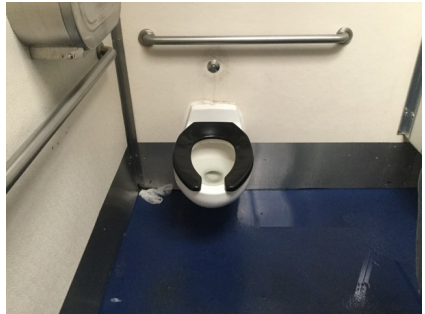
| 316 | <ul style="list-style-type: none"> <i>As-Built Description:</i> Height of water closet seat less than 17" or more than 19" from floor. <i>As-Built:</i> 16.5" high <i>Proposed Solution:</i> Provide new accessible water closet. | <p>PCODE WB08 ADAAG 91 4.16.3 ADA 2010 604.4 CBC 2007 1115B.4.1.4 CBC 2016 11B-604.4</p> <p>Priority 3 Severity 4</p> | 1 | JOB | \$1,400 | \$1,400 |

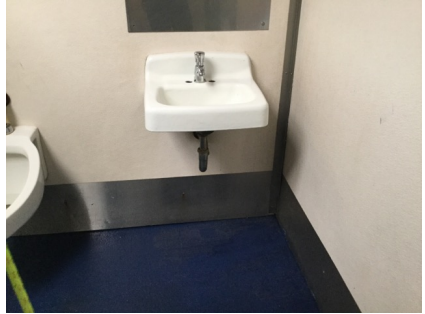
| 319 | <ul style="list-style-type: none"> <i>As-Built Description:</i> Clear floor space, 30" x 48" in front of fixture, extending 19" max. under the lavatory, not provided (CA only: Less than 18" from side wall to centerline of lavatory). <i>As-Built:</i> 17.5" o.c. <i>Proposed Solution:</i> Provide new accessible lavatory. Remodel restroom as needed. | <p>PCODE WD01 ADAAG 91 4.19.3 ADA 2010 606.2 CBC 2007 1115B.4.3 CBC 2016 11B-606.2, 11B-606.6</p> <p>Priority 3 Severity 2</p> | 1 | JOB | \$3,400 | \$3,400 |

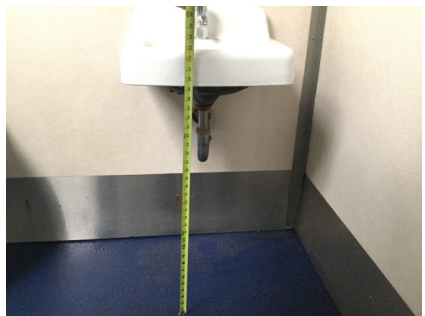
| 320 | <ul style="list-style-type: none"> <i>As-Built Description:</i> Hot or sharp-surfaced water/drain pipe not insulated or covered. <i>Proposed Solution:</i> Insulate or cover water/drain pipe. | <p>PCODE WD05 ADAAG 91 4.19.4 ADA 2010 606.5 CBC 2007 1115B.4.3.4 CBC 2016 11B-606.5</p> <p>Priority 3 Severity 3</p> | 1 | JOB | \$120 | \$120 |

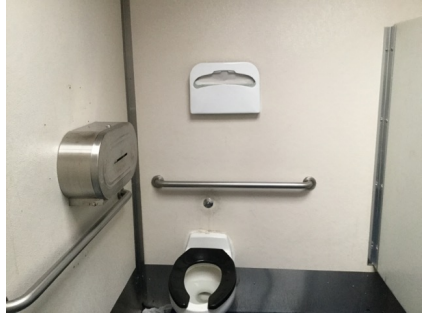
| Item No. and Name | Existing Architectural Barrier and Proposed Solution | Codes / Mitigation Info | Qty | Unit | Cost | Total |
|---|--|---|---|---|---|---|
| 318 | <ul style="list-style-type: none"> <i>As-Built Description:</i> Dispensers in sanitary facilities, such as for towels, soap, sanitary napkins, seat covers, etc., and waste receptacles more than 48" (CA only: 40") from floor to highest operating slot or control. <i>As-Built:</i> SD: 56" high SCD: 57" high <i>Proposed Solution:</i> Relocate existing restroom accessories. | PCODE WG01A ADAAG 91 4.23.7 ADA 2010 308.2.1 CBC 2007 1115B.8.3 CBC 2016 11B-603.5 Priority 3 Severity 2 | 1 | JOB | \$100 | \$100 |

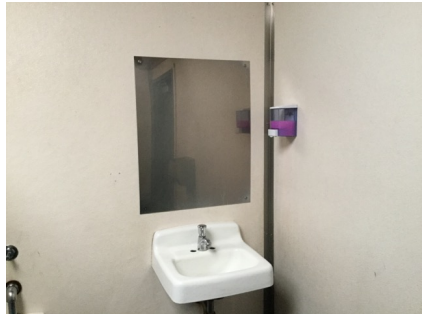
| Item No. and Name | Existing Architectural Barrier and Proposed Solution | Codes / Mitigation Info | Qty | Unit | Cost | Total |
|---|--|---|---|---|---|---|
| 321 | <ul style="list-style-type: none"> <i>As-Built Description:</i> Bottom of flat, not tilted mirror located above lavatories or countertops more than 40" above floor. <i>As-Built:</i> 40.5" high <i>Proposed Solution:</i> Relocate or provide new accessible mirror. | PCODE WG03 ADAAG 91 4.19.6 ADA 2010 603.3 CBC 2007 1115B.8.1 CBC 2016 11B-603.3 Priority 3 Severity 4 | 1 | JOB | \$150 | \$150 |

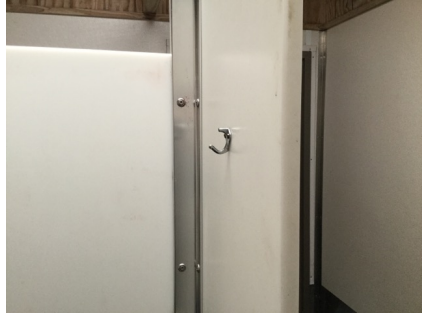
| Item No. and Name | Existing Architectural Barrier and Proposed Solution | Codes / Mitigation Info | Qty | Unit | Cost | Total |
|---|--|---|---|---|---|---|
| 317 | <ul style="list-style-type: none"> <i>As-Built Description:</i> Accessible coat hook not within reach range. <i>As-Built:</i> 60" high CH <i>Proposed Solution:</i> Adjust existing or provide new coat hook at maximum 48" height. | PCODE WG03A ADAAG 91 4.2.5 ADA 2010 603.4 CBC 2007 1118B.5 CBC 2016 11B-603.4 Priority 3 Severity 2 | 1 | JOB | \$50 | \$50 |

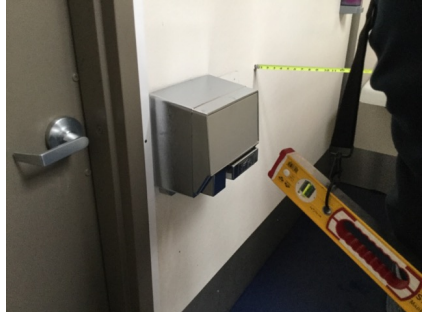
| 326 | <ul style="list-style-type: none"> • <i>As-Built Description:</i> Protruding objects more than 4" from wall, when bottom of object more than 27" or less than 80" above finished floor. • <i>As-Built:</i> PTD: 7" at 33" high • <i>Proposed Solution:</i> Remove/relocate protruding object. Patch existing surface. | <p><i>PCODE</i> EG04 <i>ADAAG 91</i> 4.4.1 <i>ADA 2010</i> 307.2 <i>CBC 2007</i> 1133B.8.6.1 <i>CBC 2016</i> 11B-307.2</p> <p>Priority 3 Severity 3</p> | 1 | JOB | \$100 | \$100 |

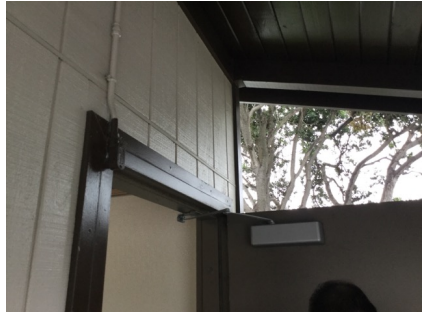
| 324 | <ul style="list-style-type: none"> • <i>As-Built Description:</i> Excessive force required to open door. • <i>As-Built:</i> 9 lbs • <i>Proposed Solution:</i> Adjust regular door closer to accessible standards (5 lbs. max). | <p><i>PCODE</i> ID03 <i>ADAAG 91</i> 4.13.11 <i>ADA 2010</i> 404.2.9 <i>CBC 2007</i> 1133B.2.5 <i>CBC 2016</i> 11B-404.2.9</p> <p>Priority 3 Severity 4</p> | 1 | JOB | \$25 | \$25 |

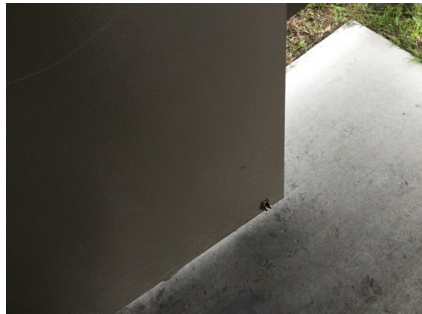
| 325 | <ul style="list-style-type: none"> • <i>As-Built Description:</i> At push side of door on accessible route, bottom 10" does not have a smooth, uninterrupted surface. • <i>Proposed Solution:</i> Remove door stopper when altering area. Provide rubber wedge. | <p><i>PCODE</i> ID06A <i>ADA 2010</i> 404.2.10 <i>CBC 2007</i> 1133B.2.6 <i>CBC 2016</i> 11B-404.2.10</p> <p>Priority 3 Severity 3</p> | 1 | JOB | \$25 | \$25 |

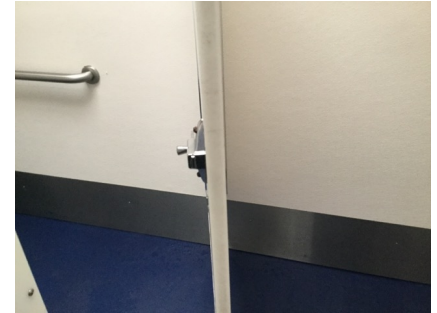
| Item No. and Name | Existing Architectural Barrier and Proposed Solution | Codes / Mitigation Info | Qty | Unit | Cost | Total |
|---|--|--|---|---|---|---|
| 332 | <ul style="list-style-type: none"> <i>As-Built Description:</i> Stall door does not have accessible operating hardware (U-pulls on both sides, flip-over or sliding lock). <i>As-Built:</i> No U-pull on both sides <i>Proposed Solution:</i> Provide new accessible locking hardware that does not require grasping, pinching, or twisting and U-pulls on both sides. | PCODE WB05C ADAAG 91 4.17.5 ADA 2010 604.8.1.2 CBC 2007 1115B.3.1.4.5 CBC 2016 11B-604.8.1.2 Priority 3 Severity 3 | 1 | JOB | \$100 | \$100 |

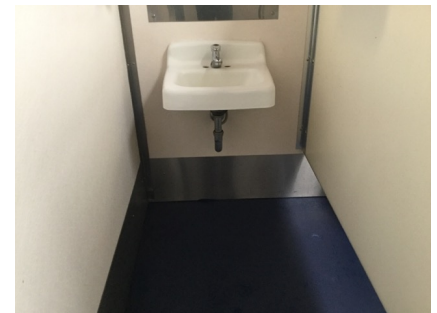
| 328 | <ul style="list-style-type: none"> <i>As-Built Description:</i> Clear floor space, 30" x 48" in front of fixture, extending 19" max. under the lavatory, not provided (CA only: Less than 18" from side wall to centerline of lavatory). <i>As-Built:</i> 17" o.c. <i>Proposed Solution:</i> Provide new accessible lavatory. Remodel restroom as needed. | PCODE WD01 ADAAG 91 4.19.3 ADA 2010 606.2 CBC 2007 1115B.4.3 CBC 2016 11B-606.2, 11B-606.6 Priority 3 Severity 2 | 1 | JOB | \$3,400 | \$3,400 |

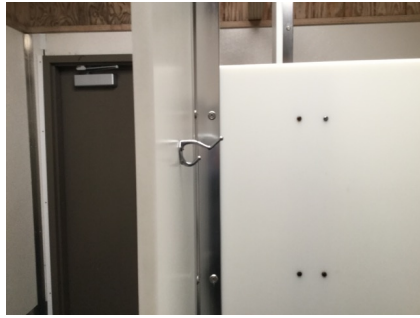
| Item No. and Name | Existing Architectural Barrier and Proposed Solution | Codes / Mitigation Info | Qty | Unit | Cost | Total |
|---|--|--|---|---|---|---|
| 335 | <ul style="list-style-type: none"> <i>As-Built Description:</i> Accessible coat hook not within reach range. <i>As-Built:</i> 60" high <i>Proposed Solution:</i> Adjust existing or provide new coat hook at maximum 48" height. | <p><i>PCODE</i> WG03A</p> <p><i>ADAAG 91</i> 4.2.5</p> <p><i>ADA 2010</i> 603.4</p> <p><i>CBC 2007</i> 1118B.5</p> <p><i>CBC 2016</i> 11B-603.4</p> <p>Priority 3</p> <p>Severity 2</p> | 1 | JOB | \$50 | \$50 |

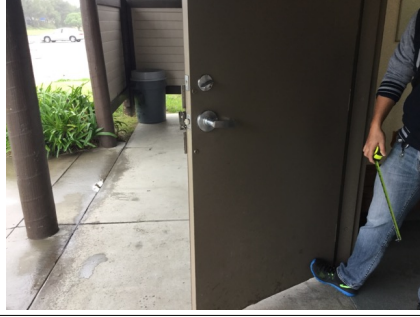
| 343 | <ul style="list-style-type: none"> <i>As-Built Description:</i> Door lock or latch less than 34" or more than 48" above the floor (CA only: 34" to 44"). <i>As-Built:</i> 47" high <i>Proposed Solution:</i> Relocate or replace existing hardware. Notes: Compliant with past code | <p><i>PCODE</i> ID17REF</p> <p><i>ADAAG 91</i> 4.13.9</p> <p><i>ADA 2010</i> 404.2.7</p> <p><i>CBC 2007</i> 1133B.2.5.2</p> <p><i>CBC 2016</i> 11B-404.2.7</p> <p>Priority 3</p> <p>Severity 4</p> | REF | | | |

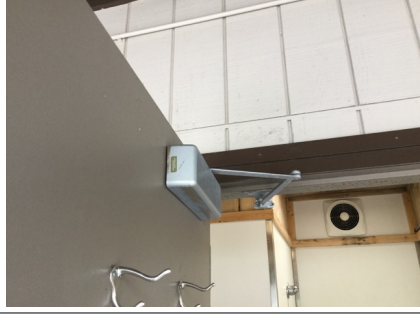
| 340 | <ul style="list-style-type: none"> <i>As-Built Description:</i> Excessive force required to open door. <i>As-Built:</i> 11 lbs <i>Proposed Solution:</i> Adjust regular door closer to accessible standards (5 lbs. max). | <p><i>PCODE</i> ID03</p> <p><i>ADAAG 91</i> 4.13.11</p> <p><i>ADA 2010</i> 404.2.9</p> <p><i>CBC 2007</i> 1133B.2.5</p> <p><i>CBC 2016</i> 11B-404.2.9</p> <p>Priority 3</p> <p>Severity 3</p> | 1 | JOB | \$25 | \$25 |

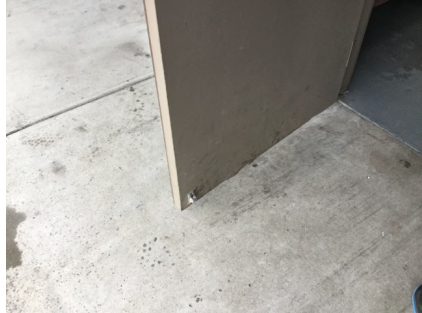
| Item No. and Name | Existing Architectural Barrier and Proposed Solution | Codes / Mitigation Info | Qty | Unit | Cost | Total |
|---|--|---|---|---|---|---|
| 342 | <ul style="list-style-type: none"> <i>As-Built Description:</i> At push side of door on accessible route, bottom 10" does not have a smooth, uninterrupted surface. <i>Proposed Solution:</i> Remove door stopper when altering area. Provide rubber wedge. | <p><i>PCODE</i> ID06A <i>ADA 2010</i> 404.2.10 <i>CBC 2007</i> 1133B.2.6 <i>CBC 2016</i> 11B-404.2.10</p> <p>Priority 3 Severity 3</p> | 1 | JOB | \$25 | \$25 |

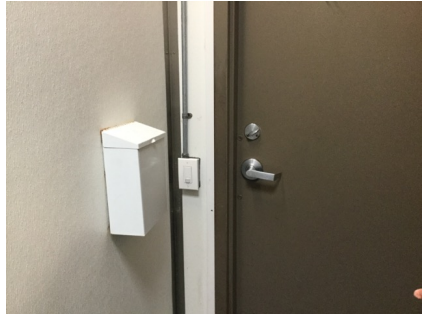
| Item No. and Name | Existing Architectural Barrier and Proposed Solution | Codes / Mitigation Info | Qty | Unit | Cost | Total |
|---|--|---|---|---|---|---|
| 344 | <ul style="list-style-type: none"> <i>As-Built Description:</i> Front approach: At push side, door does not have clear and level maneuvering space measuring door width x 48" (door width plus 12" if door has both, latch and closer). <i>As-Built:</i> 9.5" to wall <i>Proposed Solution:</i> Provide relocated new door and frame; remodel walls as needed. | <p><i>PCODE</i> ID24B <i>ADAAG 91</i> Fig. 25(a) <i>ADA 2010</i> 404.2.4 <i>CBC 2007</i> 11B-26A(a) <i>CBC 2016</i> 11B-404.2.4</p> <p>Priority 3 Severity 3</p> | 1 | JOB | \$2,600 | \$2,600 |

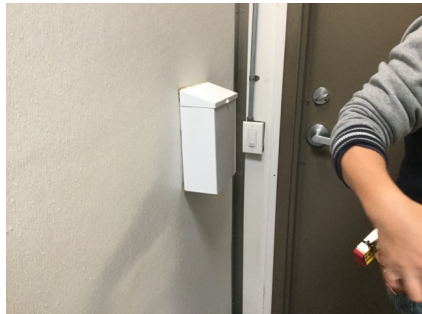
| Item No. and Name | Existing Architectural Barrier and Proposed Solution | Codes / Mitigation Info | Qty | Unit | Cost | Total |
|---|--|---|---|---|---|---|
| 345 | <ul style="list-style-type: none"> <i>As-Built Description:</i> Reach height to control or access point, exceeds 48" or is less than 15". <i>As-Built:</i> Bin: 48.5" high <i>Proposed Solution:</i> Modify equipment or mounting. | <p><i>PCODE</i> IE01 <i>ADAAG 91</i> 4.2.5 <i>ADA 2010</i> 308.2.1 <i>CBC 2007</i> 1118B.5 <i>CBC 2016</i> 11B-308.2.1</p> <p>Priority 3 Severity 4</p> | 1 | JOB | \$100 | \$100 |

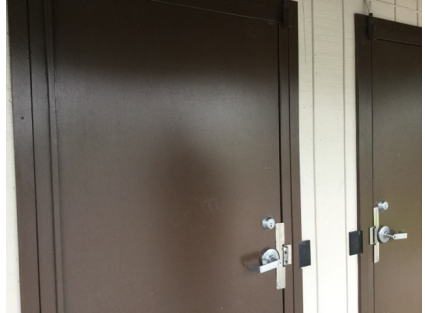
| Item No. and Name | Existing Architectural Barrier and Proposed Solution | Codes / Mitigation Info | Qty | Unit | Cost | Total |
|---|---|---|---|---|---|---|
| 338 | <ul style="list-style-type: none"> <i>As-Built Description:</i> Entrance to toilet or bathing facility not identified with ADAAG compliant signage. <i>As-Built:</i> No latch sign <i>Proposed Solution:</i> Provide ADAAG compliant sign mounted 5' high on center on nearest adjacent wall, on latch side of a single door (located not to cause a Braille reader to stand within the door swing). | PCODE SA11A ADAAG 91 4.1.3(16)(a) ADA 2010 216.8 CBC 2016 11B-216.8 Priority 3 Severity 3 | 1 | JOB | \$90 | \$90 |

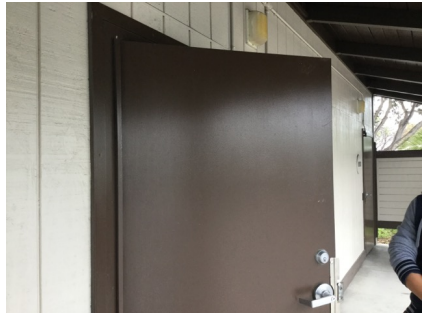
| Item No. and Name | Existing Architectural Barrier and Proposed Solution | Codes / Mitigation Info | Qty | Unit | Cost | Total |
|---|---|---|---|---|---|---|
| 339 | <ul style="list-style-type: none"> <i>As-Built Description:</i> Required in CA only: identification symbol centered 58" to 60" high on sanitary facility door that contrasts with the door not provided (women: 12" ø circle, men: 12" triangle, unisex: combined symbol). <i>Proposed Solution:</i> Provide properly mounted sanitary facility symbol when altering area. If wheelchair accessible, include International Symbol of Accessibility on sign. | PCODE SA15 CBC 2007 1115B.6 CBC 2016 11B-703.7.2.6 Priority 3 Severity 3 | 1 | JOB | \$90 | \$90 |

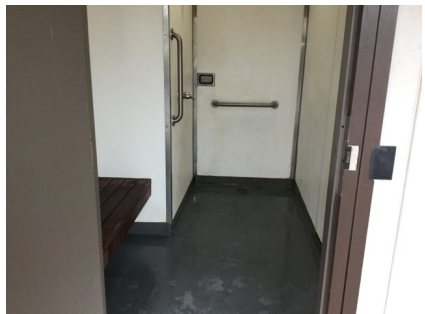
| Item No. and Name | Existing Architectural Barrier and Proposed Solution | Codes / Mitigation Info | Qty | Unit | Cost | Total |
|---|---|---|---|---|---|---|
| 347 | <ul style="list-style-type: none"> <i>As-Built Description:</i> Shower not accessible; multiple compliance violations. <i>As-Built:</i> 43" X 48" <i>Proposed Solution:</i> Provide accessible shower. | PCODE WF01 ADAAG 91 4.21 ADA 2010 608.1 CBC 2016 11B-608.1 Priority 3 Severity 3 | 1 | JOB | \$4,000 | \$4,000 |

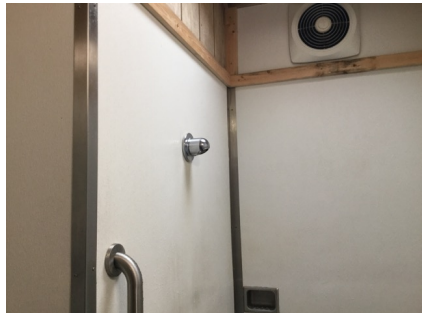
| Item No. and Name | Existing Architectural Barrier and Proposed Solution | Codes / Mitigation Info | Qty | Unit | Cost | Total |
|---|---|---|---|---|---|---|
| 348 | <ul style="list-style-type: none"> <i>As-Built Description:</i> Mounting height of shower spray bracket exceeds 48" max. height or is more than 27" from rear edge of folding seat. <i>As-Built:</i> 72" high <i>Proposed Solution:</i> Provide or remount shower spray bracket within 27" from rear edge of seat and at 48" max. height. | PCODE WF05B ADA 2010 608.5 CBC 2007 1115B.4.4.5.3 CBC 2016 11B-608.5 Priority 3 Severity 1 | 1 | JOB | \$500 | \$500 |

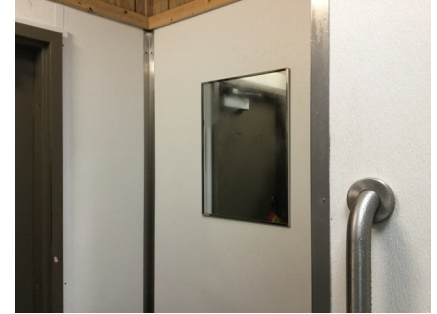
| 346 | <ul style="list-style-type: none"> • <i>As-Built Description:</i> Bottom of flat, not tilted mirror located above lavatories or countertops more than 40" above floor. • <i>As-Built:</i> 51.5" high • <i>Proposed Solution:</i> Relocate or provide new accessible mirror. | <p><i>PCODE</i> WG03 <i>ADAAG 91</i> 4.19.6 <i>ADA 2010</i> 603.3 <i>CBC 2007</i> 1115B.8.1 <i>CBC 2016</i> 11B-603.3</p> <p>Priority 3 Severity 3</p> | 1 | JOB | \$150 | \$150 |

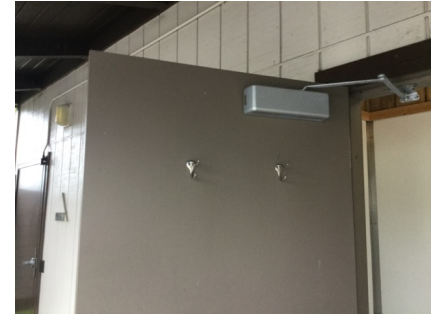
| 341 | <ul style="list-style-type: none"> • <i>As-Built Description:</i> Accessible coat hook not within reach range. • <i>As-Built:</i> 67" high CH • <i>Proposed Solution:</i> Adjust existing or provide new coat hook at maximum 48" height. | <p><i>PCODE</i> WG03A <i>ADAAG 91</i> 4.2.5 <i>ADA 2010</i> 603.4 <i>CBC 2007</i> 1118B.5 <i>CBC 2016</i> 11B-603.4</p> <p>Priority 3 Severity 1</p> | 1 | JOB | \$50 | \$50 |

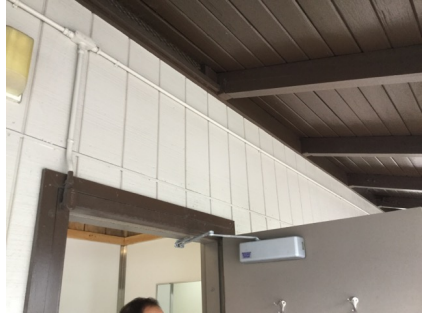
| Item No. and Name | Existing Architectural Barrier and Proposed Solution | Codes / Mitigation Info | Qty | Unit | Cost | Total |
|---|--|---|---|---|---|---|
| 353 | <ul style="list-style-type: none"> <i>As-Built Description:</i> Excessive force required to open door. <i>As-Built:</i> 14 lbs <i>Proposed Solution:</i> Adjust regular door closer to accessible standards (5 lbs. max). | <p><i>PCODE</i> ID03</p> <p>ADAAG 91 4.13.11</p> <p>ADA 2010 404.2.9</p> <p>CBC 2007 1133B.2.5</p> <p>CBC 2016 11B-404.2.9</p> <p>Priority 3</p> <p>Severity 3</p> | 1 | JOB | \$25 | \$25 |

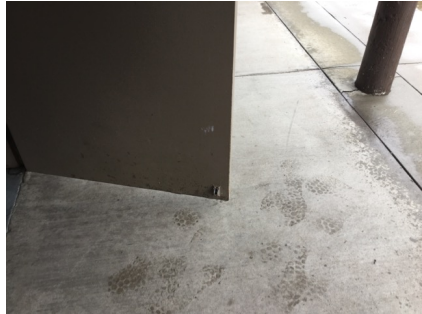
| Item No. and Name | Existing Architectural Barrier and Proposed Solution | Codes / Mitigation Info | Qty | Unit | Cost | Total |
|---|--|---|---|---|---|---|
| 351 | <ul style="list-style-type: none"> <i>As-Built Description:</i> At push side of door on accessible route, bottom 10" does not have a smooth, uninterrupted surface. <i>Proposed Solution:</i> Remove door stopper when altering area. Provide rubber wedge. | <p><i>PCODE</i> ID06A</p> <p>ADA 2010 404.2.10</p> <p>CBC 2007 1133B.2.6</p> <p>CBC 2016 11B-404.2.10</p> <p>Priority 3</p> <p>Severity 3</p> | 1 | JOB | \$25 | \$25 |

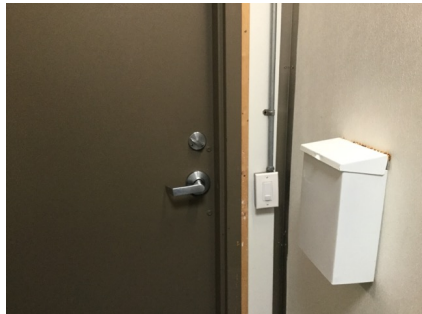
| Item No. and Name | Existing Architectural Barrier and Proposed Solution | Codes / Mitigation Info | Qty | Unit | Cost | Total |
|---|--|---|---|---|---|---|
| 356 | <ul style="list-style-type: none"> <i>As-Built Description:</i> Front approach: At push side, door does not have clear and level maneuvering space measuring door width x 48" (door width plus 12" if door has both, latch and closer). <i>As-Built:</i> 9.5" to wall <i>Proposed Solution:</i> Provide relocated new door and frame; remodel walls as needed. | <p><i>PCODE</i> ID24B</p> <p>ADAAG 91 Fig. 25(a)</p> <p>ADA 2010 404.2.4</p> <p>CBC 2007 11B-26A(a)</p> <p>CBC 2016 11B-404.2.4</p> <p>Priority 3</p> <p>Severity 3</p> | 1 | JOB | \$2,600 | \$2,600 |

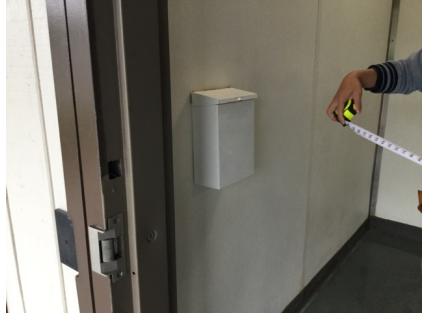
| Item No. and Name | Existing Architectural Barrier and Proposed Solution | Codes / Mitigation Info | Qty | Unit | Cost | Total |
|---|---|--|---|---|---|---|
| 355 | <ul style="list-style-type: none"> <i>As-Built Description:</i> Reach height to control or access point, exceeds 48" or is less than 15". <i>As-Built:</i> Bin: 48.5" high <i>Proposed Solution:</i> Modify equipment or mounting. | <p><i>PCODE</i> IE01 <i>ADAAG 91</i> 4.2.5 <i>ADA 2010</i> 308.2.1 <i>CBC 2007</i> 1118B.5 <i>CBC 2016</i> 11B-308.2.1</p> <p>Priority 3 Severity 4</p> | 1 | JOB | \$100 | \$100 |

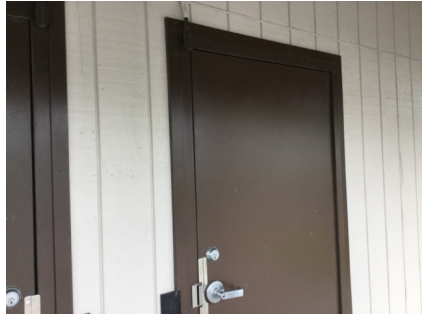
| Item No. and Name | Existing Architectural Barrier and Proposed Solution | Codes / Mitigation Info | Qty | Unit | Cost | Total |
|---|---|--|---|---|---|---|
| 349 | <ul style="list-style-type: none"> <i>As-Built Description:</i> Entrance to toilet or bathing facility not identified with ADAAG compliant signage. <i>As-Built:</i> No latch sign <i>Proposed Solution:</i> Provide ADAAG compliant sign mounted 5' high on center on nearest adjacent wall, on latch side of a single door (located not to cause a Braille reader to stand within the door swing). | <p><i>PCODE</i> SA11A <i>ADAAG 91</i> 4.1.3(16)(a) <i>ADA 2010</i> 216.8 <i>CBC 2016</i> 11B-216.8</p> <p>Priority 3 Severity 3</p> | 1 | JOB | \$90 | \$90 |

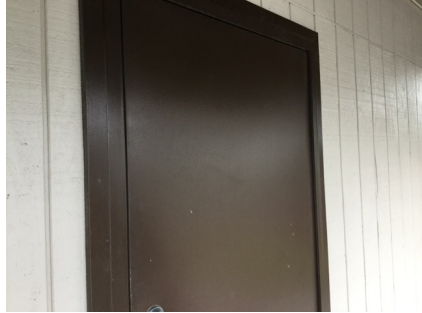
| Item No. and Name | Existing Architectural Barrier and Proposed Solution | Codes / Mitigation Info | Qty | Unit | Cost | Total |
|---|---|--|---|---|---|---|
| 350 | <ul style="list-style-type: none"> <i>As-Built Description:</i> Required in CA only: identification symbol centered 58" to 60" high on sanitary facility door that contrasts with the door not provided (women: 12" ø circle, men: 12" triangle, unisex: combined symbol). <i>Proposed Solution:</i> Provide properly mounted sanitary facility symbol when altering area. If wheelchair accessible, include International Symbol of Accessibility on sign. | <p><i>PCODE</i> SA15 <i>CBC 2007</i> 1115B.6 <i>CBC 2016</i> 11B-703.7.2.6</p> <p>Priority 3 Severity 3</p> | 1 | JOB | \$90 | \$90 |

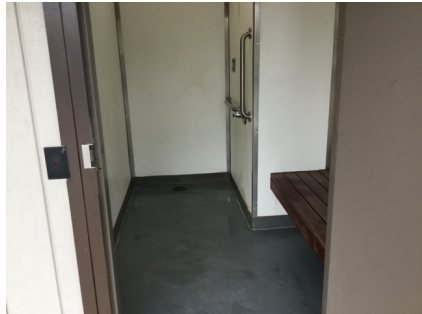
| Item No. and Name | Existing Architectural Barrier and Proposed Solution | Codes / Mitigation Info | Qty | Unit | Cost | Total |
|---|---|--|---|---|---|---|
| 359 | <ul style="list-style-type: none"> <i>As-Built Description:</i> Shower not accessible; multiple compliance violations. <i>As-Built:</i> 43" X 48.5" <i>Proposed Solution:</i> Provide accessible shower. | <p><i>PCODE</i> WF01 <i>ADAAG 91</i> 4.21 <i>ADA 2010</i> 608.1 <i>CBC 2016</i> 11B-608.1</p> <p>Priority 3 Severity 3</p> | 1 | JOB | \$4,000 | \$4,000 |

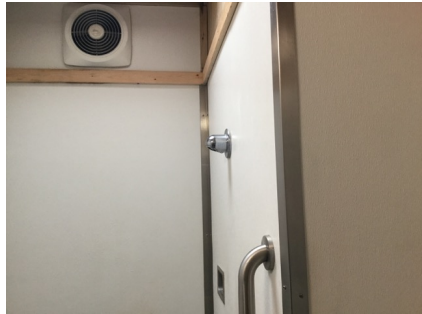
| Item No. and Name | Existing Architectural Barrier and Proposed Solution | Codes / Mitigation Info | Qty | Unit | Cost | Total |
|---|--|---|---|---|---|---|
| 358 | <ul style="list-style-type: none"> <i>As-Built Description:</i> Mounting height of shower spray bracket exceeds 48" max.height or is more than 27" from rear edge of folding seat. <i>As-Built:</i> 72" high <i>Proposed Solution:</i> Provide or remount shower spray bracket within 27" from rear edge of seat and at 48" max. height. | PCODE WF05B ADA 2010 608.5 CBC 2007 1115B.4.4.5.3 CBC 2016 11B-608.5 Priority 3 Severity 1 | 1 | JOB | \$500 | \$500 |

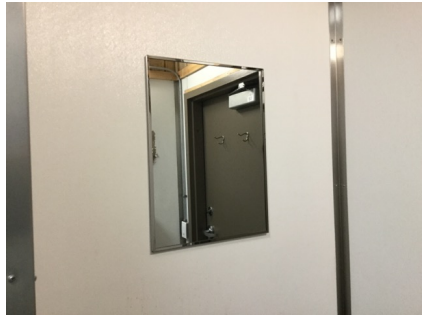
| 357 | <ul style="list-style-type: none"> <i>As-Built Description:</i> Bottom of flat, not tilted mirror located above lavatories or countertops more than 40" above floor. <i>As-Built:</i> 50.5" high <i>Proposed Solution:</i> Relocate or provide new accessible mirror. | PCODE WG03 ADAAG 91 4.19.6 ADA 2010 603.3 CBC 2007 1115B.8.1 CBC 2016 11B-603.3 Priority 3 Severity 3 | 1 | JOB | \$150 | \$150 |

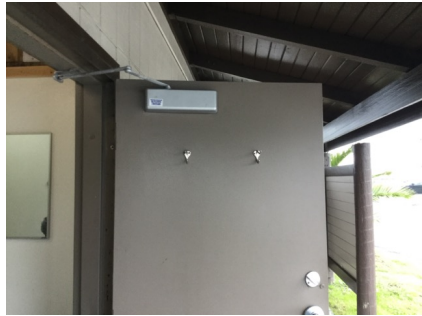
| 354 | <ul style="list-style-type: none"> <i>As-Built Description:</i> Accessible coat hook not within reach range. <i>As-Built:</i> 67" high CH <i>Proposed Solution:</i> Adjust existing or provide new coat hook at maximum 48" height. | PCODE WG03A ADAAG 91 4.2.5 ADA 2010 603.4 CBC 2007 1118B.5 CBC 2016 11B-603.4 Priority 3 Severity 1 | 1 | JOB | \$50 | \$50 |

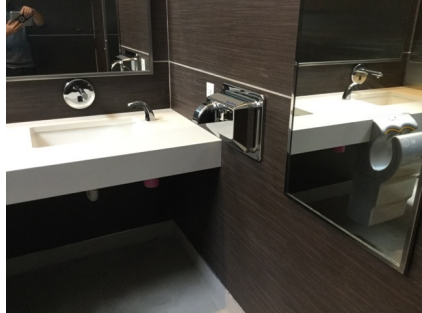
| Item No. and Name | Existing Architectural Barrier and Proposed Solution | Codes / Mitigation Info | Qty | Unit | Cost | Total |
|---|---|--|---|---|---|---|
| 364 | <ul style="list-style-type: none"> <i>As-Built Description:</i> Protruding objects more than 4" from wall, when bottom of object more than 27" or less than 80" above finished floor. <i>As-Built:</i> Hand dryer: 6.5" at 38" high <i>Proposed Solution:</i> Remove/relocate protruding object. Patch existing surface. | <p>PCODE EG04 ADAAG 91 4.4.1 ADA 2010 307.2 CBC 2007 1133B.8.6.1 CBC 2016 11B-307.2</p> <p>Priority 3 Severity 3</p> | 1 | JOB | \$100 | \$100 |

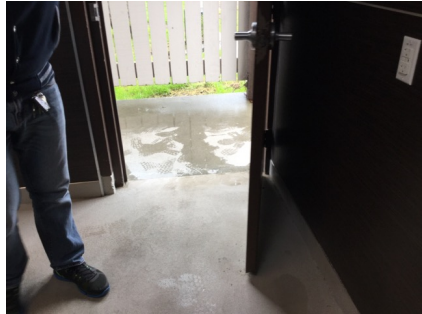
| Item No. and Name | Existing Architectural Barrier and Proposed Solution | Codes / Mitigation Info | Qty | Unit | Cost | Total |
|---|---|--|---|---|---|---|
| 363 | <ul style="list-style-type: none"> <i>As-Built Description:</i> Door on accessible route has less than 32" clear and 80" (78" min. to closer if provided) opening width when 90° open. <i>As-Built:</i> Door doesn't open 90 degrees <i>Proposed Solution:</i> Provide new, larger door and frame with new accessible hardware. | <p>PCODE ID01 ADAAG 91 4.13.5 ADA 2010 404.2.3 CBC 2007 1133B.1.1.1.1 CBC 2016 11B-404.2.3</p> <p>Priority 3 Severity 4</p> | 1 | JOB | \$2,600 | \$2,600 |

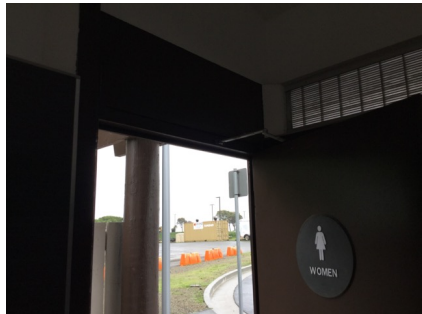
| Item No. and Name | Existing Architectural Barrier and Proposed Solution | Codes / Mitigation Info | Qty | Unit | Cost | Total |
|---|---|--|---|---|---|---|
| 362 | <ul style="list-style-type: none"> <i>As-Built Description:</i> Excessive force required to open door. <i>As-Built:</i> 15 lbs <i>Proposed Solution:</i> Adjust regular door closer to accessible standards (5 lbs. max). | <p>PCODE ID03 ADAAG 91 4.13.11 ADA 2010 404.2.9 CBC 2007 1133B.2.5 CBC 2016 11B-404.2.9</p> <p>Priority 3 Severity 3</p> | 1 | JOB | \$25 | \$25 |

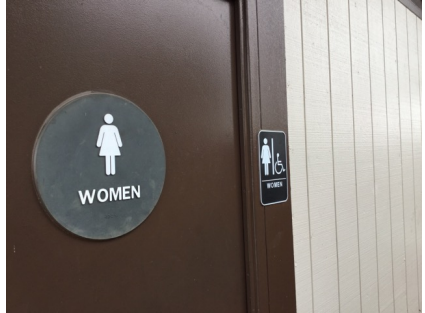
| Item No. and Name | Existing Architectural Barrier and Proposed Solution | Codes / Mitigation Info | Qty | Unit | Cost | Total |
|---|--|--|---|---|---|---|
| 360 | <ul style="list-style-type: none"> <i>As-Built Description:</i> Entrance to toilet or bathing facility not identified with ADAAG compliant signage. <i>As-Built:</i> 5" from latch <i>Proposed Solution:</i> Provide ADAAG compliant sign mounted 5' high on center on nearest adjacent wall, on latch side of a single door (located not to cause a Braille reader to stand within the door swing). | <p><i>PCODE</i> SA11A <i>ADAAG 91</i> 4.1.3(16)(a) <i>ADA 2010</i> 216.8 <i>CBC 2016</i> 11B-216.8</p> <p>Priority 3 Severity 3</p> | 1 | JOB | \$90 | \$90 |

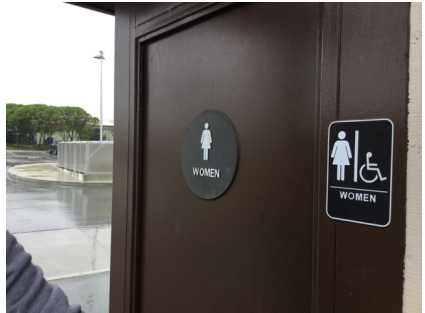
| Item No. and Name | Existing Architectural Barrier and Proposed Solution | Codes / Mitigation Info | Qty | Unit | Cost | Total |
|---|--|--|---|---|---|---|
| 361 | <ul style="list-style-type: none"> <i>As-Built Description:</i> Required in CA only: identification symbol centered 58" to 60" high on sanitary facility door that contrasts with the door not provided (women: 12" ø circle, men: 12" triangle, unisex: combined symbol). <i>As-Built:</i> 60.75" high <i>Proposed Solution:</i> Provide properly mounted sanitary facility symbol when altering area. If wheelchair accessible, include International Symbol of Accessibility on sign. | <p><i>PCODE</i> SA15 <i>CBC 2007</i> 1115B.6 <i>CBC 2016</i> 11B-703.7.2.6</p> <p>Priority 3 Severity 3</p> | 1 | JOB | \$90 | \$90 |

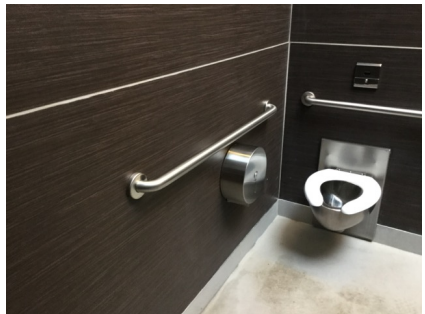
| Item No. and Name | Existing Architectural Barrier and Proposed Solution | Codes / Mitigation Info | Qty | Unit | Cost | Total |
|---|--|--|---|---|---|---|
| 370 | <ul style="list-style-type: none"> <i>As-Built Description:</i> Side grab bar less than 42" long, or located more than 12 inches max. from the rear wall, or extending less than 54" from rear wall (CA only: front end min. 24" in front of water closet). <i>As-Built:</i> 42" at 53.5" <i>Proposed Solution:</i> Provide or relocate accessible side grab bar. | <p><i>PCODE</i> WB07A <i>ADAAG 91</i> Fig. 29(b) <i>ADA 2010</i> 604.5.1 <i>CBC 2007</i> 1115B.4.1.3.1 <i>CBC 2016</i> 11B-604.5.1</p> <p>Priority 3 Severity 4</p> | 1 | JOB | \$260 | \$260 |

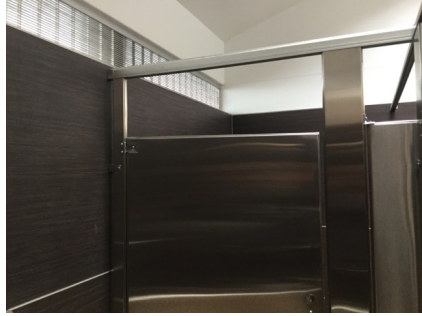
| 367 | <ul style="list-style-type: none"> <i>As-Built Description:</i> Stall door to accessible compartment not self closing. <i>Proposed Solution:</i> Adjust closer. | <p><i>PCODE</i> WB05B <i>ADAAG 91</i> 4.22.4 <i>ADA 2010</i> 604.8.1.2 <i>CBC 2007</i> 1115B.3.1.4.4 <i>CBC 2016</i> 11B-604.8.1.2</p> <p>Priority 3 Severity 4</p> | 1 | JOB | \$25 | \$25 |

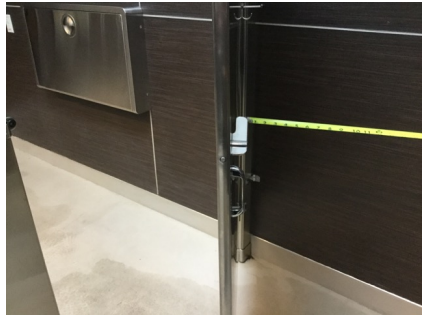
NO

| 366 | <ul style="list-style-type: none"> <i>As-Built Description:</i> Clear passage width (except doorways) from rest room entry to accessible water closet compartment less than 36" (CA only: 44" wide). <i>As-Built:</i> 32" wide <i>Proposed Solution:</i> Modify facility passage to be min. 44" wide. Demolish existing partition and replace. Notes: Only when changing station is open | <p><i>PCODE</i> WC02AREF <i>ADAAG 91</i> 4.3.3 <i>ADA 2010</i> 403.5.1 <i>CBC 2007</i> 1115B.3.2.4 <i>CBC 2016</i> 11B-403.5.1</p> <p>Priority 3 Severity 2</p> | REF | | | |

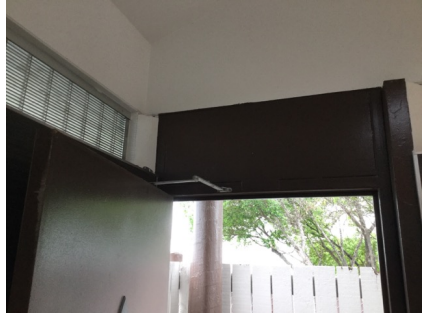
| Item No. and Name | Existing Architectural Barrier and Proposed Solution | Codes / Mitigation Info | Qty | Unit | Cost | Total |
|---|--|--|---|--|---|---|
| 375 | <ul style="list-style-type: none"> • <i>As-Built Description:</i> Excessive force required to open door. • <i>As-Built:</i> 15 lbs • <i>Proposed Solution:</i> Adjust regular door closer to accessible standards (5 lbs. max). | <p><i>PCODE</i> ID03</p> <p>ADAAG 91 4.13.11</p> <p>ADA 2010 404.2.9</p> <p>CBC 2007 1133B.2.5</p> <p>CBC 2016 11B-404.2.9</p> <p>Priority 3</p> <p>Severity 3</p> | 1 | JOB | \$25 | \$25 |

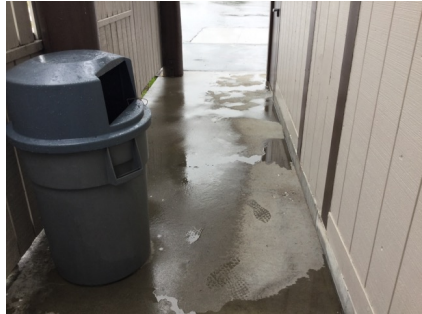
| Item No. and Name | Existing Architectural Barrier and Proposed Solution | Codes / Mitigation Info | Qty | Unit | Cost | Total |
|---|--|--|---|--|---|---|
| 373 | <ul style="list-style-type: none"> • <i>As-Built Description:</i> Corridor, for occupant load less than 10, less than 36" wide. • <i>As-Built:</i> 35.5" wide • <i>Proposed Solution:</i> Remove or relocate furniture and storage items. • Notes: Remove bin | <p><i>PCODE</i> IH03AREF</p> <p>ADAAG 91 4.3.3</p> <p>ADA 2010 403.5.1</p> <p>CBC 2007 1133B.3.1</p> <p>CBC 2016 11B-403.5.1</p> <p>Priority 3</p> <p>Severity 4</p> | REF | | | |

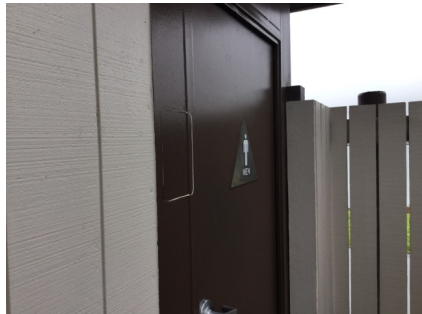
| Item No. and Name | Existing Architectural Barrier and Proposed Solution | Codes / Mitigation Info | Qty | Unit | Cost | Total |
|---|--|--|---|--|---|---|
| 372 | <ul style="list-style-type: none"> • <i>As-Built Description:</i> Entrance to toilet or bathing facility not identified with ADAAG compliant signage. • <i>As-Built:</i> No latch sign • <i>Proposed Solution:</i> Provide ADAAG compliant sign mounted 5' high on center on nearest adjacent wall, on latch side of a single door (located not to cause a Braille reader to stand within the door swing). | <p><i>PCODE</i> SA11A</p> <p>ADAAG 91 4.1.3(16)(a)</p> <p>ADA 2010 216.8</p> <p>CBC 2016 11B-216.8</p> <p>Priority 3</p> <p>Severity 3</p> | 1 | JOB | \$90 | \$90 |

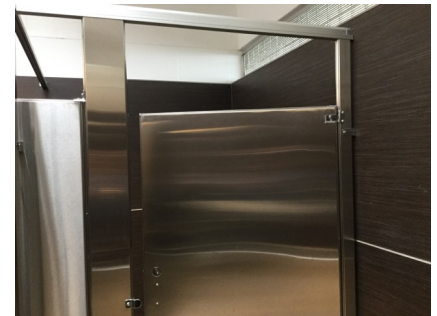
| 382 | <ul style="list-style-type: none"> As-Built Description: Stall door does not have accessible operating hardware (U-pulls on both sides, flip-over or sliding lock). As-Built: U-pull only on one side Proposed Solution: Provide new accessible locking hardware that does not require grasping, pinching, or twisting and U-pulls on both sides. | <p>PCODE WB05C</p> <p>ADAAG 91 4.17.5</p> <p>ADA 2010 604.8.1.2</p> <p>CBC 2007 1115B.3.1.4.5</p> <p>CBC 2016 11B-604.8.1.2</p> <p>Priority 3</p> <p>Severity 3</p> | 1 | JOB | \$100 | \$100 |

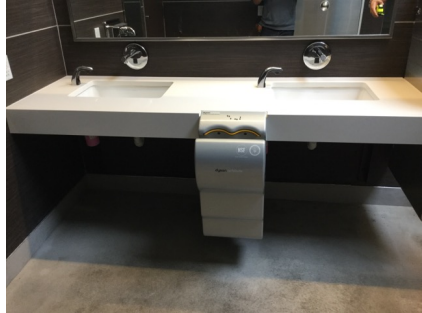
| Item No. and Name | Existing Architectural Barrier and Proposed Solution | Codes / Mitigation Info | Qty | Unit | Cost | Total |
|---|--|---|---|---|---|---|
| 378 | <ul style="list-style-type: none"> <i>As-Built Description:</i> Wheelchair clearance under lavatory apron or lavatory counter front edge less than 29" high. <i>As-Built:</i> 28.25" high apron <i>Proposed Solution:</i> Remount compliant fixture to accessible height. | <p><i>PCODE</i> WD03A</p> <p><i>ADAAG 91</i> 4.19.2</p> <p><i>ADA 2010</i> 606.3</p> <p><i>CBC 2007</i> 1115B.4.3.3</p> <p><i>CBC 2016</i> 11B-306.3.1</p> <p>Priority 3</p> <p>Severity 3</p> | 1 | JOB | \$1,500 | \$1,500 |

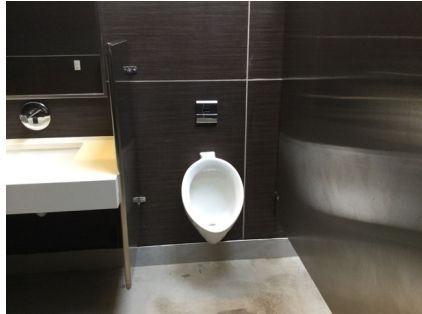
| Item No. and Name | Existing Architectural Barrier and Proposed Solution | Codes / Mitigation Info | Qty | Unit | Cost | Total |
|---|--|---|---|---|---|---|
| 379 | <ul style="list-style-type: none"> <i>As-Built Description:</i> 36" wide clearance in front of accessible urinal not provided when walls or partitions project more than 24" from the front edge of 30" x 48" clear space. <i>As-Built:</i> 32.75" wide <i>Proposed Solution:</i> Provide 36" clear floor space in front of accessible urinal. Remodel restroom as needed. | <p><i>PCODE</i> WE04A</p> <p><i>ADAAG 91</i> 4.18.3</p> <p><i>ADA 2010</i> 605.3</p> <p><i>CBC 2007</i> 1115B.4.2.3</p> <p><i>CBC 2016</i> 11B-605.3</p> <p>Priority 3</p> <p>Severity 2</p> | 1 | JOB | \$1,500 | \$1,500 |

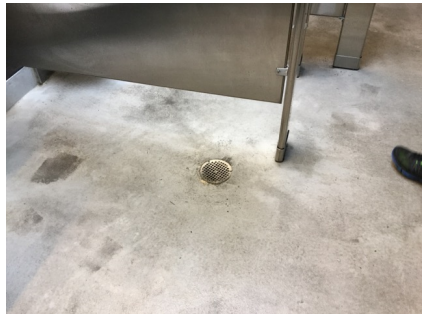
| Item No. and Name | Existing Architectural Barrier and Proposed Solution | Codes / Mitigation Info | Qty | Unit | Cost | Total |
|---|--|---|---|---|---|---|
| 380 | <ul style="list-style-type: none"> <i>As-Built Description:</i> Shower: Floor surface sloped greater than 2.0% (1:48) due to drain. <i>As-Built:</i> Sloped around drain <i>Proposed Solution:</i> Remodel floor surface in shower to compliance. | <p><i>PCODE</i> WF06A</p> <p><i>ADA 2010</i> 608.9</p> <p><i>CBC 2016</i> 11B-608.9</p> <p>Priority 3</p> <p>Severity 3</p> | 1 | JOB | \$500 | \$500 |

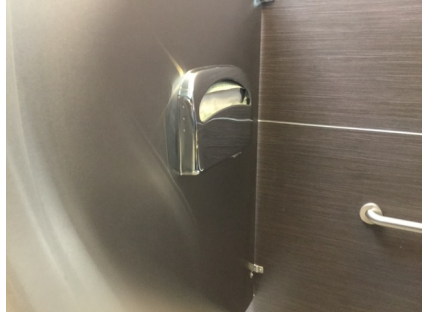
| Item No. and Name | Existing Architectural Barrier and Proposed Solution | Codes / Mitigation Info | Qty | Unit | Cost | Total |
|---|--|--|---|---|---|---|
| 383 | <ul style="list-style-type: none"> <i>As-Built Description:</i> Dispensers in sanitary facilities, such as for towels, soap, sanitary napkins, seat covers, etc., and waste receptacles more than 48" (CA only: 40") from floor to highest operating slot or control. <i>As-Built:</i> SCD: 51.5" high <i>Proposed Solution:</i> Relocate existing restroom accessories. | <p><i>PCODE</i> WG01A <i>ADAAG 91</i> 4.23.7 <i>ADA 2010</i> 308.2.1 <i>CBC 2007</i> 1115B.8.3 <i>CBC 2016</i> 11B-603.5</p> <p>Priority 3 Severity 2</p> | 1 | JOB | \$100 | \$100 |

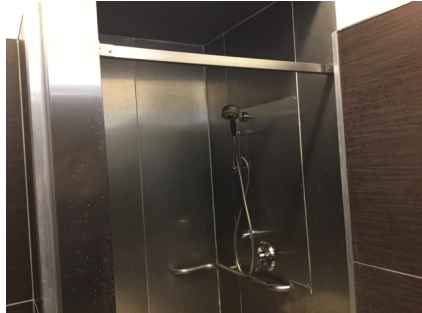
| 393 | <ul style="list-style-type: none"> <i>As-Built Description:</i> Overhead clearance less than 80" above finished floor. <i>As-Built:</i> 77.5" high curtain rod <i>Proposed Solution:</i> Modify overhead clearance. | <p><i>PCODE</i> EG01 <i>ADAAG 91</i> 4.4.2 <i>ADA 2010</i> 307.4 <i>CBC 2007</i> 1133B.8.6.2 <i>CBC 2016</i> 11B-307.4</p> <p>Priority 3 Severity 2</p> | 1 | JOB | \$100 | \$100 |

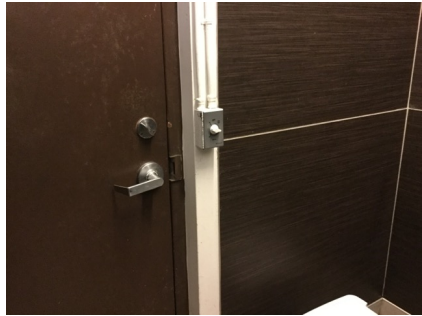
| 389 | <ul style="list-style-type: none"> <i>As-Built Description:</i> Operable part(s) require tight grasping, pinching, or twisting of the wrist with one hand. <i>As-Built:</i> Twist to operate light switch <i>Proposed Solution:</i> Modify or replace the operable part(s) to not require tight grasping, pinching, or twisting of the wrist with one hand. | <p><i>PCODE</i> IC02 <i>ADAAG 91</i> 4.27.4 <i>ADA 2010</i> 309.4 <i>CBC 2007</i> 1117B.6.4 <i>CBC 2016</i> 11B-309.4</p> <p>Priority 3 Severity 2</p> | 1 | JOB | \$300 | \$300 |

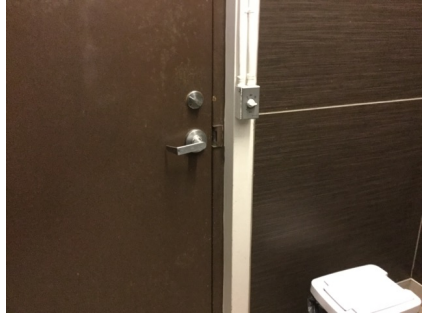
| Item No. and Name | Existing Architectural Barrier and Proposed Solution | Codes / Mitigation Info | Qty | Unit | Cost | Total |
|---|---|--|---|---|---|---|
| 391 | <ul style="list-style-type: none"> <i>As-Built Description:</i> Door lock or latch less than 34" or more than 48" above the floor (CA only: 34" to 44"). <i>As-Built:</i> 47.5" high <i>Proposed Solution:</i> Relocate or replace existing hardware. <i>Notes:</i> Compliant with past code | <p><i>PCODE</i> ID17REF</p> <p>ADAAG 91 4.13.9</p> <p>ADA 2010 404.2.7</p> <p>CBC 2007 1133B.2.5.2</p> <p>CBC 2016 11B-404.2.7</p> <p>Priority 3</p> <p>Severity 4</p> | | | | |

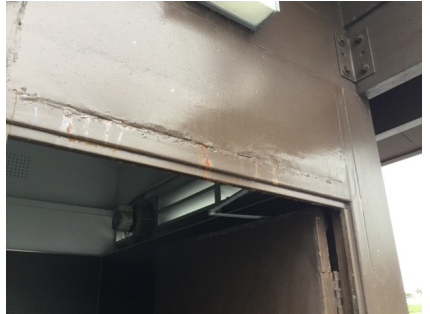
| Item No. and Name | Existing Architectural Barrier and Proposed Solution | Codes / Mitigation Info | Qty | Unit | Cost | Total |
|---|---|--|---|---|---|---|
| 388 | <ul style="list-style-type: none"> <i>As-Built Description:</i> Excessive force required to open door. <i>As-Built:</i> 15 lbs <i>Proposed Solution:</i> Adjust regular door closer to accessible standards (5 lbs. max). | <p><i>PCODE</i> ID03</p> <p>ADAAG 91 4.13.11</p> <p>ADA 2010 404.2.9</p> <p>CBC 2007 1133B.2.5</p> <p>CBC 2016 11B-404.2.9</p> <p>Priority 3</p> <p>Severity 3</p> | 1 | JOB | \$25 | \$25 |

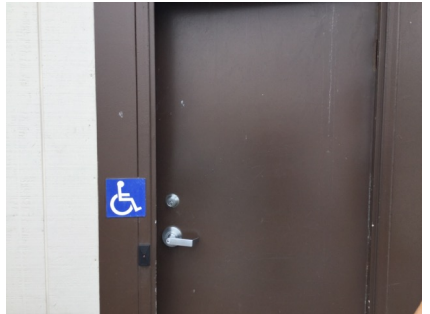
| Item No. and Name | Existing Architectural Barrier and Proposed Solution | Codes / Mitigation Info | Qty | Unit | Cost | Total |
|---|---|--|---|---|---|---|
| 386 | <ul style="list-style-type: none"> <i>As-Built Description:</i> Entrance to toilet or bathing facility not identified with ADAAG compliant signage. <i>As-Built:</i> Noncompliant latch sign <i>Proposed Solution:</i> Provide ADAAG compliant sign mounted 5' high on center on nearest adjacent wall, on latch side of a single door (located not to cause a Braille reader to stand within the door swing). | <p><i>PCODE</i> SA11A</p> <p>ADAAG 91 4.1.3(16)(a)</p> <p>ADA 2010 216.8</p> <p>CBC 2016 11B-216.8</p> <p>Priority 3</p> <p>Severity 3</p> | 1 | JOB | \$90 | \$90 |

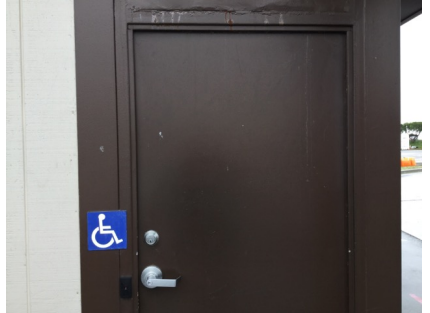
| Item No. and Name | Existing Architectural Barrier and Proposed Solution | Codes / Mitigation Info | Qty | Unit | Cost | Total |
|---|---|--|---|---|---|---|
| 387 | <ul style="list-style-type: none"> <i>As-Built Description:</i> Required in CA only: identification symbol centered 58" to 60" high on sanitary facility door that contrasts with the door not provided (women: 12" ø circle, men: 12" triangle, unisex: combined symbol). <i>Proposed Solution:</i> Provide properly mounted sanitary facility symbol when altering area. If wheelchair accessible, include International Symbol of Accessibility on sign. | <p><i>PCODE</i> SA15</p> <p>CBC 2007 1115B.6</p> <p>CBC 2016 11B-703.7.2.6</p> <p>Priority 3</p> <p>Severity 3</p> | 1 | JOB | \$90 | \$90 |

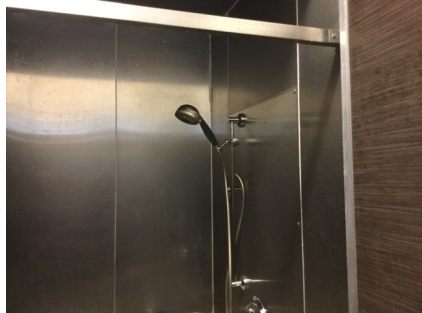
| Item No. and Name | Existing Architectural Barrier and Proposed Solution | Codes / Mitigation Info | Qty | Unit | Cost | Total |
|---|---|--|---|---|---|---|
| 395 | <ul style="list-style-type: none"> <i>As-Built Description:</i> Mounting height of shower spray bracket exceeds 48" max. height or is more than 27" from rear edge of folding seat. <i>Proposed Solution:</i> Provide or remount shower spray bracket within 27" from rear edge of seat and at 48" max. height. <i>Notes:</i> Ensure spray mounted at accessible height | PCODE WF05B ADA 2010 608.5 CBC 2007 1115B.4.4.5.3 CBC 2016 11B-608.5 Priority 3 Severity 1 | 1 | JOB | \$500 | \$500 |

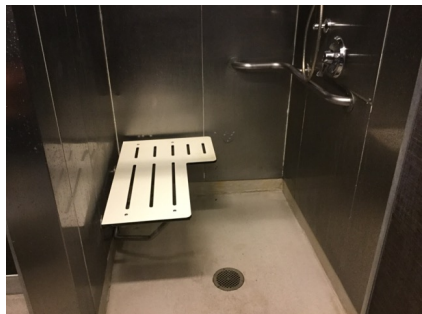
| Item No. and Name | Existing Architectural Barrier and Proposed Solution | Codes / Mitigation Info | Qty | Unit | Cost | Total |
|---|---|--|---|---|---|---|
| 394 | <ul style="list-style-type: none"> <i>As-Built Description:</i> Controls not located at 40" max. height or not within a range of no less than 19" and no more than 27" from the seat wall. <i>As-Built:</i> Shower controls not located on back wall <i>Proposed Solution:</i> Provide new, or relocate, shower controls. <i>Notes:</i> 42" wide X 48" deep | PCODE WF12 ADAAG 91 4.27.3 ADA 2010 608.5 CBC 2007 1115B.4.4.4.1 CBC 2016 11B-608.5 Priority 3 Severity 2 | 1 | JOB | \$800 | \$800 |

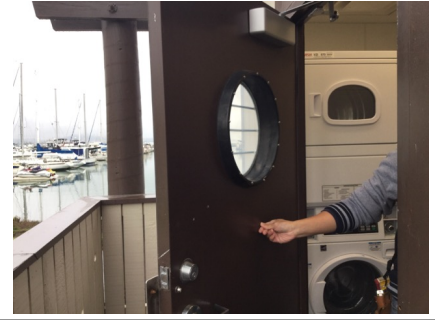
Door Closer

| 400 | <ul style="list-style-type: none"> <i>As-Built Description:</i> Excessive force required to open door. <i>As-Built:</i> 14 lbs <i>Proposed Solution:</i> Adjust regular door closer to accessible standards (5 lbs. max). | <p><i>PCODE</i> ID03REF <i>ADAAG 91</i> 4.13.11 <i>ADA 2010</i> 404.2.9 <i>CBC 2007</i> 1133B.2.5 <i>CBC 2016</i> 11B-404.2.9</p> <p>Priority 3 Severity 3</p> | REF | | | |

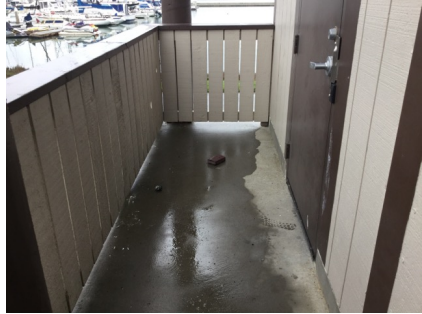
| Item No. and Name | Existing Architectural Barrier and Proposed Solution | Codes / Mitigation Info | Qty | Unit | Cost | Total |
|---|---|--|---|---|---|---|
| 399 | <ul style="list-style-type: none"> <i>As-Built Description:</i> Latch approach: At pull side, door does not have clear and level maneuvering space measuring door width plus 24" x 48" or 54" if door has closer (CA only: door width plus 24" x 60"). <i>As-Built:</i> 45" to railing <i>Proposed Solution:</i> Change door swing. | <p>PCODE ID27REF</p> <p>ADAAG 91 Fig. 25(c)</p> <p>ADA 2010 404.2.4</p> <p>CBC 2007 11B-26A(c)</p> <p>CBC 2016 11B-404.2.4</p> <p>Priority 3</p> <p>Severity 3</p> | | | | |

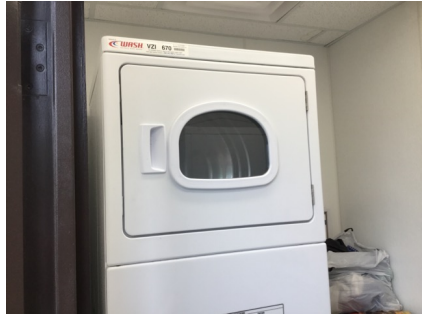
| Item No. and Name | Existing Architectural Barrier and Proposed Solution | Codes / Mitigation Info | Qty | Unit | Cost | Total |
|---|---|--|---|---|---|---|
| 402 | <ul style="list-style-type: none"> <i>As-Built Description:</i> Reach height to control or access point, exceeds 48" or is less than 15". <i>As-Built:</i> 67" high dryer controls <i>Proposed Solution:</i> Modify equipment or mounting. | <p>PCODE IE01</p> <p>ADAAG 91 4.2.5</p> <p>ADA 2010 308.2.1</p> <p>CBC 2007 1118B.5</p> <p>CBC 2016 11B-308.2.1</p> <p>Priority 3</p> <p>Severity 1</p> | 1 | JOB | \$100 | \$100 |

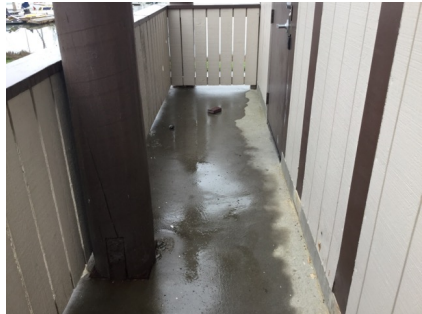
| Item No. and Name | Existing Architectural Barrier and Proposed Solution | Codes / Mitigation Info | Qty | Unit | Cost | Total |
|---|---|--|---|---|---|---|
| 397 | <ul style="list-style-type: none"> <i>As-Built Description:</i> Corridor, for occupant load less than 10, less than 36" wide. <i>As-Built:</i> 32.5" wide <i>Proposed Solution:</i> Remove or relocate furniture and storage items. Notes: Relocate room | <p>PCODE IH03AREF</p> <p>ADAAG 91 4.3.3</p> <p>ADA 2010 403.5.1</p> <p>CBC 2007 1133B.3.1</p> <p>CBC 2016 11B-403.5.1</p> <p>Priority 3</p> <p>Severity 4</p> | | | | |

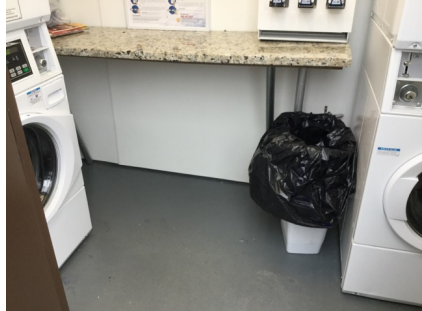
| Item No. and Name | Existing Architectural Barrier and Proposed Solution | Codes / Mitigation Info | Qty | Unit | Cost | Total |
|---|---|--|---|---|---|---|
| 398 | <ul style="list-style-type: none"> <i>As-Built Description:</i> Corridor, for occupant load less than 10, less than 36" wide. <i>As-Built:</i> Room too small to access and maneuver within. <i>Proposed Solution:</i> Remove or relocate furniture and storage items. Notes: Laundry room | <p>PCODE IH03AREF</p> <p>ADAAG 91 4.3.3</p> <p>ADA 2010 403.5.1</p> <p>CBC 2007 1133B.3.1</p> <p>CBC 2016 11B-403.5.1</p> <p>Priority 3</p> <p>Severity 4</p> | | | | |
