SAN MATEO COUNTY HARBOR DISTRICT

ADA Self-Evaluation and Transition Plan

August 2018

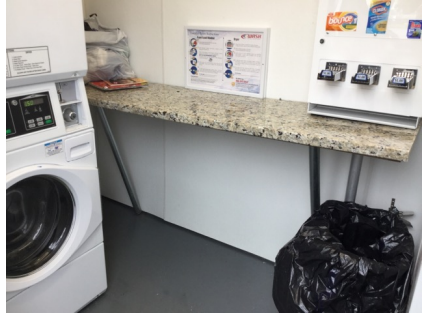
| Item No. and Name | Existing Architectural Barrier and Proposed Solution | Codes / Mitigation Info | Qty | Unit | Cost | Total |
|---|--|--|---|---|---|---|
| 403 | <ul style="list-style-type: none"> <i>As-Built Description:</i> Accessible fixed table or desk (top 28" to 34" high; knee space at least 27" high x 19" deep x 30" wide) not provided. <i>As-Built:</i> 38" high folding counter <i>Proposed Solution:</i> Provide new fixed accessible table or desk. | <p><i>PCODE</i> IN02</p> <p><i>ADAAG 91</i> 4.32.3 & .4</p> <p><i>ADA 2010</i> 306.1 & 902.3</p> <p><i>CBC 2007</i> 1122B.3 & 4</p> <p><i>CBC 2016</i> 11B-306.1 & 11B-902.3</p> <p>Priority 3</p> <p>Severity 4</p> | 1 | JOB | \$2,500 | \$2,500 |

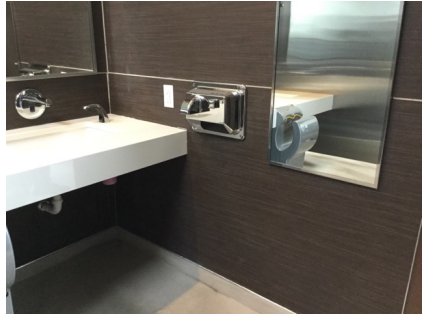
| 407 | <ul style="list-style-type: none"> <i>As-Built Description:</i> Protruding objects more than 4" from wall, when bottom of object more than 27" or less than 80" above finished floor. <i>As-Built:</i> Hand dryer: 7" at 39" high <i>Proposed Solution:</i> Remove/relocate protruding object. Patch existing surface. | <p><i>PCODE</i> EG04</p> <p><i>ADAAG 91</i> 4.4.1</p> <p><i>ADA 2010</i> 307.2</p> <p><i>CBC 2007</i> 1133B.8.6.1</p> <p><i>CBC 2016</i> 11B-307.2</p> <p>Priority 3</p> <p>Severity 3</p> | 1 | JOB | \$100 | \$100 |

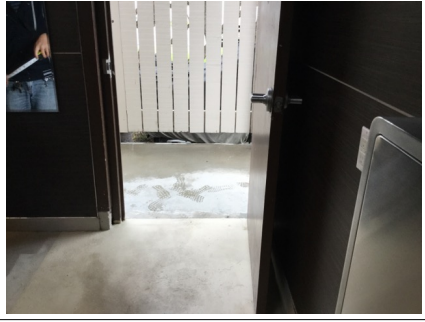
| 406 | <ul style="list-style-type: none"> <i>As-Built Description:</i> Door on accessible route has less than 32" clear and 80" (78" min. to closer if provided) opening width when 90° open. <i>As-Built:</i> Door does not open 90 degrees <i>Proposed Solution:</i> Provide new, larger door and frame with new accessible hardware. | <p><i>PCODE</i> ID01</p> <p><i>ADAAG 91</i> 4.13.5</p> <p><i>ADA 2010</i> 404.2.3</p> <p><i>CBC 2007</i> 1133B.1.1.1.1</p> <p><i>CBC 2016</i> 11B-404.2.3</p> <p>Priority 3</p> <p>Severity 4</p> | 1 | JOB | \$2,600 | \$2,600 |

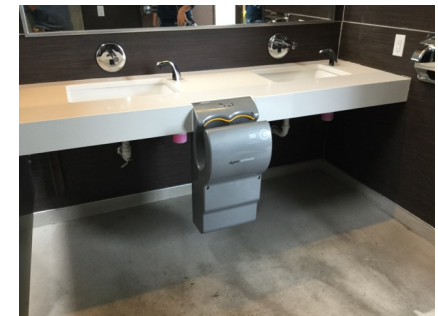
| 409 | <ul style="list-style-type: none"> <i>As-Built Description:</i> Wheelchair clearance under lavatory apron or lavatory counter front edge less than 29" high. <i>As-Built:</i> 28.875" high apron <i>Proposed Solution:</i> Provide new accessible lavatory. Remodel restroom as needed. | <p>PCODE WD03</p> <p>ADAAG 91 4.19.2</p> <p>ADA 2010 606.3</p> <p>CBC 2007 1115B.4.3.3</p> <p>CBC 2016 11B-306.3.1</p> <p>Priority 3</p> <p>Severity 2</p> | 1 | JOB | \$3,400 | \$3,400 |

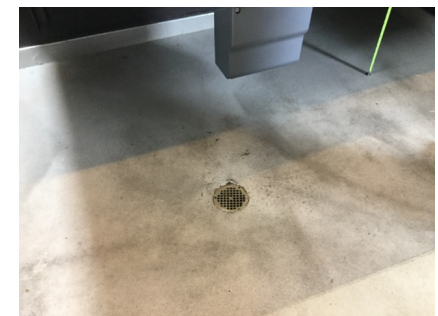
| 408 | <ul style="list-style-type: none"> <i>As-Built Description:</i> Shower: Floor surface sloped greater than 2.0% (1:48) due to drain. <i>As-Built:</i> Sloped around drain <i>Proposed Solution:</i> Remodel floor surface in shower to compliance. | <p>PCODE WF06A</p> <p>ADA 2010 608.9</p> <p>CBC 2016 11B-608.9</p> <p>Priority 3</p> <p>Severity 3</p> | 1 | JOB | \$500 | \$500 |

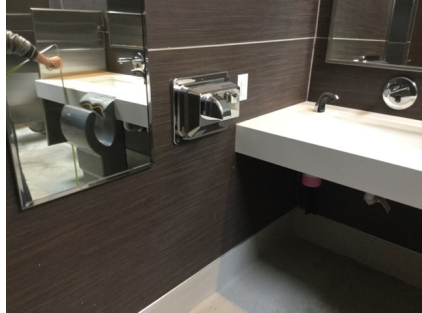
| Item No. and Name | Existing Architectural Barrier and Proposed Solution | Codes / Mitigation Info | Qty | Unit | Cost | Total |
|---|--|--|---|---|---|---|
| 418 | <ul style="list-style-type: none"> <i>As-Built Description:</i> Protruding objects more than 4" from wall, when bottom of object more than 27" or less than 80" above finished floor. <i>As-Built:</i> Hand dryer: 7" at 38" high <i>Proposed Solution:</i> Remove/relocate protruding object. Patch existing surface. | PCODE EG04 ADAAG 91 4.4.1 ADA 2010 307.2 CBC 2007 1133B.8.6.1 CBC 2016 11B-307.2 Priority 3 Severity 3 | 1 | JOB | \$100 | \$100 |

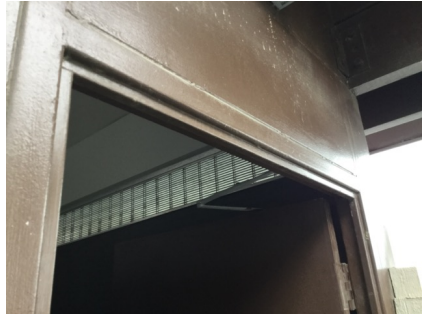
| Item No. and Name | Existing Architectural Barrier and Proposed Solution | Codes / Mitigation Info | Qty | Unit | Cost | Total |
|---|--|--|---|---|---|---|
| 416 | <ul style="list-style-type: none"> <i>As-Built Description:</i> Excessive force required to open door. <i>As-Built:</i> 15 lbs <i>Proposed Solution:</i> Adjust regular door closer to accessible standards (5 lbs. max). | PCODE ID03 ADAAG 91 4.13.11 ADA 2010 404.2.9 CBC 2007 1133B.2.5 CBC 2016 11B-404.2.9 Priority 3 Severity 3 | 1 | JOB | \$25 | \$25 |

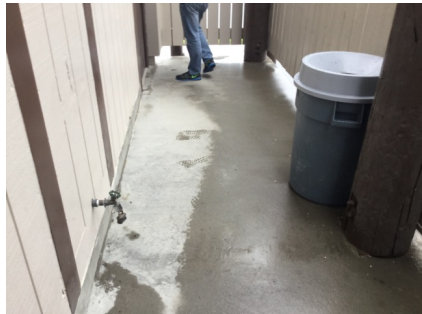
| Item No. and Name | Existing Architectural Barrier and Proposed Solution | Codes / Mitigation Info | Qty | Unit | Cost | Total |
|---|--|--|---|---|---|---|
| 413 | <ul style="list-style-type: none"> <i>As-Built Description:</i> Corridor, for occupant load less than 10, less than 36" wide. <i>As-Built:</i> 41" wide <i>Proposed Solution:</i> Remove or relocate furniture and storage items. Notes: Remove bin | PCODE IH03AREF ADAAG 91 4.3.3 ADA 2010 403.5.1 CBC 2007 1133B.3.1 CBC 2016 11B-403.5.1 Priority 3 Severity 4 | REF | | | |

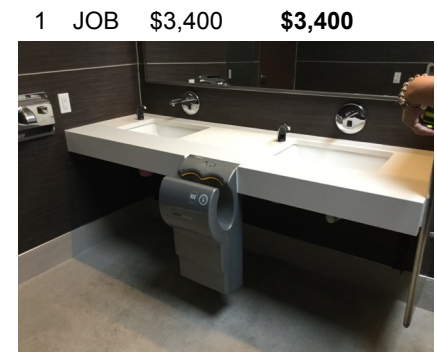
| 419 | <ul style="list-style-type: none"> • <i>As-Built Description:</i> Wheelchair clearance under lavatory apron or lavatory counter front edge less than 29" high. • <i>As-Built:</i> 28.875" high apron • <i>Proposed Solution:</i> Provide new accessible lavatory. Remodel restroom as needed. | <p>PCODE WD03 ADAAG 91 4.19.2 ADA 2010 606.3 CBC 2007 1115B.4.3.3 CBC 2016 11B-306.3.1</p> <p>Priority 3 Severity 2</p> | | | | |

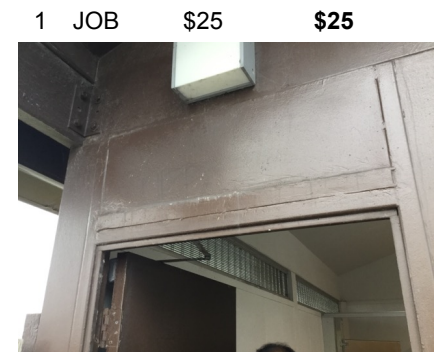
| 426 | <ul style="list-style-type: none"> • <i>As-Built Description:</i> Excessive force required to open door. • <i>As-Built:</i> 14 lbs • <i>Proposed Solution:</i> Adjust regular door closer to accessible standards (5 lbs. max). | <p>PCODE ID03 ADAAG 91 4.13.11 ADA 2010 404.2.9 CBC 2007 1133B.2.5 CBC 2016 11B-404.2.9</p> <p>Priority 3 Severity 3</p> | | | | |

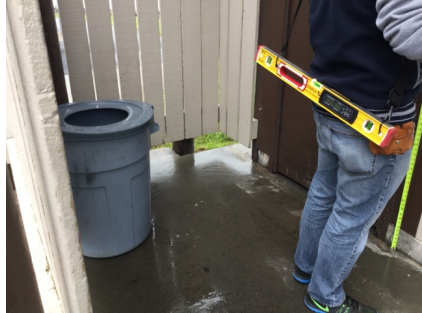
| Item No. and Name | Existing Architectural Barrier and Proposed Solution | Codes / Mitigation Info | Qty | Unit | Cost | Total |
|---|---|---|---|---|---|---|
| 423 | <ul style="list-style-type: none"> <i>As-Built Description:</i> Front approach: At push side, door does not have clear and level maneuvering space measuring door width x 48" (door width plus 12" if door has both, latch and closer). <i>As-Built:</i> 38" to bin <i>Proposed Solution:</i> Remove or relocate furniture or storage items. | <p>PCODE ID24AREF ADAAG 91 Fig. 25(a) ADA 2010 404.2.4 CBC 2007 11B-26A(a) CBC 2016 11B-404.2.4</p> <p>Priority 3 Severity 4</p> | | | | |

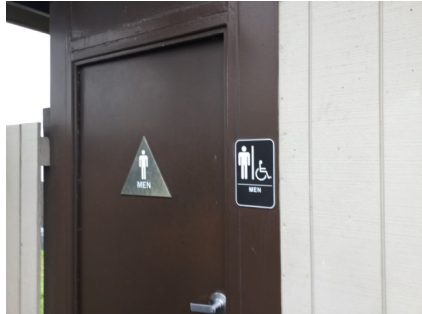
| Item No. and Name | Existing Architectural Barrier and Proposed Solution | Codes / Mitigation Info | Qty | Unit | Cost | Total |
|---|---|---|---|---|---|---|
| 425 | <ul style="list-style-type: none"> <i>As-Built Description:</i> Entrance to toilet or bathing facility not identified with ADAAG compliant signage. <i>As-Built:</i> 5.5" from latch <i>Proposed Solution:</i> Provide ADAAG compliant sign mounted 5' high on center on nearest adjacent wall, on latch side of a single door (located not to cause a Braille reader to stand within the door swing). | <p>PCODE SA11A ADAAG 91 4.1.3(16)(a) ADA 2010 216.8 CBC 2016 11B-216.8</p> <p>Priority 3 Severity 3</p> | 1 | JOB | \$90 | \$90 |

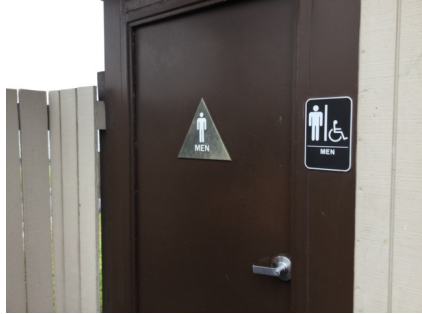
| Item No. and Name | Existing Architectural Barrier and Proposed Solution | Codes / Mitigation Info | Qty | Unit | Cost | Total |
|---|---|---|---|---|---|---|
| 424 | <ul style="list-style-type: none"> <i>As-Built Description:</i> Required in CA only: identification symbol centered 58" to 60" high on sanitary facility door that contrasts with the door not provided (women: 12" ø circle, men: 12" triangle, unisex: combined symbol). <i>As-Built:</i> 11.75" sides <i>Proposed Solution:</i> Provide properly mounted sanitary facility symbol when altering area. If wheelchair accessible, include International Symbol of Accessibility on sign. | <p>PCODE SA15 CBC 2007 1115B.6 CBC 2016 11B-703.7.2.6</p> <p>Priority 3 Severity 3</p> | 1 | JOB | \$90 | \$90 |

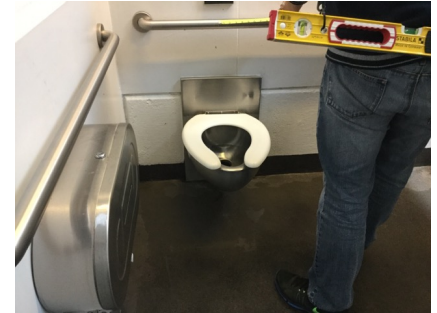
| Item No. and Name | Existing Architectural Barrier and Proposed Solution | Codes / Mitigation Info | Qty | Unit | Cost | Total |
|---|---|---|---|---|---|---|
| 432 | <ul style="list-style-type: none"> <i>As-Built Description:</i> Height of water closet seat less than 17" or more than 19" from floor. <i>As-Built:</i> 16" high <i>Proposed Solution:</i> Provide new accessible water closet. | PCODE WB08 ADAAG 91 4.16.3 ADA 2010 604.4 CBC 2007 1115B.4.1.4 CBC 2016 11B-604.4 Priority 3 Severity 4 | 1 | JOB | \$1,400 | \$1,400 |

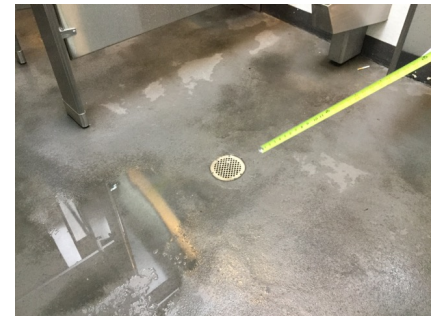
| 428 | <ul style="list-style-type: none"> <i>As-Built Description:</i> Shower: Floor surface sloped greater than 2.0% (1:48) due to drain. <i>As-Built:</i> Sloped around drain <i>Proposed Solution:</i> Remodel floor surface in shower to compliance. | PCODE WF06A ADA 2010 608.9 CBC 2016 11B-608.9 Priority 3 Severity 3 | 1 | JOB | \$500 | \$500 |

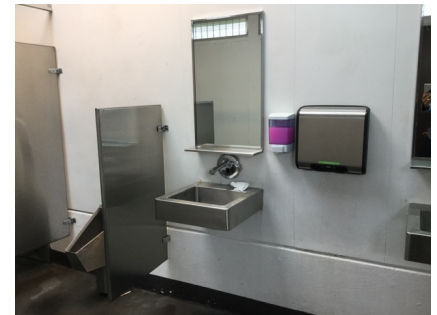
| 427 | <ul style="list-style-type: none"> <i>As-Built Description:</i> Dispensers in sanitary facilities, such as for towels, soap, sanitary napkins, seat covers, etc., and waste receptacles more than 48" (CA only: 40") from floor to highest operating slot or control. <i>As-Built:</i> SD: 44" high <i>Proposed Solution:</i> Relocate existing restroom accessories. | PCODE WG01A ADAAG 91 4.23.7 ADA 2010 308.2.1 CBC 2007 1115B.8.3 CBC 2016 11B-603.5 Priority 3 Severity 3 | 1 | JOB | \$100 | \$100 |

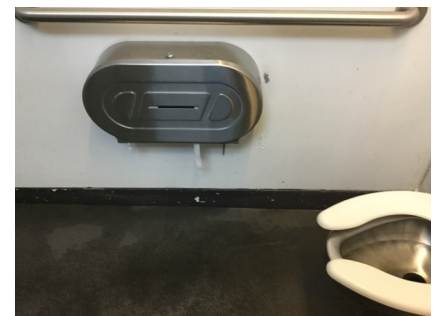
| 434 | <ul style="list-style-type: none"> <i>As-Built Description:</i> Toilet paper dispenser less than 15" (CA: 19") or more than 48" above floor or not within 7" to 9" from front of water closet (Note: CA pre-2010 is allowed within 12" from front of water closet). <i>As-Built:</i> 12" in front <i>Proposed Solution:</i> Relocate or provide new toilet paper dispenser. | PCODE WG02 ADAAG 91 4.16.6 ADA 2010 604.7 CBC 2007 1115B.8.4 CBC 2016 11B-604.7 Priority 3 Severity 4 | 1 | JOB | \$75 | \$75 |

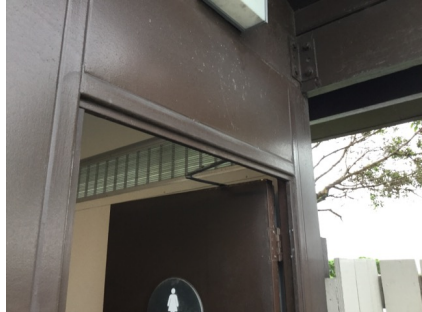
| 436 | <ul style="list-style-type: none"> <i>As-Built Description:</i> Excessive force required to open door. <i>As-Built:</i> 13 lbs <i>Proposed Solution:</i> Adjust regular door closer to accessible standards (5 lbs. max). | <p><i>PCODE</i> ID03 <i>ADAAG 91</i> 4.13.11 <i>ADA 2010</i> 404.2.9 <i>CBC 2007</i> 1133B.2.5 <i>CBC 2016</i> 11B-404.2.9</p> <p>Priority 3 Severity 3</p> | 1 | JOB | \$25 | \$25 |

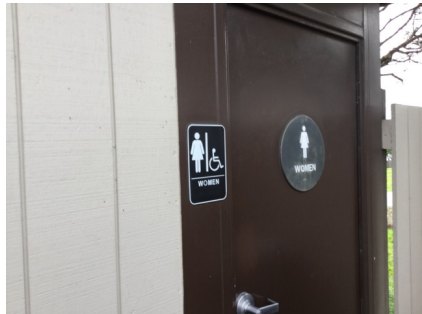
| 435 | <ul style="list-style-type: none"> <i>As-Built Description:</i> Entrance to toilet or bathing facility not identified with ADAAG compliant signage. <i>As-Built:</i> 5" from latch <i>Proposed Solution:</i> Provide ADAAG compliant sign mounted 5' high on center on nearest adjacent wall, on latch side of a single door (located not to cause a Braille reader to stand within the door swing). | <p><i>PCODE</i> SA11A <i>ADAAG 91</i> 4.1.3(16)(a) <i>ADA 2010</i> 216.8 <i>CBC 2016</i> 11B-216.8</p> <p>Priority 3 Severity 3</p> | 1 | JOB | \$90 | \$90 |

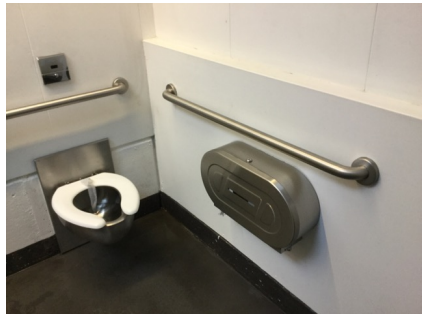
| 443 | <ul style="list-style-type: none"> <i>As-Built Description:</i> Side grab bar less than 42" long, or located more than 12 inches max. from the rear wall, or extending less than 54" from rear wall (CA only: front end min. 24" in front of water closet). <i>As-Built:</i> 42" at 52" <i>Proposed Solution:</i> Provide or relocate accessible side grab bar. | <p><i>PCODE</i> WB07A <i>ADAAG 91</i> Fig. 29(b) <i>ADA 2010</i> 604.5.1 <i>CBC 2007</i> 1115B.4.1.3.1 <i>CBC 2016</i> 11B-604.5.1</p> <p>Priority 3 Severity 4</p> | 1 | JOB | \$260 | \$260 |

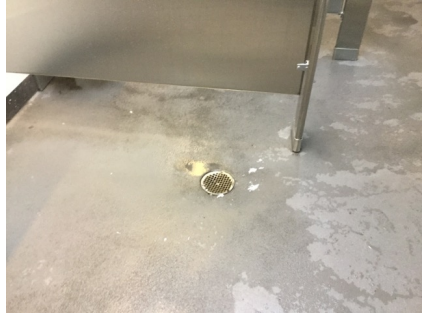
| Item No. and Name | Existing Architectural Barrier and Proposed Solution | Codes / Mitigation Info | Qty | Unit | Cost | Total |
|---|---|---|---|---|---|---|
| 437 | <ul style="list-style-type: none"> • <i>As-Built Description:</i> Shower: Floor surface sloped greater than 2.0% (1:48) due to drain. • <i>As-Built:</i> Sloped around drain • <i>Proposed Solution:</i> Remodel floor surface in shower to compliance. | <p><i>PCODE</i> WF06A <i>ADA 2010</i> 608.9 <i>CBC 2016</i> 11B-608.9</p> <p>Priority 3 Severity 3</p> | 1 | JOB | \$500 | \$500 |

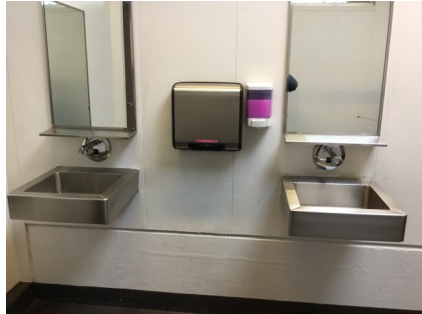
| Item No. and Name | Existing Architectural Barrier and Proposed Solution | Codes / Mitigation Info | Qty | Unit | Cost | Total |
|---|---|---|---|---|---|---|
| 438 | <ul style="list-style-type: none"> • <i>As-Built Description:</i> Dispensers in sanitary facilities, such as for towels, soap, sanitary napkins, seat covers, etc., and waste receptacles more than 48" (CA only: 40") from floor to highest operating slot or control. • <i>As-Built:</i> SD: 45" high • <i>Proposed Solution:</i> Relocate existing restroom accessories. | <p><i>PCODE</i> WG01A <i>ADAAG 91</i> 4.23.7 <i>ADA 2010</i> 308.2.1 <i>CBC 2007</i> 1115B.8.3 <i>CBC 2016</i> 11B-603.5</p> <p>Priority 3 Severity 3</p> | 1 | JOB | \$100 | \$100 |

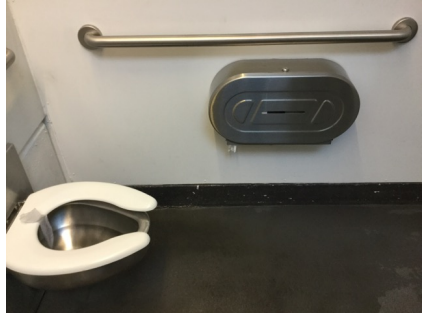
| Item No. and Name | Existing Architectural Barrier and Proposed Solution | Codes / Mitigation Info | Qty | Unit | Cost | Total |
|---|---|---|---|---|---|---|
| 444 | <ul style="list-style-type: none"> • <i>As-Built Description:</i> Toilet paper dispenser less than 15" (CA: 19") or more than 48" above floor or not within 7" to 9" from front of water closet (Note: CA pre-2010 is allowed within 12" from front of water closet). • <i>As-Built:</i> 11" in front • <i>Proposed Solution:</i> Relocate or provide new toilet paper dispenser. | <p><i>PCODE</i> WG02 <i>ADAAG 91</i> 4.16.6 <i>ADA 2010</i> 604.7 <i>CBC 2007</i> 1115B.8.4 <i>CBC 2016</i> 11B-604.7</p> <p>Priority 3 Severity 4</p> | 1 | JOB | \$75 | \$75 |

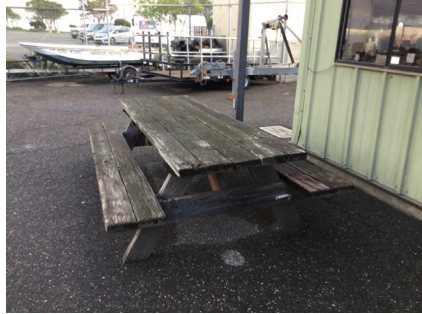
| Item No. and Name | Existing Architectural Barrier and Proposed Solution | Codes / Mitigation Info | Qty | Unit | Cost | Total |
|---|--|--|---|---|---|---|
| 516 | <ul style="list-style-type: none"> <i>As-Built Description:</i> Knee clearance at minimums 27" high, 30" wide, and 19" deep is not provided. <i>As-Built:</i> 26.25" high 12" deep knee space <i>Proposed Solution:</i> Modify picnic table as required to provide knee clearance. | PCODE NH11A ADAAG 91 16.5.4. ADA 2010 306.3 CBC 2007 1132B.1 CBC 2016 11B-306.3 Priority 4 Severity 2 | 1 | JOB | \$850 | \$850 |

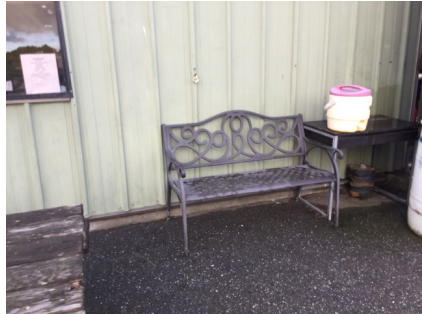
| Item No. and Name | Existing Architectural Barrier and Proposed Solution | Codes / Mitigation Info | Qty | Unit | Cost | Total |
|---|--|--|---|---|---|---|
| 517 | <ul style="list-style-type: none"> <i>As-Built Description:</i> Clear and level floor or ground space (30" x 48") not overlapping with other clear space requirements, is not provided at at least one end of the bench. <i>Proposed Solution:</i> Provide and position a clear and level floor or ground space to allow wheelchair users to be seated shoulder-to-shoulder with an individual seated on the bench. Notes: Staff Only | PCODE NO07REF ADAAG 91 4.32.2 ADA 2010 903.2 CBC 2007 1118B.4 CBC 2016 11B-903.2 Priority 4 Severity 3 | REF | | | |

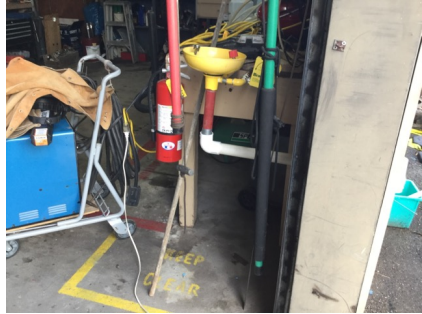
| Item No. and Name | Existing Architectural Barrier and Proposed Solution | Codes / Mitigation Info | Qty | Unit | Cost | Total |
|---|--|--|---|---|---|---|
| 479 | <ul style="list-style-type: none"> <i>As-Built Description:</i> Drinking fountain bubbler more than 36" above floor. <i>As-Built:</i> 43" high <i>Proposed Solution:</i> Provide new, accessible fountain. Notes: Eye wash station | PCODE IA03B ADAAG 91 4.15.2 ADA 2010 602.4 CBC 2007 1115B.4.6.4 CBC 2016 11B-602.4 Priority 4 Severity 3 | 1 | JOB | \$3,200 | \$3,200 |

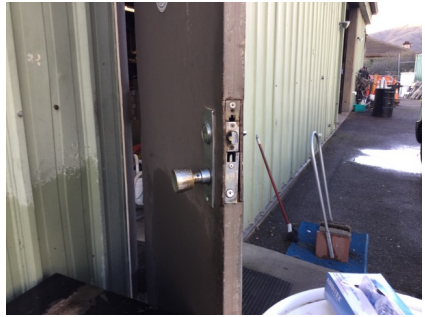
| Item No. and Name | Existing Architectural Barrier and Proposed Solution | Codes / Mitigation Info | Qty | Unit | Cost | Total |
|---|--|--|---|---|---|---|
| 472 | <ul style="list-style-type: none"> <i>As-Built Description:</i> Non-common use areas within this facility, such as offices, do not have accessible door hardware. <i>Proposed Solution:</i> Provide lever handle or other accessible hardware when a specific need is identified in the future or when altering area. | PCODE ID07C ADAAG 91 4.13.9 ADA 2010 404.2.7 CBC 2007 1133B.2.5.2 CBC 2016 11B-404.2.7 Priority 4 Severity 3 | 1 | JOB | \$250 | \$250 |

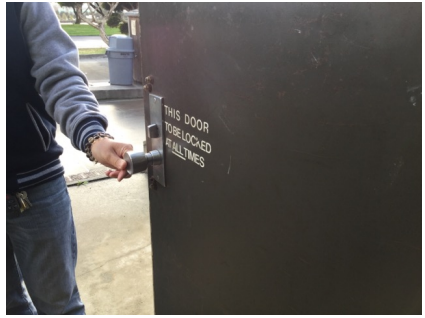
| Item No. and Name | Existing Architectural Barrier and Proposed Solution | Codes / Mitigation Info | Qty | Unit | Cost | Total |
|---|--|--|---|---|---|---|
| 484 | <ul style="list-style-type: none"> <i>As-Built Description:</i> Non-common use areas within this facility, such as offices, do not have accessible door hardware. <i>Proposed Solution:</i> Provide lever handle or other accessible hardware when a specific need is identified in the future or when altering area. Notes: Back entrance door | PCODE ID07C ADAAG 91 4.13.9 ADA 2010 404.2.7 CBC 2007 1133B.2.5.2 CBC 2016 11B-404.2.7 Priority 4 Severity 3 | 1 | JOB | \$250 | \$250 |

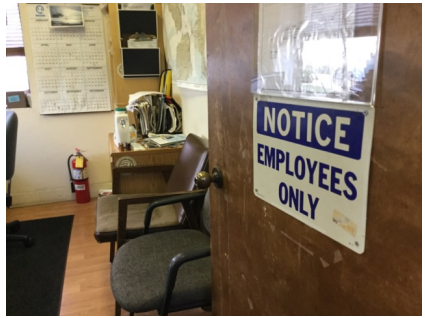
| Item No. and Name | Existing Architectural Barrier and Proposed Solution | Codes / Mitigation Info | Qty | Unit | Cost | Total |
|---|--|--|---|---|---|---|
| 515 | <ul style="list-style-type: none"> <i>As-Built Description:</i> Non-common use areas within this facility, such as offices, do not have accessible door hardware. <i>Proposed Solution:</i> Provide lever handle or other accessible hardware when a specific need is identified in the future or when altering area. Notes: Private office | PCODE ID07C ADAAG 91 4.13.9 ADA 2010 404.2.7 CBC 2007 1133B.2.5.2 CBC 2016 11B-404.2.7 Priority 4 Severity 3 | 1 | JOB | \$250 | \$250 |

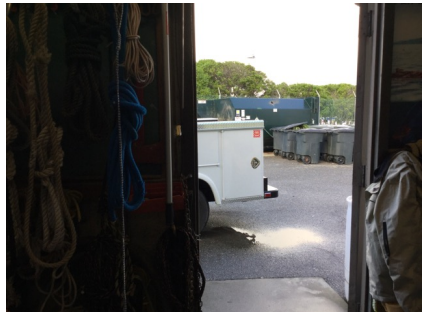
| Item No. and Name | Existing Architectural Barrier and Proposed Solution | Codes / Mitigation Info | Qty | Unit | Cost | Total |
|---|--|--|---|---|---|---|
| 475 | <ul style="list-style-type: none"> <i>As-Built Description:</i> Front approach: At push side, door does not have clear and level maneuvering space measuring door width x 48" (door width plus 12" if door has both, latch and closer). <i>Proposed Solution:</i> Remove or relocate furniture or storage items. | PCODE ID24AREF ADAAG 91 Fig. 25(a) ADA 2010 404.2.4 CBC 2007 11B-26A(a) CBC 2016 11B-404.2.4 Priority 4 Severity 4 | REF | | | |

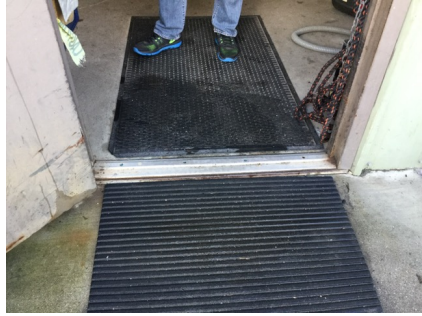
| 473 | <ul style="list-style-type: none"> <i>As-Built Description:</i> Existing threshold at door is 1/2" high or less but without a beveled edge on both sides. <i>As-Built:</i> 1" threshold <i>Proposed Solution:</i> Modify threshold to have beveled edge on each side. | <p>PCODE ID02 ADAAG 91 4.1.6(3)(d)(ii) ADA 2010 404.2.5 CBC 2007 1133B.2.4.1 CBC 2016 11B-404.2.5</p> <p>Priority 4 Severity 4</p> | 1 | JOB | \$250 | \$250 |

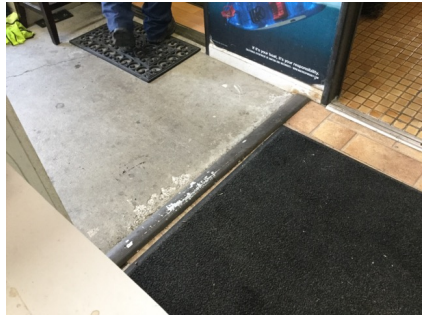
| 482 | <ul style="list-style-type: none"> <i>As-Built Description:</i> Door inaccessible due to threshold or step at door exceeding 1/2". <i>Proposed Solution:</i> Modify threshold to be no more than 1/2" by removing existing paving at door and providing landing with edge ramping (slope 1:20 max). Notes: Replace threshold Not at a door | <p>PCODE ID02A ADAAG 91 4.13.8 ADA 2010 404.2.5 CBC 2007 1133B.2.4.1 CBC 2016 11B-404.2.5</p> <p>Priority 4 Severity 4</p> | 1 | JOB | \$400 | \$400 |

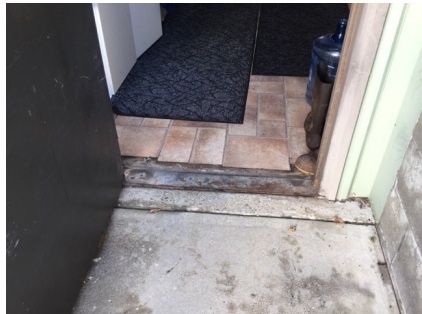
| 485 | <ul style="list-style-type: none"> <i>As-Built Description:</i> Door inaccessible due to threshold or step at door exceeding 1/2". <i>As-Built:</i> 0.5" lip due to tile <i>Proposed Solution:</i> Modify threshold to be no more than 1/2" by removing existing paving at door and providing landing with edge ramping (slope 1:20 max). | <p>PCODE ID02A ADAAG 91 4.13.8 ADA 2010 404.2.5 CBC 2007 1133B.2.4.1 CBC 2016 11B-404.2.5</p> <p>Priority 4 Severity 4</p> | 1 | JOB | \$400 | \$400 |

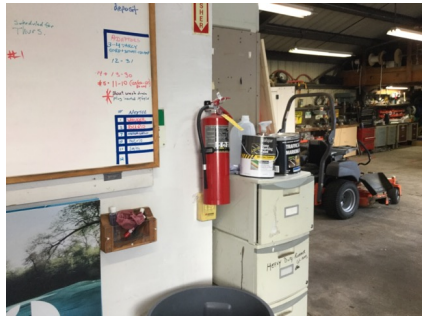
| 476 | <ul style="list-style-type: none"> <i>As-Built Description:</i> Reach height to control or access point, exceeds 48" or is less than 15". <i>As-Built:</i> FE: 62" high <i>Proposed Solution:</i> Modify equipment or mounting. | <p>PCODE IE01 ADAAG 91 4.2.5 ADA 2010 308.2.1 CBC 2007 1118B.5 CBC 2016 11B-308.2.1</p> <p>Priority 4 Severity 2</p> | 1 | JOB | \$100 | \$100 |

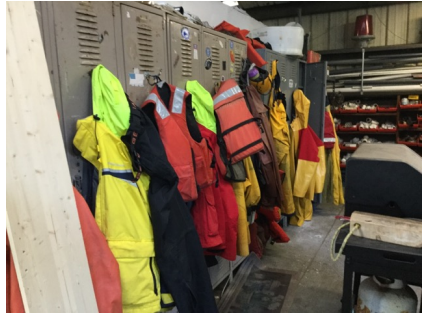
| Item No. and Name | Existing Architectural Barrier and Proposed Solution | Codes / Mitigation Info | Qty | Unit | Cost | Total |
|---|---|--|---|---|---|---|
| 478 | <ul style="list-style-type: none"> <i>As-Built Description:</i> Reach height to control or access point, exceeds 48" or is less than 15". <i>As-Built:</i> 64" high CH on lockers <i>Proposed Solution:</i> Modify equipment or mounting. | <p>PCODE IE01 ADAAG 91 4.2.5 ADA 2010 308.2.1 CBC 2007 1118B.5 CBC 2016 11B-308.2.1</p> <p>Priority 4 Severity 2</p> | 1 | JOB | \$100 | \$100 |

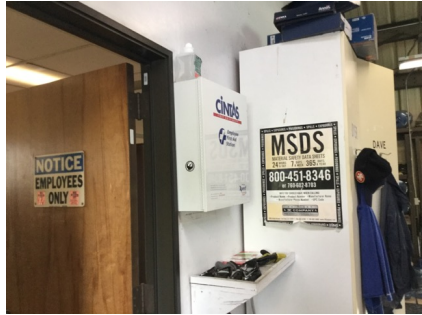
| Item No. and Name | Existing Architectural Barrier and Proposed Solution | Codes / Mitigation Info | Qty | Unit | Cost | Total |
|---|---|--|---|---|---|---|
| 481 | <ul style="list-style-type: none"> <i>As-Built Description:</i> Reach height to control or access point, exceeds 48" or is less than 15". <i>As-Built:</i> First aid kit: 60-77" high <i>Proposed Solution:</i> Modify equipment or mounting. | <p>PCODE IE01 ADAAG 91 4.2.5 ADA 2010 308.2.1 CBC 2007 1118B.5 CBC 2016 11B-308.2.1</p> <p>Priority 4 Severity 1</p> | 1 | JOB | \$100 | \$100 |

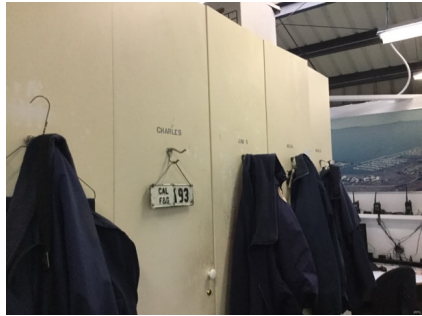
| Item No. and Name | Existing Architectural Barrier and Proposed Solution | Codes / Mitigation Info | Qty | Unit | Cost | Total |
|---|---|--|---|---|---|---|
| 487 | <ul style="list-style-type: none"> <i>As-Built Description:</i> Reach height to control or access point, exceeds 48" or is less than 15". <i>As-Built:</i> 68.5" high CH <i>Proposed Solution:</i> Modify equipment or mounting. | <p>PCODE IE01 ADAAG 91 4.2.5 ADA 2010 308.2.1 CBC 2007 1118B.5 CBC 2016 11B-308.2.1</p> <p>Priority 4 Severity 1</p> | 1 | JOB | \$100 | \$100 |

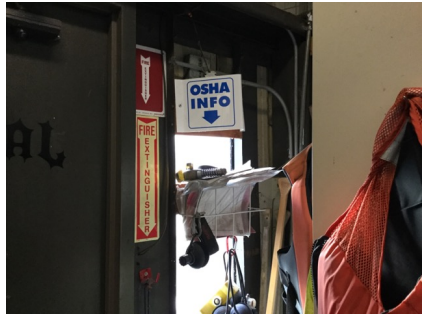
| Item No. and Name | Existing Architectural Barrier and Proposed Solution | Codes / Mitigation Info | Qty | Unit | Cost | Total |
|---|---|--|---|---|---|---|
| 486 | <ul style="list-style-type: none"> <i>As-Built Description:</i> Information brochure bins mounted above accessible height of 48". <i>As-Built:</i> 63" high OSHA info <i>Proposed Solution:</i> Relocate/remount bins at accessible height. | <p>PCODE IN08 ADAAG 91 4.2.5 & 6 ADA 2010 308.2.1 CBC 2007 1118B.5 CBC 2016 11B-308.2.1</p> <p>Priority 4 Severity 2</p> | 1 | JOB | \$100 | \$100 |

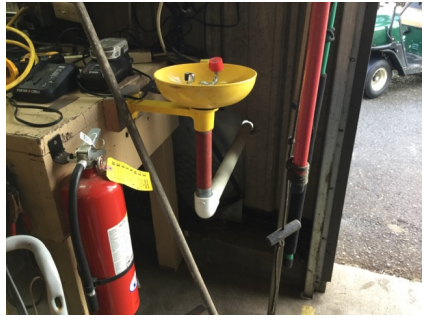
| Item No. and Name | Existing Architectural Barrier and Proposed Solution | Codes / Mitigation Info | Qty | Unit | Cost | Total |
|---|---|--|---|---|---|---|
| 480 | <ul style="list-style-type: none"> <i>As-Built Description:</i> Wheelchair space at sink not provided. <i>As-Built:</i> Stored items block use of eyewash station <i>Proposed Solution:</i> Modify as needed to provide wheelchair space. | <p>PCODE CF01 ADAAG 91 4.24.3 ADA 2010 606.2 CBC 2016 11B-606.2</p> <p>Priority 4 Severity 4</p> | 1 | JOB | \$1,400 | \$1,400 |

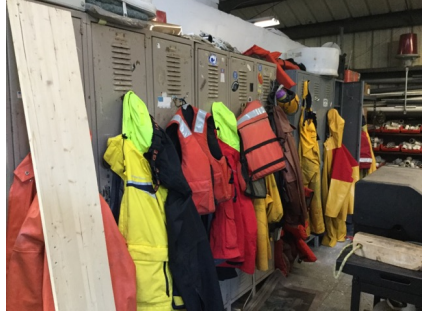
| 477 | <ul style="list-style-type: none"> <i>As-Built Description:</i> Lockers not at proper height for disabled persons (maximum height 40" to hooks, shelves, etc.). <i>Proposed Solution:</i> Make hook/shelf height comply with 40" maximum. Notes: 10 lockers Ensure mounted at accessible heights | <p>PCODE GG02 ADA 2010 803.5 CBC 2007 1118B.5 CBC 2016 11B-803.5</p> <p>Priority 4 Severity 3</p> | 1 | JOB | \$450 | \$450 |

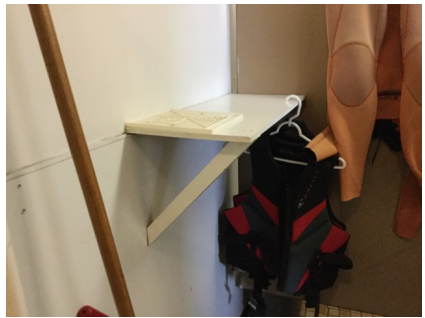
| 505 | <ul style="list-style-type: none"> <i>As-Built Description:</i> Protruding objects more than 4" from wall, when bottom of object more than 27" or less than 80" above finished floor. <i>As-Built:</i> Shelf: 12" at 48" high <i>Proposed Solution:</i> Remove/relocate protruding object. Patch existing surface. | <p>PCODE EG04 ADAAG 91 4.4.1 ADA 2010 307.2 CBC 2007 1133B.8.6.1 CBC 2016 11B-307.2</p> <p>Priority 4 Severity 1</p> | 1 | JOB | \$100 | \$100 |

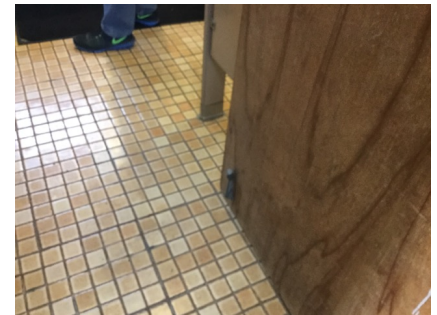
| 488 | <ul style="list-style-type: none"> • <i>As-Built Description:</i> At push side of door on accessible route, bottom 10" does not have a smooth, uninterrupted surface. • <i>Proposed Solution:</i> Remove door stopper when altering area. Provide rubber wedge. | <p>PCODE ID06A ADA 2010 404.2.10 CBC 2007 1133B.2.6 CBC 2016 11B-404.2.10</p> <p>Priority 4 Severity 3</p> | 1 | JOB | \$25 | \$25 |

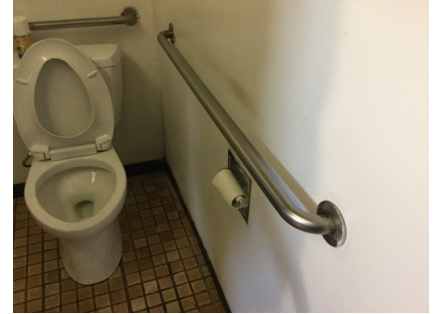
| 497 | <ul style="list-style-type: none"> <i>As-Built Description:</i> Side grab bar less than 42" long, or located more than 12 inches max. from the rear wall, or extending less than 54" from rear wall (CA only: front end min. 24" in front of water closet). <i>As-Built:</i> 42" at 53.5" <i>Proposed Solution:</i> Provide or relocate accessible side grab bar. | <p>PCODE WB07A ADAAG 91 Fig. 29(b) ADA 2010 604.5.1 CBC 2007 1115B.4.1.3.1 CBC 2016 11B-604.5.1</p> <p>Priority 4 Severity 4</p> | 1 | JOB | \$260 | \$260 |

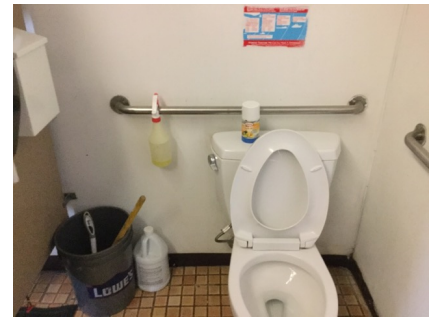
| 498 | <ul style="list-style-type: none"> <i>As-Built Description:</i> The rear wall grab is less than 36" min. or does not extend from the centerline of the water closet 12" min. on one side and 24" min. on the other side. <i>As-Built:</i> 23" on wide side <i>Proposed Solution:</i> Provide or relocate accessible rear grab bar. | <p>PCODE WB07B ADAAG 91 4.17.6 ADA 2010 604.5.2 CBC 2007 1115B.4.1.3.2 CBC 2016 11B-604.5.2</p> <p>Priority 4 Severity 4</p> | 1 | JOB | \$340 | \$340 |

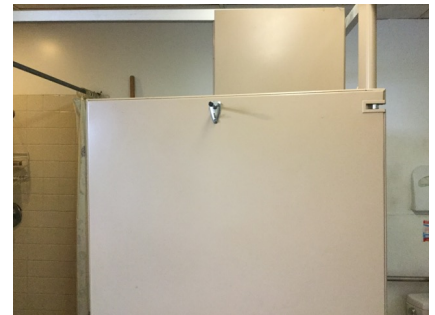
| 492 | <ul style="list-style-type: none"> <i>As-Built Description:</i> Stall door to accessible compartment not self closing. <i>Proposed Solution:</i> Adjust closer. | <p>PCODE WB05B ADAAG 91 4.22.4 ADA 2010 604.8.1.2 CBC 2007 1115B.3.1.4.4 CBC 2016 11B-604.8.1.2</p> <p>Priority 4 Severity 4</p> | 1 | JOB | \$25 | \$25 |

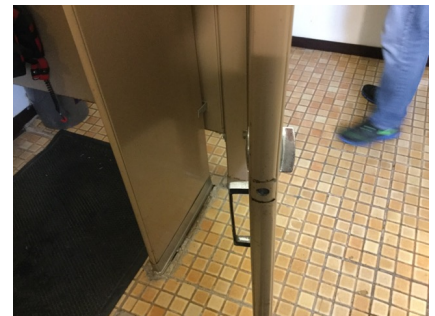
| 493 | <ul style="list-style-type: none"> <i>As-Built Description:</i> Stall door does not have accessible operating hardware (U-pulls on both sides, flip-over or sliding lock). <i>As-Built:</i> U-pull only on one side <i>Proposed Solution:</i> Provide new accessible locking hardware that does not require grasping, pinching, or twisting and U-pulls on both sides. | <p>PCODE WB05C ADAAG 91 4.17.5 ADA 2010 604.8.1.2 CBC 2007 1115B.3.1.4.5 CBC 2016 11B-604.8.1.2</p> <p>Priority 4 Severity 3</p> | 1 | JOB | \$100 | \$100 |

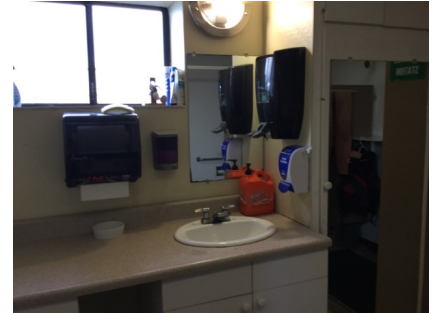
| Item No. and Name | Existing Architectural Barrier and Proposed Solution | Codes / Mitigation Info | Qty | Unit | Cost | Total |
|---|---|---|---|---|---|---|
| 491 | <ul style="list-style-type: none"> <i>As-Built Description:</i> Bottom of flat, not tilted mirror located above lavatories or countertops more than 40" above floor. <i>As-Built:</i> 44" high <i>Proposed Solution:</i> Relocate or provide new accessible mirror. | PCODE WG03 ADAAG 91 4.19.6 ADA 2010 603.3 CBC 2007 1115B.8.1 CBC 2016 11B-603.3 Priority 4 Severity 4 | 1 | JOB | \$150 | \$150 |

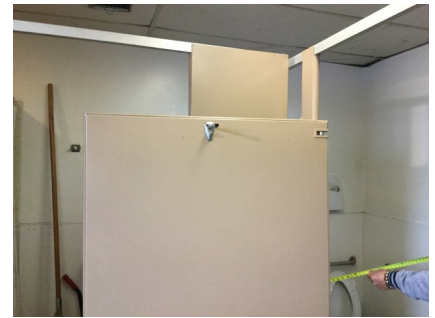
| 494 | <ul style="list-style-type: none"> <i>As-Built Description:</i> Accessible coat hook not within reach range. <i>As-Built:</i> 68" high CH <i>Proposed Solution:</i> Adjust existing or provide new coat hook at maximum 48" height. | PCODE WG03A ADAAG 91 4.2.5 ADA 2010 603.4 CBC 2007 1118B.5 CBC 2016 11B-603.4 Priority 4 Severity 1 | 1 | JOB | \$50 | \$50 |

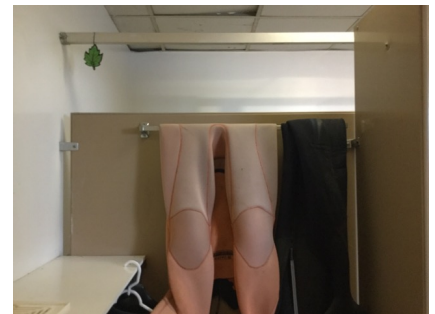
| 506 | <ul style="list-style-type: none"> <i>As-Built Description:</i> Accessible coat hook not within reach range. <i>As-Built:</i> 68" high CH <i>Proposed Solution:</i> Adjust existing or provide new coat hook at maximum 48" height. | PCODE WG03A ADAAG 91 4.2.5 ADA 2010 603.4 CBC 2007 1118B.5 CBC 2016 11B-603.4 Priority 4 Severity 1 | 1 | JOB | \$50 | \$50 |

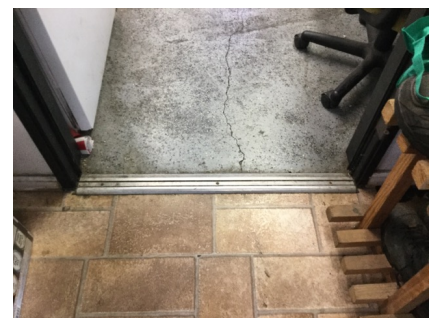
| 508 | <ul style="list-style-type: none"> <i>As-Built Description:</i> Door inaccessible due to threshold or step at door exceeding 1/2". <i>As-Built:</i> 0.5" threshold <i>Proposed Solution:</i> Modify threshold to be no more than 1/2" by removing existing paving at door and providing landing with edge ramping (slope 1:20 max). | PCODE ID02A ADAAG 91 4.13.8 ADA 2010 404.2.5 CBC 2007 1133B.2.4.1 CBC 2016 11B-404.2.5 Priority 4 Severity 4 | 1 | JOB | \$400 | \$400 |

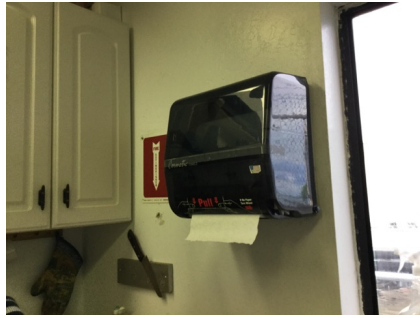
| 511 | <ul style="list-style-type: none"> As-Built Description: Reach height to control or access point, exceeds 48" or is less than 15". As-Built: PTD: 60" high Proposed Solution: Modify equipment or mounting. | <p>PCODE IE01 ADAAG 91 4.2.5 ADA 2010 308.2.1 CBC 2007 1118B.5 CBC 2016 11B-308.2.1</p> <p>Priority 4 Severity 2</p> | 1 | JOB | \$100 | \$100 |

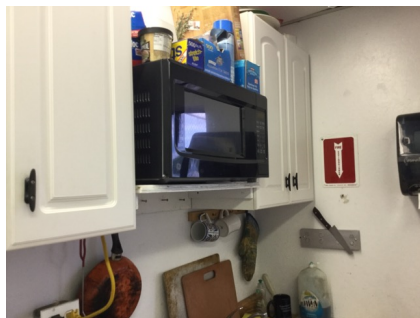
| 512 | <ul style="list-style-type: none"> As-Built Description: Reach height to control or access point, exceeds 48" or is less than 15". As-Built: Microwave: 72" high Proposed Solution: Modify equipment or mounting. | <p>PCODE IE01 ADAAG 91 4.2.5 ADA 2010 308.2.1 CBC 2007 1118B.5 CBC 2016 11B-308.2.1</p> <p>Priority 4 Severity 1</p> | 1 | JOB | \$100 | \$100 |

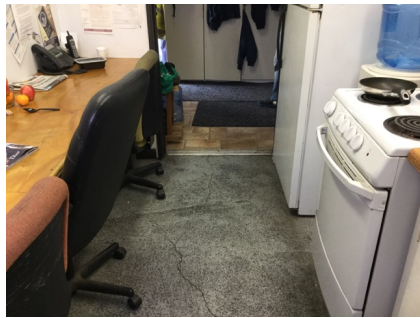
| 513 | <ul style="list-style-type: none"> As-Built Description: Corridor less than 44" wide when occupant load 10 or more. As-Built: 39" wide Proposed Solution: Enlarge or modify corridor to 44" wide. | <p>PCODE IH01 ADAAG 91 4.3.3 ADA 2010 403.5.1 CBC 2007 1133B.3.1 CBC 2016 11B-403.5.1</p> <p>Priority 4 Severity 3</p> | 10 | LF | \$105 | \$1,050 |

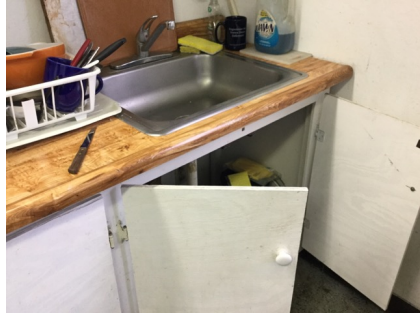
| 509 | <ul style="list-style-type: none"> As-Built Description: Sink rim higher than 34" above floor. As-Built: 37" high Proposed Solution: Remodel sink cabinet to lower sink. | <p>PCODE IN06 ADAAG 91 4.24.2 ADA 2010 606.3 CBC 2007 1115B.4.7.1 CBC 2016 11B-606.3</p> <p>Priority 4 Severity 4</p> | 1 | JOB | \$1,750 | \$1,750 |

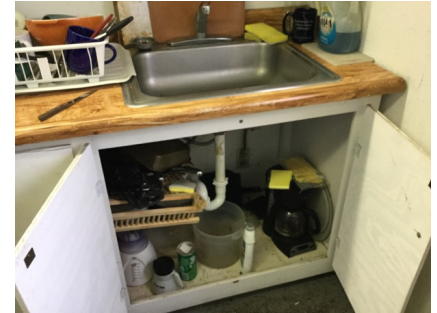
| Item No. and Name | Existing Architectural Barrier and Proposed Solution | Codes / Mitigation Info | Qty | Unit | Cost | Total |
|---|---|--|---|---|---|---|
| 510 | <ul style="list-style-type: none"> <i>As-Built Description:</i> Sink does not have knee space min. 27" high x 19" deep x 30" wide. <i>As-Built:</i> No knee space <i>Proposed Solution:</i> Remodel sink cabinet. | <p>PCODE IN06AREF</p> <p>ADAAG 91 4.24.3</p> <p>ADA 2010 606.2</p> <p>CBC 2007 1115B.4.7.1</p> <p>CBC 2016 11B-606.2</p> <p>Priority 4</p> <p>Severity 2</p> | | | | |

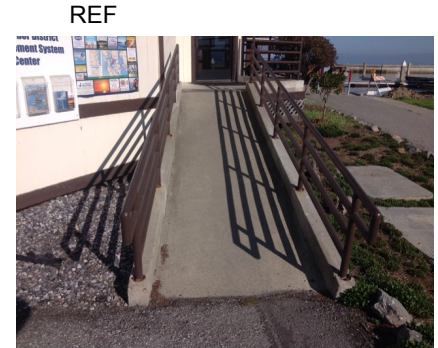
| 11 | <ul style="list-style-type: none"> As-Built Description: Slope greater than 1:12 (8.3%). As-Built: 18.9% Proposed Solution: Demolish existing and provide new ramp with handrails. | PCODE EB02 | 250 | SF | \$100 | \$25,000 |

Mitigation Project:
 Replace Harbormaster Building
Estimated Completion Date:
 2020-2021

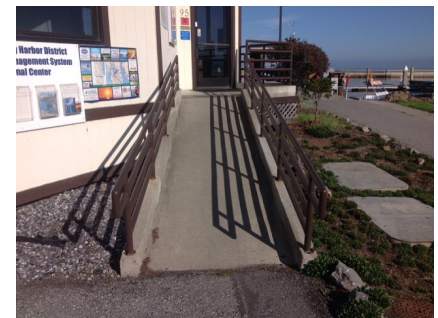
| 12 | <ul style="list-style-type: none"> As-Built Description: Level 2% max. landing for ramp not provided. As-Built: Highly irregular surface Proposed Solution: Rebuild ramp to provide landings for each ramp run with slopes no greater than 2% | PCODE EB05ANT | 30 | SF | \$100 | \$3,000 |

Mitigation Project:
 Replace Harbormaster Building
Estimated Completion Date:
 2020-2021

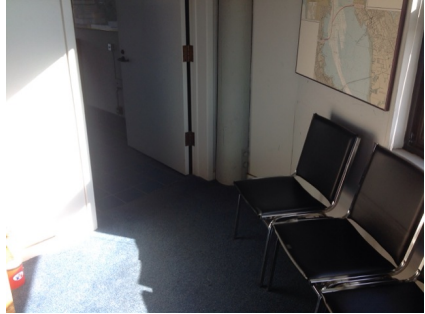
| Item No. and Name | Existing Architectural Barrier and Proposed Solution | Codes / Mitigation Info | Qty | Unit | Cost | Total |
|---|--|--|---|---|---|---|
| 25 | <ul style="list-style-type: none"> <i>As-Built Description:</i> Front approach: At push side, door does not have clear and level maneuvering space measuring door width x 48" (door width plus 12" if door has both, latch and closer). <i>Proposed Solution:</i> Remove or relocate furniture or storage items. | <p>PCODE ID24AREF ADAAG 91 Fig. 25(a) ADA 2010 404.2.4 CBC 2007 11B-26A(a) CBC 2016 11B-404.2.4</p> <p>Priority 2 Severity 4</p> <p>Mitigation Project: Replace Harbormaster Building</p> <p>Estimated Completion Date: 2020-2021</p> | | | | |

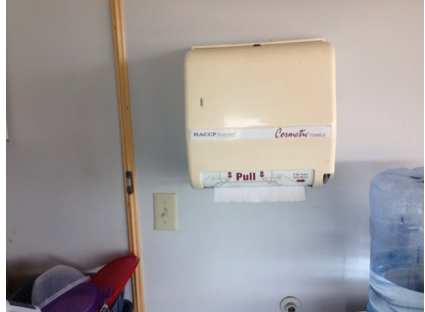
| Item No. and Name | Existing Architectural Barrier and Proposed Solution | Codes / Mitigation Info | Qty | Unit | Cost | Total |
|---|--|--|---|---|---|---|
| 28 | <ul style="list-style-type: none"> <i>As-Built Description:</i> Reach height to control or access point, exceeds 48" or is less than 15". <i>As-Built:</i> PTD: 52" high <i>Proposed Solution:</i> Modify equipment or mounting. | <p>PCODE IE01 ADAAG 91 4.2.5 ADA 2010 308.2.1 CBC 2007 1118B.5 CBC 2016 11B-308.2.1</p> <p>Priority 2 Severity 4</p> <p>Mitigation Project: Replace Harbormaster Building</p> <p>Estimated Completion Date: 2020-2021</p> | 1 | JOB | \$100 | \$100 |

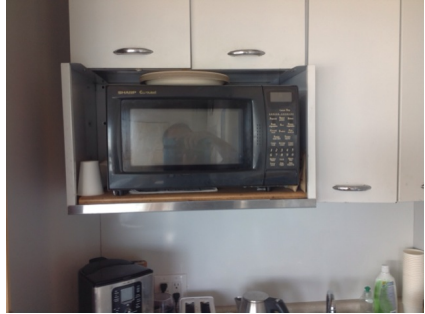
| Item No. and Name | Existing Architectural Barrier and Proposed Solution | Codes / Mitigation Info | Qty | Unit | Cost | Total |
|---|--|--|---|---|---|---|
| 29 | <ul style="list-style-type: none"> <i>As-Built Description:</i> Reach height to control or access point, exceeds 48" or is less than 15". <i>As-Built:</i> Microwave: 68" high <i>Proposed Solution:</i> Modify equipment or mounting. | <p>PCODE IE01 ADAAG 91 4.2.5 ADA 2010 308.2.1 CBC 2007 1118B.5 CBC 2016 11B-308.2.1</p> <p>Priority 2 Severity 1</p> <p>Mitigation Project: Replace Harbormaster Building</p> <p>Estimated Completion Date: 2020-2021</p> | 1 | JOB | \$100 | \$100 |

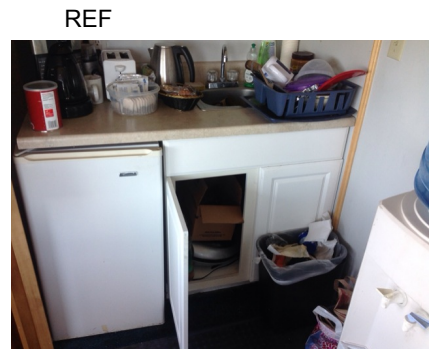
- 26 • *As-Built Description:*
Sink does not have knee space min. 27" high x 19" deep x 30" wide.
- *As-Built:* **No knee space**
- *Proposed Solution:*
Remodel sink cabinet.

Mitigation Project:
 Replace Harbormaster Building
Estimated Completion Date:
 2020-2021

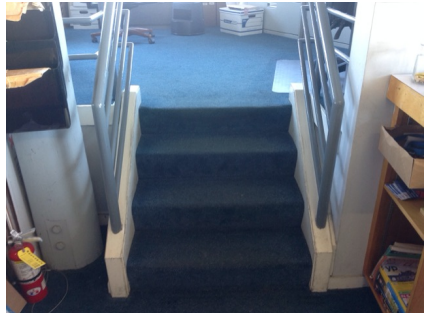
| Item No. and Name | Existing Architectural Barrier and Proposed Solution | Codes / Mitigation Info | Qty | Unit | Cost | Total |
|---|---|--|---|---|---|---|
| 31 | <ul style="list-style-type: none"> <i>As-Built Description:</i> The leading 2" of the tread does not have visual contrast of dark-on-light or light-on-dark from the remainder of the tread. <i>Proposed Solution:</i> Provide 2" min., 4" max. wide contrasting color strip 1" max. from nosing on top & bottom treads when altering area. | PCODE II02B ADA 2010 504.4 CBC 2007 1133B.4.4 CBC 2016 11B-504.4.1 Priority 4 Severity 3 Mitigation Project: Replace Harbormaster Building Estimated Completion Date: 2020-2021 | 6 | LF | \$14 | \$84 |

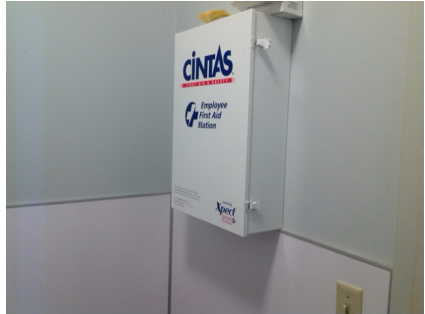
| 46 | <ul style="list-style-type: none"> <i>As-Built Description:</i> Protruding objects more than 4" from wall, when bottom of object more than 27" or less than 80" above finished floor. <i>As-Built:</i> First aid kit: 6" at 53" high <i>Proposed Solution:</i> Remove/relocate protruding object. Patch existing surface. | PCODE EG04 ADAAG 91 4.4.1 ADA 2010 307.2 CBC 2007 1133B.8.6.1 CBC 2016 11B-307.2 Priority 4 Severity 3 Mitigation Project: Replace Harbormaster Building Estimated Completion Date: 2020-2021 | 1 | JOB | \$100 | \$100 |

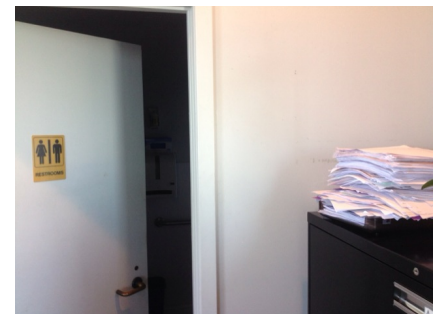
| 35 | <ul style="list-style-type: none"> <i>As-Built Description:</i> Entrance to toilet or bathing facility not identified with ADAAG compliant signage. <i>As-Built:</i> No latch sign <i>Proposed Solution:</i> Provide ADAAG compliant sign mounted 5' high on center on nearest adjacent wall, on latch side of a single door (located not to cause a Braille reader to stand within the door swing). | <p>PCODE SA11A ADAAG 91 4.1.3(16)(a) ADA 2010 216.8 CBC 2016 11B-216.8</p> <p>Priority 4 Severity 3</p> <p>Mitigation Project: Replace Harbormaster Building</p> <p>Estimated Completion Date: 2020-2021</p> | 1 | JOB | \$90 | \$90 |

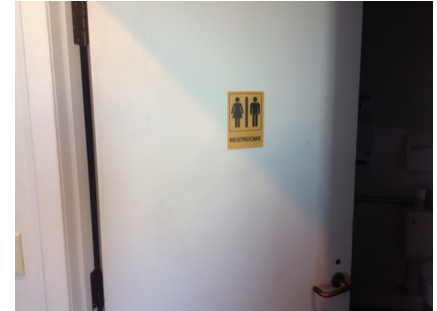
| Item No. and Name | Existing Architectural Barrier and Proposed Solution | Codes / Mitigation Info | Qty | Unit | Cost | Total |
|---|--|--|---|---|---|---|
| 36 | <ul style="list-style-type: none"> <i>As-Built Description:</i> Required in CA only: identification symbol centered 58" to 60" high on sanitary facility door that contrasts with the door not provided (women: 12" ø circle, men: 12" triangle, unisex: combined symbol). <i>As-Built:</i> Not geometric <i>Proposed Solution:</i> Provide properly mounted sanitary facility symbol when altering area. If wheelchair accessible, include International Symbol of Accessibility on sign. | <p>PCODE SA15</p> <p>CBC 2007 1115B.6</p> <p>CBC 2016 11B-703.7.2.6</p> <p>Priority 4</p> <p>Severity 3</p> <p>Mitigation Project: <i>Replace Harbormaster Building</i></p> <p>Estimated Completion Date: <i>2020-2021</i></p> | 1 | JOB | \$90 | \$90 |

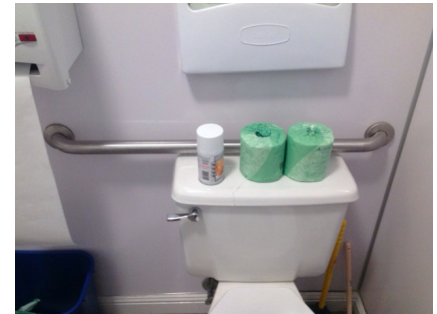
| 43 | <ul style="list-style-type: none"> <i>As-Built Description:</i> The rear wall grab is less than 36" min. or does not extend from the centerline of the water closet 12" min. on one side and 24" min. on the other side. <i>As-Built:</i> 21" on wide side <i>Proposed Solution:</i> Provide or relocate accessible rear grab bar. | <p>PCODE WB07B</p> <p>ADAAG 91 4.17.6</p> <p>ADA 2010 604.5.2</p> <p>CBC 2007 1115B.4.1.3.2</p> <p>CBC 2016 11B-604.5.2</p> <p>Priority 4</p> <p>Severity 3</p> <p>Mitigation Project: <i>Replace Harbormaster Building</i></p> <p>Estimated Completion Date: <i>2020-2021</i></p> | 1 | JOB | \$340 | \$340 |

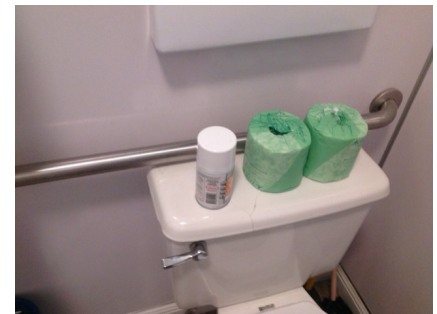
| 44 | <ul style="list-style-type: none"> <i>As-Built Description:</i> Accessories/dispensers in accessible stall located closer than 1-1/2" below or 12" above grab bar impedes its use. <i>As-Built:</i> Tank toilet 0.5" below RGB SCD 7.5" above RGB <i>Proposed Solution:</i> Relocate accessories/dispensers to be no closer than 1-1/2" below and 12" above grab bars (except if accessories are recessed, flush with wall, and have no sharp edges). | <p>PCODE WB07I</p> <p>ADAAG 91 4.26.2</p> <p>ADA 2010 609.3</p> <p>CBC 2007 1133B.4.2.5</p> <p>CBC 2016 11B-609.3</p> <p>Priority 4</p> <p>Severity 4</p> <p>Mitigation Project: <i>Replace Harbormaster Building</i></p> <p>Estimated Completion Date: <i>2020-2021</i></p> | 1 | JOB | \$75 | \$75 |

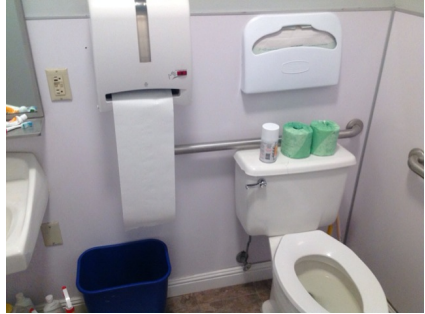
| Item No. and Name | Existing Architectural Barrier and Proposed Solution | Codes / Mitigation Info | Qty | Unit | Cost | Total |
|---|---|--|---|---|---|---|
| 42 | <ul style="list-style-type: none"> • <i>As-Built Description:</i> 60" min. clearance around a water closet measured perpendicular from the side wall not provided (Fixtures are not allowed to overlap this clearance). • <i>As-Built:</i> 56.5" from side wall to lavatory • <i>Proposed Solution:</i> Remove adjacent fixture and provide new enclosure at accessible water closet. | <p>PCODE WB01A ADA 2010 604.3.1; 604.3.2 CBC 2007 1115B.7.1.3 CBC 2016 11B-604.3.1; 11B-604.3.2</p> <p>Priority 4 Severity 4</p> <p>Mitigation Project: Replace Harbormaster Building</p> <p>Estimated Completion Date: 2020-2021</p> | 1 | JOB | \$2,000 | \$2,000 |

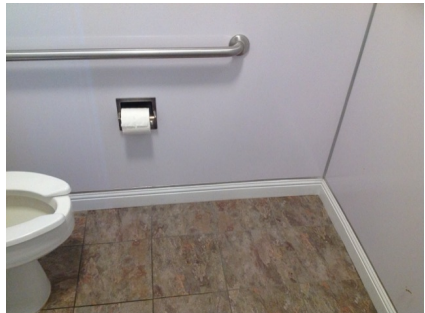
| Item No. and Name | Existing Architectural Barrier and Proposed Solution | Codes / Mitigation Info | Qty | Unit | Cost | Total |
|---|---|--|---|---|---|---|
| 45 | <ul style="list-style-type: none"> • <i>As-Built Description:</i> CA only: In single-accommodation restroom less than 48" in front of water closet provided. • <i>As-Built:</i> 45" in front • <i>Proposed Solution:</i> Remodel restroom to provide at least 48" in front of water closet. | <p>PCODE WB03A CBC 2007 1115B.3.2.1 CBC 2016 11B-604.3.1</p> <p>Priority 4 Severity 4</p> <p>Mitigation Project: Replace Harbormaster Building</p> <p>Estimated Completion Date: 2020-2021</p> | 1 | JOB | \$5,000 | \$5,000 |

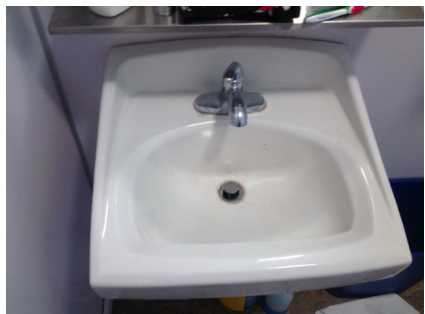
| Item No. and Name | Existing Architectural Barrier and Proposed Solution | Codes / Mitigation Info | Qty | Unit | Cost | Total |
|---|---|--|---|---|---|---|
| 39 | <ul style="list-style-type: none"> • <i>As-Built Description:</i> Clear floor space, 30" x 48" in front of fixture, extending 19" max. under the lavatory, not provided (CA only: Less than 18" from side wall to centerline of lavatory). • <i>As-Built:</i> 14.5" o.c. • <i>Proposed Solution:</i> Relocate existing lavatory. | <p>PCODE WD01A ADAAG 91 4.19.3 ADA 2010 606.2 CBC 2007 1115B.4.3 CBC 2016 11B-606.2, 11B-606.6</p> <p>Priority 4 Severity 2</p> <p>Mitigation Project: Replace Harbormaster Building</p> <p>Estimated Completion Date: 2020-2021</p> | 1 | JOB | \$900 | \$900 |

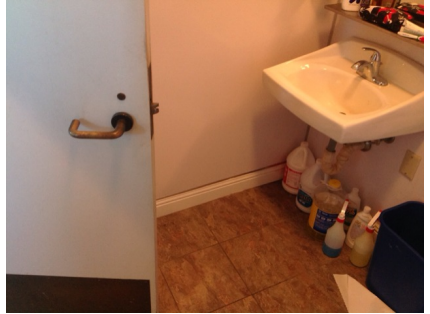
| Item No. and Name | Existing Architectural Barrier and Proposed Solution | Codes / Mitigation Info | Qty | Unit | Cost | Total |
|---|--|---|---|---|---|---|
| 49 | <ul style="list-style-type: none"> <i>As-Built Description:</i> Clear floor space, 30" x 48" in front of fixture, extending 19" max. under the lavatory, not provided (CA only: Less than 18" from side wall to centerline of lavatory). <i>As-Built:</i> Clear space to lavatory potentially obstructed by door swing. <i>Proposed Solution:</i> Change door swing. | <p>PCODE WD01NT</p> <p>ADAAG 91 4.19.3</p> <p>ADA 2010 606.2</p> <p>CBC 2007 1115B.4.3</p> <p>CBC 2016 11B-606.2, 11B-606.6</p> <p>Priority 4</p> <p>Severity 2</p> <p>Mitigation Project: <i>Replace Harbormaster Building</i></p> <p>Estimated Completion Date: <i>2020-2021</i></p> | 1 | JOB | \$460 | \$460 |

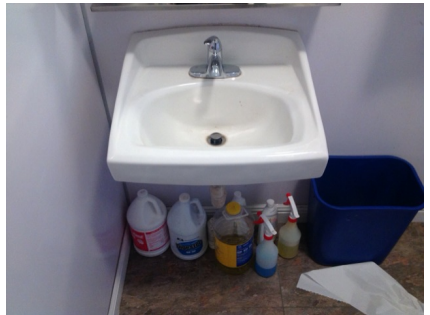
| Item No. and Name | Existing Architectural Barrier and Proposed Solution | Codes / Mitigation Info | Qty | Unit | Cost | Total |
|---|--|---|---|---|---|---|
| 38 | <ul style="list-style-type: none"> <i>As-Built Description:</i> Knee clearance 27" min. high starting 8" back from the front edge of the lavatory towards the wall is not provided. <i>As-Built:</i> 25.5" <i>Proposed Solution:</i> Remount compliant fixture to accessible height. | <p>PCODE WD04A</p> <p>ADAAG 91 Fig. 31</p> <p>ADA 2010 306.3.3</p> <p>CBC 2007 1115B.4.3</p> <p>CBC 2016 11B-306.3.3</p> <p>Priority 4</p> <p>Severity 2</p> <p>Mitigation Project: <i>Replace Harbormaster Building</i></p> <p>Estimated Completion Date: <i>2020-2021</i></p> | 1 | JOB | \$1,500 | \$1,500 |

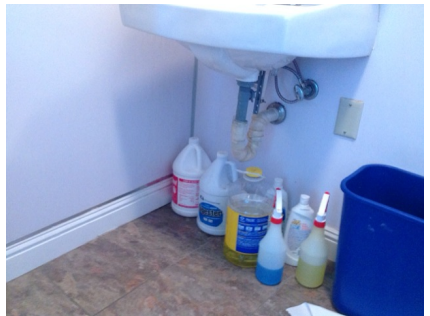
| Item No. and Name | Existing Architectural Barrier and Proposed Solution | Codes / Mitigation Info | Qty | Unit | Cost | Total |
|---|--|---|---|---|---|---|
| 50 | <ul style="list-style-type: none"> <i>As-Built Description:</i> Hot or sharp-surfaced water/drain pipe not insulated or covered. <i>Proposed Solution:</i> Insulate or cover water/drain pipe. | <p>PCODE WD05</p> <p>ADAAG 91 4.19.4</p> <p>ADA 2010 606.5</p> <p>CBC 2007 1115B.4.3.4</p> <p>CBC 2016 11B-606.5</p> <p>Priority 4</p> <p>Severity 3</p> <p>Mitigation Project: <i>Replace Harbormaster Building</i></p> <p>Estimated Completion Date: <i>2020-2021</i></p> | 1 | JOB | \$120 | \$120 |

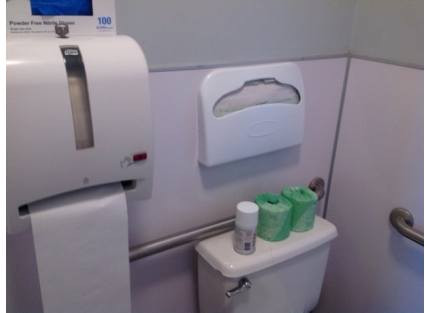
| Item No. and Name | Existing Architectural Barrier and Proposed Solution | Codes / Mitigation Info | Qty | Unit | Cost | Total |
|---|--|---|---|---|---|---|
| 41 | <ul style="list-style-type: none"> <i>As-Built Description:</i> Dispensers in sanitary facilities, such as for towels, soap, sanitary napkins, seat covers, etc., and waste receptacles more than 48" (CA only: 40") from floor to highest operating slot or control. <i>As-Built:</i> SD: 45" high SCD: 50" high <i>Proposed Solution:</i> Relocate existing restroom accessories. | <p>PCODE WG01A ADAAG 91 4.23.7 ADA 2010 308.2.1 CBC 2007 1115B.8.3 CBC 2016 11B-603.5</p> <p>Priority 4 Severity 3</p> <p>Mitigation Project: Replace Harbormaster Building</p> <p>Estimated Completion Date: 2020-2021</p> | 1 | JOB | \$100 | \$100 |

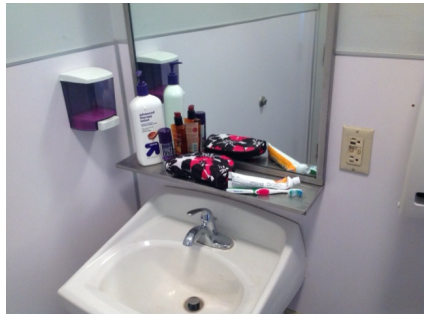
| Item No. and Name | Existing Architectural Barrier and Proposed Solution | Codes / Mitigation Info | Qty | Unit | Cost | Total |
|---|--|---|---|---|---|---|
| 40 | <ul style="list-style-type: none"> <i>As-Built Description:</i> Bottom of flat, not tilted mirror located above lavatories or countertops more than 40" above floor. <i>As-Built:</i> 40.5" high <i>Proposed Solution:</i> Relocate or provide new accessible mirror. | <p>PCODE WG03 ADAAG 91 4.19.6 ADA 2010 603.3 CBC 2007 1115B.8.1 CBC 2016 11B-603.3</p> <p>Priority 4 Severity 4</p> <p>Mitigation Project: Replace Harbormaster Building</p> <p>Estimated Completion Date: 2020-2021</p> | 1 | JOB | \$150 | \$150 |
