SAN MATEO COUNTY HARBOR DISTRICT

ADA Self-Evaluation and Transition Plan

August 2018

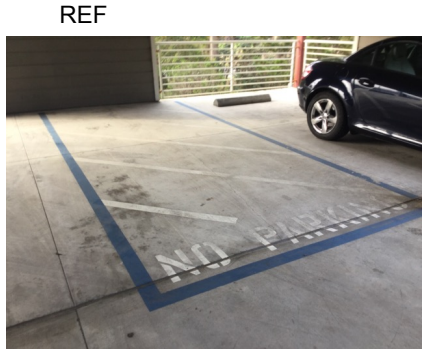
| 200 | <ul style="list-style-type: none"> <i>As-Built Description:</i> The words "NO PARKING" not painted on the ground within loading and unloading access aisle (12" min high white letters), located so that it is visible to traffic enforcement officials (required in CA only). <i>As-Built:</i> Slightly faded <i>Proposed Solution:</i> Provide the words "NO PARKING" in each access aisle, painted in 12" high letters, when altering area. | <p>PCODE EA04DREF ADA 2010 502.3.3 CBC 2007 1129B.3.1 CBC 2016 11B-502.3.3</p> <p>Priority 1 Severity 4</p> | | | | |

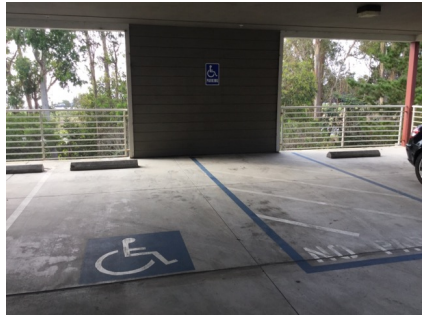
| 199 | <ul style="list-style-type: none"> <i>As-Built Description:</i> No van parking provided (one in every 6 or fraction of 6 accessible spaces, but not less than one). <i>As-Built:</i> Van space but not designated <i>Proposed Solution:</i> Provide van parking space(s) by restriping; provide van sign. | <p>PCODE EA07 ADAAG 91 4.1.2(5)(b) ADA 2010 208.2; 502.1 CBC 2007 1129B.3.2 CBC 2016 11B-208.2.4</p> <p>Priority 1 Severity 2</p> | 1 | JOB | \$350 | \$350 |

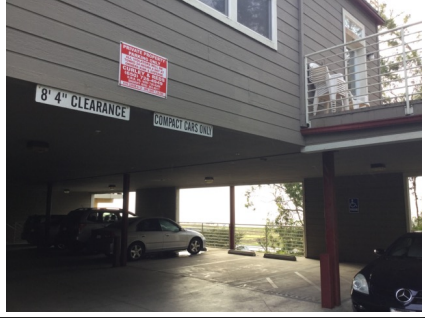
| 198 | <ul style="list-style-type: none"> <i>As-Built Description:</i> No "Tow Away" sign at parking lot entrance (required in CA only). <i>As-Built:</i> Sign does not mention disabled <i>Proposed Solution:</i> Provide "Tow Away" sign at parking lot entrance when altering area. | <p>PCODE EA04C CBC 2007 1129B.4 CBC 2016 11B-502.8.2</p> <p>Priority 1 Severity 4</p> | 1 | JOB | \$325 | \$325 |

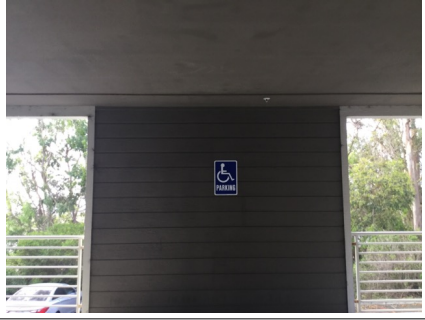
| 197 | <ul style="list-style-type: none"> <i>As-Built Description:</i> CA only: Additional Sign or additional language below the symbol of accessibility stating "Minimum Fine \$250" not provided. <i>Proposed Solution:</i> Provide compliant parking signage that includes fine information. | <p>PCODE EA04G CBC 2007 1129B.4 CBC 2016 11B-502.6.2</p> <p>Priority 1 Severity 4</p> | 1 | JOB | \$100 | \$100 |

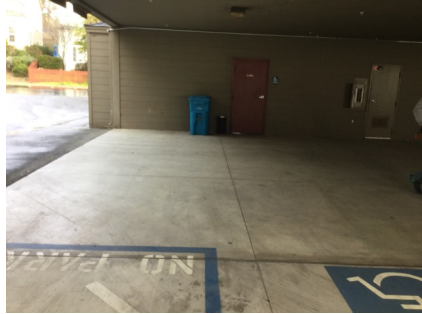
| Item No. and Name | Existing Architectural Barrier and Proposed Solution | Codes / Mitigation Info | Qty | Unit | Cost | Total |
|---|--|--|---|---|---|---|
| Detectable Warning | | | | | | |

| Item No. and Name | Existing Architectural Barrier and Proposed Solution | Codes / Mitigation Info | Qty | Unit | Cost | Total |
|---|--|--|---|---|---|---|
| 201 | <ul style="list-style-type: none"> <i>As-Built Description:</i> 36" wide band of truncated domes not provided at walkway or crossing adjoining a vehicular way, if surfaces are not separated by a curb, railing, or other element. <i>As-Built:</i> Provide DW on both ends from the entrance door to the parking aisle with a continuing marked aisle. <i>Proposed Solution:</i> Provide 36" wide, contrasting color, band of truncated domes between pedestrian and vehicular area. | <p><i>PCODE</i> EG09</p> <p><i>ADAAG 91</i> 4.29.5</p> <p><i>CBC 2007</i> 1133B.8.5</p> <p><i>CBC 2016</i> 11B-705.1.2.5</p> <p>Priority 1</p> <p>Severity 3</p> | 30 | LF | \$27 | \$810 |

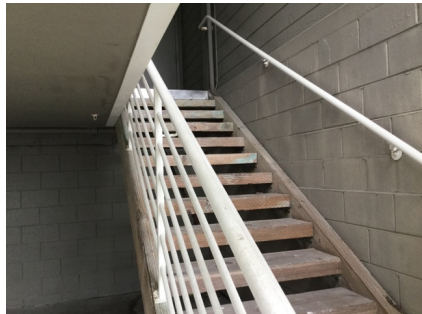
| Open Risers | | | | | | |

| 287 | <ul style="list-style-type: none"> <i>As-Built Description:</i> Stair does not have closed risers. <i>Proposed Solution:</i> Modify stair to have closed risers | <p><i>PCODE</i> EC03</p> <p><i>ADAAG 91</i> 4.9.2</p> <p><i>ADA 2010</i> 504.3</p> <p><i>CBC 2007</i> 1133B.4.5.3</p> <p><i>CBC 2016</i> 11B-504.3</p> <p>Priority 3</p> <p>Severity 3</p> | 15 | LF | \$36 | \$540 |

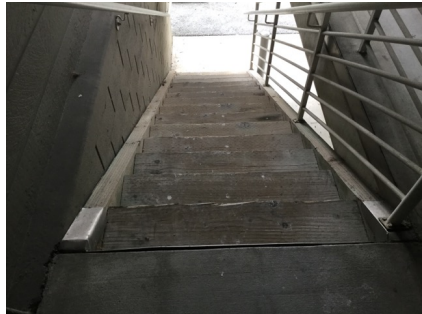
| Tread Surface | | | | | | |

| 285 | <ul style="list-style-type: none"> <i>As-Built Description:</i> The leading 2" of the tread does not have visual contrast of dark-on-light or light-on-dark from the remainder of the tread. <i>Proposed Solution:</i> Provide contrasting color strips at all exterior stair treads. | <p><i>PCODE</i> EC02</p> <p><i>ADA 2010</i> 504.4</p> <p><i>CBC 2007</i> 1133B.4.4</p> <p><i>CBC 2016</i> 11B-504.4.1</p> <p>Priority 3</p> <p>Severity 4</p> | 60 | LF | \$9 | \$540 |

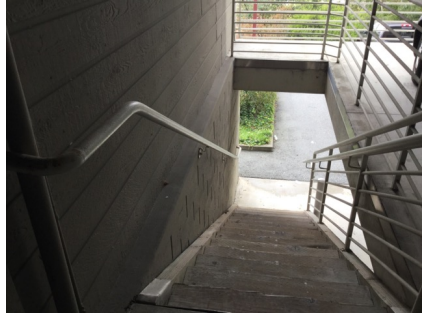
| Item No. and Name | Existing Architectural Barrier and Proposed Solution | Codes / Mitigation Info | Qty | Unit | Cost | Total |
|---|---|--|---|---|---|---|
| Top & Bottom Extension at Stairs | | | | | | |

| Item No. and Name | Existing Architectural Barrier and Proposed Solution | Codes / Mitigation Info | Qty | Unit | Cost | Total |
|---|---|--|---|---|---|---|
| 284 | <ul style="list-style-type: none"> <i>As-Built Description:</i> Stair handrail does not extend horizontally 12" minimum beyond top nosing, and one tread width sloped, plus 12" minimum horizontally beyond the bottom nosing. <i>As-Built:</i> 0-10" extensions <i>Proposed Solution:</i> Extend stair handrail at top and bottom (cost for each extension piece). | PCODE ED06 ADAAG 91 4.9.4(2) ADA 2010 505.10.2; 505.10.3 CBC 2007 1133B.4.2.2 CBC 2016 11B-505.10.2; 11B-505.10.3 Priority 3 Severity 2 | 3 | JOB | \$170 | \$510 |

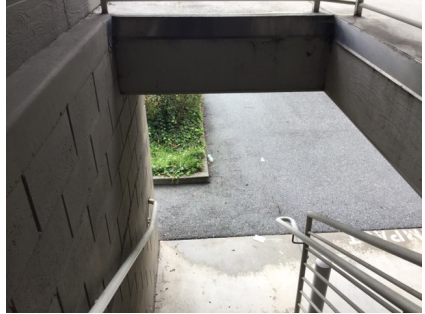
| Item No. and Name | Existing Architectural Barrier and Proposed Solution | Codes / Mitigation Info | Qty | Unit | Cost | Total |
|---|---|--|---|---|---|---|
| Vertical Clearance | | | | | | |

| Item No. and Name | Existing Architectural Barrier and Proposed Solution | Codes / Mitigation Info | Qty | Unit | Cost | Total |
|---|---|--|---|---|---|---|
| 286 | <ul style="list-style-type: none"> <i>As-Built Description:</i> Overhead clearance less than 80" above finished floor. <i>As-Built:</i> 76" high to ceiling <i>Proposed Solution:</i> Modify overhead clearance. Notes: Check feasibility of modifying | PCODE EG01REF ADAAG 91 4.4.2 ADA 2010 307.4 CBC 2007 1133B.8.6.2 CBC 2016 11B-307.4 Priority 3 Severity 2 | REF | | | |

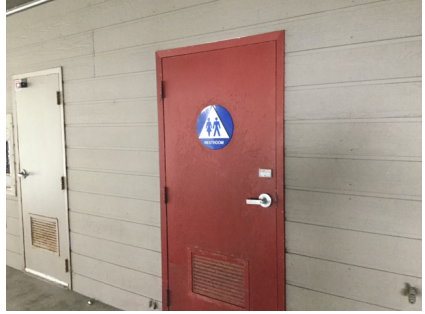
| Item No. and Name | Existing Architectural Barrier and Proposed Solution | Codes / Mitigation Info | Qty | Unit | Cost | Total |
|---|---|--|---|---|---|---|
| Existing Facility | | | | | | |

| Item No. and Name | Existing Architectural Barrier and Proposed Solution | Codes / Mitigation Info | Qty | Unit | Cost | Total |
|---|---|--|---|---|---|---|
| 282 | <ul style="list-style-type: none"> <i>As-Built Description:</i> At time of the survey, building is currently under construction and/or renovation. <i>Proposed Solution:</i> Ensure compliance with ADA and CBC Division 6. Notes: Restroom locked Verify who has access to restroom; Harbor District stated they did not have access. | PCODE XA01 ADAAG 91 4.1.6 CBC 2007 1134B.2.1 CBC 2016 11B-603.1 Priority 3 - | REF | | | |

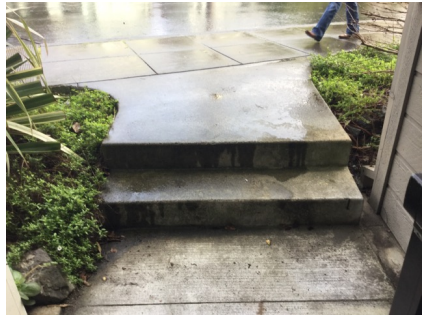
Ramps

| 3 | <ul style="list-style-type: none"> • <i>As-Built Description:</i> Ramp needed to provide disabled access at steps or change of level along path of travel. • <i>As-Built:</i> Requires a vehicle to access accessible entrance into parking lot safely. • <i>Proposed Solution:</i> Provide new concrete ramp with handrails [slope more than 1:20 (5.0%) needed]. • <i>Notes:</i> Access for wheelchair users from the sidewalk involves crossing into parking lot which has significantly steep grade at driveway. Recommend modifying stairs shown to provide a ramp as an accessible entrance instead. | <p><i>PCODE</i> EB01A <i>ADAAG 91</i> 4.1.1 <i>ADA 2010</i> 303.4 <i>CBC 2007</i> 1127B.1 <i>CBC 2016</i> 11B-303.4</p> <p>Priority 1 Severity 3</p> | 100 | SF | \$100 | \$10,000 |

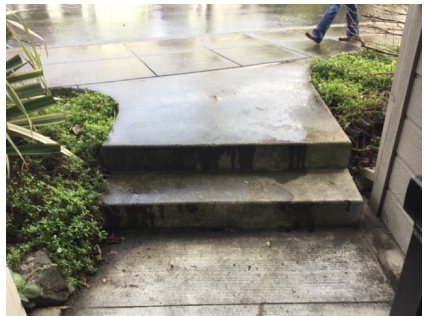
Tread Surface

| 207 | <ul style="list-style-type: none"> • <i>As-Built Description:</i> The leading 2" of the tread does not have visual contrast of dark-on-light or light-on-dark from the remainder of the tread. • <i>Proposed Solution:</i> Provide contrasting color strips at all exterior stair treads. | <p><i>PCODE</i> EC02 <i>ADA 2010</i> 504.4 <i>CBC 2007</i> 1133B.4.4 <i>CBC 2016</i> 11B-504.4.1</p> <p>Priority 1 Severity 4</p> | 10 | LF | \$9 | \$90 |

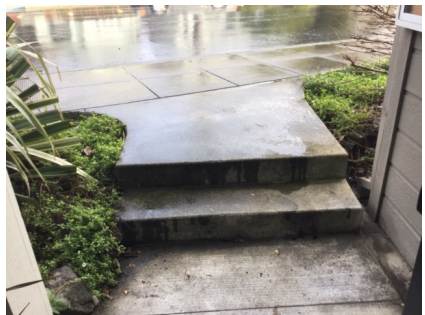
Handrails

| 206 | <ul style="list-style-type: none"> • <i>As-Built Description:</i> Handrail not provided at stairs or ramp, required on both sides (not required at curb ramps or adjacent to seating areas). • <i>Proposed Solution:</i> Provide new handrail for each side including extensions. | <p><i>PCODE</i> ED01 <i>ADAAG 91</i> 4.8.5 & 4.9.4 <i>ADA 2010</i> 505.2 <i>CBC 2007</i> 1133B.4.1.1 & .5.5 <i>CBC 2016</i> 11B-505.2</p> <p>Priority 1 Severity 2</p> | 8 | LF | \$95 | \$760 |

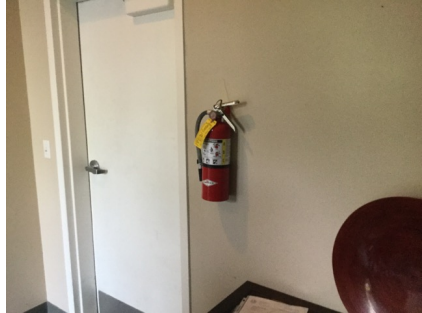
| Item No. and Name | Existing Architectural Barrier and Proposed Solution | Codes / Mitigation Info | Qty | Unit | Cost | Total |
|---|--|---|---|---|---|---|
| <u>Protrusion Limits</u> | | | | | | |

| Item No. and Name | Existing Architectural Barrier and Proposed Solution | Codes / Mitigation Info | Qty | Unit | Cost | Total |
|---|--|---|---|---|---|---|
| 208 | <ul style="list-style-type: none"> <i>As-Built Description:</i> Protruding objects more than 4" from wall, when bottom of object more than 27" or less than 80" above finished floor. <i>As-Built:</i> FE: 4.5" at 43" high <i>Proposed Solution:</i> Remove/relocate protruding object. Patch existing surface. | <p>PCODE EG04 ADAAG 91 4.4.1 ADA 2010 307.2 CBC 2007 1133B.8.6.1 CBC 2016 11B-307.2</p> <p>Priority 1 Severity 4</p> | 1 | JOB | \$100 | \$100 |

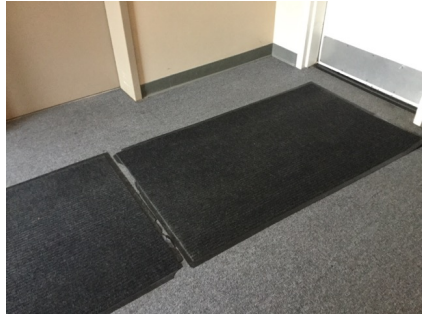
| Item No. and Name | Existing Architectural Barrier and Proposed Solution | Codes / Mitigation Info | Qty | Unit | Cost | Total |
|---|--|---|---|---|---|---|
| <u>Carpet/Doormat</u> | | | | | | |

| Item No. and Name | Existing Architectural Barrier and Proposed Solution | Codes / Mitigation Info | Qty | Unit | Cost | Total |
|---|--|---|---|---|---|---|
| 204 | <ul style="list-style-type: none"> <i>As-Built Description:</i> Doormat not securely attached to ground or floor structure. <i>Proposed Solution:</i> Attach doormat to floor surface or remove doormat. | <p>PCODE ID05A ADAAG 91 4.5.3 ADA 2010 302.2 CBC 2007 1124B.3 CBC 2016 11B-302.2</p> <p>Priority 1 Severity 3</p> | 1 | JOB | \$75 | \$75 |

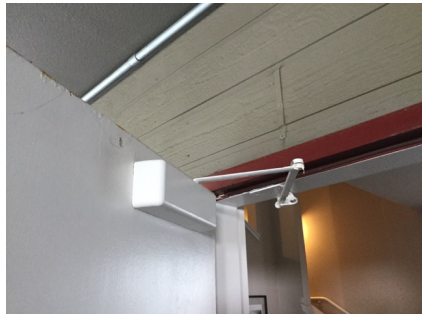
| Item No. and Name | Existing Architectural Barrier and Proposed Solution | Codes / Mitigation Info | Qty | Unit | Cost | Total |
|---|--|---|---|---|---|---|
| <u>Door Closer</u> | | | | | | |

| Item No. and Name | Existing Architectural Barrier and Proposed Solution | Codes / Mitigation Info | Qty | Unit | Cost | Total |
|---|--|---|---|---|---|---|
| 203 | <ul style="list-style-type: none"> <i>As-Built Description:</i> Excessive force required to open door. <i>As-Built:</i> 14 lbs <i>Proposed Solution:</i> Adjust regular door closer to accessible standards (5 lbs. max). | <p>PCODE ID03 ADAAG 91 4.13.11 ADA 2010 404.2.9 CBC 2007 1133B.2.5 CBC 2016 11B-404.2.9</p> <p>Priority 1 Severity 3</p> | 2 | JOB | \$25 | \$50 |

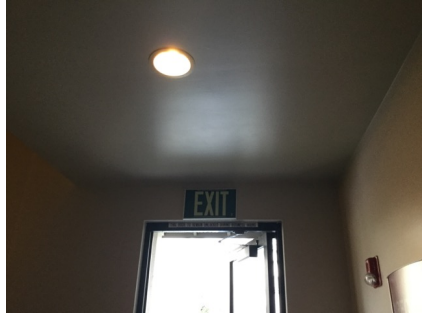
| Item No. and Name | Existing Architectural Barrier and Proposed Solution | Codes / Mitigation Info | Qty | Unit | Cost | Total |
|---|--|--|--|---|---|---|
| Signage | | | | | | |

| Item No. and Name | Existing Architectural Barrier and Proposed Solution | Codes / Mitigation Info | Qty | Unit | Cost | Total |
|---|--|--|--|---|---|---|
| 205 | <ul style="list-style-type: none"> <i>As-Built Description:</i> At final exit door to exterior: Where required exit signs are installed, signs to provide exiting information for people with vision impairment are not provided. <i>Proposed Solution:</i> Provide raised letter/Braille "EXIT" sign at door. | PCODE SA10A ADAAG 91 4.1.3(16) ADA 2010 216.4.1 CBC 2007 1011.3 CBC 2016 11B-216.4.1 Priority 1 Severity 3 | 1 | JOB | \$90 | \$90 |

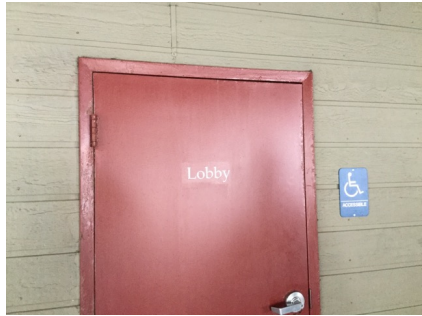
| Item No. and Name | Existing Architectural Barrier and Proposed Solution | Codes / Mitigation Info | Qty | Unit | Cost | Total |
|---|--|--|--|---|---|---|
| 202 | <ul style="list-style-type: none"> <i>As-Built Description:</i> Existing sign designating permanent room or space is noncompliant. <i>Proposed Solution:</i> Provide compliant signage. | PCODE SA13 ADAAG 91 4.1.3(16)(a) ADA 2010 216.2 CBC 2007 1117B.5 CBC 2016 11B-216.2 Priority 1 Severity 4 | 1 | JOB | \$150 | \$150 |

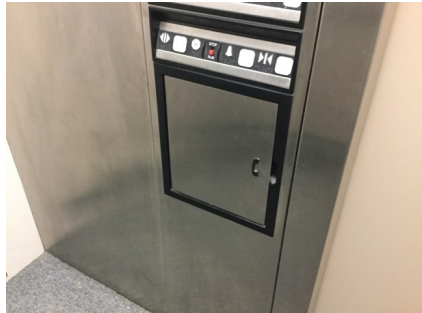
| Item No. and Name | Existing Architectural Barrier and Proposed Solution | Codes / Mitigation Info | Qty | Unit | Cost | Total |
|---|--|--|---|---|---|---|
| Elevator | | | | | | |

| Item No. and Name | Existing Architectural Barrier and Proposed Solution | Codes / Mitigation Info | Qty | Unit | Cost | Total |
|---|--|--|---|---|---|---|
| 211 | <ul style="list-style-type: none"> <i>As-Built Description:</i> Elevator car lacks emergency communication device that is not dependent on speaking/hearing ability of elevator passenger. <i>As-Built:</i> Cannot open with closed fist <i>Proposed Solution:</i> Provide elevator communication device that has combination voice and light signal communications. | PCODE IK06A ADAAG 91 4.10.14 ADA 2010 407.4.9 CBC 2007 1116B.1.8 CBC 2016 11B-407.4.9 Priority 1 Severity 3 | 1 | JOB | \$700 | \$700 |

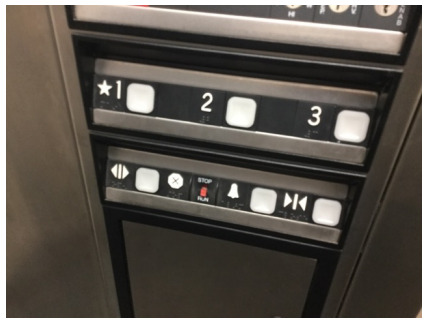
| Item No. and Name | Existing Architectural Barrier and Proposed Solution | Codes / Mitigation Info | Qty | Unit | Cost | Total |
|---|--|--|---|---|---|---|
| 212 | <ul style="list-style-type: none"> <i>As-Built Description:</i> Braille or tactile symbols at numerals not provided or noncompliant on elevator control panel. <i>As-Built:</i> Bad Braille <i>Proposed Solution:</i> Provide Braille and tactile symbols on elevator control panel. | PCODE IK07D ADAAG 91 4.10.12(2) ADA 2010 407.4.7.1 CBC 2007 1116B.1.9 CBC 2016 11B-407.4.7.1 Priority 1 Severity 3 | 1 | JOB | \$110 | \$110 |

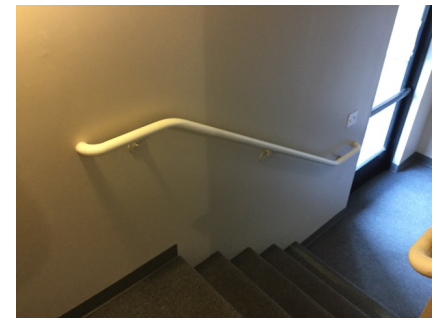
Top & Bottom Extension at Stairs

| 215 | <ul style="list-style-type: none"> <i>As-Built Description:</i> Stair handrail does not extend horizontally 12" minimum beyond top nosing, and one tread width sloped, plus 12" minimum horizontally beyond the bottom nosing. <i>As-Built:</i> 10" extensions <i>Proposed Solution:</i> Extend stair handrail at top and bottom (cost for each extension piece). | PCODE ED06 ADAAG 91 4.9.4(2) ADA 2010 505.10.2; 505.10.3 CBC 2007 1133B.4.2.2 CBC 2016 11B-505.10.2; 11B-505.10.3 Priority 1 Severity 4 | 14 | JOB | \$170 | \$2,380 |

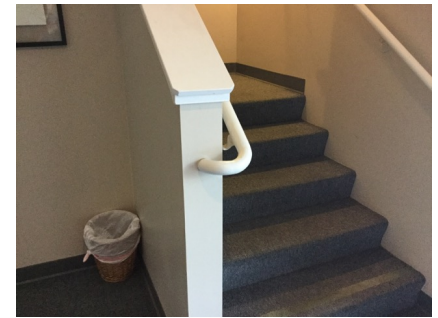
| 214 | <ul style="list-style-type: none"> <i>As-Built Description:</i> Stair handrail does not extend horizontally 12" minimum beyond top nosing, and one tread width sloped, plus 12" minimum horizontally beyond the bottom nosing. <i>Proposed Solution:</i> Extend stair handrail at top and bottom (cost for each extension piece). | PCODE ED06REF ADAAG 91 4.9.4(2) ADA 2010 505.10.2; 505.10.3 CBC 2007 1133B.4.2.2 CBC 2016 11B-505.10.2; 11B-505.10.3 Priority 1 Severity 2 | REF | | | |

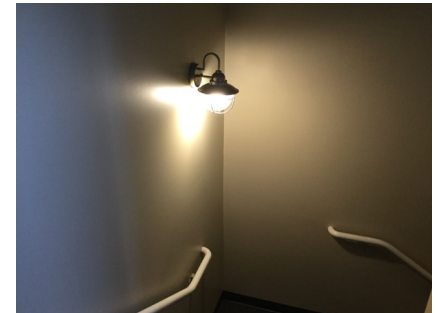
Protrusion Limits

| 216 | <ul style="list-style-type: none"> <i>As-Built Description:</i> Protruding objects more than 4" from wall, when bottom of object more than 27" or less than 80" above finished floor. <i>As-Built:</i> Lamps: 8" at 73" high <i>Proposed Solution:</i> Remove/relocate protruding object. Patch existing surface. | PCODE EG04 ADAAG 91 4.4.1 ADA 2010 307.2 CBC 2007 1133B.8.6.1 CBC 2016 11B-307.2 Priority 1 Severity 3 | 4 | JOB | \$100 | \$400 |

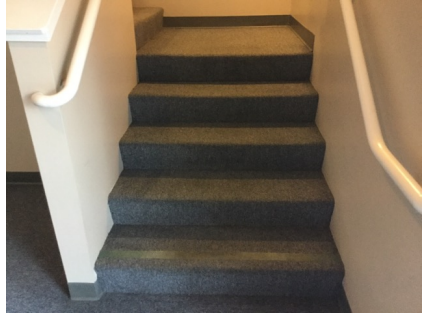
| Item No. and Name | Existing Architectural Barrier and Proposed Solution | Codes / Mitigation Info | Qty | Unit | Cost | Total |
|---|--|--|---|---|---|---|
| Stairway | | | | | | |

| Item No. and Name | Existing Architectural Barrier and Proposed Solution | Codes / Mitigation Info | Qty | Unit | Cost | Total |
|---|--|--|---|---|---|---|
| 213 | <ul style="list-style-type: none"> <i>As-Built Description:</i> The leading 2" of the tread does not have visual contrast of dark-on-light or light-on-dark from the remainder of the tread. <i>As-Built: Dark on dark</i> <i>Proposed Solution:</i> Provide 2" min., 4" max. wide contrasting color strip 1" max. from nosing on top & bottom treads when altering area. | <p><i>PCODE II02B</i></p> <p><i>ADA 2010 504.4</i></p> <p><i>CBC 2007 1133B.4.4</i></p> <p><i>CBC 2016 11B-504.4.1</i></p> <p>Priority 1</p> <p>Severity 3</p> | 48 | LF | \$14 | \$672 |

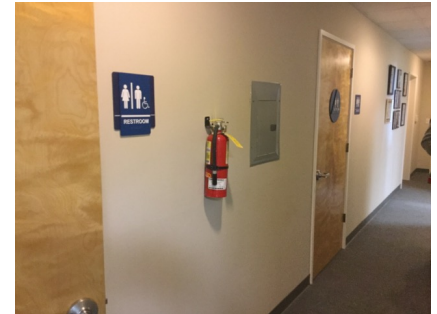
- 226
- *As-Built Description:*
At facility with a fire alarm system, visual signal (strobe) not provided at required type of common use area.
 - *Proposed Solution:*
Provide combination visual / audible signal device connected to existing fire alarm system.

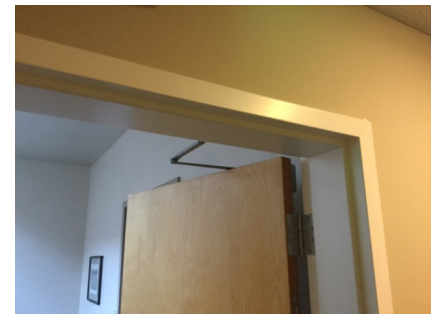
| 220 | <ul style="list-style-type: none"> <i>As-Built Description:</i> Front approach: At push side, door does not have clear and level maneuvering space measuring door width x 48" (door width plus 12" if door has both, latch and closer). <i>As-Built:</i> 9.25" to wall <i>Proposed Solution:</i> Provide relocated new door and frame; remodel walls as needed. | <p>PCODE ID24B ADAAG 91 Fig. 25(a) ADA 2010 404.2.4 CBC 2007 11B-26A(a) CBC 2016 11B-404.2.4</p> <p>Priority 1 Severity 3</p> <p>Mitigation Project: Admin Office Remodel</p> <p>Estimated Completion Date: 2017-2018</p> | 1 | JOB | \$2,600 | \$2,600 |

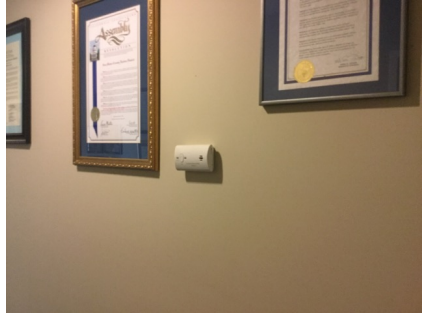
| Item No. and Name | Existing Architectural Barrier and Proposed Solution | Codes / Mitigation Info | Qty | Unit | Cost | Total |
|---|--|---|---|---|---|---|
| 223 | <ul style="list-style-type: none"> <i>As-Built Description:</i> Reach height to control or access point, exceeds 48" or is less than 15". <i>As-Built:</i> 61" high <i>Proposed Solution:</i> Modify equipment or mounting. <i>Notes:</i> Carbon monoxide alarm | <p>PCODE IE01</p> <p>ADAAG 91 4.2.5</p> <p>ADA 2010 308.2.1</p> <p>CBC 2007 1118B.5</p> <p>CBC 2016 11B-308.2.1</p> <p>Priority 1</p> <p>Severity 2</p> <p>Mitigation Project: <i>Admin Office Remodel</i></p> <p>Estimated Completion Date: <i>2017-2018</i></p> | 1 | JOB | \$100 | \$100 |

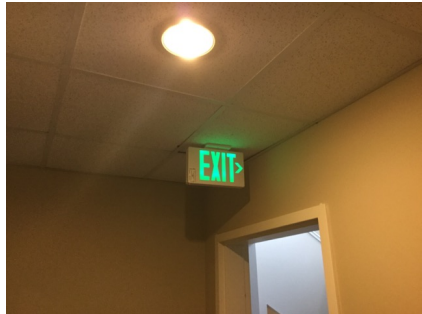
| Item No. and Name | Existing Architectural Barrier and Proposed Solution | Codes / Mitigation Info | Qty | Unit | Cost | Total |
|---|--|---|---|---|---|---|
| 218 | <ul style="list-style-type: none"> <i>As-Built Description:</i> At door leading into exit stairway: Where required exit signs are installed, signs to provide exiting information for people with vision impairment are not provided. <i>Proposed Solution:</i> Provide raised letter/Braille "EXIT STAIR UP/DOWN" sign at door. | <p>PCODE SA10B</p> <p>ADAAG 91 4.1.3(16)</p> <p>ADA 2010 216.4.1</p> <p>CBC 2007 1011.3</p> <p>CBC 2016 11B-216.4.1</p> <p>Priority 1</p> <p>Severity 3</p> <p>Mitigation Project: <i>Admin Office Remodel</i></p> <p>Estimated Completion Date: <i>2017-2018</i></p> | 1 | JOB | \$90 | \$90 |

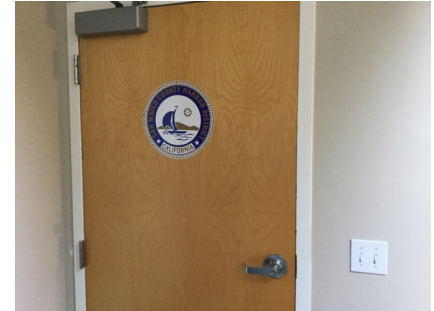
| Item No. and Name | Existing Architectural Barrier and Proposed Solution | Codes / Mitigation Info | Qty | Unit | Cost | Total |
|---|---|--|---|---|---|---|
| 217 | <ul style="list-style-type: none"> <i>As-Built Description:</i> Existing sign designating permanent room or space is noncompliant. <i>Proposed Solution:</i> Provide compliant signage. | PCODE SA13 ADAAG 91 4.1.3(16)(a) ADA 2010 216.2 CBC 2007 1117B.5 CBC 2016 11B-216.2 Priority 1 Severity 4 Mitigation Project: <i>Admin Office Remodel</i> Estimated Completion Date: 2017-2018 | 1 | JOB | \$150 | \$150 |

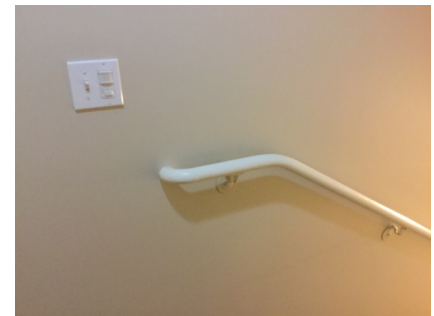
| 230 | <ul style="list-style-type: none"> <i>As-Built Description:</i> Stair handrail does not extend horizontally 12" minimum beyond top nosing, and one tread width sloped, plus 12" minimum horizontally beyond the bottom nosing. <i>As-Built:</i> 10" extensions <i>Proposed Solution:</i> Extend stair handrail at top and bottom (cost for each extension piece). | PCODE ED06 ADAAG 91 4.9.4(2) ADA 2010 505.10.2; 505.10.3 CBC 2007 1133B.4.2.2 CBC 2016 11B-505.10.2; 11B-505.10.3 Priority 3 Severity 4 Mitigation Project: <i>Admin Office Remodel</i> Estimated Completion Date: 2017-2018 | 6 | JOB | \$170 | \$1,020 |

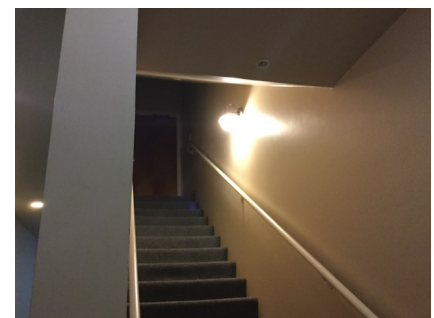
| 232 | <ul style="list-style-type: none"> <i>As-Built Description:</i> Overhead clearance less than 80" above finished floor. <i>As-Built:</i> 71" high to lamp on stairway <i>Proposed Solution:</i> Modify overhead clearance. | PCODE EG01 ADAAG 91 4.4.2 ADA 2010 307.4 CBC 2007 1133B.8.6.2 CBC 2016 11B-307.4 Priority 3 Severity 2 Mitigation Project: <i>Admin Office Remodel</i> Estimated Completion Date: 2017-2018 | 2 | JOB | \$100 | \$200 |

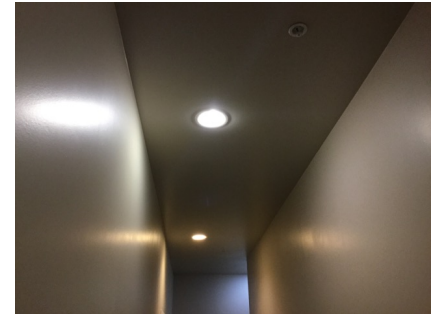
| 233 | <ul style="list-style-type: none"> <i>As-Built Description:</i> At facility with a fire alarm system, visual signal (strobe) not provided at required type of common use area. <i>Proposed Solution:</i> Provide combination visual / audible signal device connected to existing fire alarm system. | <p>PCODE IC05 ADAAG 91 4.1.3(14) & ADA 2010 4.28.3 215.1 & 702.1 CBC 2007 1114B.2.2 CBC 2016 11B-215.1 & 11B-702.1</p> <p>Priority 3 Severity 3</p> <p>Mitigation Project: Admin Office Remodel</p> <p>Estimated Completion Date: 2017-2018</p> | 1 | JOB | \$400 | \$400 |

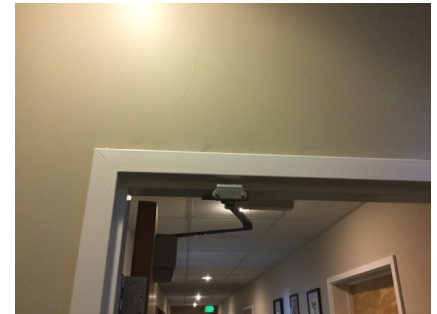
| 228 | <ul style="list-style-type: none"> <i>As-Built Description:</i> Excessive force required to open door. <i>As-Built:</i> 12 lbs <i>Proposed Solution:</i> Adjust regular door closer to accessible standards (5 lbs. max). Notes: To exit stairway | <p>PCODE ID03 ADAAG 91 4.13.11 ADA 2010 404.2.9 CBC 2007 1133B.2.5 CBC 2016 11B-404.2.9</p> <p>Priority 3 Severity 3</p> <p>Mitigation Project: Admin Office Remodel</p> <p>Estimated Completion Date: 2017-2018</p> | 1 | JOB | \$25 | \$25 |

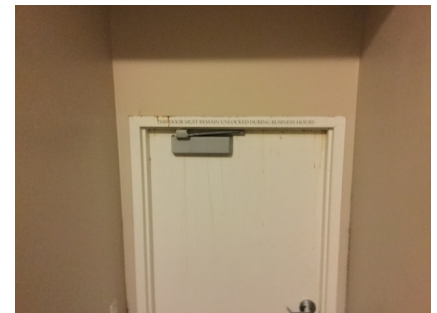
| 234 | <ul style="list-style-type: none"> <i>As-Built Description:</i> Excessive force required to open door. <i>As-Built:</i> 10 lbs <i>Proposed Solution:</i> Adjust regular door closer to accessible standards (5 lbs. max). | <p>PCODE ID03 ADAAG 91 4.13.11 ADA 2010 404.2.9 CBC 2007 1133B.2.5 CBC 2016 11B-404.2.9</p> <p>Priority 3 Severity 4</p> <p>Mitigation Project: Admin Office Remodel</p> <p>Estimated Completion Date: 2017-2018</p> | 1 | JOB | \$25 | \$25 |

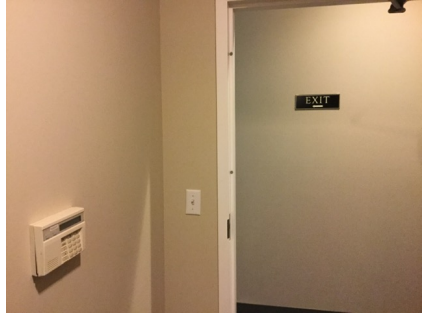
| Item No. and Name | Existing Architectural Barrier and Proposed Solution | Codes / Mitigation Info | Qty | Unit | Cost | Total |
|---|--|---|---|---|---|---|
| 227 | <ul style="list-style-type: none"> <i>As-Built Description:</i> Front approach: At pull side, door does not have clear and level maneuvering space measuring door width plus 18" x 60". (24" x 60" at exterior doors). <i>As-Built:</i> 12" to wall <i>Proposed Solution:</i> Provide relocated new door and frame; remodel walls as needed. | <p>PCODE ID23B ADAAG 91 Fig. 25(a) ADA 2010 404.2.4 CBC 2007 11B-26A(a) CBC 2016 11B-404.2.4</p> <p>Priority 3 Severity 4</p> <p>Mitigation Project: <i>Admin Office Remodel</i></p> <p>Estimated Completion Date: 2017-2018</p> | 1 | JOB | \$2,600 | \$2,600 |

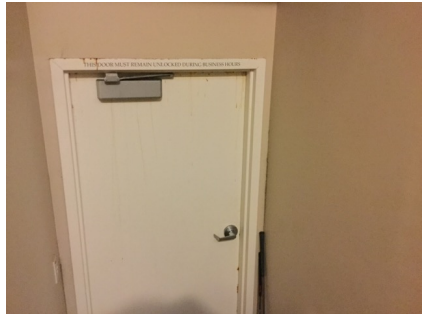
| Item No. and Name | Existing Architectural Barrier and Proposed Solution | Codes / Mitigation Info | Qty | Unit | Cost | Total |
|---|--|---|---|---|---|---|
| 235 | <ul style="list-style-type: none"> <i>As-Built Description:</i> Front approach: At push side, door does not have clear and level maneuvering space measuring door width x 48" (door width plus 12" if door has both, latch and closer). <i>As-Built:</i> 4.5" to wall <i>Proposed Solution:</i> Provide relocated new door and frame; remodel walls as needed. | <p>PCODE ID24B ADAAG 91 Fig. 25(a) ADA 2010 404.2.4 CBC 2007 11B-26A(a) CBC 2016 11B-404.2.4</p> <p>Priority 3 Severity 2</p> <p>Mitigation Project: <i>Admin Office Remodel</i></p> <p>Estimated Completion Date: 2017-2018</p> | 1 | JOB | \$2,600 | \$2,600 |

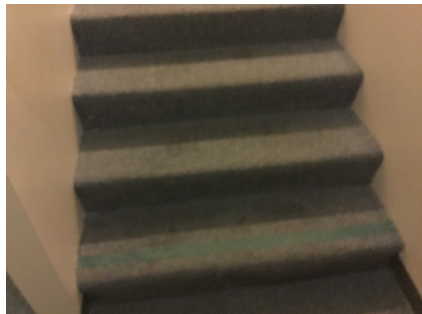
| Item No. and Name | Existing Architectural Barrier and Proposed Solution | Codes / Mitigation Info | Qty | Unit | Cost | Total |
|---|--|---|---|---|---|---|
| 231 | <ul style="list-style-type: none"> <i>As-Built Description:</i> The leading 2" of the tread does not have visual contrast of dark-on-light or light-on-dark from the remainder of the tread. <i>Proposed Solution:</i> Provide 2" min., 4" max. wide contrasting color strip 1" max. from nosing on top & bottom treads when altering area. | <p>PCODE II02B ADA 2010 504.4 CBC 2007 1133B.4.4 CBC 2016 11B-504.4.1</p> <p>Priority 3 Severity 3</p> <p>Mitigation Project: <i>Admin Office Remodel</i></p> <p>Estimated Completion Date: 2017-2018</p> | 16 | LF | \$14 | \$224 |

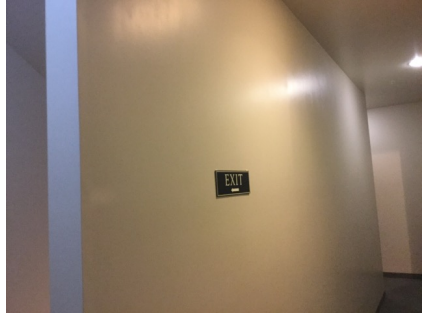
| Item No. and Name | Existing Architectural Barrier and Proposed Solution | Codes / Mitigation Info | Qty | Unit | Cost | Total |
|---|--|--|---|---|---|---|
| 229 | <ul style="list-style-type: none"> <i>As-Built Description:</i> At door leading into exit corridor: Where required exit signs are installed, signs to provide exiting information for people with vision impairment are not provided. <i>Proposed Solution:</i> Provide raised letter/Braille "EXIT ROUTE" sign at door. | PCODE SA10D ADAAG 91 4.1.3(16) ADA 2010 216.4.1 CBC 2007 1011.3 CBC 2016 11B-216.4.1 Priority 3 Severity 3 | 1 | JOB | \$90 | \$90 |

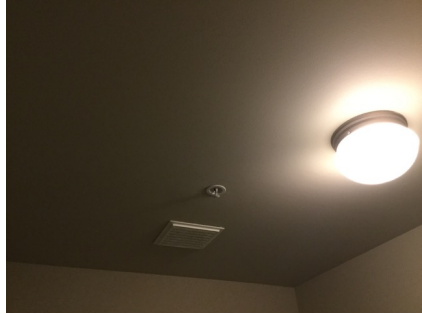
| 238 | <ul style="list-style-type: none"> <i>As-Built Description:</i> At facility with a fire alarm system, visual signal (strobe) not provided at required type of common use area. <i>Proposed Solution:</i> Provide combination visual / audible signal device connected to existing fire alarm system. | PCODE IC05 ADAAG 91 4.1.3(14) & ADA 2010 4.28.3 215.1 & 702.1 CBC 2007 1114B.2.2 CBC 2016 11B-215.1 & 11B-702.1 Priority 3 Severity 3 | 1 | JOB | \$400 | \$400 |

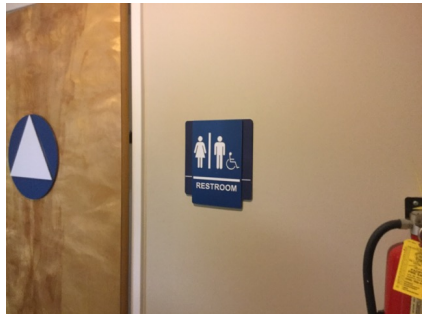
| 236 | <ul style="list-style-type: none"> <i>As-Built Description:</i> Entrance to toilet or bathing facility identified with California signage on door leaf not identified with ADAAG compliant signage. <i>As-Built:</i> Sign is not mounted directly on the wall <i>Proposed Solution:</i> Provide ADAAG compliant sign with raised letters and pictogram, mounted 5' high on center on nearest adjacent wall, on latch side of a single door. Notes: Recommend removing covered sign under compliant restroom latch sign. | PCODE SA11AREF ADAAG 91 4.1.3(16)(a) ADA 2010 216.8 CBC 2016 11B-216.8 Priority 3 Severity 3 | REF | | | |

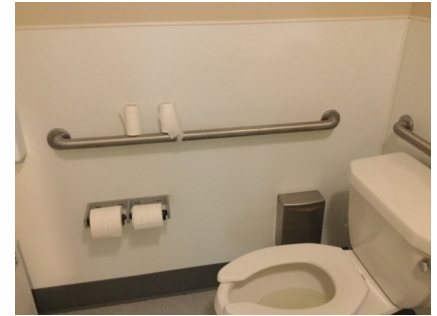
| 246 | <ul style="list-style-type: none"> <i>As-Built Description:</i> Side grab bar less than 42" long, or located more than 12 inches max. from the rear wall, or extending less than 54" from rear wall (CA only: front end min. 24" in front of water closet). <i>As-Built:</i> 42" at 52" <i>Proposed Solution:</i> Provide or relocate accessible side grab bar. | <p>PCODE WB07A ADAAG 91 Fig. 29(b) ADA 2010 604.5.1 CBC 2007 1115B.4.1.3.1 CBC 2016 11B-604.5.1</p> <p>Priority 3 Severity 4</p> <p>Mitigation Project: <i>Admin Office Remodel</i> Estimated Completion Date: <i>2017-2018</i></p> | 1 | JOB | \$260 | \$260 |

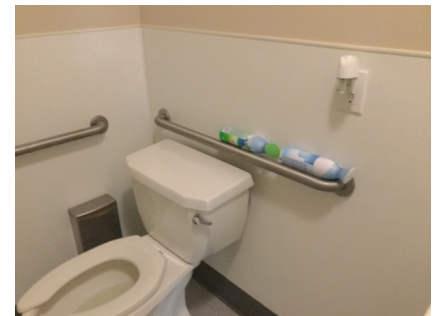
| 245 | <ul style="list-style-type: none"> <i>As-Built Description:</i> The rear wall grab is less than 36" min. or does not extend from the centerline of the water closet 12" min. on one side and 24" min. on the other side. <i>As-Built:</i> 22" on wide side <i>Proposed Solution:</i> Provide or relocate accessible rear grab bar. | <p>PCODE WB07B ADAAG 91 4.17.6 ADA 2010 604.5.2 CBC 2007 1115B.4.1.3.2 CBC 2016 11B-604.5.2</p> <p>Priority 3 Severity 4</p> <p>Mitigation Project: <i>Admin Office Remodel</i> Estimated Completion Date: <i>2017-2018</i></p> | 1 | JOB | \$340 | \$340 |

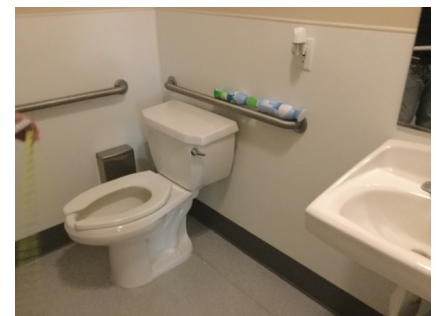
| 242 | <ul style="list-style-type: none"> <i>As-Built Description:</i> 60" min. clearance around a water closet measured perpendicular from the side wall not provided (Fixtures are not allowed to overlap this clearance). <i>As-Built:</i> 54.5" from side wall to lavatory <i>Proposed Solution:</i> Remove adjacent fixture and provide new enclosure at accessible water closet. | <p>PCODE WB01A ADA 2010 604.3.1; 604.3.2 CBC 2007 1115B.7.1.3 CBC 2016 11B-604.3.1; 11B-604.3.2</p> <p>Priority 3 Severity 3</p> <p>Mitigation Project: <i>Admin Office Remodel</i> Estimated Completion Date: <i>2017-2018</i></p> | 1 | JOB | \$2,000 | \$2,000 |

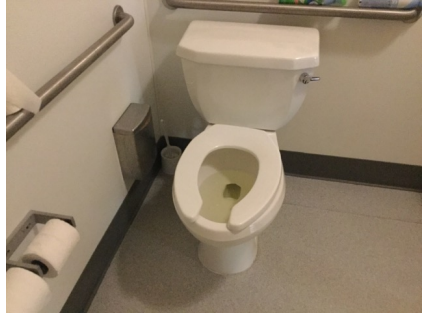
| Item No. and Name | Existing Architectural Barrier and Proposed Solution | Codes / Mitigation Info | Qty | Unit | Cost | Total |
|---|---|--|---|---|---|---|
| 243 | <ul style="list-style-type: none"> <i>As-Built Description:</i> Water closet not 16"-18" (CA: 17"-18") from near side wall to center line of water closet (2010 ADAAG: 16"-18"). <i>As-Built:</i> 18.5" o.c. <i>Proposed Solution:</i> Relocate existing water closet and plumbing, remount with offset closet flange to provide 18" max. from side wall. | <p>PCODE WB02C ADAAG 91 Fig. 28 ADA 2010 604.2 CBC 2007 1115B.4.1.1 CBC 2016 11B-604.2</p> <p>Priority 3 Severity 4</p> <p>Mitigation Project: <i>Admin Office Remodel</i> Estimated Completion Date: 2017-2018</p> | 1 | JOB | \$500 | \$500 |

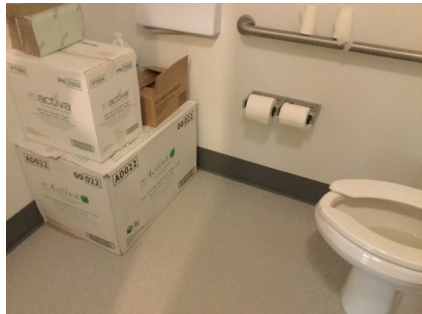
| Item No. and Name | Existing Architectural Barrier and Proposed Solution | Codes / Mitigation Info | Qty | Unit | Cost | Total |
|---|---|--|---|---|---|---|
| 244 | <ul style="list-style-type: none"> <i>As-Built Description:</i> CA only: In single-accommodation restroom less than 48" in front of water closet provided. <i>As-Built:</i> Due to stored items <i>Proposed Solution:</i> Remove stored items. Notes: Compliant to wall. | <p>PCODE WB03ANT CBC 2007 1115B.3.2.1 CBC 2016 11B-604.3.1</p> <p>Priority 3 Severity 4</p> <p>Mitigation Project: <i>Admin Office Remodel</i> Estimated Completion Date: 2017-2018</p> | 1 | JOB | \$100 | \$100 |

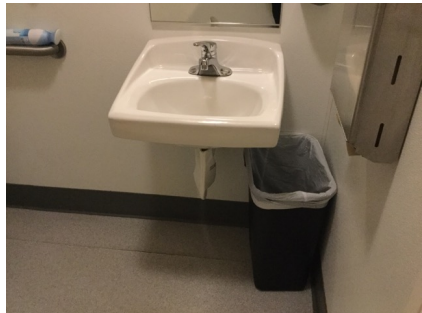
| Item No. and Name | Existing Architectural Barrier and Proposed Solution | Codes / Mitigation Info | Qty | Unit | Cost | Total |
|---|---|--|---|---|---|---|
| 239 | <ul style="list-style-type: none"> <i>As-Built Description:</i> Wheelchair clearance under lavatory apron or lavatory counter front edge less than 29" high. <i>As-Built:</i> 28.25" high apron <i>Proposed Solution:</i> Remount compliant fixture to accessible height. | <p>PCODE WD03A ADAAG 91 4.19.2 ADA 2010 606.3 CBC 2007 1115B.4.3.3 CBC 2016 11B-306.3.1</p> <p>Priority 3 Severity 3</p> <p>Mitigation Project: <i>Admin Office Remodel</i> Estimated Completion Date: 2017-2018</p> | 1 | JOB | \$1,500 | \$1,500 |

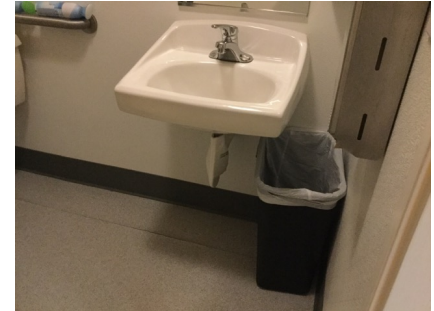
| Item No. and Name | Existing Architectural Barrier and Proposed Solution | Codes / Mitigation Info | Qty | Unit | Cost | Total |
|---|---|--|---|---|---|---|
| 240 | <ul style="list-style-type: none"> <i>As-Built Description:</i> Knee clearance 27" min. high starting 8" back from the front edge of the lavatory towards the wall is not provided. <i>Proposed Solution:</i> Remount compliant fixture to accessible height. | PCODE WD04AREF ADAAG 91 Fig. 31 ADA 2010 306.3.3 CBC 2007 1115B.4.3 CBC 2016 11B-306.3.3 Priority 3 Severity 2 Mitigation Project: <i>Admin Office Remodel</i> Estimated Completion Date: <i>2017-2018</i> | | | | |

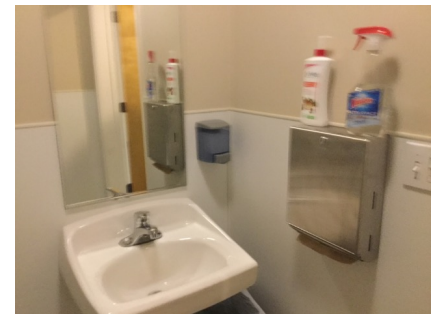
| 241 | <ul style="list-style-type: none"> <i>As-Built Description:</i> Dispensers in sanitary facilities, such as for towels, soap, sanitary napkins, seat covers, etc., and waste receptacles more than 48" (CA only: 40") from floor to highest operating slot or control. <i>As-Built:</i> SD: 41.5" high <i>Proposed Solution:</i> Relocate existing restroom accessories. | PCODE WG01A ADAAG 91 4.23.7 ADA 2010 308.2.1 CBC 2007 1115B.8.3 CBC 2016 11B-603.5 Priority 3 Severity 4 Mitigation Project: <i>Admin Office Remodel</i> Estimated Completion Date: <i>2017-2018</i> | 1 | JOB | \$100 | \$100 |

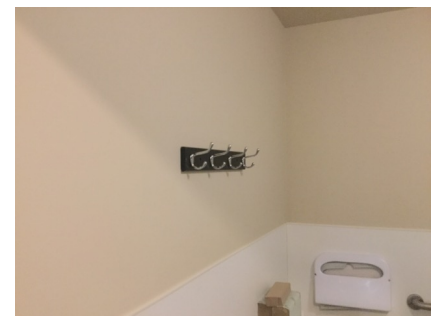
| 237 | <ul style="list-style-type: none"> <i>As-Built Description:</i> Accessible coat hook not within reach range. <i>As-Built:</i> 63" high CH <i>Proposed Solution:</i> Adjust existing or provide new coat hook at maximum 48" height. | PCODE WG03A ADAAG 91 4.2.5 ADA 2010 603.4 CBC 2007 1118B.5 CBC 2016 11B-603.4 Priority 3 Severity 2 Mitigation Project: <i>Admin Office Remodel</i> Estimated Completion Date: <i>2017-2018</i> | 1 | JOB | \$50 | \$50 |

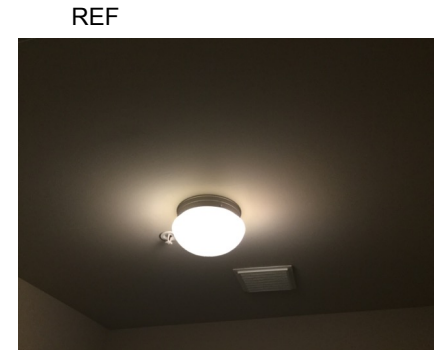
| 249 | <ul style="list-style-type: none"> <i>As-Built Description:</i> At facility with a fire alarm system, visual signal (strobe) not provided at required type of common use area. <i>Proposed Solution:</i> Provide combination visual / audible signal device connected to existing fire alarm system. | <p>PCODE IC05REF</p> <p>ADAAG 91 4.1.3(14) & ADA 2010 4.28.3 215.1 & 702.1</p> <p>CBC 2007 1114B.2.2</p> <p>CBC 2016 11B-215.1 & 11B-702.1</p> <p>Priority 3</p> <p>Severity 3</p> <p>Mitigation Project: <i>Admin Office Remodel</i></p> <p>Estimated Completion Date: <i>2017-2018</i></p> | | | | |

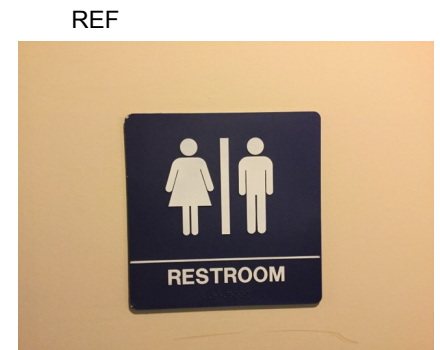
| 247 | <ul style="list-style-type: none"> <i>As-Built Description:</i> Entrance to toilet or bathing facility identified with California signage on door leaf not identified with ADAAG compliant signage. <i>As-Built:</i> Bad Braille <i>Proposed Solution:</i> Provide ADAAG compliant sign with raised letters and pictogram, mounted 5' high on center on nearest adjacent wall, on latch side of a single door. Notes: Designated accessible unisex restroom is provided | <p>PCODE SA11AREF</p> <p>ADAAG 91 4.1.3(16)(a)</p> <p>ADA 2010 216.8</p> <p>CBC 2016 11B-216.8</p> <p>Priority 3</p> <p>Severity 3</p> <p>Mitigation Project: <i>Admin Office Remodel</i></p> <p>Estimated Completion Date: <i>2017-2018</i></p> | | | | |

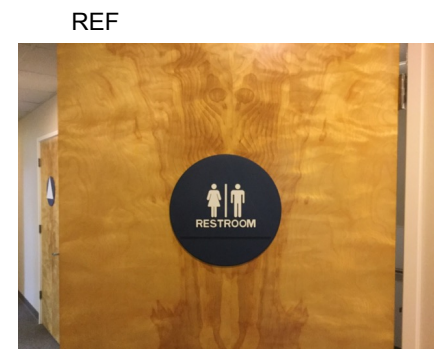
| 248 | <ul style="list-style-type: none"> <i>As-Built Description:</i> Required in CA only: identification symbol centered 58" to 60" high on sanitary facility door that contrasts with the door not provided (women: 12" ø circle, men: 12" triangle, unisex: combined symbol). <i>As-Built:</i> Geometric shapes do not contrast in color <i>Proposed Solution:</i> Provide properly mounted sanitary facility symbol when altering area. If wheelchair accessible, include International Symbol of Accessibility on sign. | <p>PCODE SA15REF</p> <p>CBC 2007 1115B.6</p> <p>CBC 2016 11B-703.7.2.6</p> <p>Priority 3</p> <p>Severity 3</p> <p>Mitigation Project: <i>Admin Office Remodel</i></p> <p>Estimated Completion Date: <i>2017-2018</i></p> | | | | |

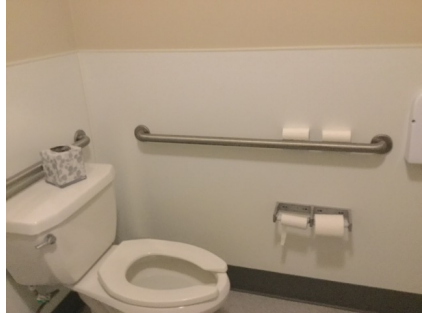
| 253 | <ul style="list-style-type: none"> <i>As-Built Description:</i> Side grab bar less than 42" long, or located more than 12 inches max. from the rear wall, or extending less than 54" from rear wall (CA only: front end min. 24" in front of water closet). <i>As-Built:</i> 42" at 52.5" <i>Proposed Solution:</i> Provide or relocate accessible side grab bar. | <p>PCODE WB07AREF ADAAG 91 Fig. 29(b) ADA 2010 604.5.1 CBC 2007 1115B.4.1.3.1 CBC 2016 11B-604.5.1</p> <p>Priority 3 Severity 4</p> <p>Mitigation Project: <i>Admin Office Remodel</i> Estimated Completion Date: 2017-2018</p> | REF | | | |

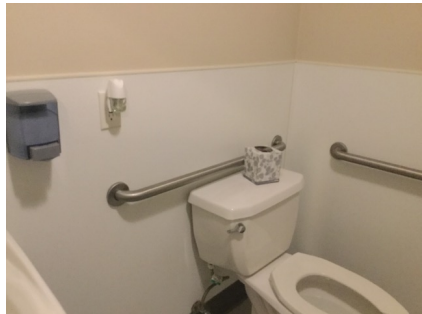
| 252 | <ul style="list-style-type: none"> <i>As-Built Description:</i> The rear wall grab is less than 36" min. or does not extend from the centerline of the water closet 12" min. on one side and 24" min. on the other side. <i>As-Built:</i> 22" on wide side <i>Proposed Solution:</i> Provide accessible rear grab bar. | <p>PCODE WB07BREF ADAAG 91 4.17.6 ADA 2010 604.5.2 CBC 2007 1115B.4.1.3.2 CBC 2016 11B-604.5.2</p> <p>Priority 3 Severity 4</p> <p>Mitigation Project: <i>Admin Office Remodel</i> Estimated Completion Date: 2017-2018</p> | REF | | | |

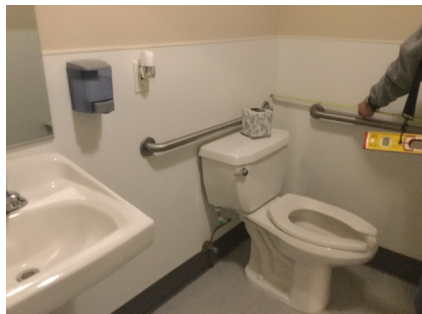
| 251 | <ul style="list-style-type: none"> <i>As-Built Description:</i> 60" min. clearance around a water closet measured perpendicular from the side wall not provided (Fixtures are not allowed to overlap this clearance). <i>As-Built:</i> 54.5" from side wall to lavatory <i>Proposed Solution:</i> Remove adjacent fixture and provide new enclosure at accessible water closet. | <p>PCODE WB01AREF ADA 2010 604.3.1; 604.3.2 CBC 2007 1115B.7.1.3 CBC 2016 11B-604.3.1; 11B-604.3.2</p> <p>Priority 3 Severity 3</p> <p>Mitigation Project: <i>Admin Office Remodel</i> Estimated Completion Date: 2017-2018</p> | REF | | | |

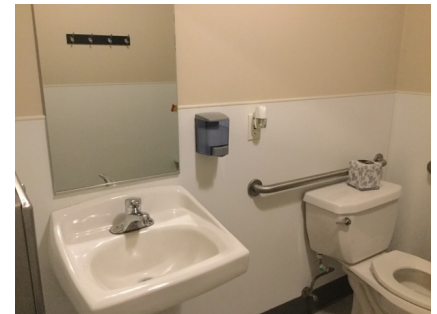
250 • *As-Built Description:*
Dispensers in sanitary facilities, such as for towels, soap, sanitary napkins, seat covers, etc., and waste receptacles more than 48" (CA only: 40") from floor to highest operating slot or control.

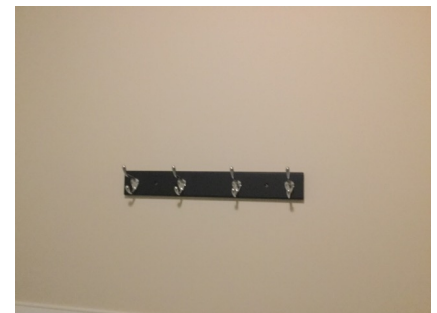
255 • *As-Built Description:*
Accessible coat hook not within reach range.

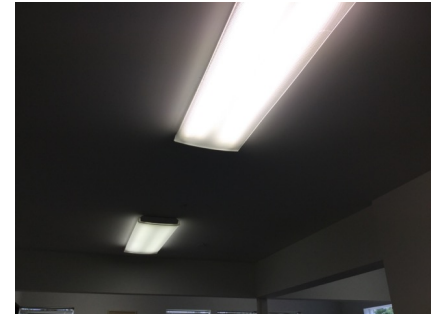
| 256 | <ul style="list-style-type: none"> <i>As-Built Description:</i> At facility with a fire alarm system, visual signal (strobe) not provided at required type of common use area. <i>Proposed Solution:</i> Provide combination visual / audible signal device connected to existing fire alarm system. | <p>PCODE IC05 ADAAG 91 4.1.3(14) & ADA 2010 4.28.3 215.1 & 702.1 CBC 2007 1114B.2.2 CBC 2016 11B-215.1 & 11B-702.1</p> <p>Priority 4 Severity 3</p> | 1 | JOB | \$400 | \$400 |

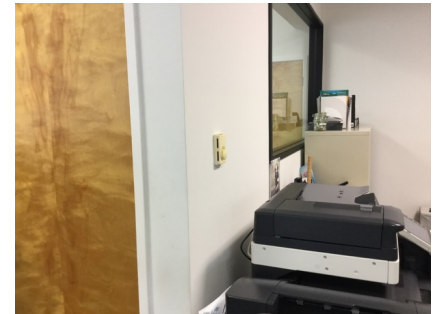
| 259 | <ul style="list-style-type: none"> <i>As-Built Description:</i> Electric switch or control mounted less than 15" measured to the bottom of the outlet box or greater than 48 inches measured to the top of the outlet box. <i>As-Built:</i> Thermostat: 54" high <i>Proposed Solution:</i> Relocate light switches or control to between 15" and 48" height. | <p>PCODE IC01 ADAAG 91 4.2.5 & 6 ADA 2010 308.2.1 & 308.2.2 CBC 2007 1117B.6.3 CBC 2016 11B-308.2.1 & 11B-308.2.2</p> <p>Priority 4 Severity 3</p> | 1 | JOB | \$300 | \$300 |

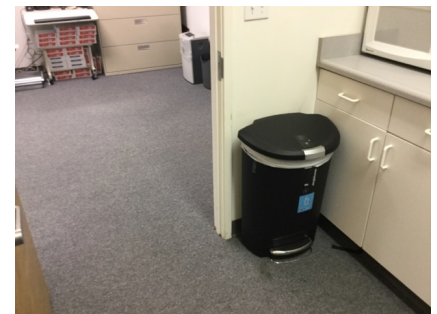
| 261 | <ul style="list-style-type: none"> <i>As-Built Description:</i> Front approach: At pull side, door does not have clear and level maneuvering space measuring door width plus 18" x 60". (24" x 60" at exterior doors). <i>Proposed Solution:</i> Remove or relocate furniture or storage items. Notes: In break room | <p>PCODE ID23A ADAAG 91 Fig. 25(a) ADA 2010 404.2.4 CBC 2007 11B-26A(a) CBC 2016 11B-404.2.4</p> <p>Priority 4 Severity 4</p> | 1 | JOB | \$50 | \$50 |

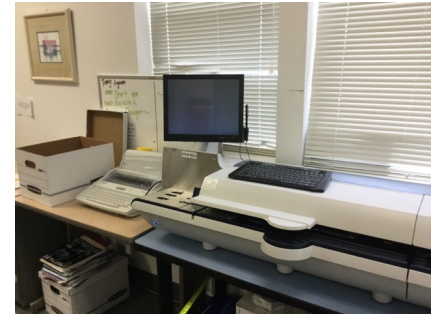
| 257 | <ul style="list-style-type: none"> <i>As-Built Description:</i> Reach height to control or access point, exceeds 48" or is less than 15". <i>As-Built:</i> 55" high to highest part of touch screen <i>Proposed Solution:</i> Modify equipment or mounting. <i>Notes:</i> Staff Only | <p>PCODE IE01 ADAAG 91 4.2.5 ADA 2010 308.2.1 CBC 2007 1118B.5 CBC 2016 11B-308.2.1</p> <p>Priority 4 Severity 3</p> <p>Mitigation Project: <i>Admin Office Remodel</i></p> <p>Estimated Completion Date: 2017-2018</p> | 1 | JOB | \$100 | \$100 |

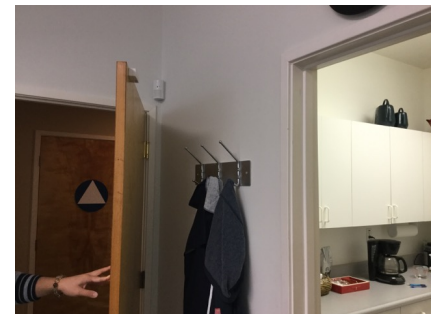
| 260 | <ul style="list-style-type: none"> <i>As-Built Description:</i> Reach height to control or access point, exceeds 48" or is less than 15". <i>As-Built:</i> 65" high CH <i>Proposed Solution:</i> Modify equipment or mounting. | <p>PCODE IE01 ADAAG 91 4.2.5 ADA 2010 308.2.1 CBC 2007 1118B.5 CBC 2016 11B-308.2.1</p> <p>Priority 4 Severity 2</p> <p>Mitigation Project: <i>Admin Office Remodel</i></p> <p>Estimated Completion Date: 2017-2018</p> | 1 | JOB | \$100 | \$100 |

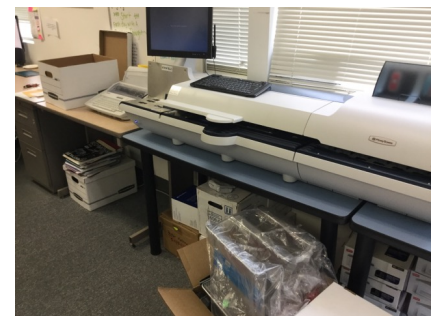
| 258 | <ul style="list-style-type: none"> <i>As-Built Description:</i> Recommended only: Accessible non-fixed table or desk (top 28" to 34" high; knee space at least 27" high x 19" deep x 30" wide) not provided. <i>As-Built:</i> No knee space due to stored items. <i>Proposed Solution:</i> Remove stored items. <i>Notes:</i> Staff Only | <p>PCODE IN02AREF ADAAG 91 4.32.3 & .4 ADA 2010 306.1 CBC 2007 1122B.3 & 4 CBC 2016 11B-306.1 & 11B-902.3</p> <p>Priority 4 Severity 2</p> <p>Mitigation Project: <i>Admin Office Remodel</i></p> <p>Estimated Completion Date: 2017-2018</p> | REF | | | |

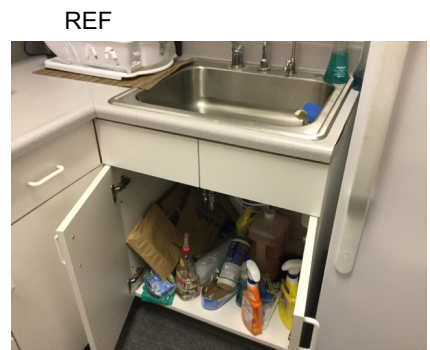
- 263
- *As-Built Description:*
Sink does not have knee space min. 27" high x 19" deep x 30" wide.
 - *Proposed Solution:*
Remodel sink cabinet.

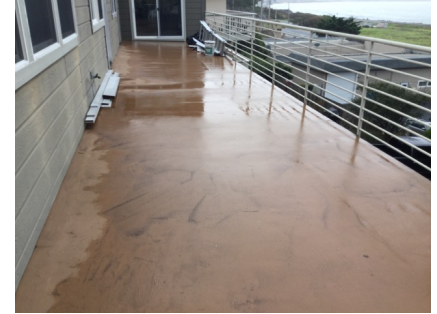
| 266 | <ul style="list-style-type: none"> • <i>As-Built Description:</i> Cross slope more than 1":48" (2.083%). • <i>As-Built:</i> 3.1% slope on balcony • <i>Proposed Solution:</i> Modify cross slope. • Notes: Throughout area done intentionally to prevent puddling | <p>PCODE EF07 ADAAG 91 4.3.7 ADA 2010 403.3 CBC 2007 1133B.7.1.3 CBC 2016 11B-403.3</p> <p>Priority 2 Severity 4</p> <p>Mitigation Project: <i>Admin Office Remodel</i></p> <p>Estimated Completion Date: 2017-2018</p> | 850 | SF | \$25 | \$21,250 |

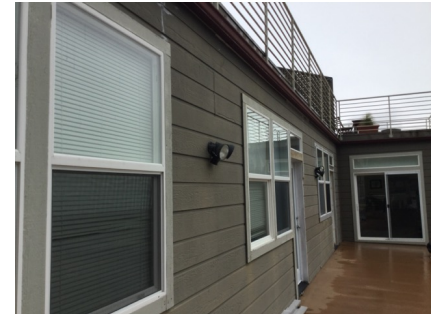
| 267 | <ul style="list-style-type: none"> • <i>As-Built Description:</i> Protruding objects more than 4" from wall, when bottom of object more than 27" or less than 80" above finished floor. • <i>As-Built:</i> Lamps: 5.5" at 73" high • <i>Proposed Solution:</i> Remove/relocate protruding object. Patch existing surface. | <p>PCODE EG04 ADAAG 91 4.4.1 ADA 2010 307.2 CBC 2007 1133B.8.6.1 CBC 2016 11B-307.2</p> <p>Priority 2 Severity 4</p> <p>Mitigation Project: <i>Admin Office Remodel</i></p> <p>Estimated Completion Date: 2017-2018</p> | 3 | JOB | \$100 | \$300 |

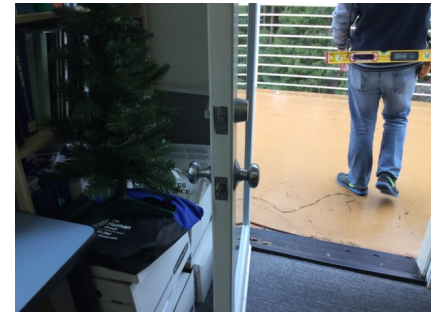
| 264 | <ul style="list-style-type: none"> • <i>As-Built Description:</i> Non-common use areas within this facility, such as offices, do not have accessible door hardware. • <i>Proposed Solution:</i> Provide lever handle or other accessible hardware when a specific need is identified in the future or when altering area. • Notes: To balcony | <p>PCODE ID07C ADAAG 91 4.13.9 ADA 2010 404.2.7 CBC 2007 1133B.2.5.2 CBC 2016 11B-404.2.7</p> <p>Priority 2 Severity 3</p> <p>Mitigation Project: <i>Admin Office Remodel</i></p> <p>Estimated Completion Date: 2017-2018</p> | 2 | JOB | \$250 | \$500 |

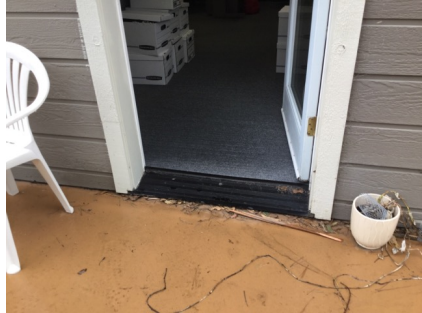
| Item No. and Name | Existing Architectural Barrier and Proposed Solution | Codes / Mitigation Info | Qty | Unit | Cost | Total |
|---|---|--|---|---|---|---|
| 265 | <ul style="list-style-type: none"> <i>As-Built Description:</i> Existing threshold at door is 1/2" high or less but without a beveled edge on both sides. <i>As-Built:</i> 1.75" threshold <i>Proposed Solution:</i> Modify threshold to have beveled edge on each side. <i>Notes:</i> Balcony area | <p><i>PCODE</i> ID02</p> <p><i>ADAAG 91</i> 4.1.6(3)(d)(ii)</p> <p><i>ADA 2010</i> 404.2.5</p> <p><i>CBC 2007</i> 1133B.2.4.1</p> <p><i>CBC 2016</i> 11B-404.2.5</p> <p>Priority 2</p> <p>Severity 3</p> <p>Mitigation Project: <i>Admin Office Remodel</i></p> <p>Estimated Completion Date: <i>2017-2018</i></p> | 3 | JOB | \$250 | \$750 |

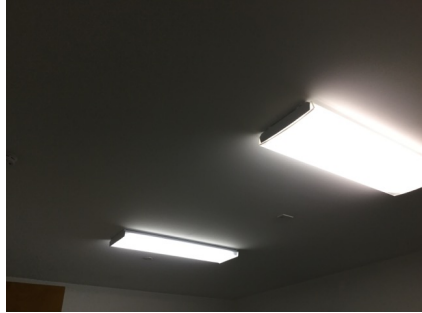
| 273 | <ul style="list-style-type: none"> <i>As-Built Description:</i> At facility with a fire alarm system, visual signal (strobe) not provided at required type of common use area. <i>Proposed Solution:</i> Provide combination visual / audible signal device connected to existing fire alarm system. | <p><i>PCODE</i> IC05</p> <p><i>ADAAG 91</i> 4.1.3(14) & 4.28.3</p> <p><i>ADA 2010</i> 215.1 & 702.1</p> <p><i>CBC 2007</i> 1114B.2.2</p> <p><i>CBC 2016</i> 11B-215.1 & 11B-702.1</p> <p>Priority 1</p> <p>Severity 3</p> <p>Mitigation Project: <i>Admin Office Remodel</i></p> <p>Estimated Completion Date: <i>2017-2018</i></p> | 1 | JOB | \$400 | \$400 |

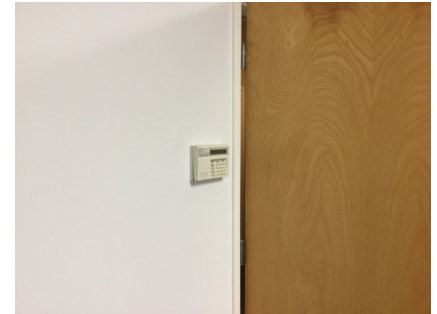
| 274 | <ul style="list-style-type: none"> • <i>As-Built Description:</i> Electric switch or control mounted less than 15" measured to the bottom of the outlet box or greater than 48 inches measured to the top of the outlet box. • <i>As-Built:</i> 57.25" high security alarm • <i>Proposed Solution:</i> Relocate light switches or control to between 15" and 48" height. | <p>PCODE IC01 ADAAG 91 4.2.5 & 6 ADA 2010 308.2.1 & 308.2.2 CBC 2007 1117B.6.3 CBC 2016 11B-308.2.1 & 11B-308.2.2</p> <p>Priority 1 Severity 3</p> <p>Mitigation Project: <i>Admin Office Remodel</i></p> <p>Estimated Completion Date: <i>2017-2018</i></p> | 1 | JOB | \$300 | \$300 |

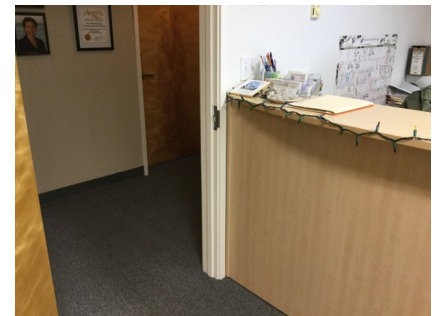
| 269 | <ul style="list-style-type: none"> • <i>As-Built Description:</i> Front approach: At pull side, door does not have clear and level maneuvering space measuring door width plus 18" x 60". (24" x 60" at exterior doors). • <i>As-Built:</i> 2" to counter • <i>Proposed Solution:</i> Provide relocated new door and frame; remodel walls as needed. | <p>PCODE ID23B ADAAG 91 Fig. 25(a) ADA 2010 404.2.4 CBC 2007 11B-26A(a) CBC 2016 11B-404.2.4</p> <p>Priority 1 Severity 2</p> <p>Mitigation Project: <i>Admin Office Remodel</i></p> <p>Estimated Completion Date: <i>2017-2018</i></p> | 1 | JOB | \$2,600 | \$2,600 |

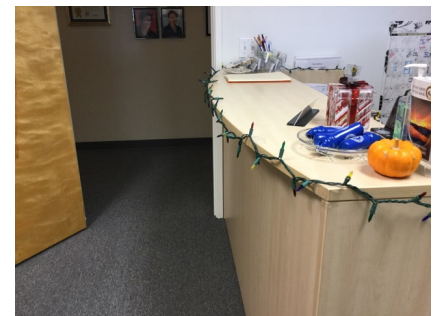
| 270 | <ul style="list-style-type: none"> • <i>As-Built Description:</i> Sales and service counter: Accessible section min. 36" length and 36" max. height (in CA: 28" to 34" high) not provided. • <i>As-Built:</i> 41" high counter • <i>Proposed Solution:</i> Provide auxiliary shelf, clipboard, or table as equivalent facilitation. | <p>PCODE IN03 ADAAG 91 7.2(2) ADA 2010 904.4 CBC 2007 1122B.4 CBC 2016 11B-904.4</p> <p>Priority 1 Severity 3</p> <p>Mitigation Project: <i>Admin Office Remodel</i></p> <p>Estimated Completion Date: <i>2017-2018</i></p> | 1 | JOB | \$150 | \$150 |

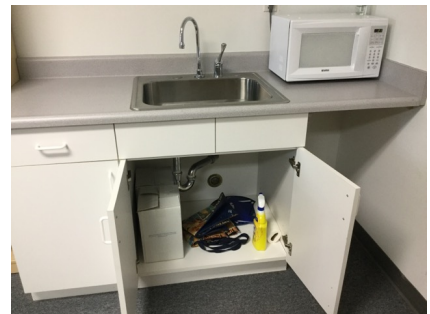
- 272
- *As-Built Description:*
Sink does not have knee space min. 27" high x 19" deep x 30" wide.
 - *Proposed Solution:*
Remodel sink cabinet.
