SAN MATEO COUNTY HARBOR DISTRICT

ADA Self-Evaluation and Transition Plan

August 2018

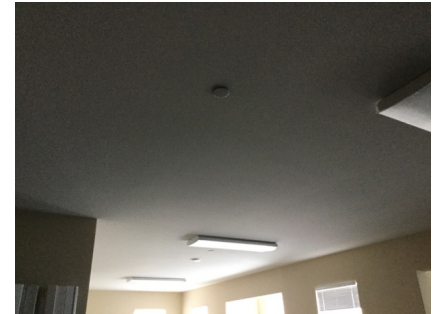
| 278 | <ul style="list-style-type: none"> <i>As-Built Description:</i> At facility with a fire alarm system, visual signal (strobe) not provided at required type of common use area. <i>Proposed Solution:</i> Provide combination visual / audible signal device connected to existing fire alarm system. | <p>PCODE IC05 ADAAG 91 4.1.3(14) & ADA 2010 4.28.3 215.1 & 702.1 CBC 2007 1114B.2.2 CBC 2016 11B-215.1 & 11B-702.1</p> <p>Priority 2 Severity 3</p> | 1 | JOB | \$400 | \$400 |

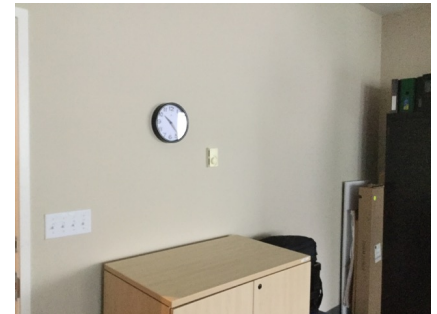
| 277 | <ul style="list-style-type: none"> <i>As-Built Description:</i> Electric switch or control mounted less than 15" measured to the bottom of the outlet box or greater than 48 inches measured to the top of the outlet box. <i>As-Built:</i> Thermostat: 57.5" high <i>Proposed Solution:</i> Relocate light switches or control to between 15" and 48" height. | <p>PCODE IC01 ADAAG 91 4.2.5 & 6 ADA 2010 308.2.1 & 308.2.2 CBC 2007 1117B.6.3 CBC 2016 11B-308.2.1 & 11B-308.2.2</p> <p>Priority 2 Severity 3</p> | 1 | JOB | \$300 | \$300 |

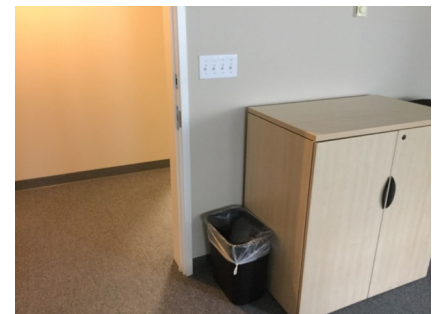
| 276 | <ul style="list-style-type: none"> <i>As-Built Description:</i> Front approach: At pull side, door does not have clear and level maneuvering space measuring door width plus 18" x 60". (24" x 60" at exterior doors). <i>As-Built:</i> 14" to cabinet <i>Proposed Solution:</i> Remove or relocate furniture or storage items. | <p>PCODE ID23AREF ADAAG 91 Fig. 25(a) ADA 2010 404.2.4 CBC 2007 11B-26A(a) CBC 2016 11B-404.2.4</p> <p>Priority 2 Severity 4</p> | REF | | | |

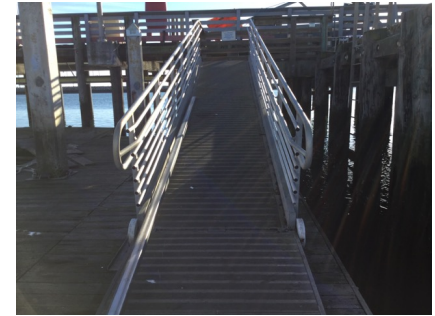
| 744 | <ul style="list-style-type: none"> • <i>As-Built Description:</i> Barriers identified along the gangway ramp are compliant per meeting one or more of the exceptions specified for recreational boating facilities. • <i>As-Built:</i> Gangway ramp serving 1 boat slip meets exceptions • <i>Proposed Solution:</i> No changes necessary. • <i>Notes:</i> 26.0% slope on gangway ramp 28' long gangway ramp serving 1 boat slip. | <p><i>PCODE</i> NZ01 <i>ADA 2010</i> 1003.2 <i>CBC 2016</i> 11B-1003.2</p> <p><i>Priority</i> 2 -</p> | REF |

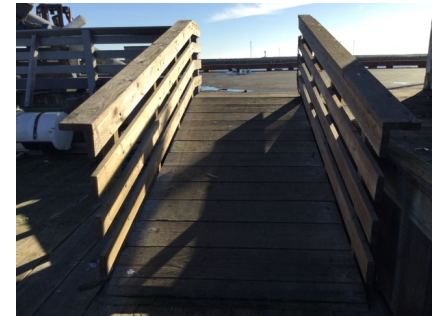
| 742 | <ul style="list-style-type: none"> • <i>As-Built Description:</i> Slope greater than 1:12 (8.3%). • <i>As-Built:</i> 23.7% • <i>Proposed Solution:</i> Demolish existing and provide new ramp with handrails. | <p><i>PCODE</i> EB02 <i>ADAAG 91</i> 4.8.2 <i>ADA 2010</i> 405.2 <i>CBC 2007</i> 1133B.5.3 <i>CBC 2016</i> 11B-405.2</p> <p><i>Priority</i> 2 <i>Severity</i> 1</p> | 240 SF \$100 \$24,000 |

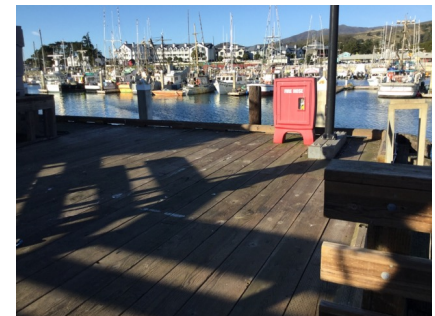
| 743 | <ul style="list-style-type: none"> • <i>As-Built Description:</i> Guards (42" high) not provided at side of ramp or landing where drop-off to adjacent grade or floor exceeds 30" height (California building code requirement only). • <i>Proposed Solution:</i> Provide new guards, including handrail at ramp. • <i>Notes:</i> Recommend guardrails at areas where no boat docking occurs | <p><i>PCODE</i> ED08 <i>CBC 2007</i> 1133B.5.7 <i>CBC 2016</i> Section 1013.2; 1013.3</p> <p><i>Priority</i> 2 <i>Severity</i> 2</p> | 60 LF \$120 \$7,200 |

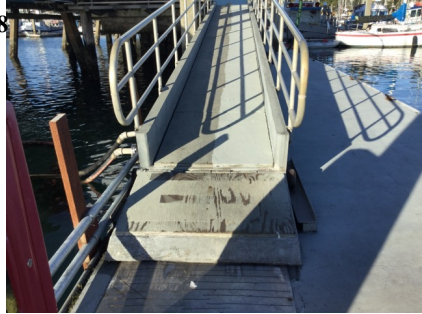
| 749 | <ul style="list-style-type: none"> • <i>As-Built Description:</i> Dislocation creates abrupt change in level exceeding 1/2" on the accessible route along the gangway ramp. • <i>As-Built:</i> Significant lip at transition plate • <i>Proposed Solution:</i> Modify gangway ramp to smooth or ramp abrupt portion. • <i>Notes:</i> Staff on duty to assist | <p>PCODE NZ01B</p> <p>ADA 2010 1003.2.1 Exception 8</p> <p>CBC 2016 11B-1003.2.1 Exception 8</p> <p>Priority 2</p> <p>Severity 3</p> | 1 | JOB | \$500 | \$500 |

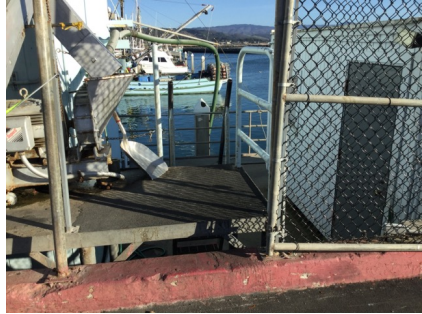
| 745 | <ul style="list-style-type: none"> • <i>As-Built Description:</i> Ramp needed to provide disabled access at steps or change of level along path of travel. • <i>As-Built:</i> Access to boat slip directly serving fueling station only by stairs or pulling up via boat • <i>Proposed Solution:</i> Provide new concrete ramp with handrails [slope more than 1:20 (5.0%) needed]. • <i>Notes:</i> Stairs significantly noncompliant. Area would require significant remodeling to provide access to the existing fueling station from the harbor area, check feasibility or possibility of relocating fuel station. | <p>PCODE EB01AREF</p> <p>ADAAG 91 4.1.1</p> <p>ADA 2010 303.4</p> <p>CBC 2007 1127B.1</p> <p>CBC 2016 11B-303.4</p> <p>Priority 2</p> <p>Severity 3</p> | REF | | | |

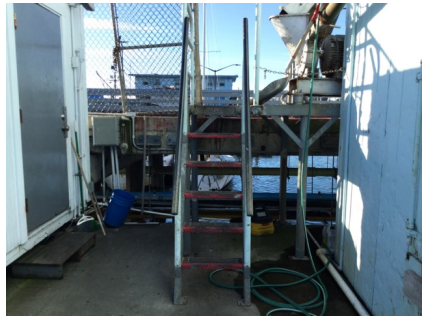
| 747 | <ul style="list-style-type: none"> • <i>As-Built Description:</i> Stair does not have closed risers. • <i>Proposed Solution:</i> Modify stair to have closed risers • <i>Notes:</i> Stair significantly noncompliant | <p>PCODE EC03REF</p> <p>ADAAG 91 4.9.2</p> <p>ADA 2010 504.3</p> <p>CBC 2007 1133B.4.5.3</p> <p>CBC 2016 11B-504.3</p> <p>Priority 2</p> <p>Severity 3</p> | REF | | | |

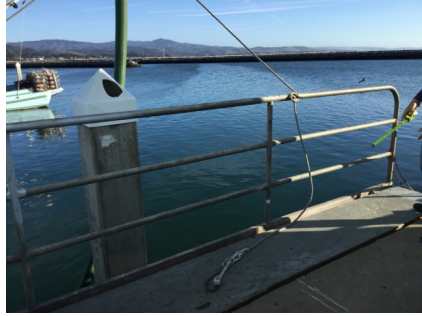
| Item No. and Name | Existing Architectural Barrier and Proposed Solution | Codes / Mitigation Info | Qty | Unit | Cost | Total |
|---|---|---|---|---|---|---|
| 748 | <ul style="list-style-type: none"> <i>As-Built Description:</i> Open guards does not have balusters or ornamental patterns such that a 4-inch-diameter (102 mm) sphere cannot pass through any opening. <i>As-Built:</i> 12" openings <i>Proposed Solution:</i> Provide new guards which do not allow passage of an 4 inch sphere at any opening. | <p><i>PCODE</i> ED08A <i>ADA 2010</i> 405.9.2 <i>CBC 2007</i> 1013.3 <i>CBC 2016</i> 11B-405.9.2</p> <p>Priority 2 Severity 2</p> | 15 | LF | \$120 | \$1,800 |

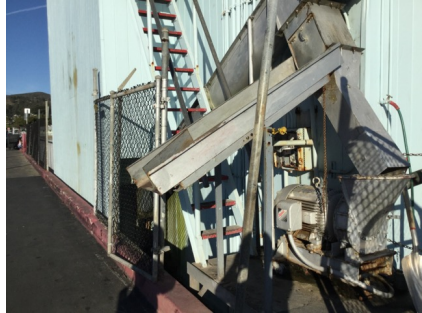
| 746 | <ul style="list-style-type: none"> <i>As-Built Description:</i> Protruding objects more than 4" from wall, when bottom of object more than 27" or less than 80" above finished floor. <i>As-Built:</i> Railing: 22" at 46" high <i>Proposed Solution:</i> Remove/relocate protruding object. Patch existing surface. | <p><i>PCODE</i> EG04 <i>ADAAG 91</i> 4.4.1 <i>ADA 2010</i> 307.2 <i>CBC 2007</i> 1133B.8.6.1 <i>CBC 2016</i> 11B-307.2</p> <p>Priority 2 Severity 1</p> | 1 | JOB | \$100 | \$100 |

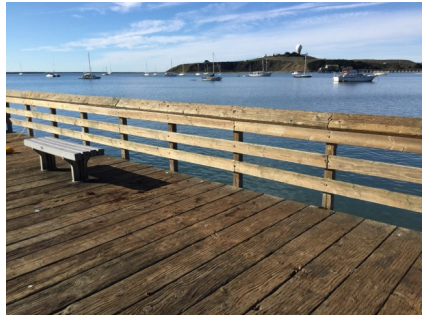
| <u>Fishing Piers and Platforms</u> | | | | | | |
|---|--|---|---|---|---|---|
| 850 | <ul style="list-style-type: none"> <i>As-Built Description:</i> Less than 25% of the railings, guards, or handrails are accessible. <i>As-Built:</i> 42" high railing throughout <i>Proposed Solution:</i> Replace at least 25% of the railings, guards, or hand rails and insure that they are a max. 34" above the ground or deck surface. Notes: Also provide 12" edge protection passed the fishing pier. | <p><i>PCODE</i> NZ02 <i>ADA 2010</i> 1005.2.1 <i>CBC 2016</i> 11B-1005.2.1</p> <p>Priority 2 Severity 3</p> | 50 | LF | \$250 | \$12,500 |

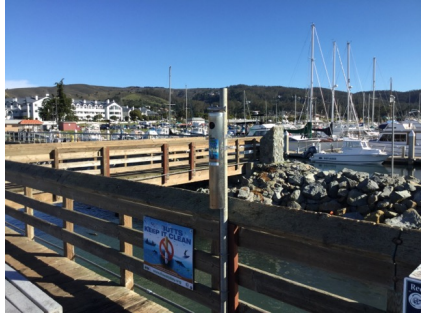
| Item No. and Name | Existing Architectural Barrier and Proposed Solution | Codes / Mitigation Info | Qty | Unit | Cost | Total |
|---|--|---|---|---|---|---|
| 851 | <ul style="list-style-type: none"> <i>As-Built Description:</i> Reach height to control or access point, exceeds 48" or is less than 15". <i>As-Built:</i> Cigarettes bin: 60" high <i>Proposed Solution:</i> Modify equipment or mounting. | <p><i>PCODE</i> IE01 <i>ADAAG 91</i> 4.2.5 <i>ADA 2010</i> 308.2.1 <i>CBC 2007</i> 1118B.5 <i>CBC 2016</i> 11B-308.2.1</p> <p>Priority 2 Severity 2</p> | 1 | JOB | \$100 | \$100 |

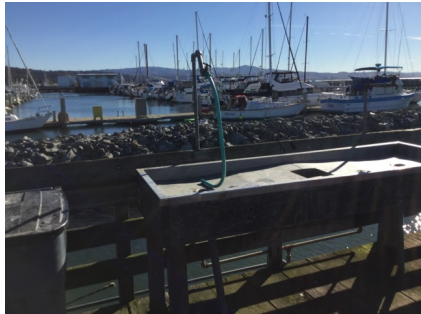
| Item No. and Name | Existing Architectural Barrier and Proposed Solution | Codes / Mitigation Info | Qty | Unit | Cost | Total |
|---|--|---|---|---|---|---|
| 853 | <ul style="list-style-type: none"> <i>As-Built Description:</i> Reach height to control or access point, exceeds 48" or is less than 15". <i>As-Built:</i> 63" high to sink controls <i>Proposed Solution:</i> Modify equipment or mounting. | <p><i>PCODE</i> IE01 <i>ADAAG 91</i> 4.2.5 <i>ADA 2010</i> 308.2.1 <i>CBC 2007</i> 1118B.5 <i>CBC 2016</i> 11B-308.2.1</p> <p>Priority 2 Severity 2</p> | 1 | JOB | \$100 | \$100 |

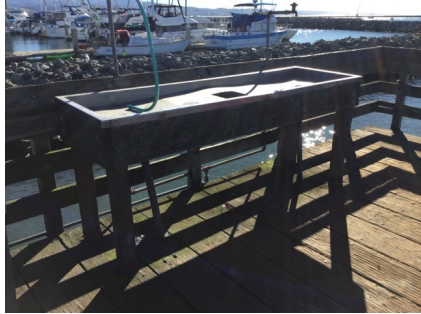
| Item No. and Name | Existing Architectural Barrier and Proposed Solution | Codes / Mitigation Info | Qty | Unit | Cost | Total |
|---|--|---|---|---|---|---|
| 852 | <ul style="list-style-type: none"> <i>As-Built Description:</i> Sink rim higher than 34" above floor. <i>As-Built:</i> 37.25" high <i>Proposed Solution:</i> Remodel sink cabinet to lower sink. | <p><i>PCODE</i> IN06 <i>ADAAG 91</i> 4.24.2 <i>ADA 2010</i> 606.3 <i>CBC 2007</i> 1115B.4.7.1 <i>CBC 2016</i> 11B-606.3</p> <p>Priority 2 Severity 4</p> | 1 | JOB | \$1,750 | \$1,750 |

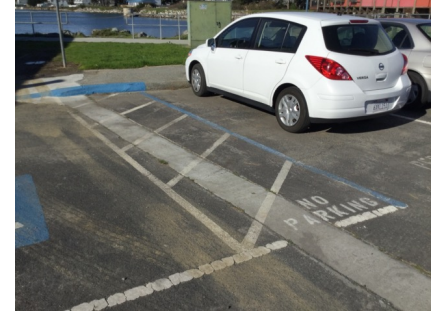
| Item No. and Name | Existing Architectural Barrier and Proposed Solution | Codes / Mitigation Info | Qty | Unit | Cost | Total |
|---|---|---|---|---|---|---|
| 869 | <ul style="list-style-type: none"> As-Built Description: The words "NO PARKING" not painted on the ground within loading and unloading access aisle (12" min high white letters), located so that it is visible to traffic enforcement officials (required in CA only). As-Built: Not 12" high lettering Proposed Solution: Provide the words "NO PARKING" in each access aisle, painted in 12" high letters, when altering area. | PCODE EA04D ADA 2010 502.3.3 CBC 2007 1129B.3.1 CBC 2016 11B-502.3.3 Priority 1 Severity 4 | 1 | JOB | \$100 | \$100 |

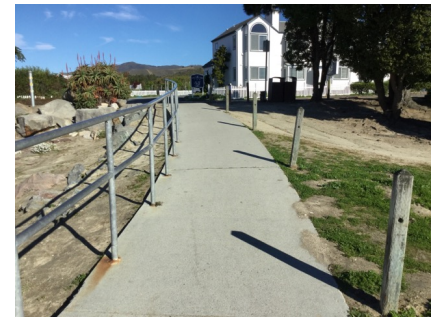
| 874 | <ul style="list-style-type: none"> As-Built Description: Slope greater than 1:12 (8.3%). As-Built: 8.3-11.1% Proposed Solution: Demolish existing and provide new ramp with handrails. Notes: Modify to be compliant either as a walk or ramp when fixing cross slope | PCODE EB02REF ADAAG 91 4.8.2 ADA 2010 405.2 CBC 2007 1133B.5.3 CBC 2016 11B-405.2 Priority 1 Severity 3 | REF | | | |

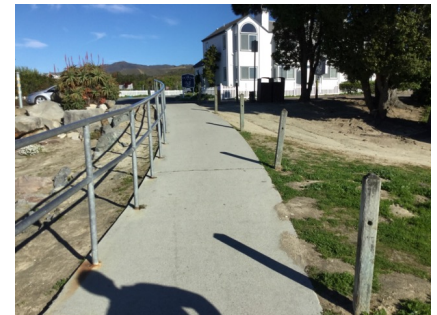
| 875 | <ul style="list-style-type: none"> As-Built Description: Handrail not provided at stairs or ramp, required on both sides (not required at curb ramps or adjacent to seating areas). Proposed Solution: Provide new handrail for each side including extensions. Notes: If choosing to consider as a ramp | PCODE ED01REF ADAAG 91 4.8.5 & 4.9.4 ADA 2010 505.2 CBC 2007 1133B.4.1.1 CBC 2016 & .5.5 11B-505.2 Priority 1 Severity 2 | REF | | | |

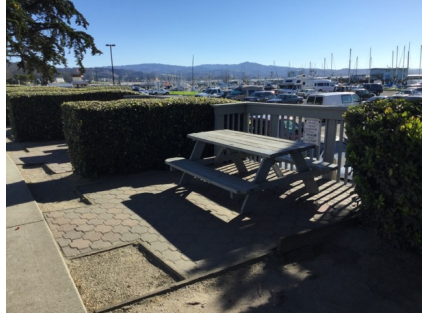
| Item No. and Name | Existing Architectural Barrier and Proposed Solution | Codes / Mitigation Info | Qty | Unit | Cost | Total |
|---|---|---|---|---|---|---|
| 876 | <ul style="list-style-type: none"> <i>As-Built Description:</i> Knee clearance at minimums 27" high, 30" wide, and 19" deep is not provided. <i>As-Built:</i> No wheelchair space at table 25" high knee <i>Proposed Solution:</i> Modify picnic table as required to provide knee clearance. | <p>PCODE NH11A ADAAG 91 16.5.4. ADA 2010 306.3 CBC 2007 1132B.1 CBC 2016 11B-306.3</p> <p>Priority 1 Severity 2</p> | 1 | JOB | \$850 | \$850 |

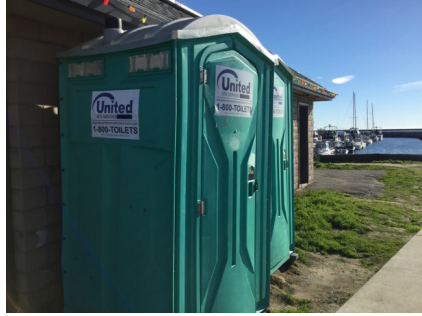
| 1068 | <ul style="list-style-type: none"> <i>As-Built Description:</i> Portable restroom not accessible; multiple compliance violations. <i>Proposed Solution:</i> Contact vendor to provide a compliance accessible unit. Notes: Provide ones of the accessible type to the public using fishing pier that do not have access to private restrooms and showers provided adjacent. | <p>PCODE WA01C ADAAG 91 4.22 ADA 2010 603.1 CBC 2007 1115B.3.1 CBC 2016 11B-603.1</p> <p>Priority 1 Severity 3</p> | 1 | JOB | \$3,000 | \$3,000 |

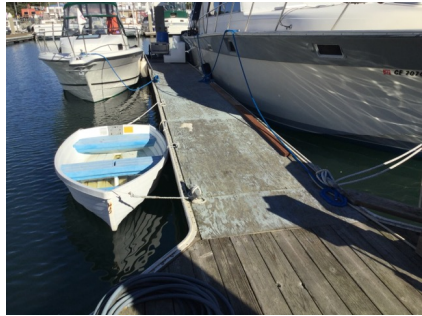
| 884 | <ul style="list-style-type: none"> <i>As-Built Description:</i> A 60" clearance for the full length of the pier is not provided or 10' max. of linear pier edge serving boat slips do not contain at least one continuous clear opening 60" wide. <i>As-Built:</i> 48" wide boat slips <i>Proposed Solution:</i> Provide a 60" clearance for the full length of the pier. Each 10' max. of linear pier edge serving boat slips shall contain at least one continuous clear opening 60" wide. Notes: Individual numbered slips are noncompliant but unnumbered slips are provided on the main slip that are compliant. | <p>PCODE NY02REF ADA 2010 1003.3.1 CBC 2016 11B-1003.3.1</p> <p>Priority 2 Severity 3</p> <p>Mitigation Project: Johnson Pier A-C docks Estimated Completion Date: 2023 and beyond</p> | REF | | | | |

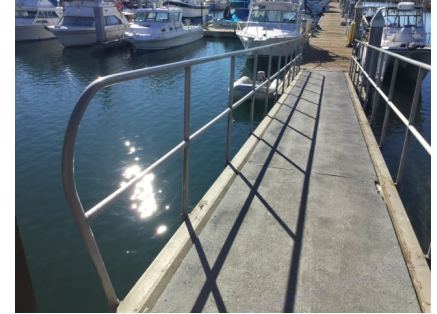
| 881 | <ul style="list-style-type: none"> <i>As-Built Description:</i> No curb (2" minimum height) or wheel guide (centered approx. 3" above surface of ramp) at sides of ramp. <i>As-Built:</i> No wheel guides provided <i>Proposed Solution:</i> Provide 2" minimum curb or wheel guide. | <p>PCODE EB14 ADAAG 91 4.8.7 ADA 2010 405.9.2 CBC 2007 1133B.5.6 CBC 2016 11B-405.9.2</p> <p>Priority 2 Severity 3</p> <p>Mitigation Project: <i>Johnson Pier A-C docks</i> Estimated Completion Date: <i>2023 and beyond</i></p> | 160 | LF | \$17 | \$2,720 |

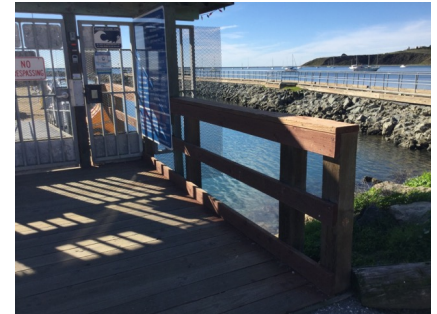
| 879 | <ul style="list-style-type: none"> <i>As-Built Description:</i> Open guards does not have balusters or ornamental patterns such that a 4-inch-diameter (102 mm) sphere cannot pass through any opening. <i>As-Built:</i> 12" openings <i>Proposed Solution:</i> Provide new guards which do not allow passage of an 4 inch sphere at any opening. | <p>PCODE ED08A ADA 2010 405.9.2 CBC 2007 1013.3 CBC 2016 11B-405.9.2</p> <p>Priority 2 Severity 2</p> <p>Mitigation Project: <i>Johnson Pier A-C docks</i> Estimated Completion Date: <i>2023 and beyond</i></p> | 25 | LF | \$120 | \$3,000 |

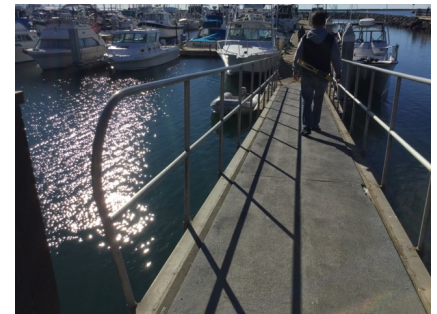
| 882 | <ul style="list-style-type: none"> <i>As-Built Description:</i> Open guards does not have balusters or ornamental patterns such that a 4-inch-diameter (102 mm) sphere cannot pass through any opening. <i>As-Built:</i> 19.5" openings <i>Proposed Solution:</i> Provide new guards which do not allow passage of an 4 inch sphere at any opening. | <p>PCODE ED08A ADA 2010 405.9.2 CBC 2007 1013.3 CBC 2016 11B-405.9.2</p> <p>Priority 2 Severity 1</p> <p>Mitigation Project: <i>Johnson Pier A-C docks</i> Estimated Completion Date: <i>2023 and beyond</i></p> | 80 | LF | \$120 | \$9,600 |

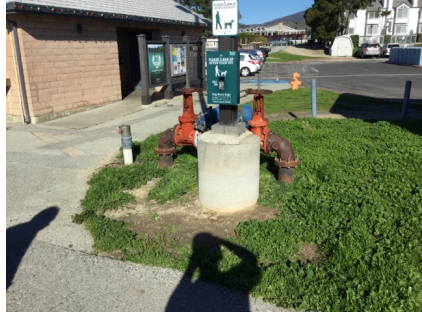
| 889 | <ul style="list-style-type: none"> <i>As-Built Description:</i> No walk / sidewalk provided to connect accessible facilities or elements that are on the same site. <i>As-Built:</i> To dog waste bags <i>Proposed Solution:</i> Provide new 48" wide walk / sidewalk. | <p><i>PCODE</i> EF13</p> <p>ADAAG 91 4.3.2</p> <p>ADA 2010 206.1</p> <p>CBC 2007 1114B.1.2</p> <p>CBC 2016 11B-206.1</p> <p>Priority 1</p> <p>Severity 3</p> | 3 | LF | \$45 | \$135 |

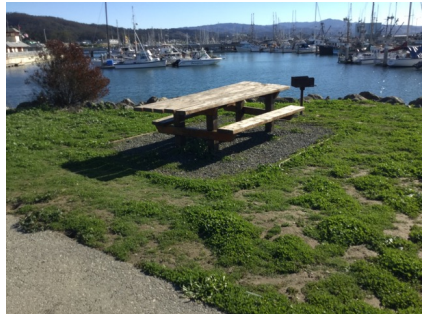
| 896 | <ul style="list-style-type: none"> <i>As-Built Description:</i> No walk / sidewalk provided to connect accessible facilities or elements that are on the same site. <i>As-Built:</i> To picnic table and grill <i>Proposed Solution:</i> Provide new 48" wide walk / sidewalk. | <p><i>PCODE</i> EF13</p> <p>ADAAG 91 4.3.2</p> <p>ADA 2010 206.1</p> <p>CBC 2007 1114B.1.2</p> <p>CBC 2016 11B-206.1</p> <p>Priority 1</p> <p>Severity 3</p> | 15 | LF | \$45 | \$675 |

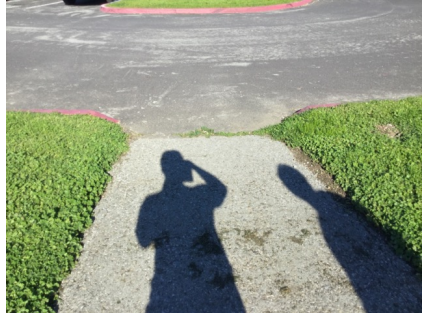
| 895 | <ul style="list-style-type: none"> <i>As-Built Description:</i> 36" wide band of truncated domes not provided at walkway or crossing adjoining a vehicular way, if surfaces are not separated by a curb, railing, or other element. <i>Proposed Solution:</i> Provide 36" wide, contrasting color, band of truncated domes between pedestrian and vehicular area. | PCODE EG09 ADAAG 91 4.29.5 CBC 2007 1133B.8.5 CBC 2016 11B-705.1.2.5 Priority 1 Severity 3 | 4 | LF | \$27 | \$108 |

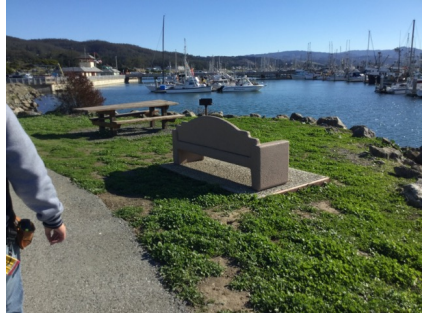
| 894 | <ul style="list-style-type: none"> <i>As-Built Description:</i> Clear and level floor or ground space (30" x 48") not overlapping with other clear space requirements, is not provided at at least one end of the bench. <i>Proposed Solution:</i> Provide and position a clear and level floor or ground space to allow wheelchair users to be seated shoulder-to-shoulder with an individual seated on the bench. Notes: 5 benches in area Provide at different viewing areas; recommend at least 3. | PCODE N007 ADAAG 91 4.32.2 ADA 2010 903.2 CBC 2007 1118B.4 CBC 2016 11B-903.2 Priority 1 Severity 3 | 3 | JOB | \$500 | \$1,500 |

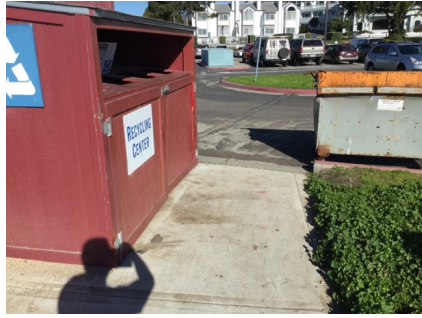
| 892 | <ul style="list-style-type: none"> <i>As-Built Description:</i> Clear spaces slope exceeds 1:48 max in all directions or not a minimum size of 30" by 48". <i>As-Built:</i> 3.8% at clear space to recycle bins <i>Proposed Solution:</i> Regrade and remodel area as required. | PCODE NS05 ADAAG 91 16.16.4 ADA 2010 305.2; 305.3 CBC 2007 1132B.1 CBC 2016 11B-305.2; 11B-305.3 Priority 1 Severity 4 | 15 | SF | \$25 | \$375 |

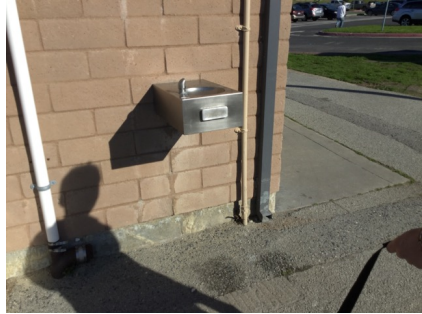
| Item No. and Name | Existing Architectural Barrier and Proposed Solution | Codes / Mitigation Info | Qty | Unit | Cost | Total |
|---|--|--|---|---|---|---|
| 887 | <ul style="list-style-type: none"> • <i>As-Built Description:</i> Drinking fountain bubbler more than 36" above floor. • <i>As-Built:</i> 44" high bubbler • <i>Proposed Solution:</i> Provide new, accessible fountain. | <p>PCODE IA03B ADAAG 91 4.15.2 ADA 2010 602.4 CBC 2007 1115B.4.6.4 CBC 2016 11B-602.4</p> <p>Priority 1 Severity 3</p> | 1 | JOB | \$3,200 | \$3,200 |

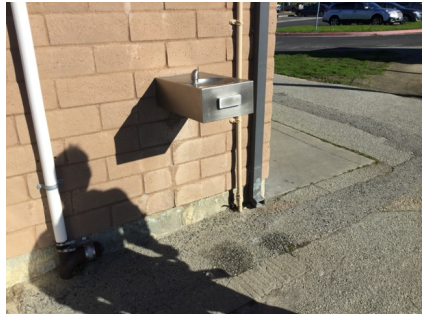
| Item No. and Name | Existing Architectural Barrier and Proposed Solution | Codes / Mitigation Info | Qty | Unit | Cost | Total |
|---|--|--|---|---|---|---|
| 886 | <ul style="list-style-type: none"> • <i>As-Built Description:</i> Drinking fountain lacks protection for visually impaired persons. • <i>Proposed Solution:</i> Provide cane-detectable rails. | <p>PCODE IA05C ADAAG 91 4.4.1 ADA 2010 307.2 CBC 2007 1115B.4.6.3 CBC 2016 11B-307.2</p> <p>Priority 1 Severity 3</p> | 1 | JOB | \$500 | \$500 |

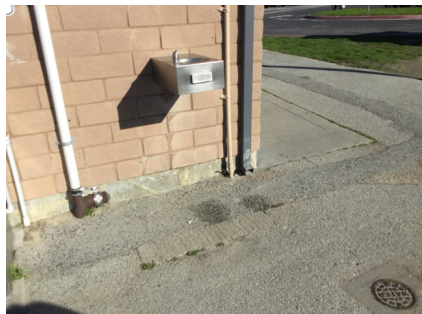
| Item No. and Name | Existing Architectural Barrier and Proposed Solution | Codes / Mitigation Info | Qty | Unit | Cost | Total |
|---|--|--|---|---|---|---|
| 888 | <ul style="list-style-type: none"> • <i>As-Built Description:</i> 30" wide x 48" long clear floor space not provided at drinking fountain. • <i>As-Built:</i> Rough surface at clear space • <i>Proposed Solution:</i> Provide clear floor space at drinking fountain. | <p>PCODE IA06REF ADAAG 91 4.15.5(1)* ADA 2010 602.2 CBC 2007 1115B.4.6.3 CBC 2016 11B-602.2</p> <p>Priority 1 Severity 3</p> | REF | | | |

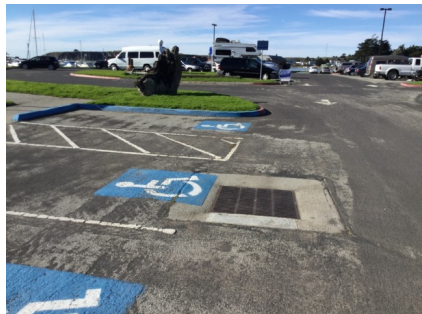
| 904 | <ul style="list-style-type: none"> • <i>As-Built Description:</i> Accessible parking space has slope greater than 1/4":12" (2%). • <i>As-Built:</i> 9.5% due to drain • <i>Proposed Solution:</i> Modify slope at accessible parking space. • Notes: Recommend relocating space | <p>PCODE EA05REF ADAAG 91 4.6.3 ADA 2010 502.4 CBC 2007 1129B.3.3 CBC 2016 11B-502.4</p> <p>Priority 1 Severity 2</p> | REF | | | |

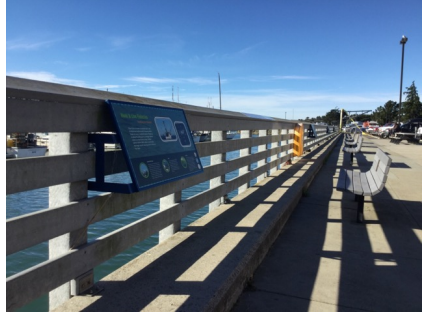
| 915 | <ul style="list-style-type: none"> • <i>As-Built Description:</i> Less than 25% of the railings, guards, or handrails are accessible. • <i>As-Built:</i> 51" high fishing railing • <i>Proposed Solution:</i> Replace at least 25% of the railings, guards, or hand rails and insure that they are a max. 34" above the ground or deck surface. • <i>Notes:</i> Curb on inside of pier prevents wheelchairs from accessing the fishing pier, recommend removing and providing a 12" edge protection passed the fishing pier. | <p><i>PCODE</i> NZ02</p> <p><i>ADA 2010</i> 1005.2.1</p> <p><i>CBC 2016</i> 11B-1005.2.1</p> <p>Priority 1</p> <p>Severity 2</p> | 60 | LF | \$250 | \$15,000 |

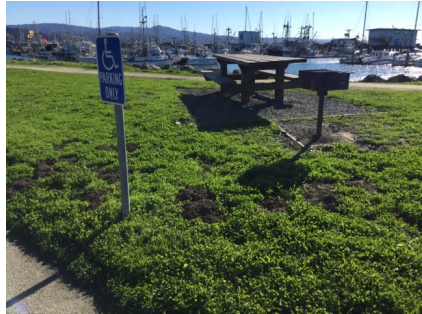
| 908 | <ul style="list-style-type: none"> • <i>As-Built Description:</i> No walk / sidewalk provided to connect accessible facilities or elements that are on the same site. • <i>As-Built:</i> To picnic table • <i>Proposed Solution:</i> Provide new 48" wide walk / sidewalk. • <i>Notes:</i> Additional tables provided and considered | <p><i>PCODE</i> EF13REF</p> <p><i>ADAAG 91</i> 4.3.2</p> <p><i>ADA 2010</i> 206.1</p> <p><i>CBC 2007</i> 1114B.1.2</p> <p><i>CBC 2016</i> 11B-206.1</p> <p>Priority 1</p> <p>Severity 3</p> | REF | | | |

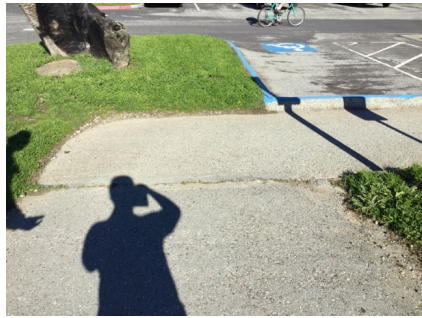
| 907 | <ul style="list-style-type: none"> • <i>As-Built Description:</i> Walk: Pavement dislocation creates abrupt change in level exceeding 1/2" in accessible route. • <i>As-Built:</i> Lip at turn • <i>Proposed Solution:</i> Remove, replace or repair area of pavement sufficient to correct abrupt change in level. | <p><i>PCODE</i> EF03</p> <p><i>ADAAG 91</i> 4.3.8</p> <p><i>ADA 2010</i> 403.4</p> <p><i>CBC 2007</i> 1133B.7.4</p> <p><i>CBC 2016</i> 11B-403.4</p> <p>Priority 1</p> <p>Severity 4</p> | 8 | SF | \$21 | \$168 |

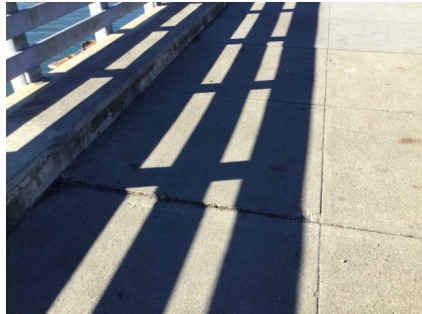
| Item No. and Name | Existing Architectural Barrier and Proposed Solution | Codes / Mitigation Info | Qty | Unit | Cost | Total |
|---|--|---|---|---|---|---|
| 914 | <ul style="list-style-type: none"> <i>As-Built Description:</i> Walk: Pavement dislocation creates abrupt change in level exceeding 1/2" in accessible route. <i>Proposed Solution:</i> Remove, replace or repair area of pavement sufficient to correct abrupt change in level. | PCODE EF03REF ADAAG 91 4.3.8 ADA 2010 403.4 CBC 2007 1133B.7.4 CBC 2016 11B-403.4 Priority 1 Severity 4 | | | | |

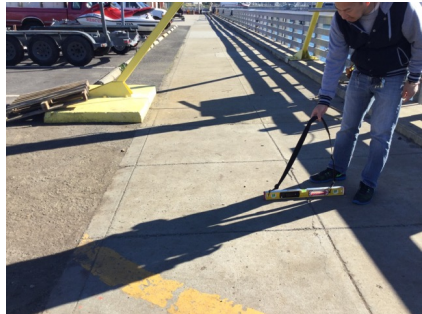
| 913 | <ul style="list-style-type: none"> <i>As-Built Description:</i> Cross slope more than 1":48" (2.083%). <i>Proposed Solution:</i> Modify cross slope. <i>Notes:</i> Entire walk is sloped | PCODE EF07 ADAAG 91 4.3.7 ADA 2010 403.3 CBC 2007 1133B.7.1.3 CBC 2016 11B-403.3 Priority 1 Severity 4 | 1950 | SF | \$25 | \$48,750 |

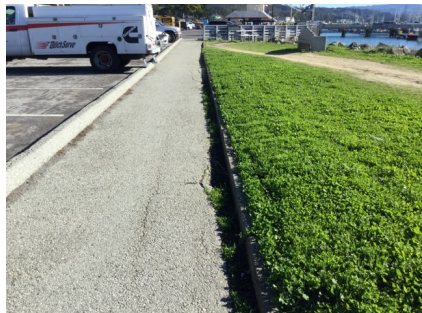
| 909 | <ul style="list-style-type: none"> <i>As-Built Description:</i> Walk: Irregular surface in pavement. <i>As-Built:</i> Along edge of walk <i>Proposed Solution:</i> Smooth pavement surface; grind or refinish surface. | PCODE EF10 ADAAG 91 4.5.2 ADA 2010 303.1; 302.1 CBC 2007 1133B.7.1 CBC 2016 11B-303.1; 11B-302.1 Priority 1 Severity 3 | 500 | SF | \$5 | \$2,500 |

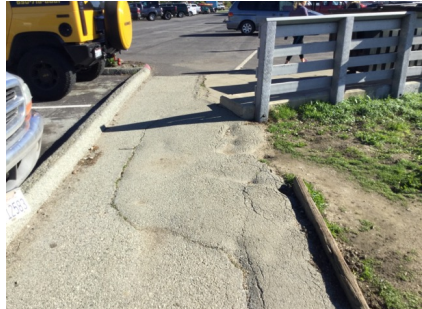
| 910 | <ul style="list-style-type: none"> <i>As-Built Description:</i> Walk: Irregular surface in pavement. <i>Proposed Solution:</i> Smooth pavement surface; grind or refinish surface. | PCODE EF10 ADAAG 91 4.5.2 ADA 2010 303.1; 302.1 CBC 2007 1133B.7.1 CBC 2016 11B-303.1; 11B-302.1 Priority 1 Severity 3 | 120 | SF | \$5 | \$600 |

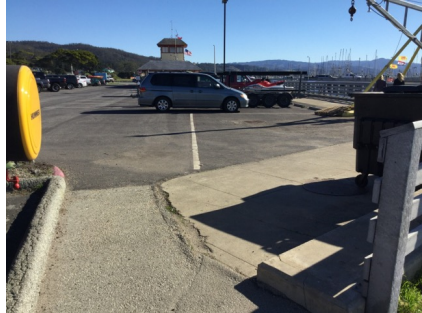
| Item No. and Name | Existing Architectural Barrier and Proposed Solution | Codes / Mitigation Info | Qty | Unit | Cost | Total |
|---|---|---|---|---|---|---|
| 911 | <ul style="list-style-type: none"> <i>As-Built Description:</i> 36" wide band of truncated domes not provided at walkway or crossing adjoining a vehicular way, if surfaces are not separated by a curb, railing, or other element. <i>Proposed Solution:</i> Provide 36" wide, contrasting color, band of truncated domes between pedestrian and vehicular area. | <p><i>PCODE</i> EG09</p> <p><i>ADAAG 91</i> 4.29.5</p> <p><i>CBC 2007</i> 1133B.8.5</p> <p><i>CBC 2016</i> 11B-705.1.2.5</p> <p>Priority 1</p> <p>Severity 3</p> | 5 | LF | \$27 | \$135 |

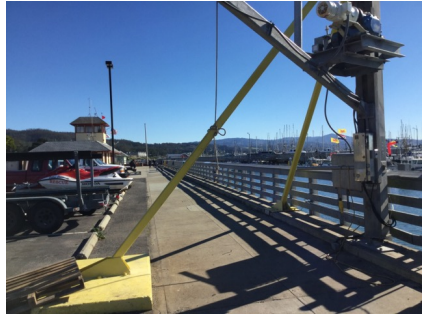
| Item No. and Name | Existing Architectural Barrier and Proposed Solution | Codes / Mitigation Info | Qty | Unit | Cost | Total |
|---|---|---|---|---|---|---|
| 912 | <ul style="list-style-type: none"> <i>As-Built Description:</i> Overhead clearance less than 80" above finished floor. <i>Proposed Solution:</i> Provide cane-detectable railing to mark area of low clearance. Notes: Crane equipment | <p><i>PCODE</i> EG01A</p> <p><i>ADAAG 91</i> 4.4.2</p> <p><i>ADA 2010</i> 307.4</p> <p><i>CBC 2007</i> 1133B.8.6.2</p> <p><i>CBC 2016</i> 11B-307.4</p> <p>Priority 1</p> <p>Severity 2</p> | 15 | LF | \$100 | \$1,500 |

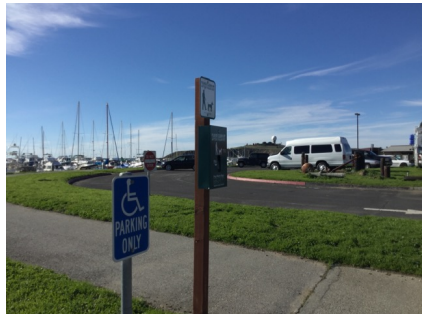
| Item No. and Name | Existing Architectural Barrier and Proposed Solution | Codes / Mitigation Info | Qty | Unit | Cost | Total |
|---|---|---|---|---|---|---|
| 906 | <ul style="list-style-type: none"> <i>As-Built Description:</i> Reach height to control or access point, exceeds 48" or is less than 15". <i>As-Built:</i> Dog waste bin: 61" high <i>Proposed Solution:</i> Modify equipment or mounting. | <p><i>PCODE</i> IE01</p> <p><i>ADAAG 91</i> 4.2.5</p> <p><i>ADA 2010</i> 308.2.1</p> <p><i>CBC 2007</i> 1118B.5</p> <p><i>CBC 2016</i> 11B-308.2.1</p> <p>Priority 1</p> <p>Severity 2</p> | 1 | JOB | \$100 | \$100 |

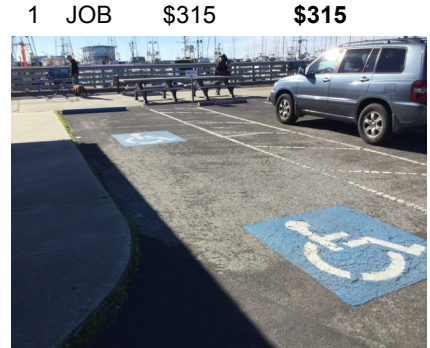
916 • *As-Built Description:*
 Sign for accessible parking space is missing or non-compliant.

Priority 1
Severity 4

Mitigation Project:
Sidewalk and Improvements on Promenade and Parking

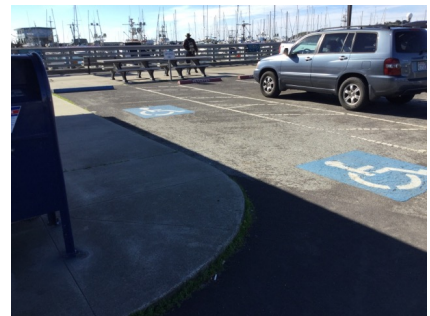
Priority 1
Severity 2

Mitigation Project:
Sidewalk and Improvements on Promenade and Parking

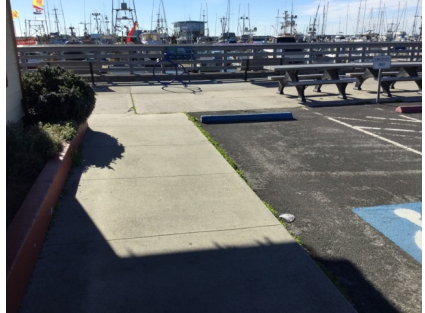
| Item No. and Name | Existing Architectural Barrier and Proposed Solution | Codes / Mitigation Info | Qty | Unit | Cost | Total |
|---|--|--|---|---|---|---|
| 922 | <ul style="list-style-type: none"> • <i>As-Built Description:</i> Cross slope more than 1":48" (2.083%). • <i>As-Built:</i> 4.2-4.5% • <i>Proposed Solution:</i> Modify cross slope. | <p><i>PCODE</i> EF07</p> <p><i>ADAAG 91</i> 4.3.7</p> <p><i>ADA 2010</i> 403.3</p> <p><i>CBC 2007</i> 1133B.7.1.3</p> <p><i>CBC 2016</i> 11B-403.3</p> <p>Priority 1</p> <p>Severity 3</p> <p>Mitigation Project: <i>Sidewalk and Improvements on Promenade and Parking</i></p> <p>Estimated Completion Date: <i>2017-2018</i></p> | 80 | SF | \$25 | \$2,000 |

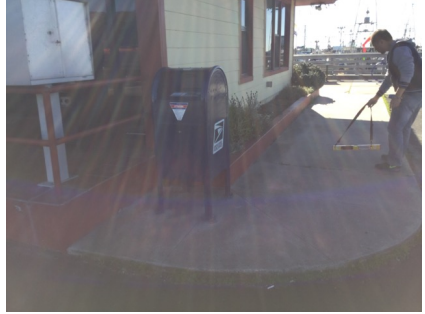
| 920 | <ul style="list-style-type: none"> • <i>As-Built Description:</i> Clear spaces slope exceeds 1:48 max in all directions or not a minimum size of 30" by 48". • <i>As-Built:</i> 28" clear space to mailbox • <i>Proposed Solution:</i> Regrade and remodel area as required. | <p><i>PCODE</i> NS05</p> <p><i>ADAAG 91</i> 16.16.4</p> <p><i>ADA 2010</i> 305.2; 305.3</p> <p><i>CBC 2007</i> 1132B.1</p> <p><i>CBC 2016</i> 11B-305.2; 11B-305.3</p> <p>Priority 1</p> <p>Severity 2</p> <p>Mitigation Project: <i>Sidewalk and Improvements on Promenade and Parking</i></p> <p>Estimated Completion Date: <i>2017-2018</i></p> | 15 | SF | \$25 | \$375 |

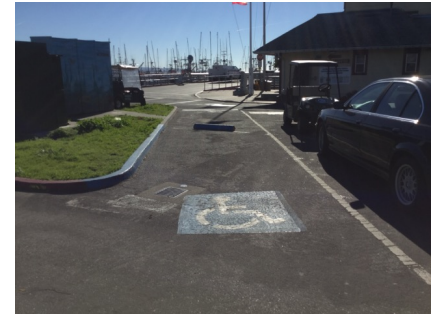
• **Notes:**
Recommend relocating space closer to either the Harbor office or businesses

Priority 1
Severity 4

Mitigation Project:
Sidewalk and Improvements on Promenade and Parking

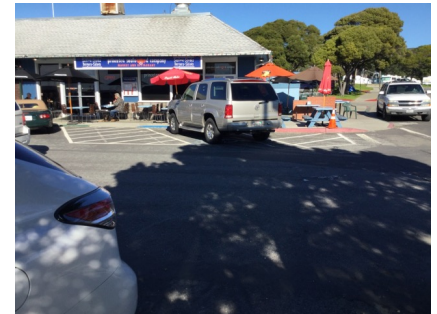
Priority 1
Severity 2

Mitigation Project:
Sidewalk and Improvements on Promenade and Parking

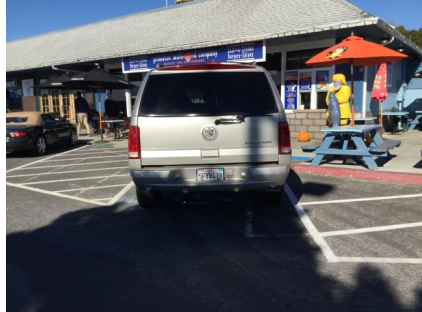
| Item No. and Name | Existing Architectural Barrier and Proposed Solution | Codes / Mitigation Info | Qty | Unit | Cost | Total |
|---|--|---|--|---|---|---|
| 928 | <ul style="list-style-type: none"> <i>As-Built Description:</i> Accessible parking space smaller than 8' wide (CA only: 9' x 18'). <i>Proposed Solution:</i> Modify parking space(s) to create accessible space. | <p>PCODE EA02A ADAAG 91 4.6.3 ADA 2010 502.2 CBC 2007 1129B.3.1 CBC 2016 11B-502.2</p> <p>Priority 1 Severity 4</p> <p>Mitigation Project: <i>Sidewalk and Improvements on Promenade and Parking</i></p> <p>Estimated Completion Date: 2017-2018</p> | 1 | JOB | \$200 | \$200 |

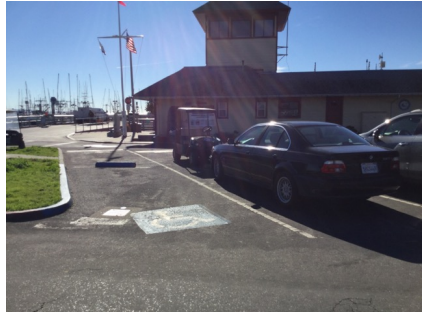
| Item No. and Name | Existing Architectural Barrier and Proposed Solution | Codes / Mitigation Info | Qty | Unit | Cost | Total |
|---|--|---|--|---|---|---|
| 924 | <ul style="list-style-type: none"> <i>As-Built Description:</i> Accessible parking space does not have 5' wide access aisle; 8' wide for van accessible aisle. <i>As-Built:</i> Aisle not provided <i>Proposed Solution:</i> Modify parking aisle(s) to create accessible space by restriping. Notes: In middle between restaurants and harbor office | <p>PCODE EA02B ADAAG 91 4.6.3 ADA 2010 502.3 CBC 2007 1129B.3.1 CBC 2016 11B-502.2; 11B-502.3.1</p> <p>Priority 1 Severity 1</p> <p>Mitigation Project: <i>Sidewalk and Improvements on Promenade and Parking</i></p> <p>Estimated Completion Date: 2017-2018</p> | 1 | JOB | \$200 | \$200 |

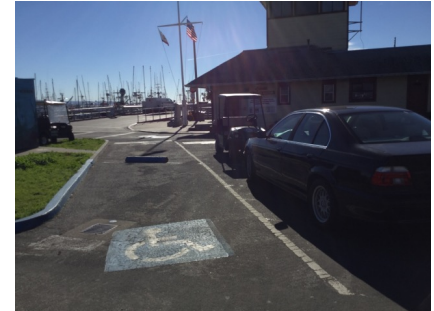
| Item No. and Name | Existing Architectural Barrier and Proposed Solution | Codes / Mitigation Info | Qty | Unit | Cost | Total |
|---|---|--|---|---|---|---|
| 925 | <ul style="list-style-type: none"> <i>As-Built Description:</i> Parking sign is not located between 60" and 80" above the finish floor or ground surface measured to the bottom of the sign. <i>As-Built:</i> No parking signs provided <i>Proposed Solution:</i> Remount existing sign at accessible height. <i>Notes:</i> At all spaces except one on the west end of the restaurants | PCODE EA04H ADAAG 91 4.6.4 ADA 2010 502.7 CBC 2007 1129B.4 CBC 2016 11B-502.6 Priority 1 Severity 4 Mitigation Project: <i>Sidewalk and Improvements on Promenade and Parking</i> Estimated Completion Date: 2017-2018 | 5 | JOB | \$45 | \$225 |

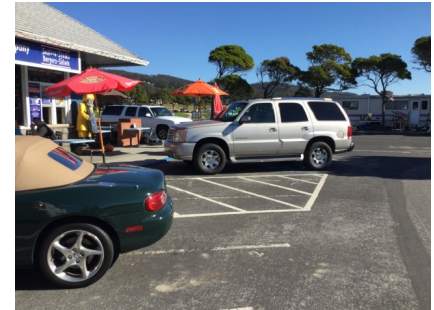
| 931 | <ul style="list-style-type: none"> <i>As-Built Description:</i> No van parking provided (one in every 6 or fraction of 6 accessible spaces, but not less than one). <i>As-Built:</i> No van space <i>Proposed Solution:</i> Provide van parking space(s) by restriping; provide van sign. | PCODE EA07 ADAAG 91 4.1.2(5)(b) ADA 2010 208.2; 502.1 CBC 2007 1129B.3.2 CBC 2016 11B-208.2.4 Priority 1 Severity 2 Mitigation Project: <i>Sidewalk and Improvements on Promenade and Parking</i> Estimated Completion Date: 2017-2018 | 1 | JOB | \$350 | \$350 |

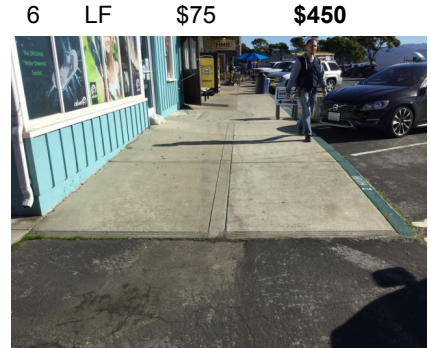
- 935
- *As-Built Description:*
Walk: Pavement dislocation creates abrupt change in level exceeding 1/2" in accessible route.
 - *Proposed Solution:*
Remove, replace or repair area of pavement sufficient to correct abrupt change in level.
 - **Notes:**
Toward service building

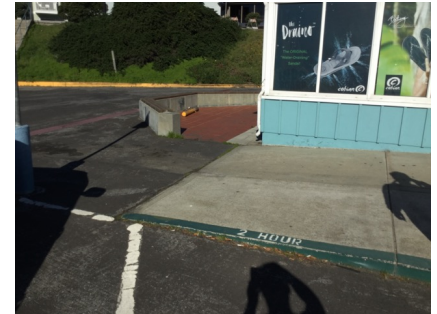
- 930
- *As-Built Description:*
Detectable warning not provided where pedestrian crosses vehicular area.
 - *Proposed Solution:*
Provide detectable warning surface (i.e. in-line truncated domes) at regular curb ramp.

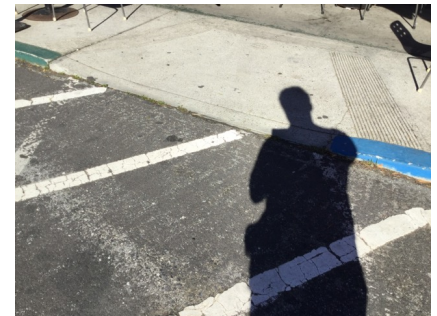
| Item No. and Name | Existing Architectural Barrier and Proposed Solution | Codes / Mitigation Info | Qty | Unit | Cost | Total |
|---|--|--|---|---|---|---|
| 937 | <ul style="list-style-type: none"> <i>As-Built Description:</i> Surface of required maneuvering clearance at door slopes more than 1/4":12" (2.0%). <i>As-Built:</i> Sloped entry at business doors <i>Proposed Solution:</i> Modify surface slope at door. <i>Notes:</i> Lower portion is compliant | <p>PCODE ID11REF ADAAG 91 4.13.6 ADA 2010 404.2.4.4 CBC 2007 1133B.2.4 CBC 2016 11B-404.2.4</p> <p>Priority 1 Severity 4</p> <p>Mitigation Project: <i>Sidewalk and Improvements on Promenade and Parking</i></p> <p>Estimated Completion Date: 2017-2018</p> | | | | |

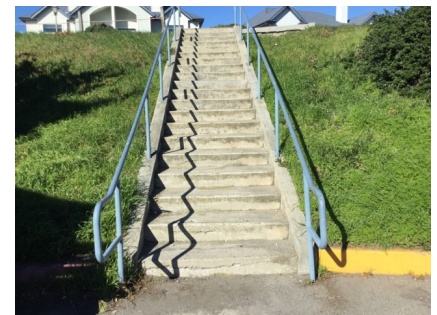
| Item No. and Name | Existing Architectural Barrier and Proposed Solution | Codes / Mitigation Info | Qty | Unit | Cost | Total |
|---|---|--|---|---|---|---|
| 941 | <ul style="list-style-type: none"> <i>As-Built Description:</i> Stair handrail does not extend horizontally 12" minimum beyond top nosing, and one tread width sloped, plus 12" minimum horizontally beyond the bottom nosing. <i>As-Built:</i> 10" extensions <i>Proposed Solution:</i> Extend stair handrail at top and bottom (cost for each extension piece). | PCODE ED06 ADAAG 91 4.9.4(2) ADA 2010 505.10.2; 505.10.3 CBC 2007 1133B.4.2.2 CBC 2016 11B-505.10.2; 11B-505.10.3 Priority 1 Severity 4 | 3 | JOB | \$170 | \$510 |

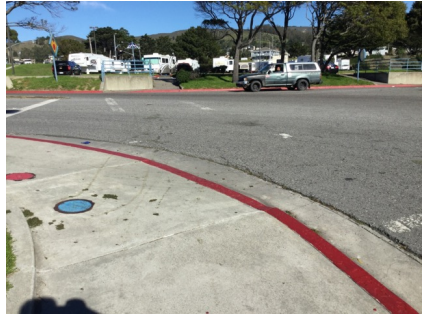
| 947 | <ul style="list-style-type: none"> <i>As-Built Description:</i> Walk: Pavement dislocation creates abrupt change in level exceeding 1/2" in accessible route. <i>As-Built:</i> 0.75" lip <i>Proposed Solution:</i> Remove, replace or repair area of pavement sufficient to correct abrupt change in level. | PCODE EF03 ADAAG 91 4.3.8 ADA 2010 403.4 CBC 2007 1133B.7.4 CBC 2016 11B-403.4 Priority 1 Severity 4 Mitigation Project: <i>Sidewalk and Improvements on Promenade and Parking</i> Estimated Completion Date: 2017-2018 | 4 | SF | \$21 | \$84 |

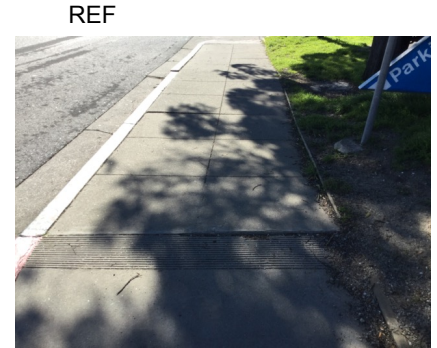
| 953 | <ul style="list-style-type: none"> <i>As-Built Description:</i> Cross slope more than 1":48" (2.083%). <i>As-Built:</i> 5.1-7.9% due to driveway <i>Proposed Solution:</i> Modify cross slope. Notes: Provide flat portion | <p>PCODE EF07</p> <p>ADAAG 91 4.3.7</p> <p>ADA 2010 403.3</p> <p>CBC 2007 1133B.7.1.3</p> <p>CBC 2016 11B-403.3</p> <p>Priority 1</p> <p>Severity 2</p> <p>Mitigation Project: <i>Sidewalk and Improvements on Promenade and Parking</i></p> <p>Estimated Completion Date: <i>2017-2018</i></p> | 80 | SF | \$25 | \$2,000 |

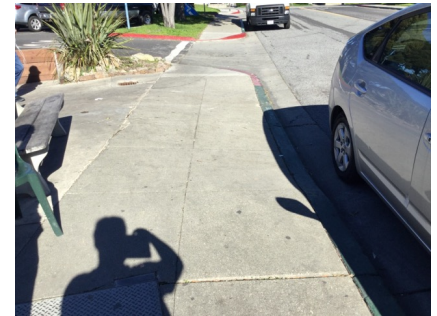
| 954 | <ul style="list-style-type: none"> <i>As-Built Description:</i> Cross slope more than 1":48" (2.083%). <i>As-Built:</i> 5.1% crossings <i>Proposed Solution:</i> Modify cross slope. | <p>PCODE EF07</p> <p>ADAAG 91 4.3.7</p> <p>ADA 2010 403.3</p> <p>CBC 2007 1133B.7.1.3</p> <p>CBC 2016 11B-403.3</p> <p>Priority 1</p> <p>Severity 3</p> <p>Mitigation Project: <i>Sidewalk and Improvements on Promenade and Parking</i></p> <p>Estimated Completion Date: <i>2017-2018</i></p> | 120 | SF | \$25 | \$3,000 |

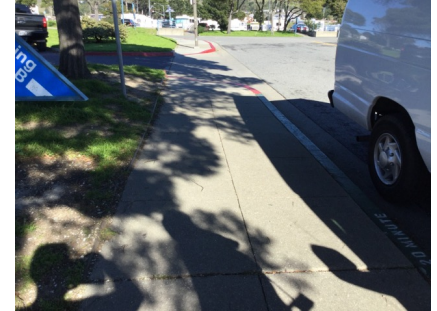
| 960 | <ul style="list-style-type: none"> • <i>As-Built Description:</i> Cross slope more than 1":48" (2.083%). • <i>As-Built:</i> 2.4-4.2% • <i>Proposed Solution:</i> Modify cross slope. | PCODE EF07 ADAAG 91 4.3.7 ADA 2010 403.3 CBC 2007 1133B.7.1.3 CBC 2016 11B-403.3 Priority 1 Severity 4 Mitigation Project: <i>Sidewalk and Improvements on Promenade and Parking</i> Estimated Completion Date: 2017-2018 | 80 | SF | \$25 | \$2,000 |

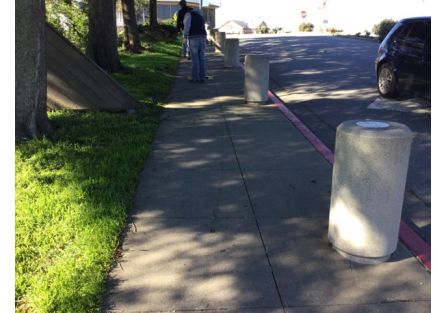
| 950 | <ul style="list-style-type: none"> • <i>As-Built Description:</i> Walk: Irregular surface in pavement. • <i>Proposed Solution:</i> Smooth pavement surface; grind or refinish surface. • Notes: Recommend redoing crossing and widening crossing so width is consistent by reducing the intermediate island. | PCODE EF10 ADAAG 91 4.5.2 ADA 2010 303.1; 302.1 CBC 2007 1133B.7.1 CBC 2016 11B-303.1; 11B-302.1 Priority 1 Severity 3 Mitigation Project: <i>Sidewalk and Improvements on Promenade and Parking</i> Estimated Completion Date: 2017-2018 | 600 | SF | \$5 | \$3,000 |

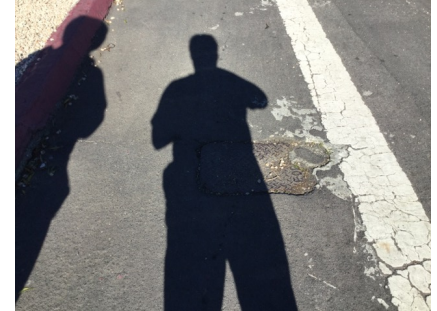
| 945 | <ul style="list-style-type: none"> <i>As-Built Description:</i> Slope greater than 1:12 (8.3%). <i>As-Built:</i> 11.6% <i>Proposed Solution:</i> Demolish existing and provide new curb ramp. | PCODE EH02A ADAAG 91 4.7.2 ADA 2010 406.1 CBC 2007 1127B.5.3 CBC 2016 11B-406.2.1 Priority 1 Severity 3 Mitigation Project: <i>Sidewalk and Improvements on Promenade and Parking</i> Estimated Completion Date: 2017-2018 | 1 | JOB | \$2,500 | \$2,500 |

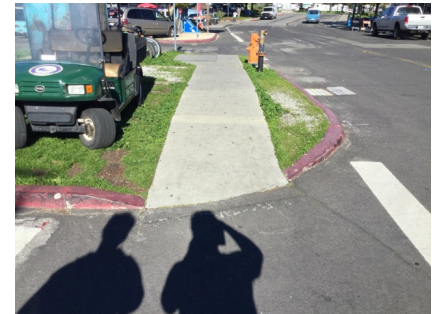
| 948 | <ul style="list-style-type: none"> <i>As-Built Description:</i> Slope greater than 1:12 (8.3%). <i>As-Built:</i> 13.0% <i>Proposed Solution:</i> Demolish existing and provide new curb ramp. Notes: At Parking A exit crossing | PCODE EH02A ADAAG 91 4.7.2 ADA 2010 406.1 CBC 2007 1127B.5.3 CBC 2016 11B-406.2.1 Priority 1 Severity 2 Mitigation Project: <i>Sidewalk and Improvements on Promenade and Parking</i> Estimated Completion Date: 2017-2018 | 1 | JOB | \$2,500 | \$2,500 |

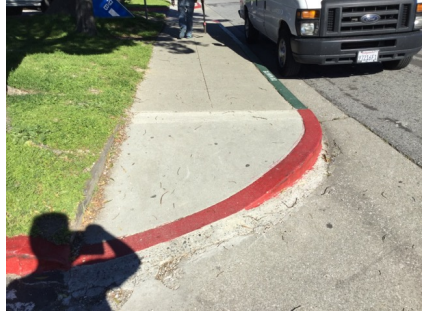
| Item No. and Name | Existing Architectural Barrier and Proposed Solution | Codes / Mitigation Info | Qty | Unit | Cost | Total |
|---|--|---|---|---|---|---|
| 944 | <ul style="list-style-type: none"> • <i>As-Built Description:</i> Transition from curb ramp to gutter does not have a smooth transition. • <i>As-Built:</i> 0.75" gutter lip • <i>Proposed Solution:</i> Grind lip. • <i>Notes:</i> To restrooms | <p>PCODE EH02D</p> <p>ADAAG 91 4.7.2</p> <p>ADA 2010 406.2</p> <p>CBC 2007 1127B.5.3</p> <p>CBC 2016 11B-406.5.8</p> <p>Priority 1</p> <p>Severity 4</p> <p>Mitigation Project: <i>Sidewalk and Improvements on Promenade and Parking</i></p> <p>Estimated Completion Date: <i>2017-2018</i></p> | 1 | JOB | \$100 | \$100 |

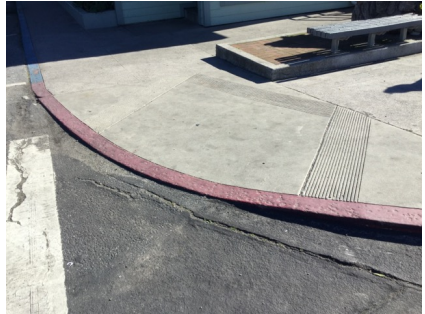
| Item No. and Name | Existing Architectural Barrier and Proposed Solution | Codes / Mitigation Info | Qty | Unit | Cost | Total |
|---|--|---|---|---|---|---|
| 946 | <ul style="list-style-type: none"> • <i>As-Built Description:</i> Transition from ramp to gutter does not have a smooth transition. • <i>As-Built:</i> 0.5" lip • <i>Proposed Solution:</i> Grind lip. | <p>PCODE EH02DREF</p> <p>ADAAG 91 4.7.2</p> <p>ADA 2010 406.2</p> <p>CBC 2007 1133B.5.3</p> <p>CBC 2016 11B-406.5.8</p> <p>Priority 1</p> <p>Severity 4</p> <p>Mitigation Project: <i>Sidewalk and Improvements on Promenade and Parking</i></p> <p>Estimated Completion Date: <i>2017-2018</i></p> | | REF | | |

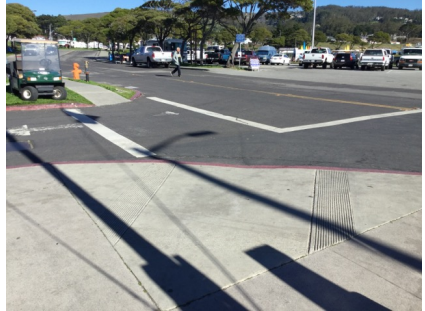
| Item No. and Name | Existing Architectural Barrier and Proposed Solution | Codes / Mitigation Info | Qty | Unit | Cost | Total |
|---|---|--|---|---|---|---|
| 949 | <ul style="list-style-type: none"> As-Built Description: Detectable warning not provided where pedestrian crosses vehicular area. Proposed Solution: Provide detectable warning surface (i.e. in-line truncated domes) at regular curb ramp. Notes: Parking A entrance and exit | PCODE EH07A ADAAG 91 4.7.7 ADA 2010 705.1 CBC 2007 1127B.5.7 CBC 2016 11B-705.1.2.2 Priority 1 Severity 3 Mitigation Project: <i>Sidewalk and Improvements on Promenade and Parking</i> Estimated Completion Date: 2017-2018 | 2 | JOB | \$250 | \$500 |

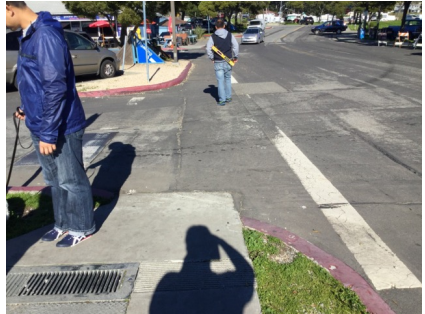
| Item No. and Name | Existing Architectural Barrier and Proposed Solution | Codes / Mitigation Info | Qty | Unit | Cost | Total |
|---|---|--|---|---|---|---|
| 952 | <ul style="list-style-type: none"> As-Built Description: Detectable warning not provided where pedestrian crosses vehicular area. Proposed Solution: Provide detectable warning surface (i.e. in-line truncated domes) at regular curb ramp. Notes: At Parking B driveways | PCODE EH07A ADAAG 91 4.7.7 ADA 2010 705.1 CBC 2007 1127B.5.7 CBC 2016 11B-705.1.2.2 Priority 1 Severity 3 Mitigation Project: <i>Sidewalk and Improvements on Promenade and Parking</i> Estimated Completion Date: 2017-2018 | 4 | JOB | \$250 | \$1,000 |

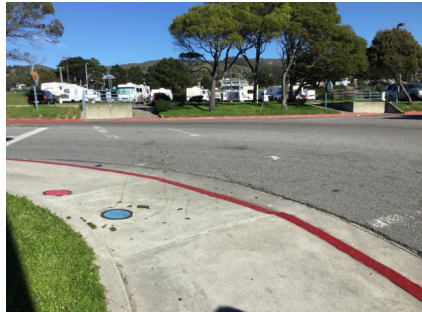
| 962 | <ul style="list-style-type: none"> As-Built Description: Running slope at bottom landing of existing parallel curb ramp exceeds 2%. As-Built: 2.7-6.7% BL Proposed Solution: Demolish existing and provide new parallel curb ramp including detectable warning surfaces, and top and bottom landings as required. | <p>PCODE PC24A ADAAG 91 4.8.4; 4.8.6 PROW R304.3.2 CBC 2016 11B-406.3.2</p> <p>Priority 1 Severity 2</p> | 1 | JOB | \$3,000 | \$3,000 |

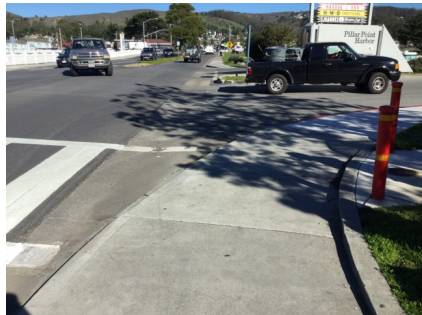
| 964 | <ul style="list-style-type: none"> As-Built Description: Slope greater than 1:12 (8.3%). As-Built: 9.0% Proposed Solution: Demolish existing and provide new curb ramp. | <p>PCODE EH02A ADAAG 91 4.7.2 ADA 2010 406.1 CBC 2007 1127B.5.3 CBC 2016 11B-406.2.1</p> <p>Priority 1 Severity 4</p> | 1 | JOB | \$2,500 | \$2,500 |

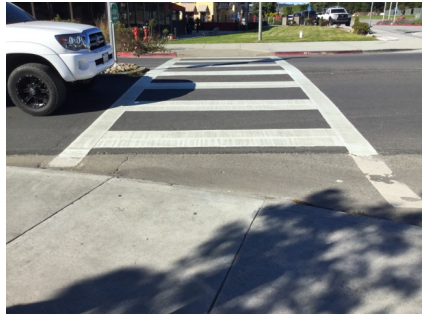
| Item No. and Name | Existing Architectural Barrier and Proposed Solution | Codes / Mitigation Info | Qty | Unit | Cost | Total |
|---|--|---|---|---|---|---|
| 961 | <ul style="list-style-type: none"> As-Built Description: Detectable warning not provided where pedestrian crosses vehicular area. Proposed Solution: Provide detectable warning surface (i.e. in-line truncated domes) at regular curb ramp. Notes: Verify if Harbor District has ownership of vehicular roadway. | PCODE EH07A ADAAG 91 4.7.7 ADA 2010 705.1 CBC 2007 1127B.5.7 CBC 2016 11B-705.1.2.2 Priority 1 Severity 3 | 3 | JOB | \$250 | \$750 |

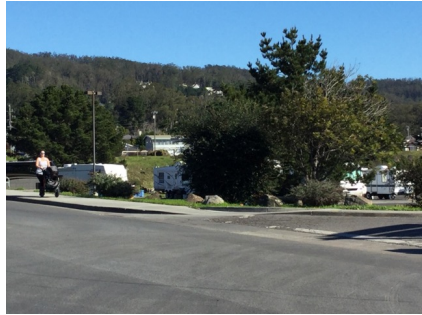
| Item No. and Name | Existing Architectural Barrier and Proposed Solution | Codes / Mitigation Info | Qty | Unit | Cost | Total |
|---|--|---|---|---|---|---|
| 963 | <ul style="list-style-type: none"> As-Built Description: Detectable warning not provided where pedestrian crosses vehicular area. Proposed Solution: Provide detectable warning surface (i.e. in-line truncated domes) at regular curb ramp. Notes: Recommend instead to remove curb ramp in NE corner as no crossing connects to it and the sidewalk immediately ends going into the harbor area. Replace curb ramp with a pedestrian barricade and provide signage at main intersection on Highway 1 to direct pedestrians across street. | PCODE EH07ANT ADAAG 91 4.7.7 ADA 2010 705.1 CBC 2007 1127B.5.7 CBC 2016 11B-705.1.2.2 Priority 1 Severity 3 | 1 | JOB | \$250 | \$250 |

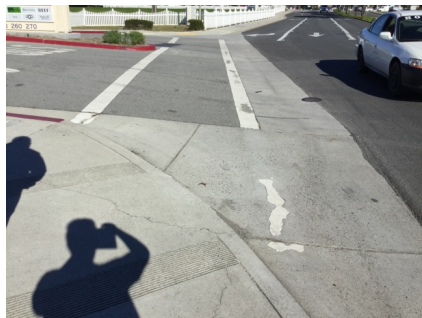
| Item No. and Name | Existing Architectural Barrier and Proposed Solution | Codes / Mitigation Info | Qty | Unit | Cost | Total |
|---|--|---|---|---|---|---|
| 965 | <ul style="list-style-type: none"> As-Built Description: Curb ramp or 48" level space at bottom of ramp not within marked crosswalk. As-Built: BL not fully within crosswalk Proposed Solution: Modify marked crossing; remove old lines & paint new lines at crosswalk. | PCODE EH09 ADAAG 91 4.7.9 + 10 ADA 2010 406.5 CBC 2007 1127B.5.9 CBC 2016 11B-406.5.9 Priority 1 Severity 4 | 50 | LF | \$20 | \$1,000 |

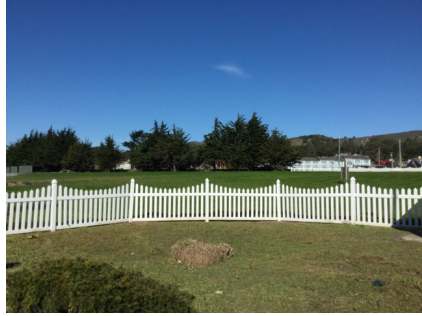
| Item No. and Name | Existing Architectural Barrier and Proposed Solution | Codes / Mitigation Info | Qty | Unit | Cost | Total |
|---|---|---|---|---|---|---|
| 966 | <ul style="list-style-type: none"> <i>As-Built Description:</i> At parking lot with 201-300 spaces, the number of accessible spaces is less than required by code; 7 spaces required. <i>Proposed Solution:</i> Provide required accessible parking spaces with signs including a minimum of one van space. <i>Notes:</i> Undeveloped land does not appear to be utilized by Harbor District. | <p>PCODE EA01GREF</p> <p>ADAAG 91 4.1.2(5)*</p> <p>ADA 2010 208.2</p> <p>CBC 2007 Tbl. 11B-6</p> <p>CBC 2016 11B-208.2 Tbl. 11B-208.2</p> <p>Priority 1</p> <p>-</p> | | | | |

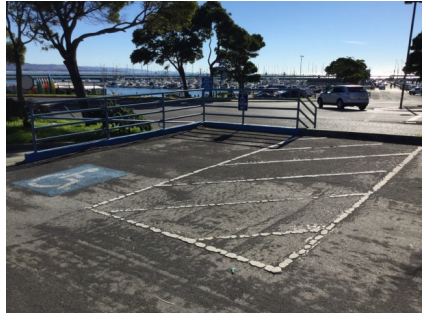
| Floor or Ground Surfaces | | | | | | |
|---|--|---|---|---|---|--|
| 974 | <ul style="list-style-type: none"> <i>As-Built Description:</i> Accessible parking space has slope greater than 1/4":12" (2%). <i>Proposed Solution:</i> Modify slope at accessible parking space. <i>Notes:</i> Sloped at both spaces | <p>PCODE EA05</p> <p>ADAAG 91 4.6.3</p> <p>ADA 2010 502.4</p> <p>CBC 2007 1129B.3.3</p> <p>CBC 2016 11B-502.4</p> <p>Priority 1</p> <p>Severity 4</p> | 612 | SF | \$12 | \$7,344 |

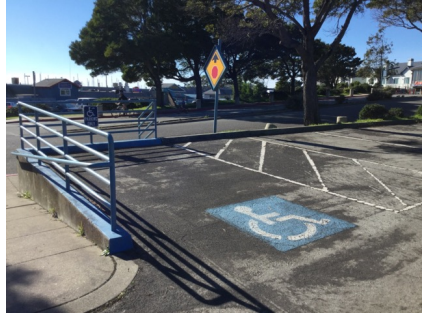
| Minimum Number | | | | | | |
|---|--|--|---|---|---|---|
| 967 | <ul style="list-style-type: none"> <i>As-Built Description:</i> At parking lot with 76-100 spaces, the number of accessible spaces is less than required by code; 4 spaces required. <i>Proposed Solution:</i> Provide required accessible parking spaces with signs including a minimum of one van space. <i>Notes:</i> 95 total single spaces 2 accessible single spaces 40 total trailer spaces 0 accessible trailer spaces Recommend at least 2 more additional accessible single spaces and 2 accessible trailer spaces | <p>PCODE EA01D</p> <p>ADAAG 91 4.1.2(5)*</p> <p>ADA 2010 208.2</p> <p>CBC 2007 Tbl. 11B-6</p> <p>CBC 2016 11B-208.2 Tbl. 11B-208.2</p> <p>Priority 1</p> <p>Severity 2</p> | 1 | JOB | \$300 | \$300 |

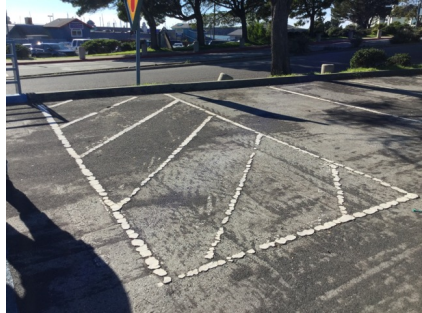
| Item No. and Name | Existing Architectural Barrier and Proposed Solution | Codes / Mitigation Info | Qty | Unit | Cost | Total |
|---|--|--|---|---|---|---|
| 971 | <ul style="list-style-type: none"> <i>As-Built Description:</i> The words "NO PARKING" not painted on the ground within loading and unloading access aisle (12" min high white letters), located so that it is visible to traffic enforcement officials (required in CA only). <i>Proposed Solution:</i> Provide the words "NO PARKING" in each access aisle, painted in 12" high letters, when altering area. | <p>PCODE EA04D</p> <p>ADA 2010 502.3.3</p> <p>CBC 2007 1129B.3.1</p> <p>CBC 2016 11B-502.3.3</p> <p>Priority 1</p> <p>Severity 4</p> | 2 | JOB | \$100 | \$200 |
