SAN MATEO COUNTY HARBOR DISTRICT

ADA Self-Evaluation and Transition Plan

August 2018

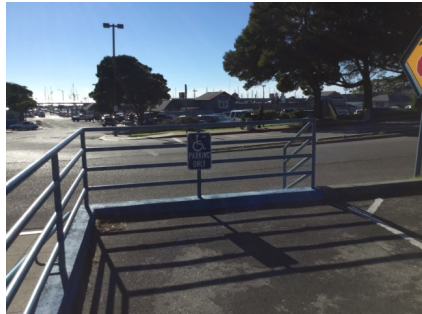
| Item No. and Name | Existing Architectural Barrier and Proposed Solution | Codes / Mitigation Info | Qty | Unit | Cost | Total |
|---|--|--|---|---|---|---|
| 970 | <ul style="list-style-type: none"> <i>As-Built Description:</i> Parking sign is not located between 60" and 80" above the finish floor or ground surface measured to the bottom of the sign. <i>As-Built:</i> 19" high <i>Proposed Solution:</i> Remount existing sign at accessible height. | <p>PCODE EA04H</p> <p>ADAAG 91 4.6.4</p> <p>ADA 2010 502.7</p> <p>CBC 2007 1129B.4</p> <p>CBC 2016 11B-502.6</p> <p>Priority 1</p> <p>Severity 4</p> | 2 | JOB | \$45 | \$90 |

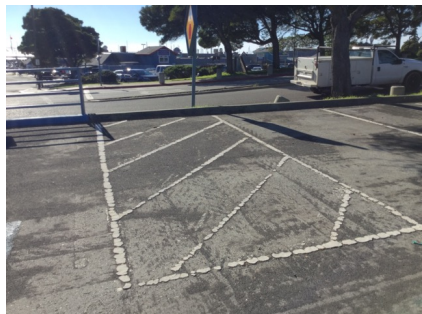
| Item No. and Name | Existing Architectural Barrier and Proposed Solution | Codes / Mitigation Info | Qty | Unit | Cost | Total |
|---|--|--|---|---|---|---|
| 972 | <ul style="list-style-type: none"> <i>As-Built Description:</i> CA only: The area within the blue borderlines not marked with hatched lines a maximum of 36" on center. <i>As-Built:</i> No blue border <i>Proposed Solution:</i> Restripe to provide hatched lines at 36" on center within access aisle. | <p>PCODE EA04I</p> <p>CBC 2007 1129B.3.1</p> <p>CBC 2016 11B-502.3.3</p> <p>Priority 1</p> <p>Severity 4</p> | 2 | JOB | \$100 | \$200 |

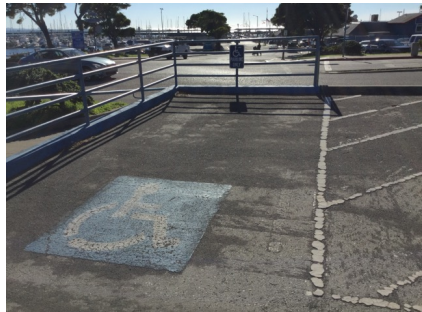
| Item No. and Name | Existing Architectural Barrier and Proposed Solution | Codes / Mitigation Info | Qty | Unit | Cost | Total |
|---|--|--|---|---|---|---|
| 973 | <ul style="list-style-type: none"> <i>As-Built Description:</i> CA only: Additional Sign or additional language below the symbol of accessibility stating "Minimum Fine \$250" not provided. <i>Proposed Solution:</i> Provide compliant parking signage that includes fine information. | <p>PCODE EA04G</p> <p>CBC 2007 1129B.4</p> <p>CBC 2016 11B-502.6.2</p> <p>Priority 1</p> <p>Severity 4</p> | 2 | JOB | \$100 | \$200 |

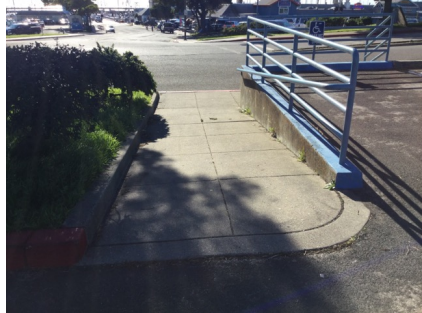
| Item No. and Name | Existing Architectural Barrier and Proposed Solution | Codes / Mitigation Info | Qty | Unit | Cost | Total |
|---|--|---|---|---|---|---|
| 968 | <ul style="list-style-type: none"> <i>As-Built Description:</i> Slope greater than 1:12 (8.3%). <i>As-Built:</i> 9.2-12.4% <i>Proposed Solution:</i> Demolish existing and provide new ramp with handrails. <i>Notes:</i> 2 ramps serving an accessible space each Highly noncompliant ramp | <p><i>PCODE</i> EB02</p> <p><i>ADAAG 91</i> 4.8.2</p> <p><i>ADA 2010</i> 405.2</p> <p><i>CBC 2007</i> 1133B.5.3</p> <p><i>CBC 2016</i> 11B-405.2</p> <p>Priority 1</p> <p>Severity 3</p> | 250 | SF | \$100 | \$25,000 |

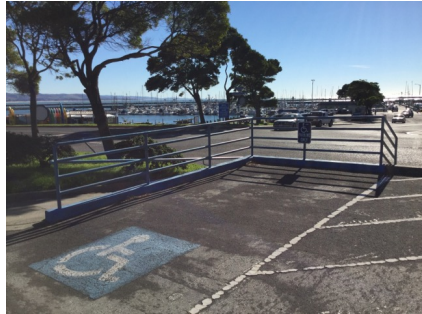
| Item No. and Name | Existing Architectural Barrier and Proposed Solution | Codes / Mitigation Info | Qty | Unit | Cost | Total |
|---|--|---|---|---|---|---|
| 975 | <ul style="list-style-type: none"> <i>As-Built Description:</i> Open guards does not have balusters or ornamental patterns such that a 4-inch-diameter (102 mm) sphere cannot pass through any opening. <i>As-Built:</i> 8" openings <i>Proposed Solution:</i> Provide new guards which do not allow passage of an 4 inch sphere at any opening. <i>Notes:</i> On both ramps | <p><i>PCODE</i> ED08A</p> <p><i>ADA 2010</i> 405.9.2</p> <p><i>CBC 2007</i> 1013.3</p> <p><i>CBC 2016</i> 11B-405.9.2</p> <p>Priority 1</p> <p>Severity 3</p> | 40 | LF | \$120 | \$4,800 |

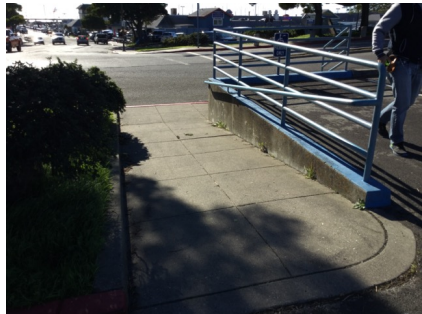
| Item No. and Name | Existing Architectural Barrier and Proposed Solution | Codes / Mitigation Info | Qty | Unit | Cost | Total |
|---|--|---|---|---|---|---|
| 969 | <ul style="list-style-type: none"> <i>As-Built Description:</i> Handrail not provided at stairs or ramp, required on both sides (not required at curb ramps or adjacent to seating areas). <i>As-Built:</i> Only on one side <i>Proposed Solution:</i> Provide new handrail for each side including extensions. | <p><i>PCODE</i> ED01REF</p> <p><i>ADAAG 91</i> 4.8.5 & 4.9.4</p> <p><i>ADA 2010</i> 505.2</p> <p><i>CBC 2007</i> 1133B.4.1.1</p> <p><i>CBC 2016</i> & .5.5</p> <p>11B-505.2</p> <p>Priority 1</p> <p>Severity 2</p> | REF | | | |

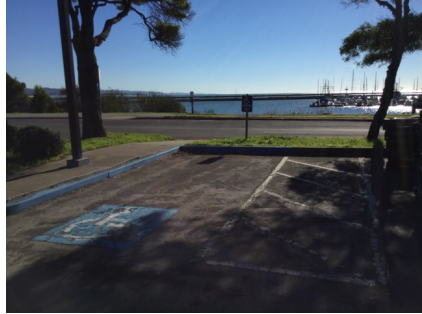
| Item No. and Name | Existing Architectural Barrier and Proposed Solution | Codes / Mitigation Info | Qty | Unit | Cost | Total |
|---|---|---|---|---|---|---|
| 983 | <ul style="list-style-type: none"> <i>As-Built Description:</i> At parking lot with 51-75 spaces, the number of accessible spaces is less than required by code; 3 spaces required. <i>Proposed Solution:</i> Provide required accessible parking spaces with signs including a minimum of one van space. <i>Notes:</i> 61 total single spaces 4 accessible single spaces 72 total trailer spaces 2 accessible trailer spaces Recommend at least one additional accessible trailer space but would provide all accessible spaces closer to the launch ramp. | <p>PCODE EA01C ADAAG 91 4.1.2(5)* ADA 2010 208.2 CBC 2007 Tbl. 11B-6 CBC 2016 11B-208.2 Tbl. 11B-208.2</p> <p>Priority 1 Severity 2</p> | 1 | JOB | \$300 | \$300 |

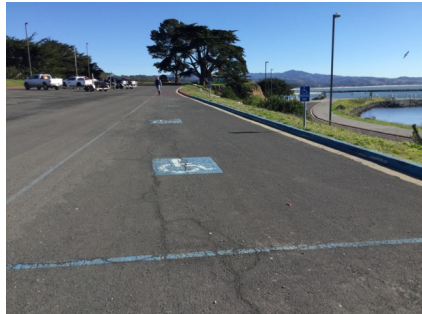
| Item No. and Name | Existing Architectural Barrier and Proposed Solution | Codes / Mitigation Info | Qty | Unit | Cost | Total |
|---|---|---|---|---|---|---|
| 985 | <ul style="list-style-type: none"> <i>As-Built Description:</i> Accessible parking space does not have 5' wide access aisle; 8' wide for van accessible aisle. <i>As-Built:</i> No aisle serving boat spaces <i>Proposed Solution:</i> Modify parking aisle(s) to create accessible space by restriping. | <p>PCODE EA02B ADAAG 91 4.6.3 ADA 2010 502.3 CBC 2007 1129B.3.1 CBC 2016 11B-502.2; 11B-502.3.1</p> <p>Priority 1 Severity 1</p> | 1 | JOB | \$200 | \$200 |

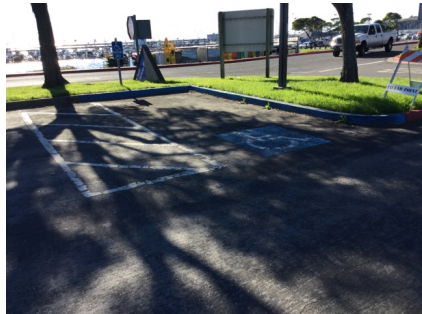
| Item No. and Name | Existing Architectural Barrier and Proposed Solution | Codes / Mitigation Info | Qty | Unit | Cost | Total |
|---|---|---|---|---|---|---|
| 982 | <ul style="list-style-type: none"> <i>As-Built Description:</i> Disabled persons must wheel or walk behind parked car(s) other than their own. <i>As-Built:</i> Aisle does not connect to an accessible route <i>Proposed Solution:</i> Relocate parking and provide curb ramp to accessible route. | <p>PCODE EA03 ADAAG 91 Fig.9 ADA 2010 502.3 CBC 2007 1129B.3.1 CBC 2016 11B-502.7.1</p> <p>Priority 1 Severity 3</p> | 5 | JOB | \$730 | \$3,650 |

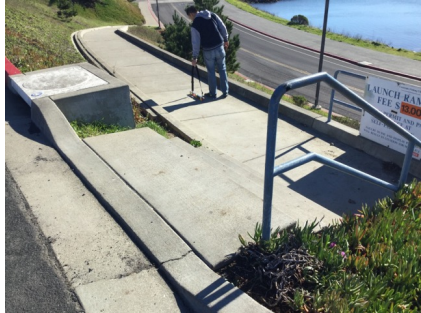
| Item No. and Name | Existing Architectural Barrier and Proposed Solution | Codes / Mitigation Info | Qty | Unit | Cost | Total |
|---|---|--|---|---|---|---|
| 988 | <ul style="list-style-type: none"> <i>As-Built Description:</i> Ramp needed to provide disabled access at steps or change of level along path of travel. <i>As-Built:</i> Stairs only mean of connection to ramp from trailer parking to launch ramp <i>Proposed Solution:</i> Provide new concrete ramp with handrails [slope more than 1:20 (5.0%) needed]. <i>Notes:</i> Significant redesign of area is needed to provide a compliant ramp leading from the trailer parking to the launch ramp. Option to also modify launch ramp area to provide accessible trailer parking spaces directly. | PCODE EB01AREF ADAAG 91 4.1.1 ADA 2010 303.4 CBC 2007 1127B.1 CBC 2016 11B-303.4 Priority 1 Severity 3 | | | | |

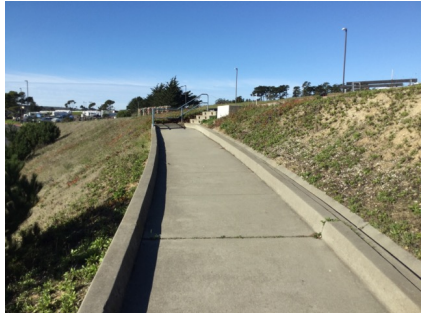
| Item No. and Name | Existing Architectural Barrier and Proposed Solution | Codes / Mitigation Info | Qty | Unit | Cost | Total |
|---|---|--|---|---|---|---|
| 991 | <ul style="list-style-type: none"> <i>As-Built Description:</i> Guards (42" high) not provided at side of ramp or landing where drop-off to adjacent grade or floor exceeds 30" height (California building code requirement only). <i>Proposed Solution:</i> Provide new guards, including handrail at ramp. <i>Notes:</i> Guards must be provided if converted to a ramp | PCODE ED08REF CBC 2007 1133B.5.7 CBC 2016 Section 1013.2; 1013.3 Priority 1 Severity 2 | | | | |

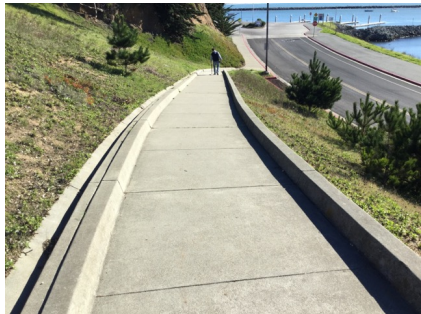
| Item No. and Name | Existing Architectural Barrier and Proposed Solution | Codes / Mitigation Info | Qty | Unit | Cost | Total |
|---|---|--|---|---|---|---|
| 989 | <ul style="list-style-type: none"> <i>As-Built Description:</i> Walk: Slope greater than 1:20 (5.0%), and walk does not comply with requirements for ramps. <i>As-Built:</i> 9.6-14.6% <i>Proposed Solution:</i> Modify walk/sidewalk slope to 1:20 or less. <i>Notes:</i> Significant redesign of area is needed to provide a compliant ramp leading from the trailer parking to the launch ramp. Option to also modify launch ramp area to provide accessible trailer parking spaces directly. | PCODE EF01 ADAAG 91 4.3.7 ADA 2010 403.3 CBC 2007 1133B.7.3 CBC 2016 11B-403.3 Priority 1 Severity 2 | 3000 | SF | \$25 | \$75,000 |

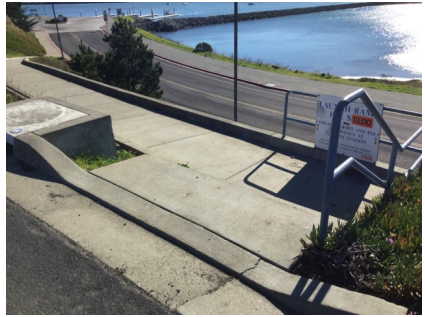
| Item No. and Name | Existing Architectural Barrier and Proposed Solution | Codes / Mitigation Info | Qty | Unit | Cost | Total |
|---|---|---|---|---|---|---|
| 987 | <ul style="list-style-type: none"> <i>As-Built Description:</i> Transition from ramp to gutter does not have a smooth transition. <i>As-Built:</i> 1" lip <i>Proposed Solution:</i> Grind lip. <i>Notes:</i> Stairs and ramp to launch ramp | <p><i>PCODE</i> EH02DREF</p> <p><i>ADAAG 91</i> 4.7.2</p> <p><i>ADA 2010</i> 406.2</p> <p><i>CBC 2007</i> 1133B.5.3</p> <p><i>CBC 2016</i> 11B-406.5.8</p> <p>Priority 1</p> <p>Severity 4</p> | | | | |

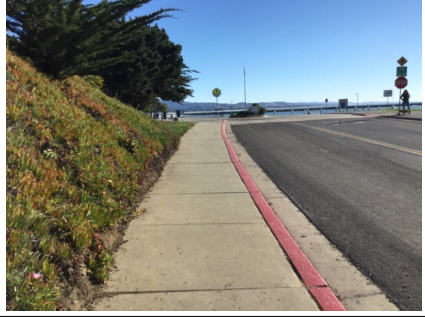
| 992 | <ul style="list-style-type: none"> <i>As-Built Description:</i> Cross slope more than 1":48" (2.083%). <i>As-Built:</i> 2.4-4.2% <i>Proposed Solution:</i> Modify cross slope. | <p><i>PCODE</i> EF07</p> <p><i>ADAAG 91</i> 4.3.7</p> <p><i>ADA 2010</i> 403.3</p> <p><i>CBC 2007</i> 1133B.7.1.3</p> <p><i>CBC 2016</i> 11B-403.3</p> <p>Priority 1</p> <p>Severity 4</p> | 600 | SF | \$25 | \$15,000 |

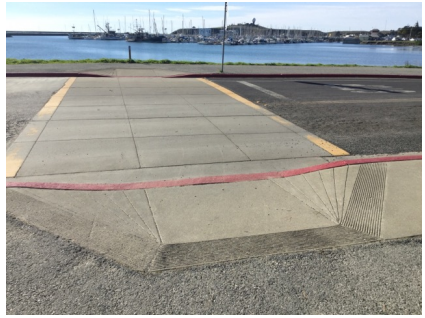
| 996 | <ul style="list-style-type: none"> <i>As-Built Description:</i> Cross slope more than 1":48" (2.083%). <i>As-Built:</i> 3.2% in TL <i>Proposed Solution:</i> Modify cross slope. | <p><i>PCODE</i> EF07REF</p> <p><i>ADAAG 91</i> 4.3.7</p> <p><i>ADA 2010</i> 403.3</p> <p><i>CBC 2007</i> 1133B.7.1.3</p> <p><i>CBC 2016</i> 11B-403.3</p> <p>Priority 1</p> <p>Severity 4</p> | | | | |

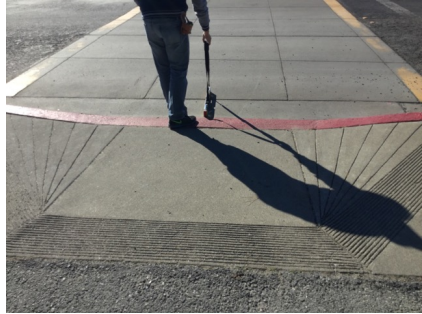
| Item No. and Name | Existing Architectural Barrier and Proposed Solution | Codes / Mitigation Info | Qty | Unit | Cost | Total |
|---|--|---|---|---|---|---|
| 995 | <ul style="list-style-type: none"> <i>As-Built Description:</i> Slope greater than 1:12 (8.3%). <i>As-Built:</i> 9.8% <i>Proposed Solution:</i> Demolish existing and provide new curb ramp. | PCODE EH02A ADAAG 91 4.7.2 ADA 2010 406.1 CBC 2007 1127B.5.3 CBC 2016 11B-406.2.1 Priority 1 Severity 4 | 2 | JOB | \$2,500 | \$5,000 |

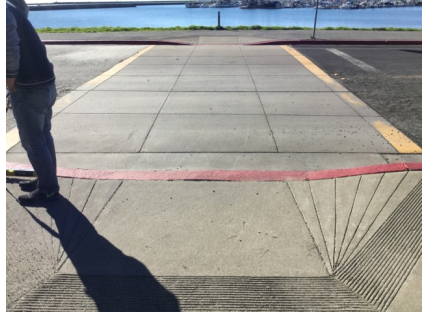
| Item No. and Name | Existing Architectural Barrier and Proposed Solution | Codes / Mitigation Info | Qty | Unit | Cost | Total |
|---|--|---|---|---|---|---|
| 993 | <ul style="list-style-type: none"> <i>As-Built Description:</i> Detectable warning not provided where pedestrian crosses vehicular area. <i>Proposed Solution:</i> Provide detectable warning surface (i.e. in-line truncated domes) at regular curb ramp. | PCODE EH07A ADAAG 91 4.7.7 ADA 2010 705.1 CBC 2007 1127B.5.7 CBC 2016 11B-705.1.2.2 Priority 1 Severity 3 | 2 | JOB | \$250 | \$500 |

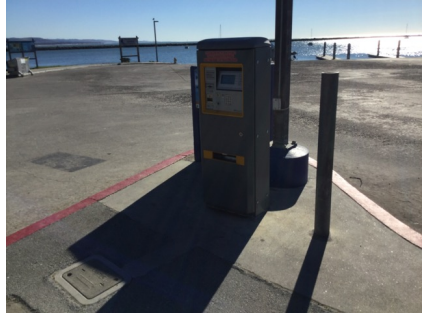
| 1000 | <ul style="list-style-type: none"> <i>As-Built Description:</i> Clear spaces slope exceeds 1:48 max in all directions or not a minimum size of 30" by 48". <i>As-Built:</i> Irregular surface in front of pay station. <i>Proposed Solution:</i> Regrade and remodel area as required. | PCODE NS05 ADAAG 91 16.16.4 ADA 2010 305.2; 305.3 CBC 2007 1132B.1 CBC 2016 11B-305.2; 11B-305.3 Priority 1 Severity 4 | 15 | SF | \$25 | \$375 |

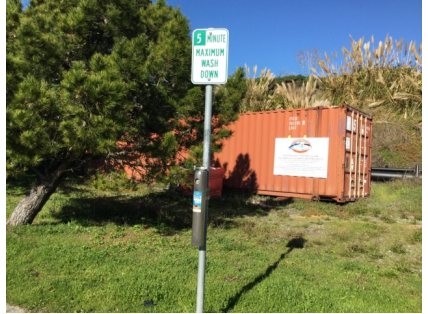
| 999 | <ul style="list-style-type: none"> <i>As-Built Description:</i> Reach height to control or access point, exceeds 48" or is less than 15". <i>As-Built:</i> Cigarettes bin: 52" high <i>Proposed Solution:</i> Modify equipment or mounting. | PCODE IE01 ADAAG 91 4.2.5 ADA 2010 308.2.1 CBC 2007 1118B.5 CBC 2016 11B-308.2.1 Priority 1 Severity 4 | 1 | JOB | \$100 | \$100 |

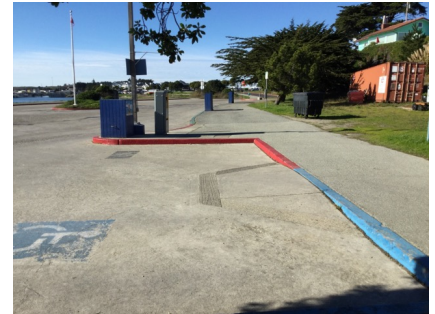
| 1005 | <ul style="list-style-type: none"> <i>As-Built Description:</i> Access aisle at accessible parking space has slope greater than 1/4":12" (2%) due to built-up curb ramp within aisle. <i>As-Built:</i> Built-up curb ramp <i>Proposed Solution:</i> Provide curb cut. | <p>PCODE EA05A ADAAG 91 4.6.3 ADA 2010 502.4 CBC 2007 1129B.3.3 CBC 2016 11B-502.4</p> <p>Priority 1 Severity 2</p> <p>Mitigation Project: Launch Ramp Restrooms Estimated Completion Date: 2018-2019</p> | 1 | JOB | \$2,500 | \$2,500 |

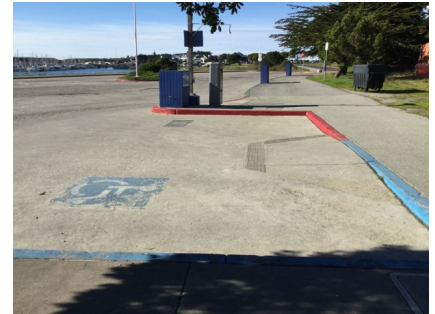
| 1004 | <ul style="list-style-type: none"> <i>As-Built Description:</i> Accessible parking space does not have 5' wide access aisle; 8' wide for van accessible aisle. <i>As-Built:</i> No aisle <i>Proposed Solution:</i> Modify parking aisle(s) to create accessible space by restriping. | <p>PCODE EA02B ADAAG 91 4.6.3 ADA 2010 502.3 CBC 2007 1129B.3.1 CBC 2016 11B-502.2; 11B-502.3.1</p> <p>Priority 1 Severity 1</p> <p>Mitigation Project: Launch Ramp Restrooms Estimated Completion Date: 2018-2019</p> | 1 | JOB | \$200 | \$200 |

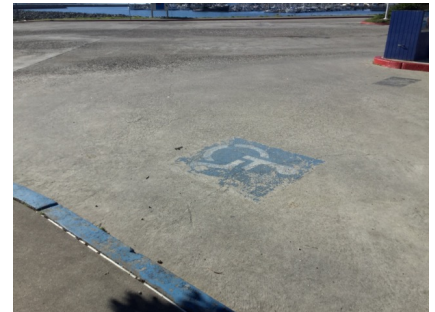
| 1001 | <ul style="list-style-type: none"> <i>As-Built Description:</i> International Symbol of Accessibility (36" square, in white on blue) is not painted on the pavement near the rear end of the parking space (required in CA only). <i>As-Built:</i> Faded <i>Proposed Solution:</i> Apply symbol on parking space pavement when altering area. | <p>PCODE EA04A CBC 2007 1129B.4 CBC 2016 11B-502.6.4.1</p> <p>Priority 1 Severity 4</p> <p>Mitigation Project: Launch Ramp Restrooms Estimated Completion Date: 2018-2019</p> | 1 | JOB | \$120 | \$120 |

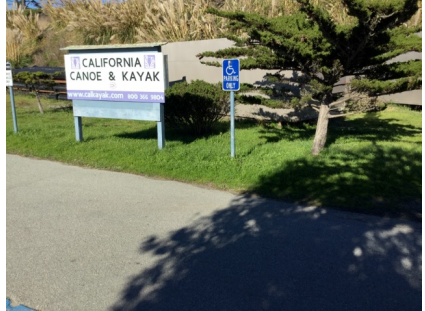
| Item No. and Name | Existing Architectural Barrier and Proposed Solution | Codes / Mitigation Info | Qty | Unit | Cost | Total |
|---|--|--|---|---|---|---|
| 1002 | <ul style="list-style-type: none"> <i>As-Built Description:</i> Parking sign is not located between 60" and 80" above the finish floor or ground surface measured to the bottom of the sign. <i>As-Built:</i> 50" high <i>Proposed Solution:</i> Remount existing sign at accessible height. | PCODE EA04H ADAAG 91 4.6.4 ADA 2010 502.7 CBC 2007 1129B.4 CBC 2016 11B-502.6 Priority 1 Severity 4 Mitigation Project: Launch Ramp Restrooms Estimated Completion Date: 2018-2019 | 1 | JOB | \$45 | \$45 |

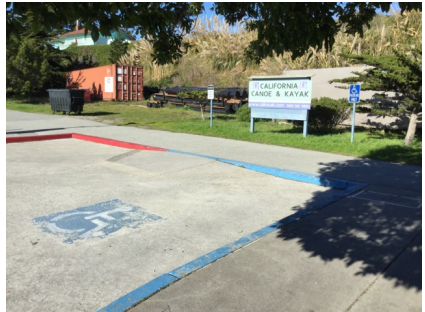
| Item No. and Name | Existing Architectural Barrier and Proposed Solution | Codes / Mitigation Info | Qty | Unit | Cost | Total |
|---|--|--|---|---|---|---|
| 1006 | <ul style="list-style-type: none"> <i>As-Built Description:</i> No van parking provided (one in every 6 or fraction of 6 accessible spaces, but not less than one). <i>As-Built:</i> No Van space <i>Proposed Solution:</i> Provide van parking space(s) by restriping; provide van sign. | PCODE EA07 ADAAG 91 4.1.2(5)(b) ADA 2010 208.2; 502.1 CBC 2007 1129B.3.2 CBC 2016 11B-208.2.4 Priority 1 Severity 2 Mitigation Project: Launch Ramp Restrooms Estimated Completion Date: 2018-2019 | 1 | JOB | \$350 | \$350 |

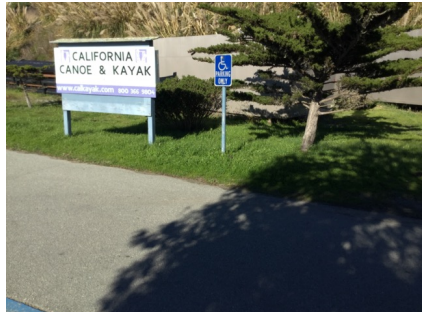
| Item No. and Name | Existing Architectural Barrier and Proposed Solution | Codes / Mitigation Info | Qty | Unit | Cost | Total |
|---|--|--|---|---|---|---|
| 1003 | <ul style="list-style-type: none"> <i>As-Built Description:</i> CA only: Additional Sign or additional language below the symbol of accessibility stating "Minimum Fine \$250" not provided. <i>Proposed Solution:</i> Provide compliant parking signage that includes fine information. | PCODE EA04G CBC 2007 1129B.4 CBC 2016 11B-502.6.2 Priority 1 Severity 4 Mitigation Project: Launch Ramp Restrooms Estimated Completion Date: 2018-2019 | 1 | JOB | \$100 | \$100 |

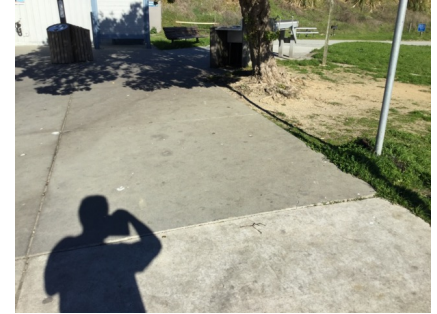
| 1011 | <ul style="list-style-type: none"> <i>As-Built Description:</i> Walk: Pavement dislocation creates abrupt change in level exceeding 1/2" in accessible route. <i>As-Built:</i> 0.5" lip <i>Proposed Solution:</i> Remove, replace or repair area of pavement sufficient to correct abrupt change in level. | <p><i>PCODE</i> EF03 <i>ADAAG 91</i> 4.3.8 <i>ADA 2010</i> 403.4 <i>CBC 2007</i> 1133B.7.4 <i>CBC 2016</i> 11B-403.4</p> <p>Priority 1 Severity 4</p> <p>Mitigation Project: <i>Launch Ramp Restrooms</i> Estimated Completion Date: <i>2018-2019</i></p> | 10 | SF | \$21 | \$210 |

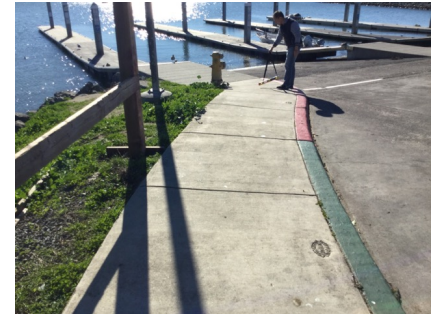
| 1013 | <ul style="list-style-type: none"> <i>As-Built Description:</i> Cross slope more than 1":48" (2.083%). <i>As-Built:</i> 2.8-6.7% <i>Proposed Solution:</i> Modify cross slope. | <p><i>PCODE</i> EF07 <i>ADAAG 91</i> 4.3.7 <i>ADA 2010</i> 403.3 <i>CBC 2007</i> 1133B.7.1.3 <i>CBC 2016</i> 11B-403.3</p> <p>Priority 1 Severity 3</p> <p>Mitigation Project: <i>Launch Ramp Restrooms</i> Estimated Completion Date: <i>2018-2019</i></p> | 120 | SF | \$25 | \$3,000 |

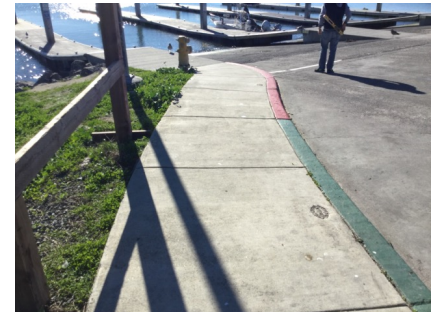
| 1014 | <ul style="list-style-type: none"> <i>As-Built Description:</i> Walk: Slope greater than 1:20 (5.0%), and walk does not comply with requirements for ramps. <i>As-Built:</i> 15.1% <i>Proposed Solution:</i> Modify walk/sidewalk slope to 1:20 or less. | <p><i>PCODE</i> EF01REF <i>ADAAG 91</i> 4.3.7 <i>ADA 2010</i> 403.3 <i>CBC 2007</i> 1133B.7.3 <i>CBC 2016</i> 11B-403.3</p> <p>Priority 1 Severity 2</p> <p>Mitigation Project: <i>Launch Ramp Restrooms</i> Estimated Completion Date: <i>2018-2019</i></p> | REF | | | |

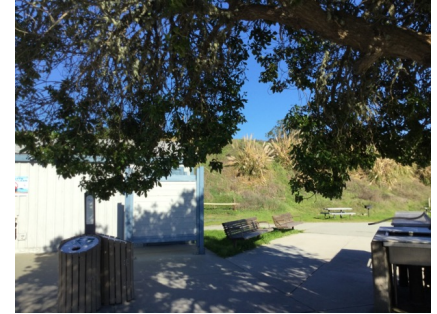
| 1010 | <ul style="list-style-type: none"> <i>As-Built Description:</i> Overhead clearance less than 80" above finished floor. <i>As-Built:</i> Low hanging tree branches <i>Proposed Solution:</i> Modify overhead clearance. Notes: Trim | <p>PCODE EG01 ADAAG 91 4.4.2 ADA 2010 307.4 CBC 2007 1133B.8.6.2 CBC 2016 11B-307.4</p> <p>Priority 1 Severity 2</p> <p>Mitigation Project: Launch Ramp Restrooms Estimated Completion Date: 2018-2019</p> | 1 | JOB | \$100 | \$100 |

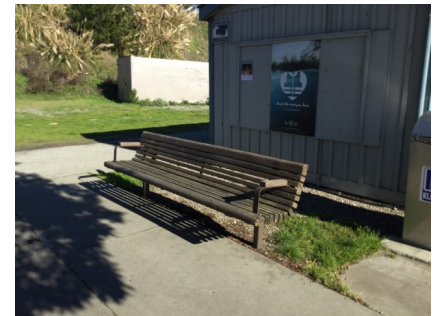
| 1007 | <ul style="list-style-type: none"> <i>As-Built Description:</i> Clear and level floor or ground space (30" x 48") not overlapping with other clear space requirements, is not provided at at least one end of the bench. <i>Proposed Solution:</i> Provide and position a clear and level floor or ground space to allow wheelchair users to be seated shoulder-to-shoulder with an individual seated on the bench. Notes: 3 benches around restrooms | <p>PCODE N007 ADAAG 91 4.32.2 ADA 2010 903.2 CBC 2007 1118B.4 CBC 2016 11B-903.2</p> <p>Priority 1 Severity 3</p> <p>Mitigation Project: Launch Ramp Restrooms Estimated Completion Date: 2018-2019</p> | 1 | JOB | \$500 | \$500 |

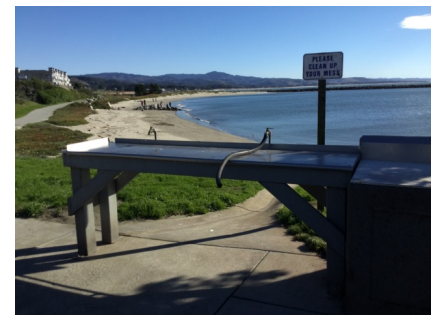
| 1009 | <ul style="list-style-type: none"> <i>As-Built Description:</i> Reach height to control or access point, exceeds 48" or is less than 15". <i>As-Built:</i> 50" high to faucet <i>Proposed Solution:</i> Modify equipment or mounting. | <p>PCODE IE01 ADAAG 91 4.2.5 ADA 2010 308.2.1 CBC 2007 1118B.5 CBC 2016 11B-308.2.1</p> <p>Priority 1 Severity 4</p> <p>Mitigation Project: Launch Ramp Restrooms Estimated Completion Date: 2018-2019</p> | 1 | JOB | \$100 | \$100 |

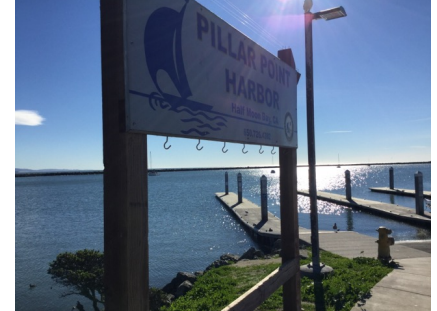
| Item No. and Name | Existing Architectural Barrier and Proposed Solution | Codes / Mitigation Info | Qty | Unit | Cost | Total |
|---|--|---|---|---|---|---|
| 1012 | <ul style="list-style-type: none"> <i>As-Built Description:</i> Reach height to control or access point, exceeds 48" or is less than 15". <i>As-Built:</i> 70" high CH <i>Proposed Solution:</i> Modify equipment or mounting. | PCODE IE01 ADAAG 91 4.2.5 ADA 2010 308.2.1 CBC 2007 1118B.5 CBC 2016 11B-308.2.1 Priority 1 Severity 1 Mitigation Project: Launch Ramp Restrooms Estimated Completion Date: 2018-2019 | 1 | JOB | \$100 | \$100 |

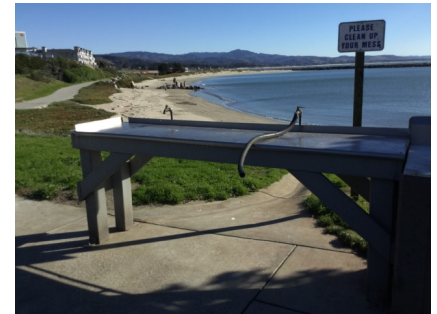
| 1008 | <ul style="list-style-type: none"> <i>As-Built Description:</i> Sink rim higher than 34" above floor. <i>As-Built:</i> 42" high sink <i>Proposed Solution:</i> Remodel sink cabinet to lower sink. Notes: 5.2% slope in front of sink | PCODE IN06 ADAAG 91 4.24.2 ADA 2010 606.3 CBC 2007 1115B.4.7.1 CBC 2016 11B-606.3 Priority 1 Severity 3 Mitigation Project: Launch Ramp Restrooms Estimated Completion Date: 2018-2019 | 1 | JOB | \$1,750 | \$1,750 |

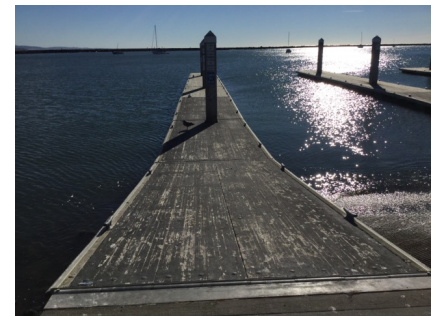
| 1015 | <ul style="list-style-type: none"> <i>As-Built Description:</i> Barriers identified along the gangway ramp are compliant per meeting one or more of the exceptions specified for recreational boating facilities. <i>As-Built:</i> 15.6% <i>Proposed Solution:</i> No changes necessary. Notes: Launch ramp varies by tide 120' long ramp meets exceptions | PCODE NZ01 ADA 2010 1003.2 CBC 2016 11B-1003.2 Priority 2 - | REF | | | |

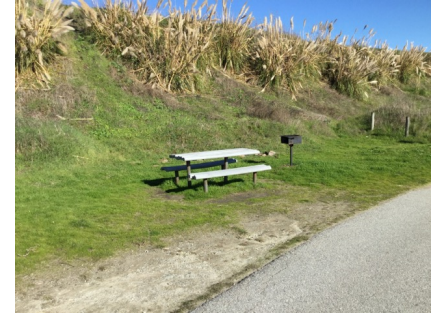
| 1016 | <ul style="list-style-type: none"> <i>As-Built Description:</i> No walk / sidewalk provided to connect accessible facilities or elements that are on the same site. <i>Proposed Solution:</i> Provide new 48" wide walk / sidewalk. | PCODE EF13 ADAAG 91 4.3.2 ADA 2010 206.1 CBC 2007 1114B.1.2 CBC 2016 11B-206.1 Priority 1 Severity 3 | 10 | LF | \$45 | \$450 |

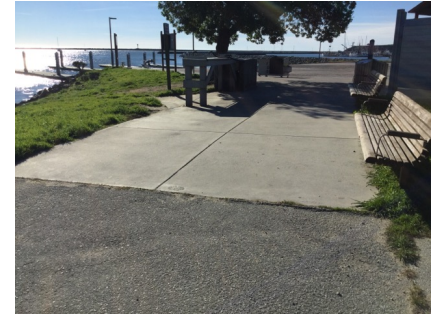
| 1017 | <ul style="list-style-type: none"> <i>As-Built Description:</i> Walk: Pavement dislocation creates abrupt change in level exceeding 1/2" in accessible route. <i>As-Built:</i> 1" lip <i>Proposed Solution:</i> Remove, replace or repair area of pavement sufficient to correct abrupt change in level. | PCODE EF03 ADAAG 91 4.3.8 ADA 2010 403.4 CBC 2007 1133B.7.4 CBC 2016 11B-403.4 Priority 1 Severity 4 | 12 | SF | \$21 | \$252 |

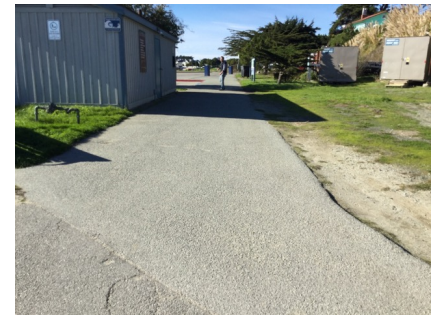
| 1019 | <ul style="list-style-type: none"> <i>As-Built Description:</i> Cross slope more than 1":48" (2.083%). <i>As-Built:</i> 2.7-3.5% <i>Proposed Solution:</i> Modify cross slope. | PCODE EF07 ADAAG 91 4.3.7 ADA 2010 403.3 CBC 2007 1133B.7.1.3 CBC 2016 11B-403.3 Priority 1 Severity 4 | 1000 | SF | \$25 | \$25,000 |

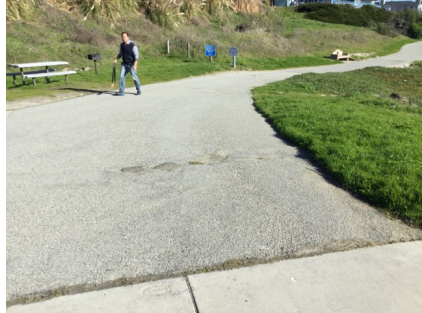
| Item No. and Name | Existing Architectural Barrier and Proposed Solution | Codes / Mitigation Info | Qty | Unit | Cost | Total |
|---|---|--|---|---|---|---|
| 1018 | <ul style="list-style-type: none"> <i>As-Built Description:</i> Walk: Irregular surface in pavement. <i>Proposed Solution:</i> Smooth pavement surface; grind or refinish surface. Notes: Maintain area | <p>PCODE EF10REF</p> <p>ADAAG 91 4.5.2</p> <p>ADA 2010 303.1; 302.1</p> <p>CBC 2007 1133B.7.1</p> <p>CBC 2016 11B-303.1; 11B-302.1</p> <p>Priority 1</p> <p>Severity 3</p> | | | | |

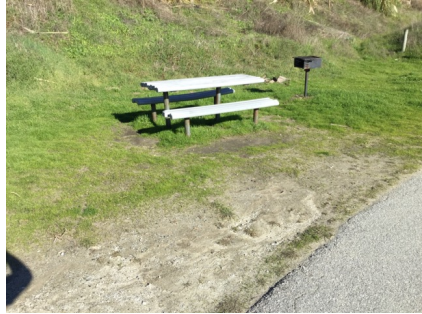
| Item No. and Name | Existing Architectural Barrier and Proposed Solution | Codes / Mitigation Info | Qty | Unit | Cost | Total |
|---|---|--|---|---|---|---|
| 1020 | <ul style="list-style-type: none"> <i>As-Built Description:</i> Knee clearance at minimums 27" high, 30" wide, and 19" deep is not provided. <i>As-Built:</i> 9" deep knee space <i>Proposed Solution:</i> Modify picnic table as required to provide knee clearance. | <p>PCODE NH11A</p> <p>ADAAG 91 16.5.4.</p> <p>ADA 2010 306.3</p> <p>CBC 2007 1132B.1</p> <p>CBC 2016 11B-306.3</p> <p>Priority 1</p> <p>Severity 2</p> | 1 | JOB | \$850 | \$850 |

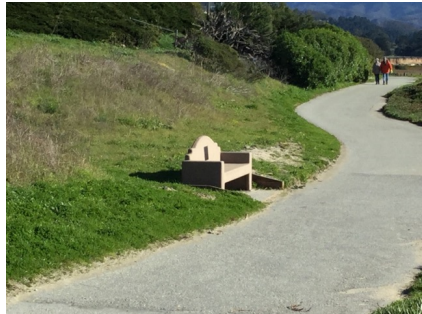
| Item No. and Name | Existing Architectural Barrier and Proposed Solution | Codes / Mitigation Info | Qty | Unit | Cost | Total |
|---|---|--|---|---|---|---|
| 1021 | <ul style="list-style-type: none"> <i>As-Built Description:</i> Clear and level floor or ground space (30" x 48") not overlapping with other clear space requirements, is not provided at at least one end of the bench. <i>Proposed Solution:</i> Provide and position a clear and level floor or ground space to allow wheelchair users to be seated shoulder-to-shoulder with an individual seated on the bench. | <p>PCODE N007</p> <p>ADAAG 91 4.32.2</p> <p>ADA 2010 903.2</p> <p>CBC 2007 1118B.4</p> <p>CBC 2016 11B-903.2</p> <p>Priority 1</p> <p>Severity 3</p> | 1 | JOB | \$500 | \$500 |

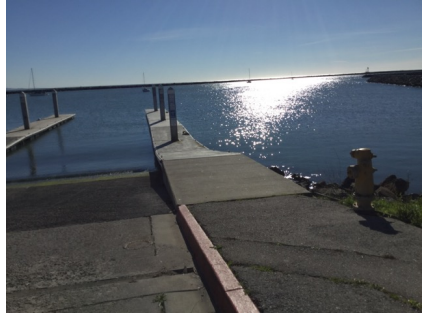
| Item No. and Name | Existing Architectural Barrier and Proposed Solution | Codes / Mitigation Info | Qty | Unit | Cost | Total |
|---|---|--|---|---|---|---|
| 1022 | <ul style="list-style-type: none"> <i>As-Built Description:</i> Guards (42" high) not provided at side of ramp or landing where drop-off to adjacent grade or floor exceeds 30" height (California building code requirement only). <i>Proposed Solution:</i> Provide new guards, including handrail at ramp. Notes: Provide guards on launch ramps connecting to walks | <p><i>PCODE</i> ED08</p> <p><i>CBC 2007</i> 1133B.5.7</p> <p><i>CBC 2016</i> Section 1013.2; 1013.3</p> <p>Priority 1</p> <p>Severity 2</p> | 30 | LF | \$120 | \$3,600 |

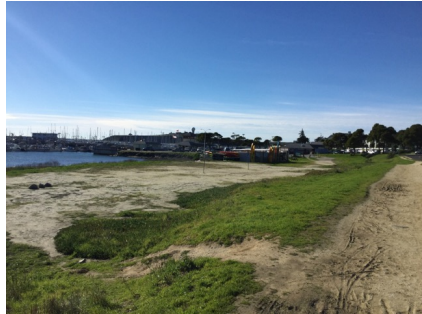
| Item No. and Name | Existing Architectural Barrier and Proposed Solution | Codes / Mitigation Info | Qty | Unit | Cost | Total |
|---|---|--|---|---|---|---|
| 1034 | <ul style="list-style-type: none"> <i>As-Built Description:</i> No walk / sidewalk provided to connect accessible facilities or elements that are on the same site. <i>As-Built:</i> To volleyball court <i>Proposed Solution:</i> Provide new 48" wide walk / sidewalk. Notes: Provide path from kayak rental area to court area that is well-compacted | <p><i>PCODE</i> EF13</p> <p><i>ADAAG 91</i> 4.3.2</p> <p><i>ADA 2010</i> 206.1</p> <p><i>CBC 2007</i> 1114B.1.2</p> <p><i>CBC 2016</i> 11B-206.1</p> <p>Priority 1</p> <p>Severity 3</p> | 100 | LF | \$45 | \$4,500 |

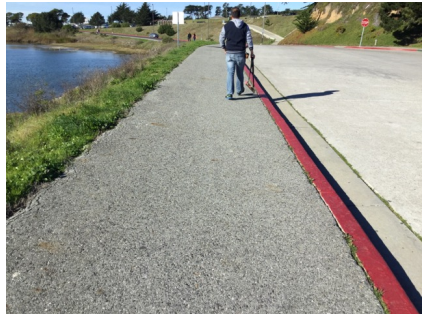
| Item No. and Name | Existing Architectural Barrier and Proposed Solution | Codes / Mitigation Info | Qty | Unit | Cost | Total |
|---|---|--|---|---|---|---|
| 1025 | <ul style="list-style-type: none"> <i>As-Built Description:</i> Cross slope more than 1":48" (2.083%). <i>As-Built:</i> 2.7-4.6% <i>Proposed Solution:</i> Modify cross slope. | <p><i>PCODE</i> EF07</p> <p><i>ADAAG 91</i> 4.3.7</p> <p><i>ADA 2010</i> 403.3</p> <p><i>CBC 2007</i> 1133B.7.1.3</p> <p><i>CBC 2016</i> 11B-403.3</p> <p>Priority 1</p> <p>Severity 3</p> | 1200 | SF | \$25 | \$30,000 |

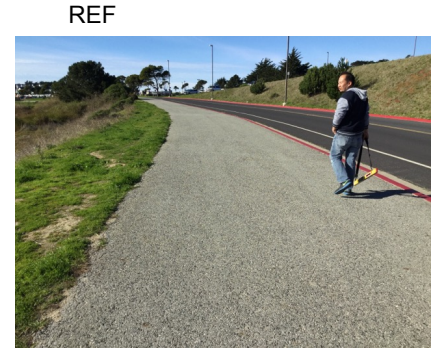
| Item No. and Name | Existing Architectural Barrier and Proposed Solution | Codes / Mitigation Info | Qty | Unit | Cost | Total |
|---|--|--|---|---|---|---|
| 1027 | <ul style="list-style-type: none"> <i>As-Built Description:</i> Cross slope more than 1":48" (2.083%). <i>As-Built:</i> 2.7-3.4% randomly <i>Proposed Solution:</i> Modify cross slope. <i>Notes:</i> Path can be negotiated | <p>PCODE EF07REF</p> <p>ADAAG 91 4.3.7</p> <p>ADA 2010 403.3</p> <p>CBC 2007 1133B.7.1.3</p> <p>CBC 2016 11B-403.3</p> <p>Priority 1</p> <p>Severity 4</p> | | | | |

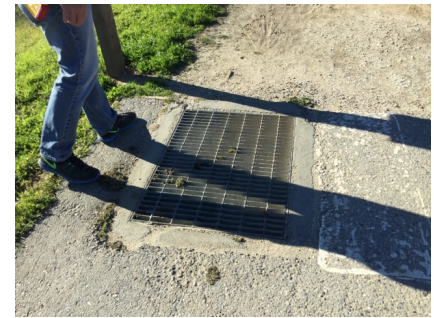
| 1032 | <ul style="list-style-type: none"> <i>As-Built Description:</i> Walk: Grating has grid openings greater than 1/2" along the line of traffic flow. <i>As-Built:</i> 1" X 4" grate opening <i>Proposed Solution:</i> Provide new grating, with grid openings 1/2" max. along the line of traffic flow. | <p>PCODE EF04</p> <p>ADAAG 91 4.3.6; 4.5.4</p> <p>ADA 2010 403.2; 302.3</p> <p>CBC 2007 1133B.7.2</p> <p>CBC 2016 11B-403.2; 11B-302.3</p> <p>Priority 1</p> <p>Severity 2</p> | 6 | SF | \$80 | \$480 |

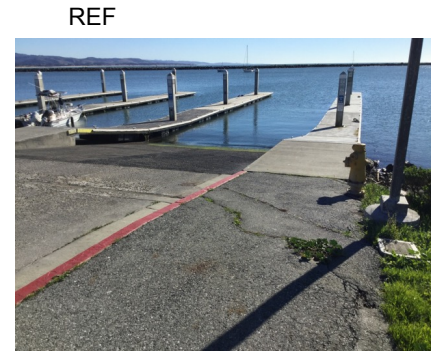
| 1024 | <ul style="list-style-type: none"> <i>As-Built Description:</i> Walk: Slope greater than 1:20 (5.0%), and walk does not comply with requirements for ramps. <i>As-Built:</i> 14.6% <i>Proposed Solution:</i> Modify walk/sidewalk slope to 1:20 or less. <i>Notes:</i> Steep adjacent slope | <p>PCODE EF01REF</p> <p>ADAAG 91 4.3.7</p> <p>ADA 2010 403.3</p> <p>CBC 2007 1133B.7.3</p> <p>CBC 2016 11B-403.3</p> <p>Priority 1</p> <p>Severity 2</p> | | | | |

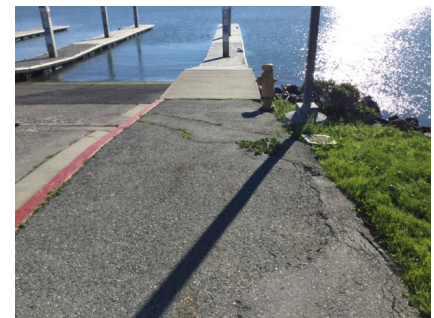
| 1023 | <ul style="list-style-type: none"> <i>As-Built Description:</i> Walk: Irregular surface in pavement. <i>Proposed Solution:</i> Smooth pavement surface; grind or refinish surface. | <p>PCODE EF10</p> <p>ADAAG 91 4.5.2</p> <p>ADA 2010 303.1; 302.1</p> <p>CBC 2007 1133B.7.1</p> <p>CBC 2016 11B-303.1; 11B-302.1</p> <p>Priority 1</p> <p>Severity 3</p> | 320 | SF | \$5 | \$1,600 |

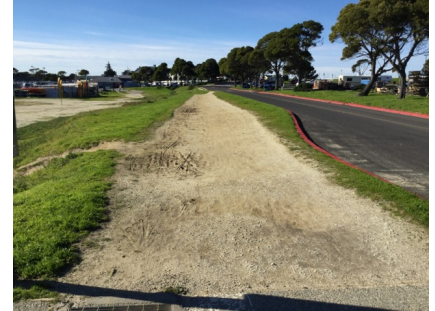
| Item No. and Name | Existing Architectural Barrier and Proposed Solution | Codes / Mitigation Info | Qty | Unit | Cost | Total |
|---|--|--|---|---|---|---|
| 1033 | <ul style="list-style-type: none"> <i>As-Built Description:</i> Walk: Irregular surface along compacted dirt or decomposed granite pathway. <i>Proposed Solution:</i> Regrade and maintain pathway to be even and smooth, provide firm, stable, and slip resistant surface. <i>Notes:</i> Maintain dirt path | PCODE EF10C ADAAG 91 4.5.2 ADA 2010 303.1; 302.1 CBC 2007 1133B.7.1 CBC 2016 11B-303.1; 11B-302.1 Priority 1 Severity 3 | 1600 | SF | \$4 | \$6,400 |

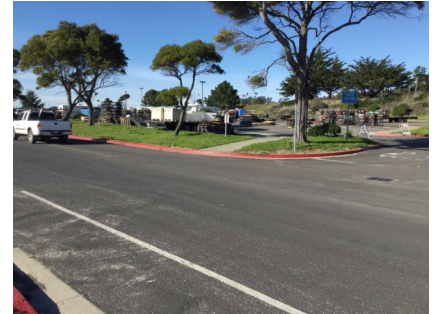
| 1031 | <ul style="list-style-type: none"> <i>As-Built Description:</i> No curb ramp available where an accessible route crosses a curb. <i>Proposed Solution:</i> Provide new curb ramp. <i>Notes:</i> Provide a CR and connecting crossing | PCODE EH01 ADAAG 91 4.7.1 ADA 2010 303.4 CBC 2007 1127B.5.1 CBC 2016 11B-402.2 Priority 1 Severity 3 | 1 | JOB | \$2,500 | \$2,500 |

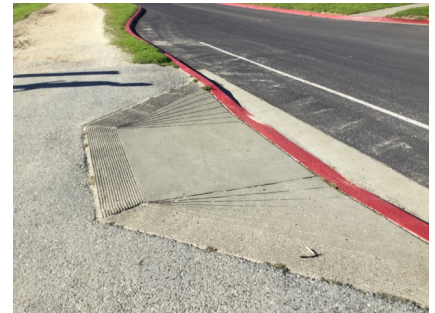
| 1030 | <ul style="list-style-type: none"> <i>As-Built Description:</i> Slope greater than 1:12 (8.3%). <i>As-Built:</i> 8.7% <i>Proposed Solution:</i> Demolish existing and provide new curb ramp. | PCODE EH02A ADAAG 91 4.7.2 ADA 2010 406.1 CBC 2007 1127B.5.3 CBC 2016 11B-406.2.1 Priority 1 Severity 4 | 1 | JOB | \$2,500 | \$2,500 |

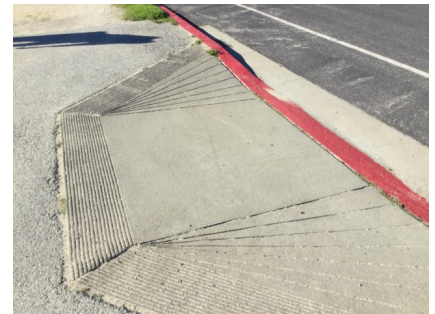
| 1029 | <ul style="list-style-type: none"> <i>As-Built Description:</i> Detectable warning not provided where pedestrian crosses vehicular area. <i>Proposed Solution:</i> Provide detectable warning surface (i.e. in-line truncated domes) at regular curb ramp. | PCODE EH07A ADAAG 91 4.7.7 ADA 2010 705.1 CBC 2007 1127B.5.7 CBC 2016 11B-705.1.2.2 Priority 1 Severity 3 | 1 | JOB | \$250 | \$250 |

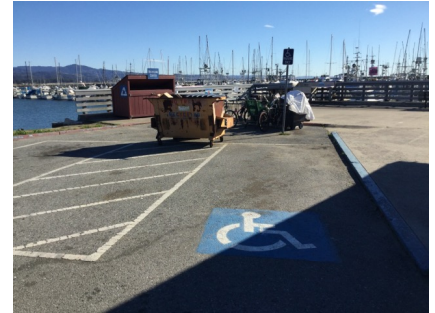
| Item No. and Name | Existing Architectural Barrier and Proposed Solution | Codes / Mitigation Info | Qty | Unit | Cost | Total |
|---|---|---|---|---|---|---|
| 1038 | <ul style="list-style-type: none"> <i>As-Built Description:</i> No van parking provided (one in every 6 or fraction of 6 accessible spaces, but not less than one). <i>As-Built:</i> No van space provided <i>Proposed Solution:</i> Provide van parking space(s) by restriping; provide van sign. <i>Notes:</i> Relocate aisle to passenger side | PCODE EA07 ADAAG 91 4.1.2(5)(b) ADA 2010 208.2; 502.1 CBC 2007 1129B.3.2 CBC 2016 11B-208.2.4 Priority 1 Severity 2 | 1 | JOB | \$350 | \$350 |

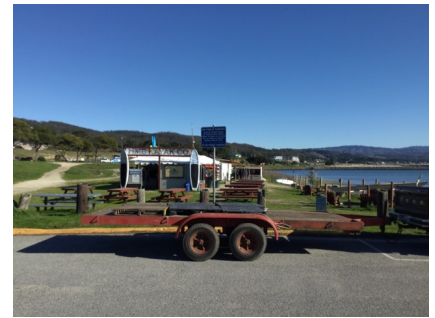
| 1035 | <ul style="list-style-type: none"> <i>As-Built Description:</i> No "Tow Away" sign at parking lot entrance (required in CA only). <i>As-Built:</i> No language for disabled parking <i>Proposed Solution:</i> Provide "Tow Away" sign at parking lot entrance when altering area. | PCODE EA04C CBC 2007 1129B.4 CBC 2016 11B-502.8.2 Priority 1 Severity 4 | 1 | JOB | \$325 | \$325 |

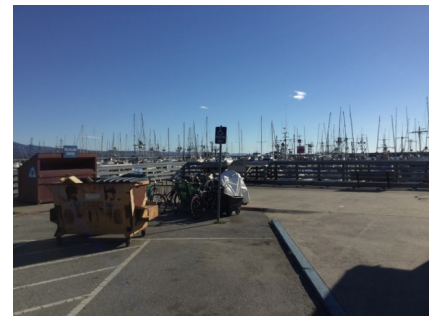
| 1039 | <ul style="list-style-type: none"> <i>As-Built Description:</i> CA only: Additional Sign or additional language below the symbol of accessibility stating "Minimum Fine \$250" not provided. <i>Proposed Solution:</i> Provide compliant parking signage that includes fine information. | PCODE EA04G CBC 2007 1129B.4 CBC 2016 11B-502.6.2 Priority 1 Severity 4 | 1 | JOB | \$100 | \$100 |

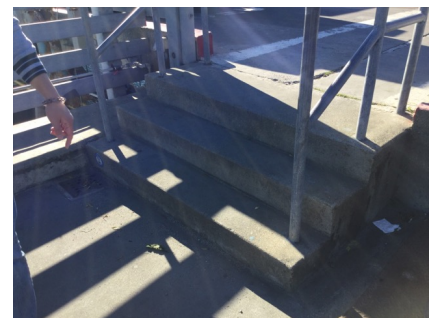
| 1050 | <ul style="list-style-type: none"> <i>As-Built Description:</i> The leading 2" of the tread does not have visual contrast of dark-on-light or light-on-dark from the remainder of the tread. <i>Proposed Solution:</i> Provide contrasting color strips at all exterior stair treads. | PCODE EC02 ADA 2010 504.4 CBC 2007 1133B.4.4 CBC 2016 11B-504.4.1 Priority 1 Severity 4 | 30 | LF | \$9 | \$270 |

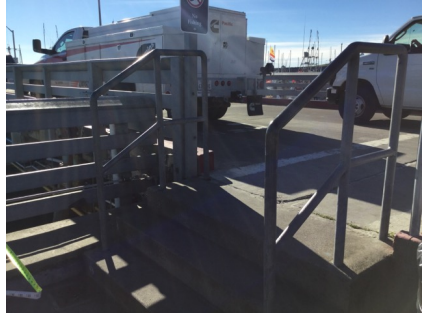
| Item No. and Name | Existing Architectural Barrier and Proposed Solution | Codes / Mitigation Info | Qty | Unit | Cost | Total |
|---|--|---|---|---|---|---|
| 1049 | <ul style="list-style-type: none"> <i>As-Built Description:</i> Handrail gripping surface top not mounted between 34" and 38" above ramp surface or stair nosings. <i>As-Built:</i> 40" high <i>Proposed Solution:</i> Remove existing and provide new handrail. | <p><i>PCODE</i> ED02 <i>ADAAG 91</i> 4.9.4(5) <i>ADA 2010</i> 505.4 <i>CBC 2007</i> 1133B.4.2.1 & B.5.5.1 <i>CBC 2016</i> 11B-505.4</p> <p>Priority 1 Severity 4</p> | 20 | LF | \$75 | \$1,500 |

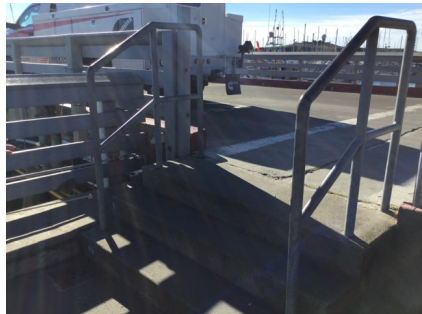
| Item No. and Name | Existing Architectural Barrier and Proposed Solution | Codes / Mitigation Info | Qty | Unit | Cost | Total |
|---|--|---|---|---|---|---|
| 1048 | <ul style="list-style-type: none"> <i>As-Built Description:</i> Stair handrail does not extend horizontally 12" minimum beyond top nosing, and one tread width sloped, plus 12" minimum horizontally beyond the bottom nosing. <i>Proposed Solution:</i> Extend stair handrail at top and bottom (cost for each extension piece). Notes: 2 sets of stairs | <p><i>PCODE</i> ED06 <i>ADAAG 91</i> 4.9.4(2) <i>ADA 2010</i> 505.10.2; 505.10.3 <i>CBC 2007</i> 1133B.4.2.2 <i>CBC 2016</i> 11B-505.10.2; 11B-505.10.3</p> <p>Priority 1 Severity 2</p> | 4 | JOB | \$170 | \$680 |

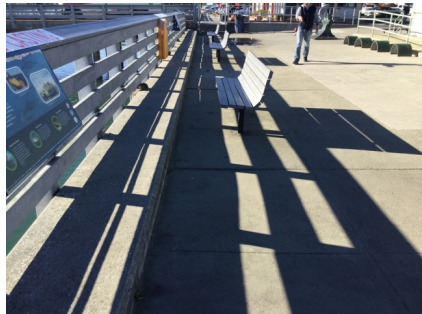
| Item No. and Name | Existing Architectural Barrier and Proposed Solution | Codes / Mitigation Info | Qty | Unit | Cost | Total |
|---|--|---|---|---|---|---|
| 1047 | <ul style="list-style-type: none"> <i>As-Built Description:</i> Cross slope more than 1":48" (2.083%). <i>As-Built:</i> Sloped next to fishing pier railing <i>Proposed Solution:</i> Modify cross slope. | <p><i>PCODE</i> EF07 <i>ADAAG 91</i> 4.3.7 <i>ADA 2010</i> 403.3 <i>CBC 2007</i> 1133B.7.1.3 <i>CBC 2016</i> 11B-403.3</p> <p>Priority 1 Severity 4</p> | 800 | SF | \$25 | \$20,000 |

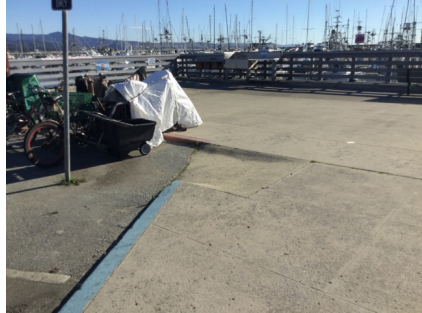
| Item No. and Name | Existing Architectural Barrier and Proposed Solution | Codes / Mitigation Info | Qty | Unit | Cost | Total |
|---|---|---|---|---|---|---|
| 1041 | <ul style="list-style-type: none"> <i>As-Built Description:</i> 36" wide band of truncated domes not provided at walkway or crossing adjoining a vehicular way, if surfaces are not separated by a curb, railing, or other element. <i>Proposed Solution:</i> Provide 36" wide, contrasting color, band of truncated domes between pedestrian and vehicular area. <i>Notes:</i> Widen walk to parking aisle | PCODE EG09 ADAAG 91 4.29.5 CBC 2007 1133B.8.5 CBC 2016 11B-705.1.2.5 Priority 1 Severity 3 | 4 | LF | \$27 | \$108 |

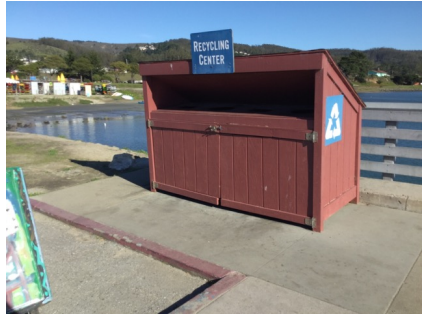
| Item No. and Name | Existing Architectural Barrier and Proposed Solution | Codes / Mitigation Info | Qty | Unit | Cost | Total |
|---|---|---|---|---|---|---|
| 1043 | <ul style="list-style-type: none"> <i>As-Built Description:</i> Clear spaces slope exceeds 1:48 max in all directions or not a minimum size of 30" by 48". <i>As-Built:</i> 46" space in front of recycle bin <i>Proposed Solution:</i> Regrade and remodel area as required. | PCODE NS05 ADAAG 91 16.16.4 ADA 2010 305.2; 305.3 CBC 2007 1132B.1 CBC 2016 11B-305.2; 11B-305.3 Priority 1 Severity 4 | 35 | SF | \$25 | \$875 |

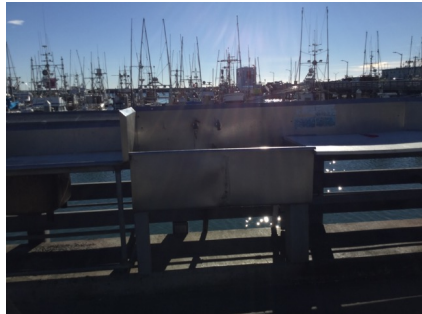
| Item No. and Name | Existing Architectural Barrier and Proposed Solution | Codes / Mitigation Info | Qty | Unit | Cost | Total |
|---|---|---|---|---|---|---|
| 1045 | <ul style="list-style-type: none"> <i>As-Built Description:</i> Reach height to control or access point, where side approach is available, exceeds 48" or is less than 15" in height, or exceeds 10" in depth. <i>As-Built:</i> 52" high at 26" deep faucet <i>Proposed Solution:</i> Modify equipment or mounting. <i>Notes:</i> 2.7% space in front | PCODE IE02 ADAAG 91 4.2.6 ADA 2010 308.3.1 CBC 2007 1118B.6 CBC 2016 11B-308.3 Priority 1 Severity 4 | 1 | JOB | \$100 | \$100 |

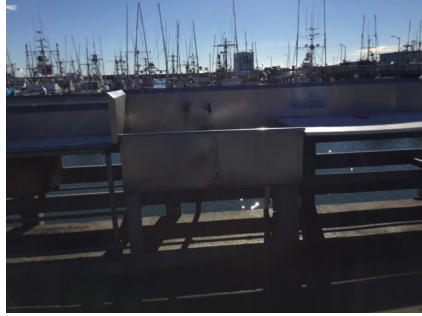
| Item No. and Name | Existing Architectural Barrier and Proposed Solution | Codes / Mitigation Info | Qty | Unit | Cost | Total |
|---|---|---|---|---|---|---|
| 1044 | <ul style="list-style-type: none"> <i>As-Built Description:</i> Sink rim higher than 34" above floor. <i>As-Built:</i> 38.5" high <i>Proposed Solution:</i> Remodel sink cabinet to lower sink. | PCODE IN06 ADAAG 91 4.24.2 ADA 2010 606.3 CBC 2007 1115B.4.7.1 CBC 2016 11B-606.3 Priority 1 Severity 4 | 1 | JOB | \$1,750 | \$1,750 |

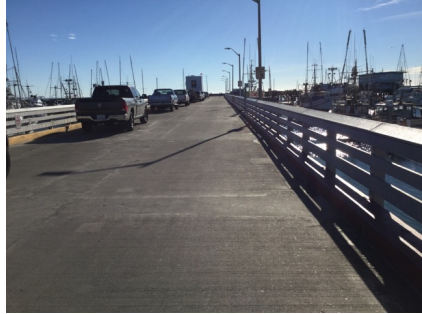
| 1053 | <ul style="list-style-type: none"> <i>As-Built Description:</i> No walk / sidewalk provided to connect accessible facilities or elements that are on the same site. <i>Proposed Solution:</i> Provide new 48" wide walk / sidewalk. Notes: POT is shared with vehicular way consider curb for pedestrians | PCODE EF13REF ADAAG 91 4.3.2 ADA 2010 206.1 CBC 2007 1114B.1.2 CBC 2016 11B-206.1 Priority 2 Severity 3 | REF | | | |

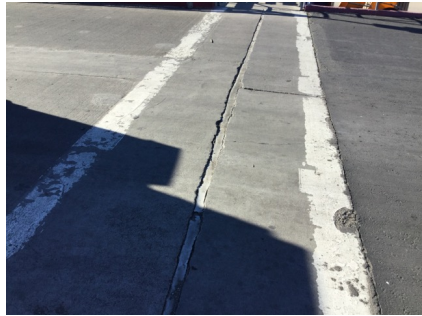
| 1051 | <ul style="list-style-type: none"> <i>As-Built Description:</i> Walk: Pavement dislocation creates abrupt change in level exceeding 1/2" in accessible route. <i>As-Built:</i> 0.5" lip at transition to pier <i>Proposed Solution:</i> Remove, replace or repair area of pavement sufficient to correct abrupt change in level. | PCODE EF03 ADAAG 91 4.3.8 ADA 2010 403.4 CBC 2007 1133B.7.4 CBC 2016 11B-403.4 Priority 2 Severity 4 | 20 | SF | \$21 | \$420 |

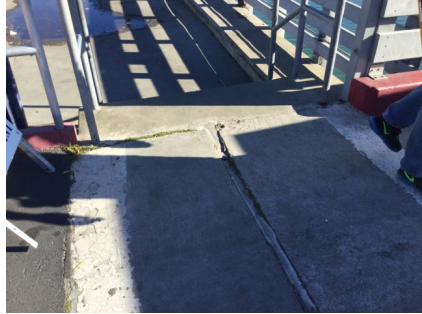
| Item No. and Name | Existing Architectural Barrier and Proposed Solution | Codes / Mitigation Info | Qty | Unit | Cost | Total |
|---|---|---|---|---|---|---|
| 1052 | <ul style="list-style-type: none"> <i>As-Built Description:</i> 36" wide band of truncated domes not provided at walkway or crossing adjoining a vehicular way, if surfaces are not separated by a curb, railing, or other element. <i>Proposed Solution:</i> Provide 36" wide, contrasting color, band of truncated domes between pedestrian and vehicular area. <i>Notes:</i> At transition to pier | PCODE EG09 ADAAG 91 4.29.5 CBC 2007 1133B.8.5 CBC 2016 11B-705.1.2.5 Priority 2 Severity 3 | 10 | LF | \$27 | \$270 |

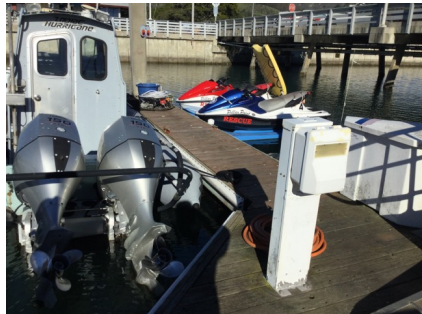
| <u>Boat Slip</u> | | | | | | | |
|---|---|--|---|--|--|--|--|
| 1059 | <ul style="list-style-type: none"> <i>As-Built Description:</i> A 60" clearance for the full length of the pier is not provided or 10' max. of linear pier edge serving boat slips do not contain at least one continuous clear opening 60" wide. <i>As-Built:</i> 40" wide individual boat slips <i>Proposed Solution:</i> Provide a 60" clearance for the full length of the pier. Each 10' max. of linear pier edge serving boat slips shall contain at least one continuous clear opening 60" wide. <i>Notes:</i> Main slip is compliant and assistance is provided by businesses on the slip when requested. | PCODE NY02REF ADA 2010 1003.3.1 CBC 2016 11B-1003.3.1 Priority 2 Severity 3 Mitigation Project: Johnson Pier D Dock Estimated Completion Date: 2020-2021 | REF | | | | |

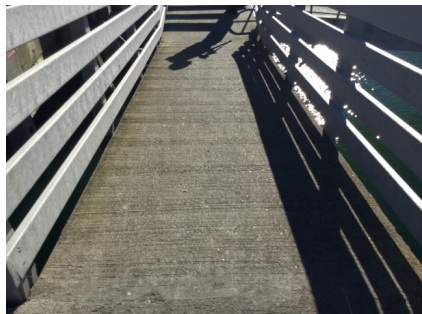
| <u>Slope</u> | | | | | | |
|---|---|---|---|---|---|---|
| 1055 | <ul style="list-style-type: none"> <i>As-Built Description:</i> Slope greater than 1:12 (8.3%). <i>As-Built:</i> 20.3% <i>Proposed Solution:</i> Demolish existing and provide new ramp with handrails. | PCODE EB02 ADAAG 91 4.8.2 ADA 2010 405.2 CBC 2007 1133B.5.3 CBC 2016 11B-405.2 Priority 2 Severity 1 Mitigation Project: Johnson Pier D Dock Estimated Completion Date: 2020-2021 | 75 | SF | \$100 | \$7,500 |

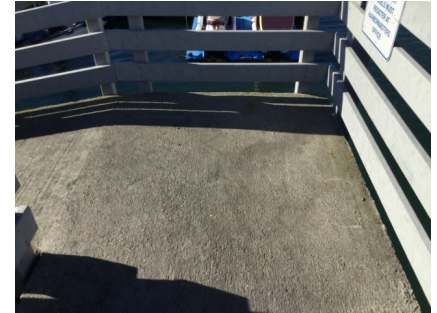
| Item No. and Name | Existing Architectural Barrier and Proposed Solution | Codes / Mitigation Info | Qty | Unit | Cost | Total |
|---|---|--|---|---|---|---|
| 1054 | <ul style="list-style-type: none"> <i>As-Built Description:</i> Level 2% max. landing for ramp not provided. <i>As-Built:</i> 3.7% TL <i>Proposed Solution:</i> Rebuild ramp to provide landings for each ramp run with slopes no greater than 2% | PCODE EB05A ADAAG 91 4.8.4 ADA 2010 405.7.1 CBC 2007 1133B.5.4.1 CBC 2016 11B-405.7.1 Priority 2 Severity 4 Mitigation Project: <i>Johnson Pier D Dock</i> Estimated Completion Date: <i>2020-2021</i> | 25 | SF | \$100 | \$2,500 |

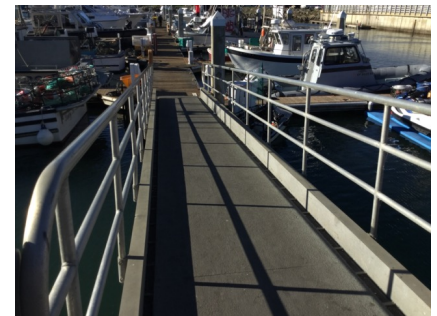
| 1057 | <ul style="list-style-type: none"> <i>As-Built Description:</i> Open guards does not have balusters or ornamental patterns such that a 4-inch-diameter (102 mm) sphere cannot pass through any opening. <i>As-Built:</i> 9.5" openings in guardrails <i>Proposed Solution:</i> Provide new guards which do not allow passage of an 4 inch sphere at any opening. | PCODE ED08A ADA 2010 405.9.2 CBC 2007 1013.3 CBC 2016 11B-405.9.2 Priority 2 Severity 3 Mitigation Project: <i>Johnson Pier D Dock</i> Estimated Completion Date: <i>2020-2021</i> | 80 | LF | \$120 | \$9,600 |

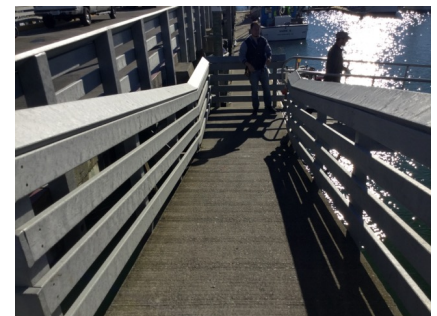
| 1056 | <ul style="list-style-type: none"> <i>As-Built Description:</i> Handrail not provided at stairs or ramp, required on both sides (not required at curb ramps or adjacent to seating areas). <i>Proposed Solution:</i> Provide new handrail for each side including extensions. | PCODE ED01 ADAAG 91 4.8.5 & 4.9.4 ADA 2010 505.2 CBC 2007 1133B.4.1.1 CBC 2016 & .5.5 11B-505.2 Priority 2 Severity 2 Mitigation Project: <i>Johnson Pier D Dock</i> Estimated Completion Date: <i>2020-2021</i> | 30 | LF | \$95 | \$2,850 |

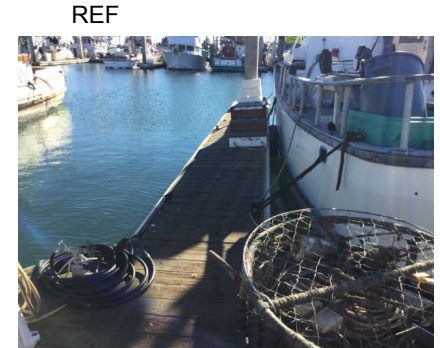
Priority 2
Severity 3

Mitigation Project:
Johnson Pier Docks
Estimated Completion Date:
2017-2022

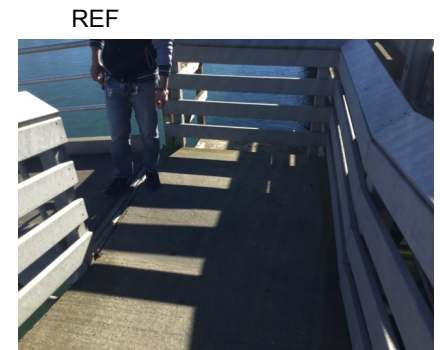
1062 • *As-Built Description:*
 Landing at change of direction not 60" minimum by 72" minimum in the direction of downward travel from the upper ramp run.

Priority 2
Severity 4

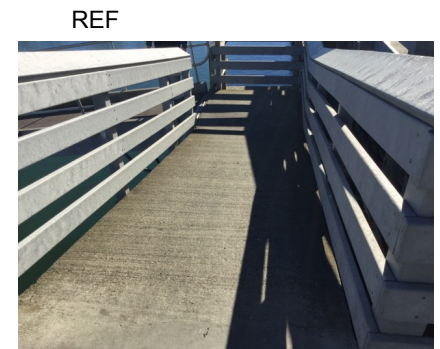
1061 • *As-Built Description:*
 Slope greater than 1:12 (8.3%).

Priority 2
Severity 1

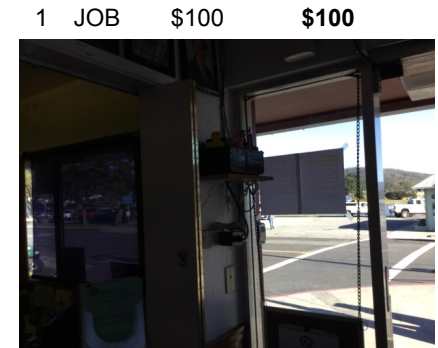
- 616 • *As-Built Description:*
Doormat not securely attached to ground or floor structure.
- *Proposed Solution:*
Attach doormat to floor surface or remove doormat.

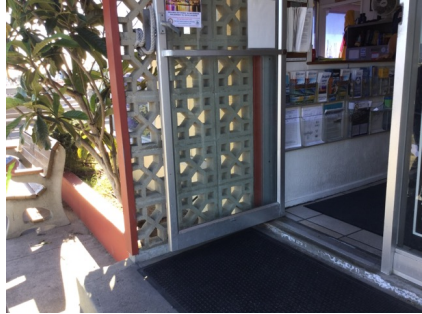
| Item No. and Name | Existing Architectural Barrier and Proposed Solution | Codes / Mitigation Info | Qty | Unit | Cost | Total |
|---|---|---|---|---|---|---|
| 617 | <ul style="list-style-type: none"> <i>As-Built Description:</i> At push side of door on accessible route, bottom 10" does not have a smooth, uninterrupted surface. <i>As-Built:</i> 4" bottom surface <i>Proposed Solution:</i> Provide 10" min. "kick plate" covering width of door when altering area. | <p><i>PCODE ID06</i></p> <p>ADA 2010 404.2.10</p> <p>CBC 2007 1133B.2.6</p> <p>CBC 2016 11B-404.2.10</p> <p>Priority 1</p> <p>Severity 3</p> <p>Mitigation Project: <i>Harbor Office Remodel (ADA, Services)</i></p> <p>Estimated Completion Date: <i>2018-2019</i></p> | 1 | JOB | \$100 | \$100 |

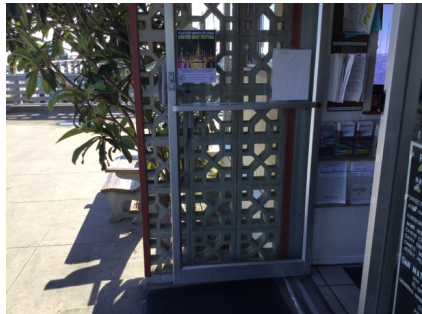
| Item No. and Name | Existing Architectural Barrier and Proposed Solution | Codes / Mitigation Info | Qty | Unit | Cost | Total |
|---|---|---|---|---|---|---|
| 618 | <ul style="list-style-type: none"> <i>As-Built Description:</i> Door lock or latch less than 34" or more than 48" above the floor (CA only: 34" to 44"). <i>As-Built:</i> 53" high <i>Proposed Solution:</i> Relocate or replace existing hardware. | <p><i>PCODE ID17</i></p> <p>ADAAG 91 4.13.9</p> <p>ADA 2010 404.2.7</p> <p>CBC 2007 1133B.2.5.2</p> <p>CBC 2016 11B-404.2.7</p> <p>Priority 1</p> <p>Severity 4</p> <p>Mitigation Project: <i>Harbor Office Remodel (ADA, Services)</i></p> <p>Estimated Completion Date: <i>2018-2019</i></p> | 1 | JOB | \$300 | \$300 |
