SAN MATEO COUNTY HARBOR DISTRICT

ADA Self-Evaluation and Transition Plan

August 2018

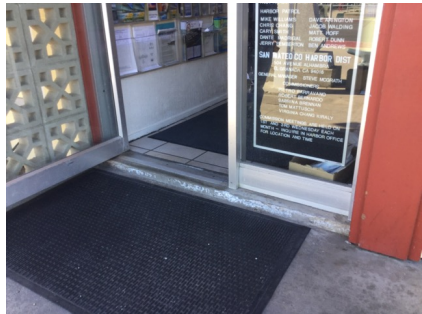
| Item No. and Name | Existing Architectural Barrier and Proposed Solution | Codes / Mitigation Info | Qty | Unit | Cost | Total |
|---|---|---|---|---|---|---|
| 615 | <ul style="list-style-type: none"> <i>As-Built Description:</i> Door inaccessible due to threshold or step at door exceeding 1/2". <i>As-Built:</i> 2" threshold <i>Proposed Solution:</i> Modify threshold to be no more than 1/2" by removing existing paving at door and providing landing with edge ramping (slope 1:20 max). | <p><i>PCODE ID02A</i></p> <p>ADAAG 91 4.13.8</p> <p>ADA 2010 404.2.5</p> <p>CBC 2007 1133B.2.4.1</p> <p>CBC 2016 11B-404.2.5</p> <p>Priority 1</p> <p>Severity 2</p> <p>Mitigation Project: <i>Harbor Office Remodel (ADA, Services)</i></p> <p>Estimated Completion Date: <i>2018-2019</i></p> | 1 | JOB | \$400 | \$400 |

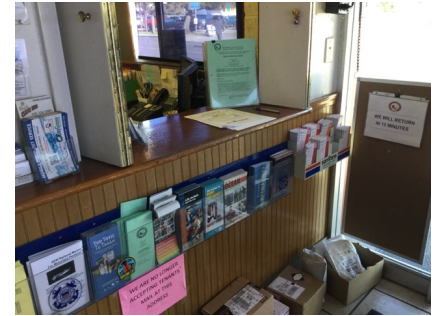
| Item No. and Name | Existing Architectural Barrier and Proposed Solution | Codes / Mitigation Info | Qty | Unit | Cost | Total |
|---|---|--|---|---|---|---|
| 620 | <ul style="list-style-type: none"> <i>As-Built Description:</i> Sales and service counter: Accessible section min. 36" length and 36" max. height (in CA: 28" to 34" high) not provided. <i>As-Built:</i> 42" high counter <i>Proposed Solution:</i> Provide auxiliary shelf, clipboard, or table as equivalent facilitation. | <p>PCODE IN03 ADAAG 91 7.2(2) ADA 2010 904.4 CBC 2007 1122B.4 CBC 2016 11B-904.4</p> <p>Priority 1 Severity 3</p> <p>Mitigation Project: Harbor Office Remodel (ADA, Services)</p> <p>Estimated Completion Date: 2018-2019</p> | 1 | JOB | \$150 | \$150 |

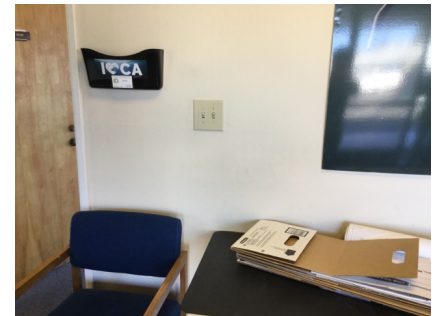
| 631 | <ul style="list-style-type: none"> <i>As-Built Description:</i> Electric switch or control mounted less than 15" measured to the bottom of the outlet box or greater than 48 inches measured to the top of the outlet box. <i>As-Built:</i> 50.25" high light switch <i>Proposed Solution:</i> Relocate light switches or control to between 15" and 48" height. | <p>PCODE IC01 ADAAG 91 4.2.5 & 6 ADA 2010 308.2.1 & 308.2.2 CBC 2007 1117B.6.3 CBC 2016 11B-308.2.1 & 11B-308.2.2</p> <p>Priority 4 Severity 4</p> <p>Mitigation Project: Harbor Office Remodel (ADA, Services)</p> <p>Estimated Completion Date: 2018-2019</p> | 1 | JOB | \$300 | \$300 |

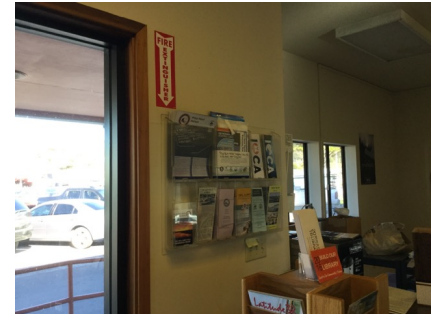
| 633 | <ul style="list-style-type: none"> <i>As-Built Description:</i> Information brochure bins mounted above accessible height of 48". <i>As-Built:</i> 60-73" high brochures <i>Proposed Solution:</i> Relocate/remount bins at accessible height. | <p>PCODE IN08 ADAAG 91 4.2.5 & 6 ADA 2010 308.2.1 CBC 2007 1118B.5 CBC 2016 11B-308.2.1</p> <p>Priority 4 Severity 1</p> <p>Mitigation Project: Harbor Office Remodel (ADA, Services)</p> <p>Estimated Completion Date: 2018-2019</p> | 1 | JOB | \$100 | \$100 |

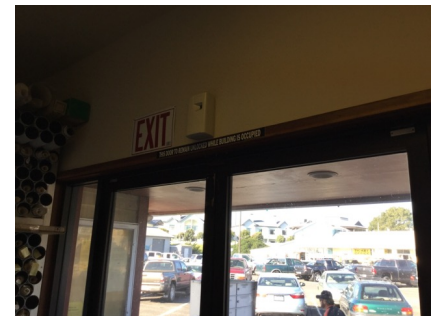
| 629 | <ul style="list-style-type: none"> <i>As-Built Description:</i> At final exit door to exterior: Where required exit signs are installed, signs to provide exiting information for people with vision impairment are not provided. <i>Proposed Solution:</i> Provide raised letter/Braille "EXIT" sign at door. | <p>PCODE SA10A ADAAG 91 4.1.3(16) ADA 2010 216.4.1 CBC 2007 1011.3 CBC 2016 11B-216.4.1</p> <p>Priority 4 Severity 3</p> <p>Mitigation Project: Harbor Office Remodel (ADA, Services)</p> <p>Estimated Completion Date: 2018-2019</p> | 1 | JOB | \$90 | \$90 |

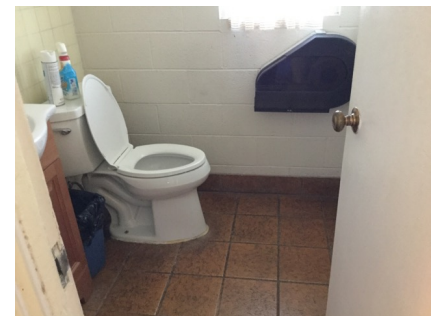
| 624 | <ul style="list-style-type: none"> <i>As-Built Description:</i> Single accommodation restroom not accessible; multiple compliance violations. <i>As-Built:</i> Multiple noncompliance items <i>Proposed Solution:</i> Remodel area to provide single-occupant accessible restroom. Notes: 2 staff restrooms provided, both noncompliant | <p>PCODE WA01 ADAAG 91 4.22 ADA 2010 603.1 CBC 2007 1115B.3.2 CBC 2016 11B-603.1</p> <p>Priority 4 Severity 2</p> <p>Mitigation Project: Harbor Office Remodel (ADA, Services)</p> <p>Estimated Completion Date: 2018-2019</p> | 1 | JOB | \$30,000 | \$30,000 |

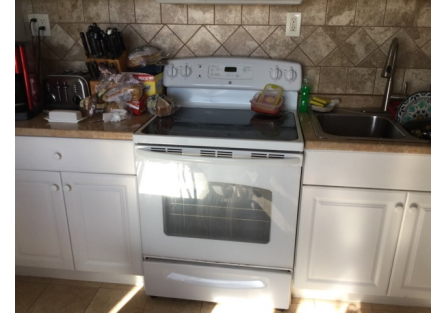
- 639
- *As-Built Description:*
Cooktop controls require reaching across the burners.
 - *Proposed Solution:*
Provide cooktop with accessible controls.

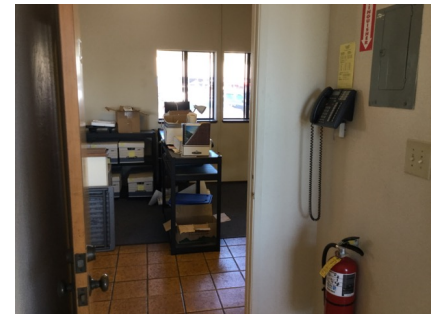
- 635
- *As-Built Description:*
Front approach: At pull side, door does not have clear and level maneuvering space measuring door width plus 18" x 60". (24" x 60" at exterior doors).
 - *As-Built:* **16" to wall**
 - *Proposed Solution:*
Provide relocated new door and frame; remodel walls as needed.

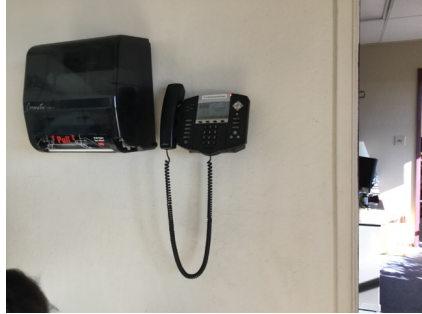
| Item No. and Name | Existing Architectural Barrier and Proposed Solution | Codes / Mitigation Info | Qty | Unit | Cost | Total |
|---|--|--|---|---|---|---|
| 634 | <ul style="list-style-type: none"> • <i>As-Built Description:</i> Reach height to control or access point, exceeds 48" or is less than 15". • <i>As-Built:</i> Phone: 62" high • <i>Proposed Solution:</i> Modify equipment or mounting. | <p><i>PCODE IE01</i> <i>ADAAG 91 4.2.5</i> <i>ADA 2010 308.2.1</i> <i>CBC 2007 1118B.5</i> <i>CBC 2016 11B-308.2.1</i></p> <p>Priority 4 Severity 2</p> <p>Mitigation Project: <i>Harbor Office Remodel (ADA, Services)</i></p> <p>Estimated Completion Date: <i>2018-2019</i></p> | 1 | JOB | \$100 | \$100 |

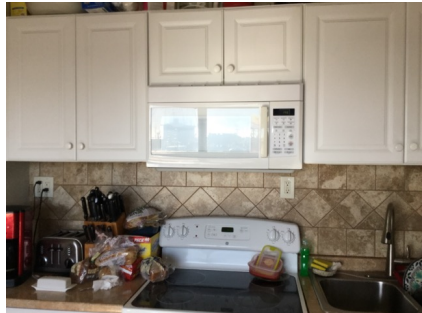
| Item No. and Name | Existing Architectural Barrier and Proposed Solution | Codes / Mitigation Info | Qty | Unit | Cost | Total |
|---|--|--|---|---|---|---|
| 640 | <ul style="list-style-type: none"> • <i>As-Built Description:</i> Reach height to control or access point, exceeds 48" or is less than 15". • <i>As-Built:</i> Microwave: 68" high • <i>Proposed Solution:</i> Modify equipment or mounting. | <p><i>PCODE IE01</i> <i>ADAAG 91 4.2.5</i> <i>ADA 2010 308.2.1</i> <i>CBC 2007 1118B.5</i> <i>CBC 2016 11B-308.2.1</i></p> <p>Priority 4 Severity 1</p> <p>Mitigation Project: <i>Harbor Office Remodel (ADA, Services)</i></p> <p>Estimated Completion Date: <i>2018-2019</i></p> | 1 | JOB | \$100 | \$100 |

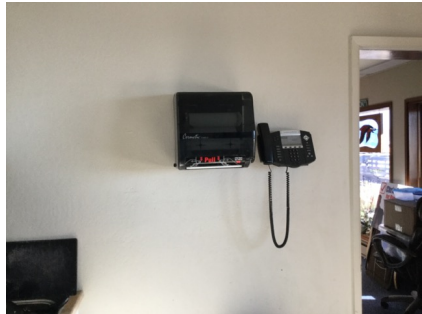
| Item No. and Name | Existing Architectural Barrier and Proposed Solution | Codes / Mitigation Info | Qty | Unit | Cost | Total |
|---|--|--|---|---|---|---|
| 641 | <ul style="list-style-type: none"> • <i>As-Built Description:</i> Reach height to control or access point, exceeds 48" or is less than 15". • <i>As-Built:</i> PTD: 57" high • <i>Proposed Solution:</i> Modify equipment or mounting. | <p><i>PCODE IE01</i> <i>ADAAG 91 4.2.5</i> <i>ADA 2010 308.2.1</i> <i>CBC 2007 1118B.5</i> <i>CBC 2016 11B-308.2.1</i></p> <p>Priority 4 Severity 3</p> <p>Mitigation Project: <i>Harbor Office Remodel (ADA, Services)</i></p> <p>Estimated Completion Date: <i>2018-2019</i></p> | 1 | JOB | \$100 | \$100 |

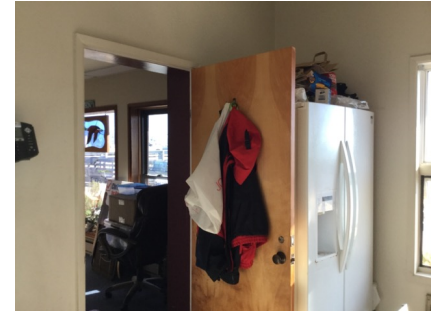
| Item No. and Name | Existing Architectural Barrier and Proposed Solution | Codes / Mitigation Info | Qty | Unit | Cost | Total |
|---|---|--|---|---|---|---|
| 642 | <ul style="list-style-type: none"> <i>As-Built Description:</i> Reach height to control or access point, exceeds 48" or is less than 15". <i>As-Built:</i> 71" high CH <i>Proposed Solution:</i> Modify equipment or mounting. <i>Notes:</i> On each door | PCODE IE01 ADAAG 91 4.2.5 ADA 2010 308.2.1 CBC 2007 1118B.5 CBC 2016 11B-308.2.1 Priority 4 Severity 1 Mitigation Project: <i>Harbor Office Remodel (ADA, Services)</i> Estimated Completion Date: 2018-2019 | 7 | JOB | \$100 | \$700 |

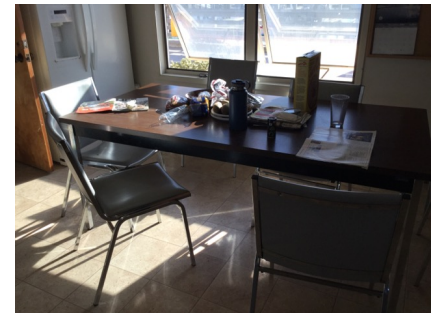
| 636 | <ul style="list-style-type: none"> <i>As-Built Description:</i> Accessible non-fixed table or desk (top 28" to 34" high; knee space at least 27" high x 19" deep x 30" wide) not provided. <i>As-Built:</i> 24.75" high knee space <i>Proposed Solution:</i> Provide table or desk with accessible dimensions when purchasing new furniture. | PCODE IN02A ADAAG 91 4.32.3 & .4 ADA 2010 306.1 CBC 2007 1122B.3 & 4 CBC 2016 11B-306.1 & 11B-902.3 Priority 4 Severity 2 Mitigation Project: <i>Harbor Office Remodel (ADA, Services)</i> Estimated Completion Date: 2018-2019 | 1 | JOB | \$1,600 | \$1,600 |

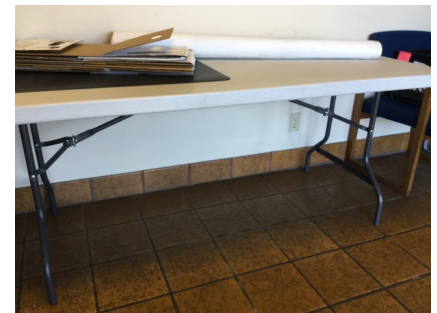
| 644 | <ul style="list-style-type: none"> <i>As-Built Description:</i> Accessible non-fixed table or desk (top 28" to 34" high; knee space at least 27" high x 19" deep x 30" wide) not provided. <i>As-Built:</i> 14" deep knee space <i>Proposed Solution:</i> Provide table or desk with accessible dimensions when purchasing new furniture. | PCODE IN02A ADAAG 91 4.32.3 & .4 ADA 2010 306.1 CBC 2007 1122B.3 & 4 CBC 2016 11B-306.1 & 11B-902.3 Priority 4 Severity 2 Mitigation Project: <i>Harbor Office Remodel (ADA, Services)</i> Estimated Completion Date: 2018-2019 | 1 | JOB | \$1,600 | \$1,600 |

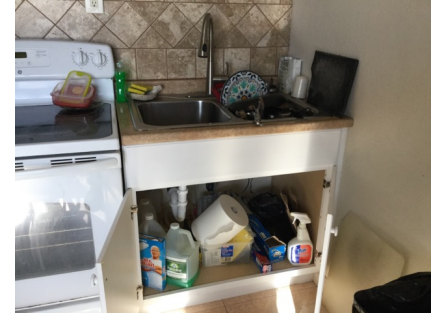
| Item No. and Name | Existing Architectural Barrier and Proposed Solution | Codes / Mitigation Info | Qty | Unit | Cost | Total |
|---|---|---|---|---|---|---|
| 637 | <ul style="list-style-type: none"> <i>As-Built Description:</i> Sink rim higher than 34" above floor. <i>As-Built:</i> 36.5" high <i>Proposed Solution:</i> Remodel sink cabinet to lower sink. | PCODE IN06 ADAAG 91 4.24.2 ADA 2010 606.3 CBC 2007 1115B.4.7.1 CBC 2016 11B-606.3 Priority 4 Severity 4 Mitigation Project: Harbor Office Remodel (ADA, Services) Estimated Completion Date: 2018-2019 | 1 | JOB | \$1,750 | \$1,750 |

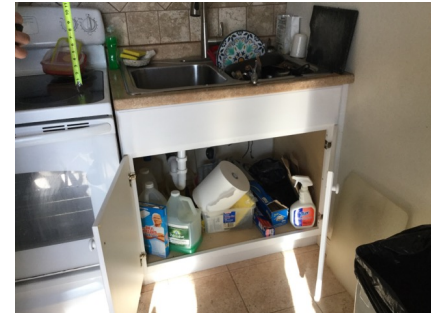
| 638 | <ul style="list-style-type: none"> <i>As-Built Description:</i> Sink does not have knee space min. 27" high x 19" deep x 30" wide. <i>Proposed Solution:</i> Remodel sink cabinet. | PCODE IN06AREF ADAAG 91 4.24.3 ADA 2010 606.2 CBC 2007 1115B.4.7.1 CBC 2016 11B-606.2 Priority 4 Severity 2 Mitigation Project: Harbor Office Remodel (ADA, Services) Estimated Completion Date: 2018-2019 | REF | | | |

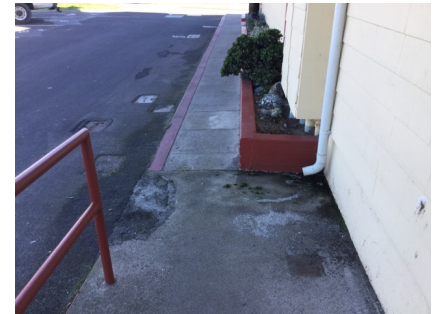
| Change in Direction | | | | | | |
|---|--|---|---|---|---|---|
| 649 | <ul style="list-style-type: none"> <i>As-Built Description:</i> Landing at change of direction not 60" minimum by 72" minimum in the direction of downward travel from the upper ramp run. <i>As-Built:</i> 43" long BL <i>Proposed Solution:</i> Modify landing at change of direction to 60" x 72". Notes: Widen landing and walk leading to landing Also provide signage designating as accessible entrance | PCODE EB08 ADAAG 91 4.8.4(3) ADA 2010 405.7.4 CBC 2007 1133B.5.4 CBC 2016 11B-405.7.4 Priority 4 Severity 2 Mitigation Project: Harbor Office Remodel (ADA, Services) Estimated Completion Date: 2018-2019 | 25 | SF | \$45 | \$1,125 |

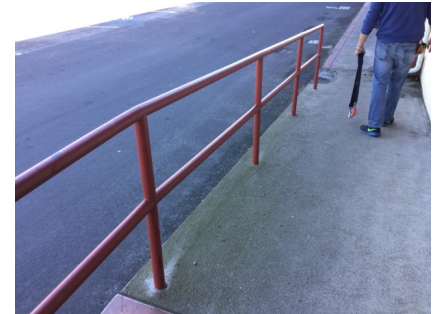
| 645 | <ul style="list-style-type: none"> <i>As-Built Description:</i> No curb (2" minimum height) or wheel guide (centered approx. 3" above surface of ramp) at sides of ramp. <i>Proposed Solution:</i> Provide 2" minimum curb or wheel guide. | <p>PCODE EB14 ADAAG 91 4.8.7 ADA 2010 405.9.2 CBC 2007 1133B.5.6 CBC 2016 11B-405.9.2</p> <p>Priority 4 Severity 3</p> <p>Mitigation Project: <i>Harbor Office Remodel (ADA, Services)</i></p> <p>Estimated Completion Date: <i>2018-2019</i></p> | 25 | LF | \$17 | \$425 |

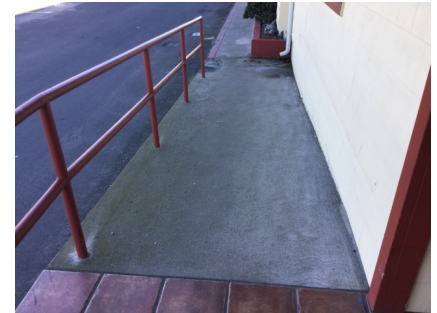
| 647 | <ul style="list-style-type: none"> <i>As-Built Description:</i> Slope greater than 1:12 (8.3%). <i>As-Built:</i> 8.3-9.8% <i>Proposed Solution:</i> Demolish existing and provide new ramp with handrails. | <p>PCODE EB02 ADAAG 91 4.8.2 ADA 2010 405.2 CBC 2007 1133B.5.3 CBC 2016 11B-405.2</p> <p>Priority 4 Severity 4</p> <p>Mitigation Project: <i>Harbor Office Remodel (ADA, Services)</i></p> <p>Estimated Completion Date: <i>2018-2019</i></p> | 100 | SF | \$100 | \$10,000 |

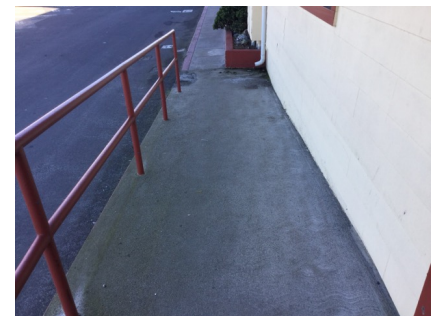
Handrails

| 646 | <ul style="list-style-type: none"> <i>As-Built Description:</i> Handrail not provided at stairs or ramp, required on both sides (not required at curb ramps or adjacent to seating areas). <i>As-Built:</i> On one side only <i>Proposed Solution:</i> Provide new handrail for each side including extensions. | <p>PCODE ED01 ADAAG 91 4.8.5 & 4.9.4 ADA 2010 505.2 CBC 2007 1133B.4.1.1 CBC 2016 & .5.5 11B-505.2</p> <p>Priority 4 Severity 2</p> <p>Mitigation Project: <i>Harbor Office Remodel (ADA, Services)</i></p> <p>Estimated Completion Date: <i>2018-2019</i></p> | 25 | LF | \$95 | \$2,375 |

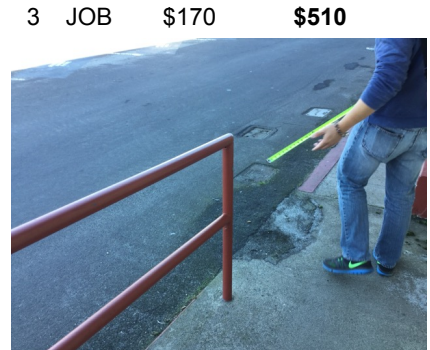
- 648
- *As-Built Description:*
Ramp handrail does not extend horizontally 12" past top and / or bottom of ramp.
 - *Proposed Solution:*
Provide ramp handrail extension (cost for each extension piece).

PCODE ED05
 ADAAG 91 4.8.5(2)
 ADA 2010 505.10.1
 CBC 2007 1133B.4.2.2 & 1133B.5.5.1
 CBC 2016 11B-505.10.1

Priority 4
 Severity 2

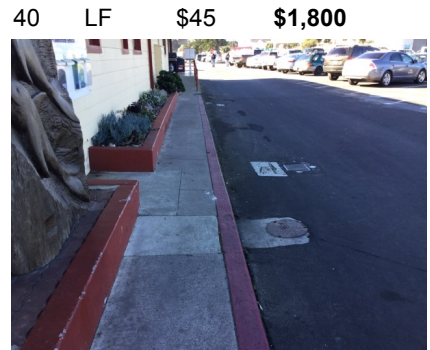
- 650
- *As-Built Description:*
No walk / sidewalk provided to connect accessible facilities or elements that are on the same site.
 - *As-Built:* **29" wide sidewalk to service ramp**
 - *Proposed Solution:*
Provide new 48" wide walk / sidewalk.

PCODE EF13
 ADAAG 91 4.3.2
 ADA 2010 206.1
 CBC 2007 1114B.1.2
 CBC 2016 11B-206.1

Priority 4
 Severity 3

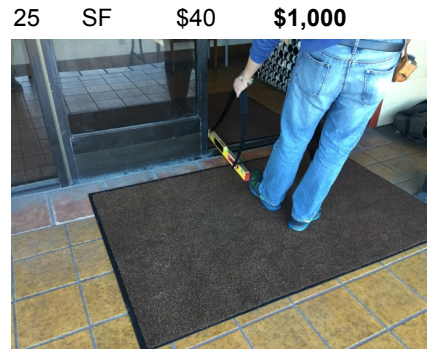
- 643
- *As-Built Description:*
Surface of required maneuvering clearance at door slopes more than 1/4":12" (2.0%).
 - *As-Built:* **11.1%**
 - *Proposed Solution:*
Modify surface slope at door.

PCODE ID11
 ADAAG 91 4.13.6
 ADA 2010 404.2.4.4
 CBC 2007 1133B.2.4
 CBC 2016 11B-404.2.4

Priority 4
 Severity 1

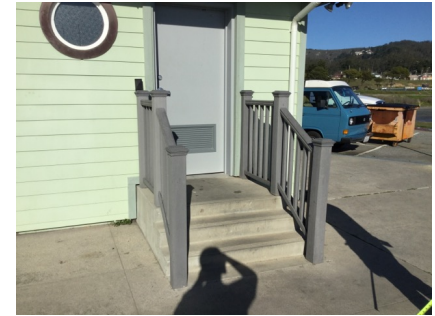
Ramps

| 653 | <ul style="list-style-type: none"> <i>As-Built Description:</i> Ramp needed to provide disabled access at steps or change of level along path of travel. <i>As-Built:</i> Access provided only by stairs <i>Proposed Solution:</i> Provide new concrete ramp with handrails [slope more than 1:20 (5.0%) needed]. <i>Notes:</i> Provide a ramp to showers | <p><i>PCODE</i> EB01A <i>ADAAG 91</i> 4.1.1 <i>ADA 2010</i> 303.4 <i>CBC 2007</i> 1127B.1 <i>CBC 2016</i> 11B-303.4</p> <p>Priority 3 Severity 3</p> | 100 | SF | \$100 | \$10,000 |

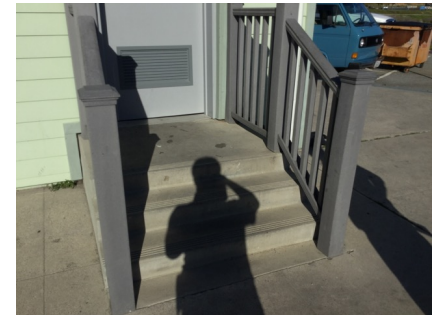
Tread Surface

| 651 | <ul style="list-style-type: none"> <i>As-Built Description:</i> Contrasting color strip not provided at all stair nosings. <i>Proposed Solution:</i> Provide contrasting color strips at all exterior stair treads when altering area. | <p><i>PCODE</i> EC02REF <i>ADA 2010</i> 504.4 <i>CBC 2007</i> 1133B.4.4 <i>CBC 2016</i> 11B-504.4.1</p> <p>Priority 3 Severity 4</p> | REF | | | |

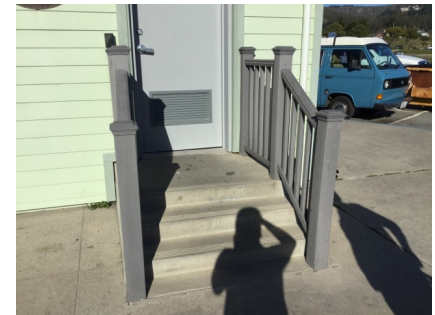
Handrails

| 652 | <ul style="list-style-type: none"> <i>As-Built Description:</i> Handrail not provided at stairs or ramp, required on both sides (not required at curb ramps or adjacent to seating areas). <i>Proposed Solution:</i> Provide new handrail for each side including extensions. | <p><i>PCODE</i> ED01REF <i>ADAAG 91</i> 4.8.5 & 4.9.4 <i>ADA 2010</i> 505.2 <i>CBC 2007</i> 1133B.4.1.1 & .5.5 <i>CBC 2016</i> 11B-505.2</p> <p>Priority 3 Severity 2</p> | REF | | | |

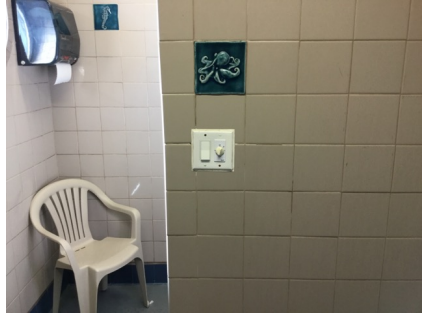
Electrical

| 656 | <ul style="list-style-type: none"> <i>As-Built Description:</i> Electric switch or control mounted less than 15" measured to the bottom of the outlet box or greater than 48 inches measured to the top of the outlet box. <i>As-Built:</i> 49" high switch <i>Proposed Solution:</i> Relocate light switches or control to between 15" and 48" height. <i>Notes:</i> Twist to operate | <p><i>PCODE</i> IC01 <i>ADAAG 91</i> 4.2.5 & 6 <i>ADA 2010</i> 308.2.1 & 308.2.2 <i>CBC 2007</i> 1117B.6.3 <i>CBC 2016</i> 11B-308.2.1 & 11B-308.2.2</p> <p>Priority 3 Severity 4</p> | 1 | JOB | \$300 | \$300 |

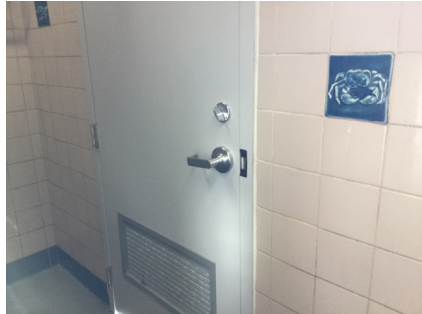
| 655 | <ul style="list-style-type: none"> <i>As-Built Description:</i> Door lock or latch less than 34" or more than 48" above the floor (CA only: 34" to 44"). <i>As-Built:</i> 49" high <i>Proposed Solution:</i> Relocate or replace existing hardware. | <p><i>PCODE</i> ID17 <i>ADAAG 91</i> 4.13.9 <i>ADA 2010</i> 404.2.7 <i>CBC 2007</i> 1133B.2.5.2 <i>CBC 2016</i> 11B-404.2.7</p> <p>Priority 3 Severity 4</p> | 1 | JOB | \$300 | \$300 |

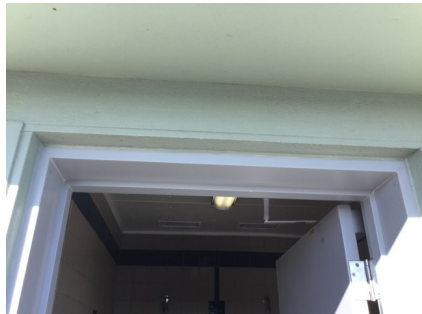
Door Closer

| 654 | <ul style="list-style-type: none"> <i>As-Built Description:</i> Excessive force required to open door. <i>As-Built:</i> 15 lbs <i>Proposed Solution:</i> Adjust regular door closer to accessible standards (5 lbs. max). | <p><i>PCODE</i> ID03 <i>ADAAG 91</i> 4.13.11 <i>ADA 2010</i> 404.2.9 <i>CBC 2007</i> 1133B.2.5 <i>CBC 2016</i> 11B-404.2.9</p> <p>Priority 3 Severity 3</p> | 1 | JOB | \$25 | \$25 |

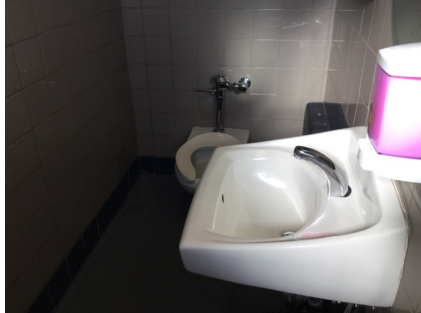
| Item No. and Name | Existing Architectural Barrier and Proposed Solution | Codes / Mitigation Info | Qty | Unit | Cost | Total |
|---|---|--|---|---|---|---|
| 659 | <ul style="list-style-type: none"> <i>As-Built Description:</i> Single accommodation restroom not accessible; multiple compliance violations. <i>Proposed Solution:</i> Remodel area to provide single-occupant accessible restroom. Notes: Accessible public restrooms are provided directly adjacent | PCODE WA01REF ADAAG 91 4.22 ADA 2010 603.1 CBC 2007 1115B.3.2 CBC 2016 11B-603.1 Priority 3 Severity 2 | | | | |

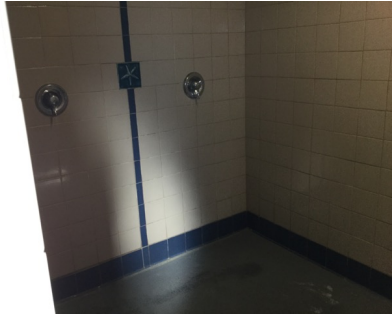
| Item No. and Name | Existing Architectural Barrier and Proposed Solution | Codes / Mitigation Info | Qty | Unit | Cost | Total |
|---|---|--|---|---|---|---|
| Shower | | | | | | |

| Item No. and Name | Existing Architectural Barrier and Proposed Solution | Codes / Mitigation Info | Qty | Unit | Cost | Total |
|---|---|--|---|---|---|---|
| 660 | <ul style="list-style-type: none"> <i>As-Built Description:</i> Shower not accessible; multiple compliance violations. <i>Proposed Solution:</i> Provide accessible shower. | PCODE WF01 ADAAG 91 4.21 ADA 2010 608.1 CBC 2016 11B-608.1 Priority 3 Severity 3 | 1 | JOB | \$4,000 | \$4,000 |

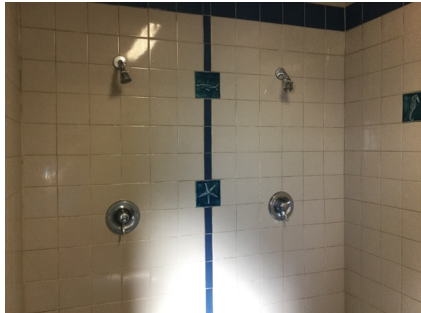
| Item No. and Name | Existing Architectural Barrier and Proposed Solution | Codes / Mitigation Info | Qty | Unit | Cost | Total |
|---|---|--|---|---|---|---|
| 661 | <ul style="list-style-type: none"> <i>As-Built Description:</i> CA only: Mounting height of shower spray bracket exceeds 48" max. or is more than 27" from rear edge of folding seat. <i>As-Built:</i> 49" high controls 76" high spray mount <i>Proposed Solution:</i> Provide or remount shower spray bracket within 27" from rear edge of seat. | PCODE WF05BREF ADA 2010 608.5 CBC 2007 1115B.4.4.5.3 CBC 2016 11B-608.5 Priority 3 Severity 1 | | | | |

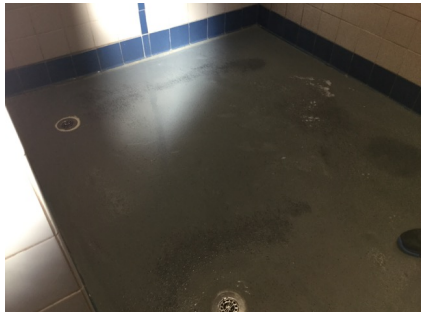
| Item No. and Name | Existing Architectural Barrier and Proposed Solution | Codes / Mitigation Info | Qty | Unit | Cost | Total |
|---|---|--|---|---|---|---|
| 663 | <ul style="list-style-type: none"> <i>As-Built Description:</i> Shower: Floor surface sloped greater than 2.0% (1:48) due to drain. <i>As-Built:</i> Sloped drain <i>Proposed Solution:</i> Remodel floor surface in shower to compliance. | PCODE WF06A ADA 2010 608.9 CBC 2016 11B-608.9 Priority 3 Severity 3 | 1 | JOB | \$500 | \$500 |

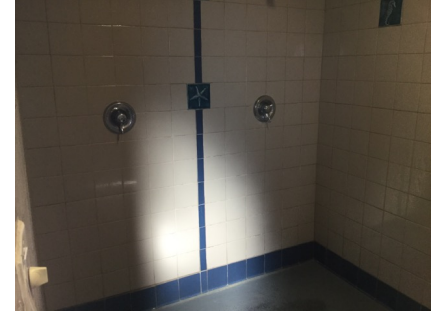
| Item No. and Name | Existing Architectural Barrier and Proposed Solution | Codes / Mitigation Info | Qty | Unit | Cost | Total |
|---|---|---|---|---|---|---|
| 662 | <ul style="list-style-type: none"> <i>As-Built Description:</i> ADAAG: L-shaped shower seat extending the full depth of the stall. The seat shall be located 1-1/2 inches (38 mm) maximum from the wall. The front of the seat (nearest to the opening) shall extend a maximum 16 inches (330 mm) from the wall. The back of the seat (against the back wall) shall extend a maximum of 23 inches (582 mm) from the side <i>As-Built:</i> No seat <i>Proposed Solution:</i> Provide new, or relocate, folding wall-mounted shower seat. | <p>PCODE WF07A</p> <p>ADAAG 91 4.21.3</p> <p>ADA 2010 610.3.2</p> <p>CBC 2007 1115B.4.4.8.1</p> <p>CBC 2016 11B-610.3.2</p> <p>Priority 3</p> <p>Severity 3</p> | 1 | JOB | \$550 | \$550 |

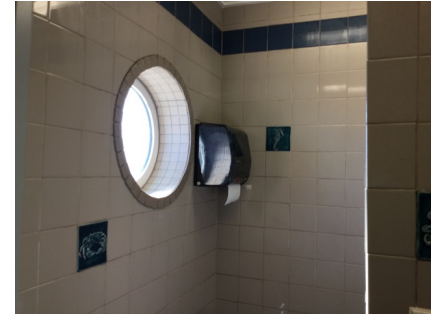
Accessories

| 658 | <ul style="list-style-type: none"> <i>As-Built Description:</i> Dispensers in sanitary facilities, such as for towels, soap, sanitary napkins, seat covers, etc., and waste receptacles more than 48" (CA only: 40") from floor to highest operating slot or control. <i>As-Built:</i> PTD: 58" high <i>Proposed Solution:</i> Relocate existing restroom accessories. | <p>PCODE WG01A</p> <p>ADAAG 91 4.23.7</p> <p>ADA 2010 308.2.1</p> <p>CBC 2007 1115B.8.3</p> <p>CBC 2016 11B-603.5</p> <p>Priority 3</p> <p>Severity 2</p> | 1 | JOB | \$100 | \$100 |

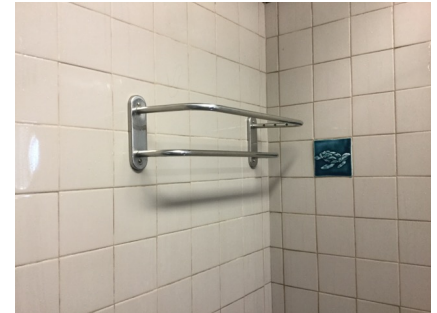
Coat Hook

| 657 | <ul style="list-style-type: none"> <i>As-Built Description:</i> Accessible coat hook not within reach range. <i>As-Built:</i> 64.5" high CH <i>Proposed Solution:</i> Adjust existing or provide new coat hook at maximum 48" height. | <p>PCODE WG03A</p> <p>ADAAG 91 4.2.5</p> <p>ADA 2010 603.4</p> <p>CBC 2007 1118B.5</p> <p>CBC 2016 11B-603.4</p> <p>Priority 3</p> <p>Severity 2</p> | 1 | JOB | \$50 | \$50 |

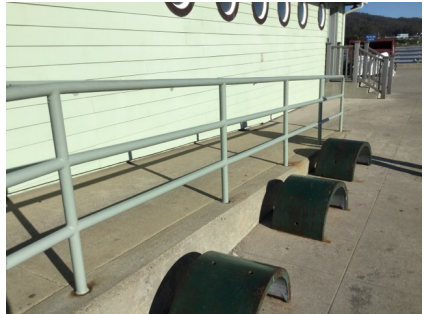
Curb or Barrier

| 666 | <ul style="list-style-type: none"> <i>As-Built Description:</i> No curb (2" minimum height) or wheel guide (centered approx. 3" above surface of ramp) at sides of ramp. <i>Proposed Solution:</i> Provide 2" minimum curb or wheel guide. | PCODE EB14 ADAAG 91 4.8.7 ADA 2010 405.9.2 CBC 2007 1133B.5.6 CBC 2016 11B-405.9.2 Priority 3 Severity 3 | 25 | LF | \$17 | \$425 |

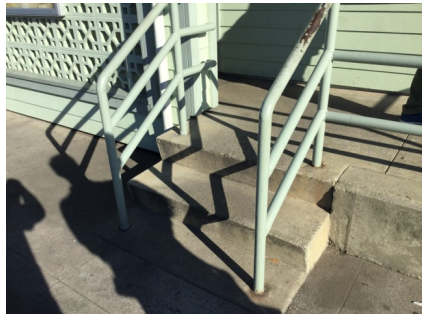
Tread Surface

| 665 | <ul style="list-style-type: none"> <i>As-Built Description:</i> The leading 2" of the tread does not have visual contrast of dark-on-light or light-on-dark from the remainder of the tread. <i>Proposed Solution:</i> Provide contrasting color strips at all exterior stair treads. | PCODE EC02 ADA 2010 504.4 CBC 2007 1133B.4.4 CBC 2016 11B-504.4.1 Priority 3 Severity 4 | 8 | LF | \$9 | \$72 |

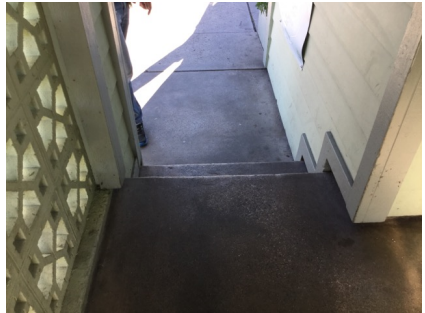
| 670 | <ul style="list-style-type: none"> <i>As-Built Description:</i> The leading 2" of the tread does not have visual contrast of dark-on-light or light-on-dark from the remainder of the tread. <i>Proposed Solution:</i> Provide contrasting color strips at all exterior stair treads. | PCODE EC02 ADA 2010 504.4 CBC 2007 1133B.4.4 CBC 2016 11B-504.4.1 Priority 3 Severity 4 | 8 | LF | \$9 | \$72 |

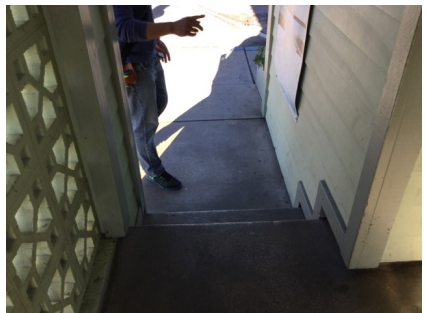
Handrails

| 669 | <ul style="list-style-type: none"> <i>As-Built Description:</i> Handrail not provided at stairs or ramp, required on both sides (not required at curb ramps or adjacent to seating areas). <i>Proposed Solution:</i> Provide new handrail for each side including extensions. | PCODE ED01 ADAAG 91 4.8.5 & 4.9.4 ADA 2010 505.2 CBC 2007 1133B.4.1.1 & .5.5 CBC 2016 11B-505.2 Priority 3 Severity 2 | 10 | LF | \$95 | \$950 |

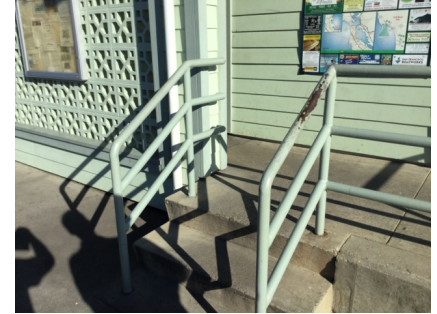
Top & Bottom Extension at Stairs

| 664 | <ul style="list-style-type: none"> <i>As-Built Description:</i> Stair handrail does not extend horizontally 12" minimum beyond top nosing, and one tread width sloped, plus 12" minimum horizontally beyond the bottom nosing. <i>As-Built:</i> No extensions <i>Proposed Solution:</i> Extend stair handrail at top and bottom (cost for each extension piece). | <p><i>PCODE</i> ED06 <i>ADAAG 91</i> 4.9.4(2) <i>ADA 2010</i> 505.10.2; 505.10.3 <i>CBC 2007</i> 1133B.4.2.2 <i>CBC 2016</i> 11B-505.10.2; 11B-505.10.3</p> <p>Priority 3 Severity 2</p> | 2 | JOB | \$170 | \$340 |

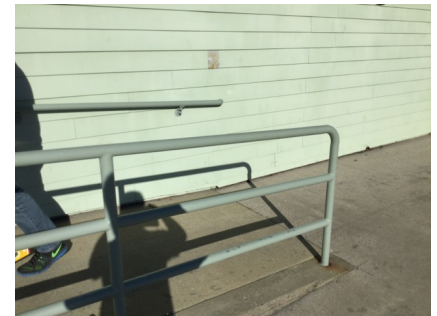
Top and Bottom Extension at

| 667 | <ul style="list-style-type: none"> <i>As-Built Description:</i> Ramp handrail does not extend horizontally 12" past top and / or bottom of ramp. <i>Proposed Solution:</i> Provide ramp handrail extension (cost for each extension piece). | <p><i>PCODE</i> ED05 <i>ADAAG 91</i> 4.8.5(2) <i>ADA 2010</i> 505.10.1 <i>CBC 2007</i> 1133B.4.2.2 & 1133B.5.5.1 11B-505.10.1</p> <p>Priority 3 Severity 2</p> | 2 | JOB | \$170 | \$340 |

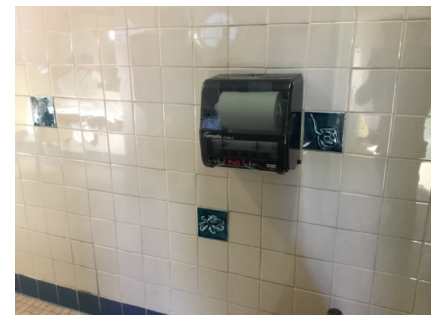
Protrusion Limits

| 674 | <ul style="list-style-type: none"> <i>As-Built Description:</i> Protruding objects more than 4" from wall, when bottom of object more than 27" or less than 80" above finished floor. <i>As-Built:</i> PTD: 8.5" at 40" high <i>Proposed Solution:</i> Remove/relocate protruding object. Patch existing surface. | <p><i>PCODE</i> EG04 <i>ADAAG 91</i> 4.4.1 <i>ADA 2010</i> 307.2 <i>CBC 2007</i> 1133B.8.6.1 11B-307.2</p> <p>Priority 3 Severity 3</p> | 2 | JOB | \$100 | \$200 |

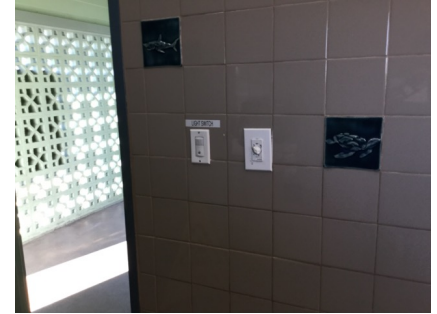
Electrical

| 675 | <ul style="list-style-type: none"> <i>As-Built Description:</i> Electric switch or control mounted less than 15" measured to the bottom of the outlet box or greater than 48 inches measured to the top of the outlet box. <i>As-Built:</i> 50" high light switch <i>Proposed Solution:</i> Relocate light switches or control to between 15" and 48" height. | <p><i>PCODE</i> IC01 <i>ADAAG 91</i> 4.2.5 & 6 <i>ADA 2010</i> 308.2.1 & 308.2.2 <i>CBC 2007</i> 1117B.6.3 <i>CBC 2016</i> 11B-308.2.1 & 11B-308.2.2</p> <p>Priority 3 Severity 4</p> | 1 | JOB | \$300 | \$300 |

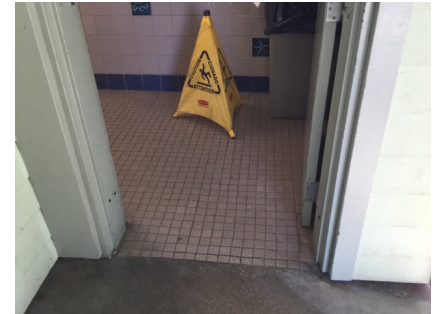
Door

| 682 | <ul style="list-style-type: none"> <i>As-Built Description:</i> Surface of required maneuvering clearance at door slopes more than 1/4":12" (2.0%). <i>As-Built:</i> Sloped landing at door <i>Proposed Solution:</i> Modify surface slope at door. | <p><i>PCODE</i> ID11 <i>ADAAG 91</i> 4.13.6 <i>ADA 2010</i> 404.2.4.4 <i>CBC 2007</i> 1133B.2.4 <i>CBC 2016</i> 11B-404.2.4</p> <p>Priority 3 Severity 4</p> | 20 | SF | \$40 | \$800 |

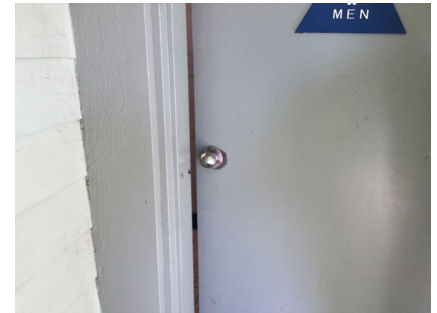
Door Hardware

| 672 | <ul style="list-style-type: none"> <i>As-Built Description:</i> Door does not have accessible operating hardware. <i>Proposed Solution:</i> Provide lever handle or other accessible hardware. | <p><i>PCODE</i> ID07 <i>ADAAG 91</i> 4.13.9 <i>ADA 2010</i> 404.2.7 <i>CBC 2007</i> 1133B.2.5.2 <i>CBC 2016</i> 11B-404.2.7</p> <p>Priority 3 Severity 3</p> | 1 | JOB | \$250 | \$250 |

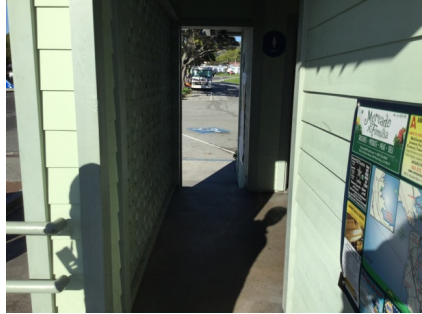
| Item No. and Name | Existing Architectural Barrier and Proposed Solution | Codes / Mitigation Info | Qty | Unit | Cost | Total |
|---|--|--|---|---|---|---|
| Corridor | | | | | | |

| Item No. and Name | Existing Architectural Barrier and Proposed Solution | Codes / Mitigation Info | Qty | Unit | Cost | Total |
|---|--|--|---|---|---|---|
| 668 | <ul style="list-style-type: none"> <i>As-Built Description:</i> Corridor less than 44" wide when occupant load 10 or more. <i>As-Built:</i> 36" wide <i>Proposed Solution:</i> Enlarge or modify corridor to 44" wide. | <p><i>PCODE</i> IH01 <i>ADAAG 91</i> 4.3.3 <i>ADA 2010</i> 403.5.1 <i>CBC 2007</i> 1133B.3.1 <i>CBC 2016</i> 11B-403.5.1</p> <p>Priority 3 Severity 2</p> | 5 | LF | \$105 | \$525 |

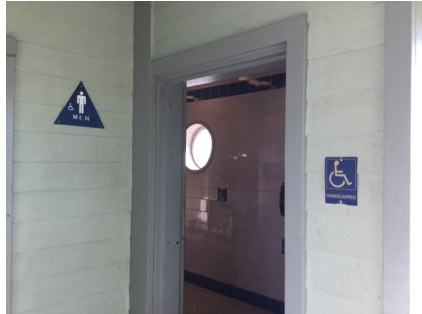
| Item No. and Name | Existing Architectural Barrier and Proposed Solution | Codes / Mitigation Info | Qty | Unit | Cost | Total |
|---|--|--|---|---|---|---|
| 671 | <ul style="list-style-type: none"> <i>As-Built Description:</i> Entrance to toilet or bathing facility not identified with ADAAG compliant signage. <i>As-Built:</i> Noncompliant latch sign <i>Proposed Solution:</i> Provide ADAAG compliant sign mounted 5' high on center on nearest adjacent wall, on latch side of a single door (located not to cause a Braille reader to stand within the door swing). | <p><i>PCODE</i> SA11A <i>ADAAG 91</i> 4.1.3(16)(a) <i>ADA 2010</i> 216.8 <i>CBC 2016</i> 11B-216.8</p> <p>Priority 3 Severity 3</p> | 1 | JOB | \$90 | \$90 |

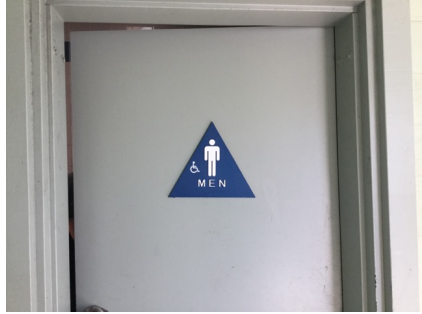
| Item No. and Name | Existing Architectural Barrier and Proposed Solution | Codes / Mitigation Info | Qty | Unit | Cost | Total |
|---|--|--|---|---|---|---|
| 673 | <ul style="list-style-type: none"> <i>As-Built Description:</i> Required in CA only: identification symbol centered 58" to 60" high on sanitary facility door that contrasts with the door not provided (women: 12" ø circle, men: 12" triangle, unisex: combined symbol). <i>As-Built:</i> 61" high 11.5" sides <i>Proposed Solution:</i> Provide properly mounted sanitary facility symbol when altering area. If wheelchair accessible, include International Symbol of Accessibility on sign. | <p><i>PCODE</i> SA15 <i>CBC 2007</i> 1115B.6 <i>CBC 2016</i> 11B-703.7.2.6</p> <p>Priority 3 Severity 3</p> | 1 | JOB | \$90 | \$90 |

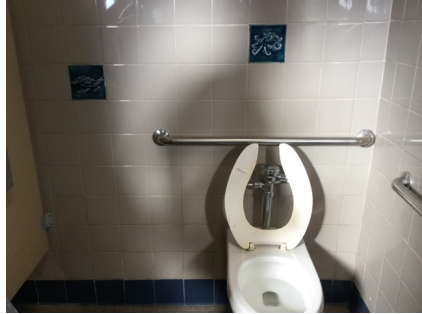
| Item No. and Name | Existing Architectural Barrier and Proposed Solution | Codes / Mitigation Info | Qty | Unit | Cost | Total |
|---|---|---|---|---|---|---|
| 739 | <ul style="list-style-type: none"> <i>As-Built Description:</i> The rear wall grab is less than 36" min. or does not extend from the centerline of the water closet 12" min. on one side and 24" min. on the other side. <i>As-Built:</i> 19" on wide side <i>Proposed Solution:</i> Provide or relocate accessible rear grab bar. | <p>PCODE WB07B</p> <p>ADAAG 91 4.17.6</p> <p>ADA 2010 604.5.2</p> <p>CBC 2007 1115B.4.1.3.2</p> <p>CBC 2016 11B-604.5.2</p> <p>Priority 3</p> <p>Severity 3</p> | 1 | JOB | \$340 | \$340 |

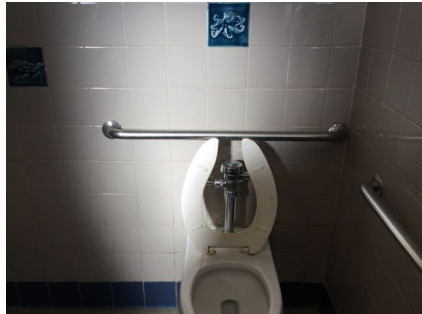
| Item No. and Name | Existing Architectural Barrier and Proposed Solution | Codes / Mitigation Info | Qty | Unit | Cost | Total |
|---|---|---|---|---|---|---|
| 740 | <ul style="list-style-type: none"> <i>As-Built Description:</i> Grab bars not at 33" to 36" from floor <i>As-Built:</i> 36.75" high <i>Proposed Solution:</i> Relocate accessible grab bars. | <p>PCODE WB07C</p> <p>ADAAG 91 4.16.4</p> <p>ADA 2010 609.4</p> <p>CBC 2007 1115B.4.1.3.1</p> <p>CBC 2016 & 2 11B-609.4</p> <p>Priority 3</p> <p>Severity 4</p> | 1 | JOB | \$260 | \$260 |

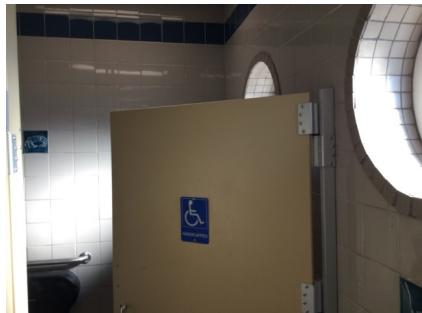
| Item No. and Name | Existing Architectural Barrier and Proposed Solution | Codes / Mitigation Info | Qty | Unit | Cost | Total |
|---|---|---|---|---|---|---|
| 737 | <ul style="list-style-type: none"> <i>As-Built Description:</i> Stall door to accessible compartment not self closing. <i>Proposed Solution:</i> Adjust closer. | <p>PCODE WB05B</p> <p>ADAAG 91 4.22.4</p> <p>ADA 2010 604.8.1.2</p> <p>CBC 2007 1115B.3.1.4.4</p> <p>CBC 2016 11B-604.8.1.2</p> <p>Priority 3</p> <p>Severity 4</p> | 1 | JOB | \$25 | \$25 |

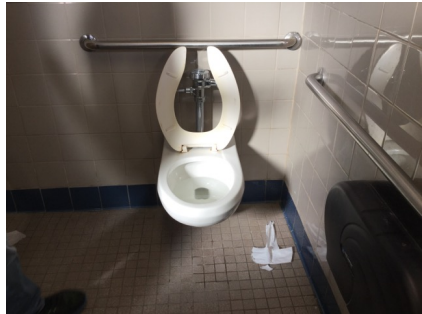
| Item No. and Name | Existing Architectural Barrier and Proposed Solution | Codes / Mitigation Info | Qty | Unit | Cost | Total |
|---|---|---|---|---|---|---|
| 738 | <ul style="list-style-type: none"> <i>As-Built Description:</i> Water closet not 16"-18" (CA: 17"-18") from near side wall to center line of water closet (2010 ADAAG: 16"-18"). <i>As-Built:</i> 19" o.c. <i>Proposed Solution:</i> Relocate existing water closet and plumbing, remount with offset closet flange to provide 18" max. from side wall. | <p>PCODE WB02C</p> <p>ADAAG 91 Fig. 28</p> <p>ADA 2010 604.2</p> <p>CBC 2007 1115B.4.1.1</p> <p>CBC 2016 11B-604.2</p> <p>Priority 3</p> <p>Severity 4</p> | 1 | JOB | \$500 | \$500 |

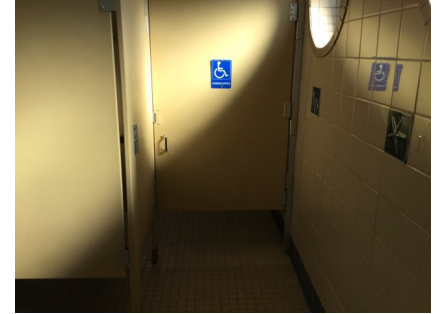
| 681 | <ul style="list-style-type: none"> <i>As-Built Description:</i> Clear passage width (except doorways) from rest room entry to accessible water closet compartment less than 36" (CA only: 44" wide). <i>As-Built:</i> 37" wide <i>Proposed Solution:</i> Modify facility passage to be min. 44" wide. Demolish existing partition and replace. | <p><i>PCODE</i> WC02A <i>ADAAG 91</i> 4.3.3 <i>ADA 2010</i> 403.5.1 <i>CBC 2007</i> 1115B.3.2.4 <i>CBC 2016</i> 11B-403.5.1</p> <p>Priority 3 Severity 2</p> | 5 | LF | \$170 | \$850 |

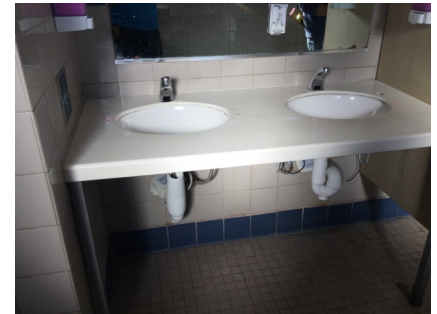
| 676 | <ul style="list-style-type: none"> <i>As-Built Description:</i> Clear floor space, 30" x 48" in front of fixture, extending 19" max. under the lavatory, not provided (CA only: Less than 18" from side wall to centerline of lavatory). <i>As-Built:</i> 13.5-14" o.c. <i>Proposed Solution:</i> Provide new accessible lavatory. Remodel restroom as needed. | <p><i>PCODE</i> WD01 <i>ADAAG 91</i> 4.19.3 <i>ADA 2010</i> 606.2 <i>CBC 2007</i> 1115B.4.3 <i>CBC 2016</i> 11B-606.2, 11B-606.6</p> <p>Priority 3 Severity 2</p> | 1 | JOB | \$3,400 | \$3,400 |

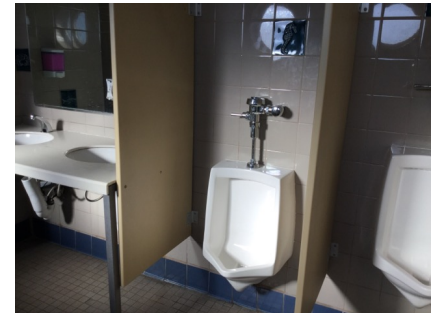
| 679 | <ul style="list-style-type: none"> <i>As-Built Description:</i> 36" wide clearance in front of accessible urinal not provided when walls or partitions project more than 24" from the front edge of 30" x 48" clear space. <i>As-Built:</i> 30.75" wide <i>Proposed Solution:</i> Provide 36" clear floor space in front of accessible urinal. Remodel restroom as needed. | <p><i>PCODE</i> WE04A <i>ADAAG 91</i> 4.18.3 <i>ADA 2010</i> 605.3 <i>CBC 2007</i> 1115B.4.2.3 <i>CBC 2016</i> 11B-605.3</p> <p>Priority 3 Severity 2</p> | 1 | JOB | \$1,500 | \$1,500 |

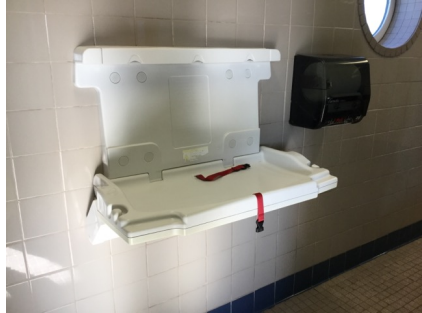
| Item No. and Name | Existing Architectural Barrier and Proposed Solution | Codes / Mitigation Info | Qty | Unit | Cost | Total |
|---|---|---|---|---|---|---|
| 687 | <ul style="list-style-type: none"> <i>As-Built Description:</i> Protruding objects more than 4" from wall, when bottom of object more than 27" or less than 80" above finished floor. <i>As-Built:</i> 18" at 35" high when changing table is down <i>Proposed Solution:</i> Remove/relocate protruding object. Patch existing surface. <i>Notes:</i> Ensure changing station remains closed when not in use via self closer. | <p>PCODE EG04 ADAAG 91 4.4.1 ADA 2010 307.2 CBC 2007 1133B.8.6.1 CBC 2016 11B-307.2</p> <p>Priority 3 Severity 1</p> | 1 | JOB | \$100 | \$100 |

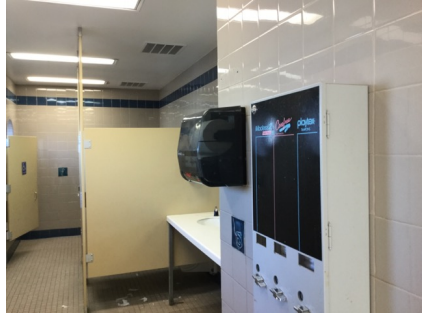
| Item No. and Name | Existing Architectural Barrier and Proposed Solution | Codes / Mitigation Info | Qty | Unit | Cost | Total |
|---|---|---|---|---|---|---|
| 689 | <ul style="list-style-type: none"> <i>As-Built Description:</i> Protruding objects more than 4" from wall, when bottom of object more than 27" or less than 80" above finished floor. <i>As-Built:</i> PTD: 9" at 42" high <i>Proposed Solution:</i> Remove/relocate protruding object. Patch existing surface. | <p>PCODE EG04 ADAAG 91 4.4.1 ADA 2010 307.2 CBC 2007 1133B.8.6.1 CBC 2016 11B-307.2</p> <p>Priority 3 Severity 2</p> | 1 | JOB | \$100 | \$100 |

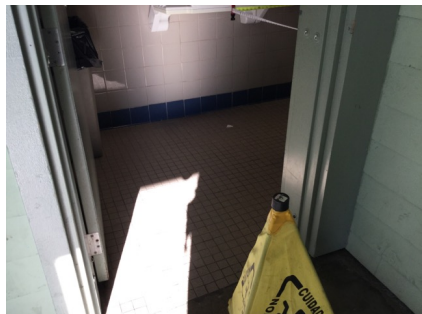
| Item No. and Name | Existing Architectural Barrier and Proposed Solution | Codes / Mitigation Info | Qty | Unit | Cost | Total |
|---|---|---|---|---|---|---|
| 686 | <ul style="list-style-type: none"> <i>As-Built Description:</i> Surface of required maneuvering clearance at door slopes more than 1/4":12" (2.0%). <i>As-Built:</i> Sloped landing at door <i>Proposed Solution:</i> Modify surface slope at door. | <p>PCODE ID11 ADAAG 91 4.13.6 ADA 2010 404.2.4.4 CBC 2007 1133B.2.4 CBC 2016 11B-404.2.4</p> <p>Priority 3 Severity 4</p> | 20 | SF | \$40 | \$800 |

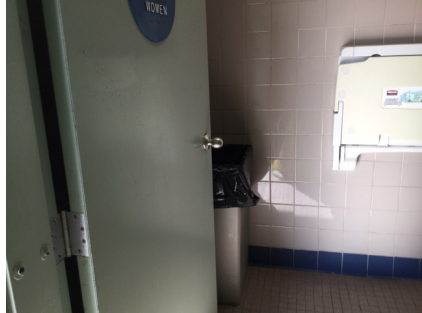
| Item No. and Name | Existing Architectural Barrier and Proposed Solution | Codes / Mitigation Info | Qty | Unit | Cost | Total |
|---|--|--|---|---|---|---|
| 685 | <ul style="list-style-type: none"> <i>As-Built Description:</i> Door does not have accessible operating hardware. <i>Proposed Solution:</i> Provide lever handle or other accessible hardware. | <p><i>PCODE</i> ID07 <i>ADAAG 91</i> 4.13.9 <i>ADA 2010</i> 404.2.7 <i>CBC 2007</i> 1133B.2.5.2 <i>CBC 2016</i> 11B-404.2.7</p> <p>Priority 3 Severity 3</p> | 1 | JOB | \$250 | \$250 |

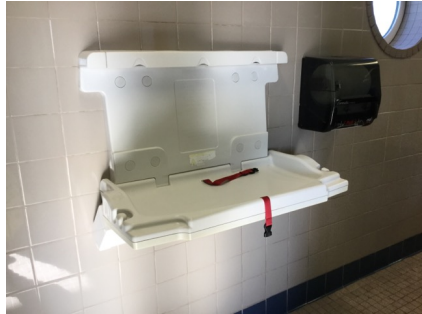
| Item No. and Name | Existing Architectural Barrier and Proposed Solution | Codes / Mitigation Info | Qty | Unit | Cost | Total |
|---|--|--|---|---|---|---|
| 688 | <ul style="list-style-type: none"> <i>As-Built Description:</i> Changing table (top 28" to 34" high; knee space at least 27" high x 19" deep x 30" wide) not provided." <i>As-Built:</i> 38" high changing table <i>Proposed Solution:</i> Remount changing table. | <p><i>PCODE</i> IN02NT <i>ADAAG 91</i> 4.32.3 & .4 <i>ADA 2010</i> 306.1 & 902.3 <i>CBC 2007</i> 1122B.3 & 4 <i>CBC 2016</i> 11B-306.1 & 11B-902.3</p> <p>Priority 3 Severity 4</p> | 1 | JOB | \$100 | \$100 |

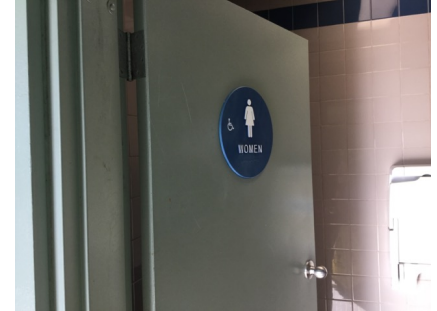
| Item No. and Name | Existing Architectural Barrier and Proposed Solution | Codes / Mitigation Info | Qty | Unit | Cost | Total |
|---|---|---|---|---|---|---|
| 684 | <ul style="list-style-type: none"> <i>As-Built Description:</i> Required in CA only: identification symbol centered 58" to 60" high on sanitary facility door that contrasts with the door not provided (women: 12" ø circle, men: 12" triangle, unisex: combined symbol). <i>As-Built:</i> 63.5" high <i>Proposed Solution:</i> Provide properly mounted sanitary facility symbol when altering area. If wheelchair accessible, include International Symbol of Accessibility on sign. | <p>PCODE SA15</p> <p>CBC 2007 1115B.6</p> <p>CBC 2016 11B-703.7.2.6</p> <p>Priority 3</p> <p>Severity 3</p> | 1 | JOB | \$90 | \$90 |

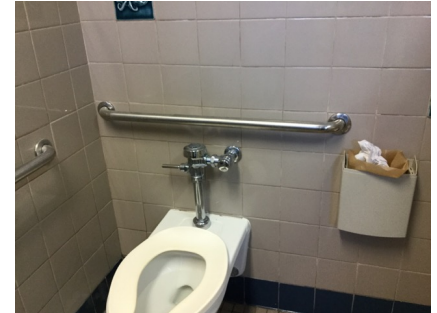
| 698 | <ul style="list-style-type: none"> <i>As-Built Description:</i> The rear wall grab is less than 36" min. or does not extend from the centerline of the water closet 12" min. on one side and 24" min. on the other side. <i>As-Built:</i> 20.5" on wide side <i>Proposed Solution:</i> Provide or relocate accessible rear grab bar. | <p>PCODE WB07B</p> <p>ADAAG 91 4.17.6</p> <p>ADA 2010 604.5.2</p> <p>CBC 2007 1115B.4.1.3.2</p> <p>CBC 2016 11B-604.5.2</p> <p>Priority 3</p> <p>Severity 3</p> | 1 | JOB | \$340 | \$340 |

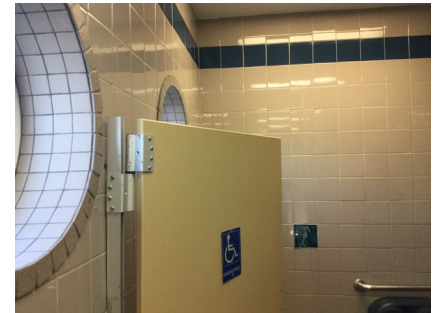
| 696 | <ul style="list-style-type: none"> <i>As-Built Description:</i> Stall door to accessible compartment not self closing. <i>Proposed Solution:</i> Adjust closer. | <p>PCODE WB05B</p> <p>ADAAG 91 4.22.4</p> <p>ADA 2010 604.8.1.2</p> <p>CBC 2007 1115B.3.1.4.4</p> <p>CBC 2016 11B-604.8.1.2</p> <p>Priority 3</p> <p>Severity 4</p> | 1 | JOB | \$25 | \$25 |

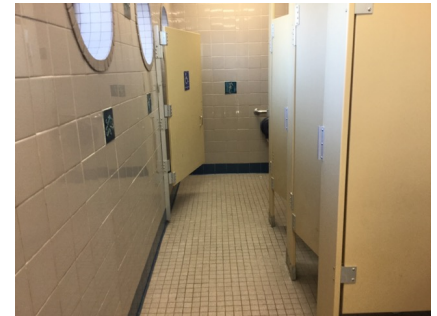
694 • *As-Built Description:*
Clear passage width (except doorways) from rest room entry to accessible water closet compartment less than 36" (CA only: 44" wide).

• *Proposed Solution:*
Modify facility passage to be min. 44" wide. Demolish existing partition and replace.

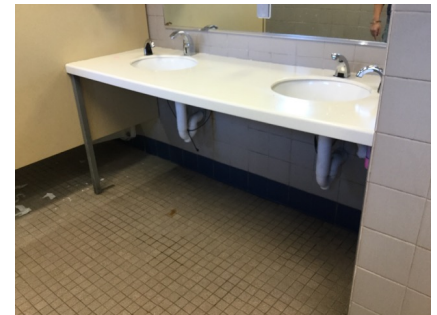
691 • *As-Built Description:*
Lavatory: Fixture rim or counter height more than 34" above floor.

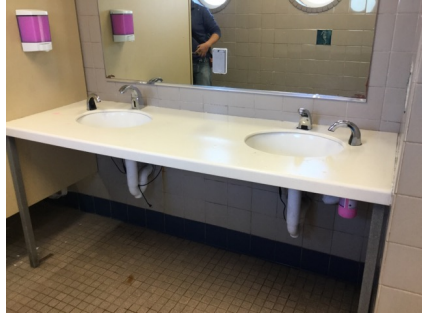
| Item No. and Name | Existing Architectural Barrier and Proposed Solution | Codes / Mitigation Info | Qty | Unit | Cost | Total |
|---|---|---|---|---|---|---|
| 692 | <ul style="list-style-type: none"> <i>As-Built Description:</i> Clear floor space, 30" x 48" in front of fixture, extending 19" max. under the lavatory, not provided (CA only: Less than 18" from side wall to centerline of lavatory). <i>As-Built:</i> 16-17" o.c. <i>Proposed Solution:</i> Provide new accessible lavatory. Remodel restroom as needed. | <p><i>PCODE</i> WD01</p> <p><i>ADAAG 91</i> 4.19.3</p> <p><i>ADA 2010</i> 606.2</p> <p><i>CBC 2007</i> 1115B.4.3</p> <p><i>CBC 2016</i> 11B-606.2, 11B-606.6</p> <p>Priority 3</p> <p>Severity 2</p> | 1 | JOB | \$3,400 | \$3,400 |

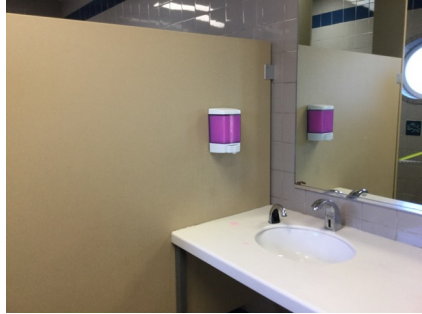
| Item No. and Name | Existing Architectural Barrier and Proposed Solution | Codes / Mitigation Info | Qty | Unit | Cost | Total |
|---|---|---|---|---|---|---|
| 693 | <ul style="list-style-type: none"> <i>As-Built Description:</i> Dispensers in sanitary facilities, such as for towels, soap, sanitary napkins, seat covers, etc., and waste receptacles more than 48" (CA only: 40") from floor to highest operating slot or control. <i>As-Built:</i> SD: 48.5" high <i>Proposed Solution:</i> Relocate existing restroom accessories. | <p><i>PCODE</i> WG01A</p> <p><i>ADAAG 91</i> 4.23.7</p> <p><i>ADA 2010</i> 308.2.1</p> <p><i>CBC 2007</i> 1115B.8.3</p> <p><i>CBC 2016</i> 11B-603.5</p> <p>Priority 3</p> <p>Severity 2</p> | 1 | JOB | \$100 | \$100 |

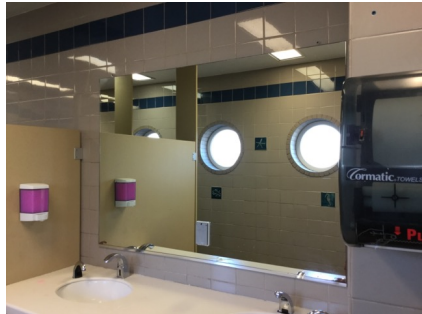
| Item No. and Name | Existing Architectural Barrier and Proposed Solution | Codes / Mitigation Info | Qty | Unit | Cost | Total |
|---|---|---|---|---|---|---|
| 695 | <ul style="list-style-type: none"> <i>As-Built Description:</i> Bottom of flat, not tilted mirror located above lavatories or countertops more than 40" above floor. <i>As-Built:</i> 40.25" high <i>Proposed Solution:</i> Relocate or provide new accessible mirror. | <p><i>PCODE</i> WG03</p> <p><i>ADAAG 91</i> 4.19.6</p> <p><i>ADA 2010</i> 603.3</p> <p><i>CBC 2007</i> 1115B.8.1</p> <p><i>CBC 2016</i> 11B-603.3</p> <p>Priority 3</p> <p>Severity 4</p> | 1 | JOB | \$150 | \$150 |

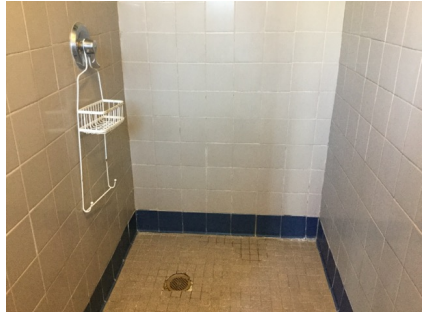
| Item No. and Name | Existing Architectural Barrier and Proposed Solution | Codes / Mitigation Info | Qty | Unit | Cost | Total |
|---|--|--|---|---|---|--|
| 708 | <ul style="list-style-type: none"> As-Built Description: ADAAG: L-shaped shower seat extending the full depth of the stall. The seat shall be located 1-1/2 inches (38 mm) maximum from the wall. The front of the seat (nearest to the opening) shall extend a maximum 16 inches (330 mm) from the wall. The back of the seat (against the back wall) shall extend a maximum of 23 inches (582 mm) from the side Proposed Solution: Provide new, or relocate, folding wall-mounted shower seat. | PCODE WF07A ADAAG 91 4.21.3 ADA 2010 610.3.2 CBC 2007 1115B.4.4.8.1 CBC 2016 11B-610.3.2 Priority 3 Severity 3 | 1 | JOB | \$550 | \$550 |

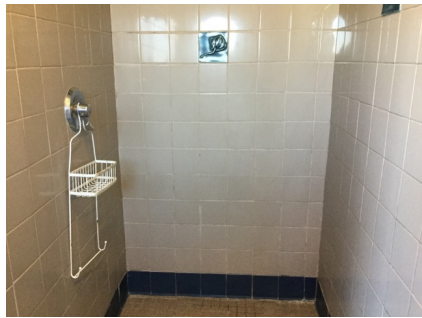
| Item No. and Name | Existing Architectural Barrier and Proposed Solution | Codes / Mitigation Info | Qty | Unit | Cost | Total |
|---|--|--|---|---|---|--|
| 710 | <ul style="list-style-type: none"> As-Built Description: Grab bar not mounted between 33" to 36" above the shower floor. Proposed Solution: Remount grab bar in shower. | PCODE WF08REF ADAAG 91 Fig. 37(a) ADA 2010 608.3 CBC 2007 1115B.4.4.8.2 CBC 2016 11B-608.3 Priority 3 Severity 3 | | REF | | |

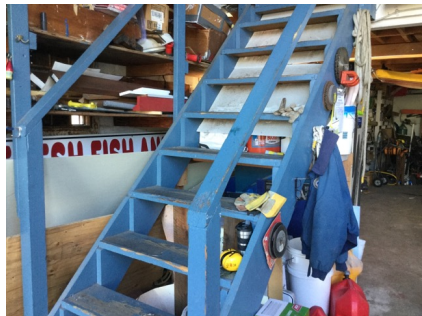
| 717 | <ul style="list-style-type: none"> As-Built Description: Stair does not have closed risers. Proposed Solution: Modify stair to have closed risers | PCODE EC03 ADAAG 91 4.9.2 ADA 2010 504.3 CBC 2007 1133B.4.5.3 CBC 2016 11B-504.3 Priority 4 Severity 3 | 40 | LF | \$36 | \$1,440 |

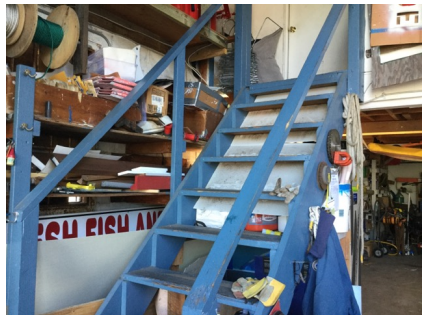
Cross Section

| 720 | <ul style="list-style-type: none"> As-Built Description: Standard handrail: Gripping section narrower than 1-1/4" or wider than 2". As-Built: Too wide Proposed Solution: Provide new handrail. | PCODE ED03 ADAAG 91 4.26.2 ADA 2010 505.7 CBC 2007 1133B.4.2.6 CBC 2016 11B-505.7 Priority 4 Severity 1 | 20 | LF | \$75 | \$1,500 |

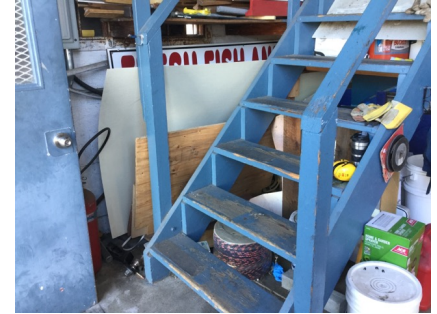
Top & Bottom Extension at Stairs

| 718 | <ul style="list-style-type: none"> <i>As-Built Description:</i> Stair handrail does not extend horizontally 12" minimum beyond top nosing, and one tread width sloped, plus 12" minimum horizontally beyond the bottom nosing. <i>Proposed Solution:</i> Extend stair handrail at top and bottom (cost for each extension piece). | <p>PCODE ED06 ADAAG 91 4.9.4(2) ADA 2010 505.10.2; 505.10.3 CBC 2007 1133B.4.2.2 CBC 2016 11B-505.10.2; 11B-505.10.3</p> <p>Priority 4 Severity 2</p> | 1 | JOB | \$170 | \$170 |

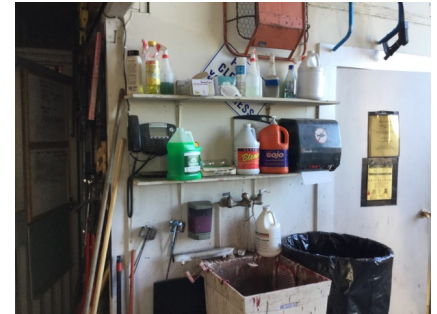
Protrusion Limits

| 730 | <ul style="list-style-type: none"> <i>As-Built Description:</i> Protruding objects more than 4" from wall, when bottom of object more than 27" or less than 80" above finished floor. <i>As-Built:</i> Shelf: 63" high <i>Proposed Solution:</i> Remove/relocate protruding object. Patch existing surface. | <p>PCODE EG04 ADAAG 91 4.4.1 ADA 2010 307.2 CBC 2007 1133B.8.6.1 CBC 2016 11B-307.2</p> <p>Priority 4 Severity 4</p> | 1 | JOB | \$100 | \$100 |

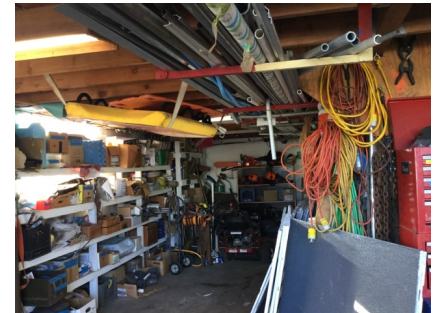
Vertical Clearance

| 726 | <ul style="list-style-type: none"> <i>As-Built Description:</i> Overhead clearance less than 80" above finished floor. <i>As-Built:</i> 74" high overhead clearance <i>Proposed Solution:</i> Modify overhead clearance. Notes: Throughout area | <p>PCODE EG01 ADAAG 91 4.4.2 ADA 2010 307.4 CBC 2007 1133B.8.6.2 CBC 2016 11B-307.4</p> <p>Priority 4 Severity 2</p> | 1 | JOB | \$100 | \$100 |
