SAN MATEO COUNTY HARBOR DISTRICT

ADA Self-Evaluation and Transition Plan

August 2018

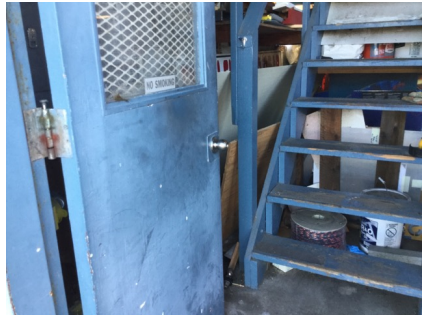
| Item No. and Name | Existing Architectural Barrier and Proposed Solution | Codes / Mitigation Info | Qty | Unit | Cost | Total |
|---|--|---|---|---|---|---|
| 715 | <ul style="list-style-type: none"> <i>As-Built Description:</i> Non-common use areas within this facility, such as offices, do not have accessible door hardware. <i>Proposed Solution:</i> Provide lever handle or other accessible hardware when a specific need is identified in the future or when altering area. | PCODE ID07C ADAAG 91 4.13.9 ADA 2010 404.2.7 CBC 2007 1133B.2.5.2 CBC 2016 11B-404.2.7 Priority 4 Severity 3 | 1 | JOB | \$250 | \$250 |

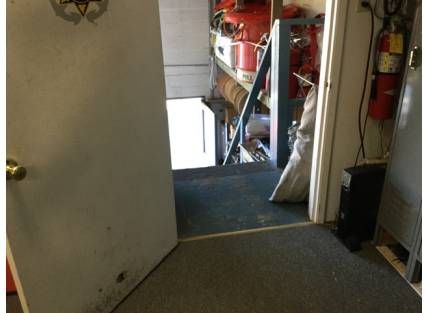
| Item No. and Name | Existing Architectural Barrier and Proposed Solution | Codes / Mitigation Info | Qty | Unit | Cost | Total |
|---|---|--|---|---|---|---|
| 735 | <ul style="list-style-type: none"> <i>As-Built Description:</i> Elevator not provided in multistory building. <i>As-Built:</i> Access only by stairs <i>Proposed Solution:</i> Provide new elevator with two stops. <i>Notes:</i> Second floor contains a changing room used by staff by a changing room also provided in the main Harbormaster Office. | <p><i>PCODE</i> IK01 <i>ADAAG 91</i> 4.1.3(5) <i>ADA 2010</i> 402.2 <i>CBC 2007</i> 1007.2.1 <i>CBC 2016</i> 11B-402.2</p> <p>Priority 4 Severity 3</p> | 1 | JOB | ? | \$200,000 |

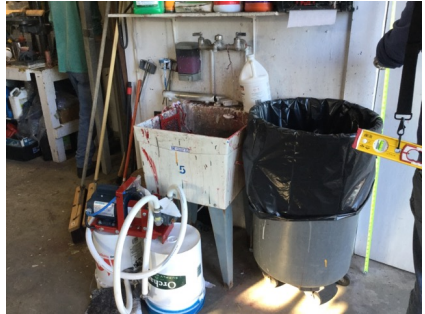
| Item No. and Name | Existing Architectural Barrier and Proposed Solution | Codes / Mitigation Info | Qty | Unit | Cost | Total |
|---|---|--|---|---|---|---|
| 721 | <ul style="list-style-type: none"> <i>As-Built Description:</i> Sink does not have knee space min. 27" high x 19" deep x 30" wide. <i>Proposed Solution:</i> Remodel sink cabinet. | <p><i>PCODE</i> IN06A <i>ADAAG 91</i> 4.24.3 <i>ADA 2010</i> 606.2 <i>CBC 2007</i> 1115B.4.7.1 <i>CBC 2016</i> 11B-606.2</p> <p>Priority 4 Severity 2</p> | 1 | JOB | \$1,750 | \$1,750 |

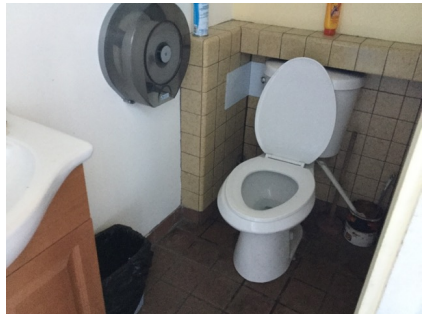
| Item No. and Name | Existing Architectural Barrier and Proposed Solution | Codes / Mitigation Info | Qty | Unit | Cost | Total |
|---|---|--|---|---|---|---|
| 723 | <ul style="list-style-type: none"> <i>As-Built Description:</i> Single accommodation restroom not accessible; multiple compliance violations. <i>Proposed Solution:</i> Remodel area to provide single-occupant accessible restroom. | <p><i>PCODE</i> WA01 <i>ADAAG 91</i> 4.22 <i>ADA 2010</i> 603.1 <i>CBC 2007</i> 1115B.3.2 <i>CBC 2016</i> 11B-603.1</p> <p>Priority 4 Severity 2</p> | 1 | JOB | \$30,000 | \$30,000 |

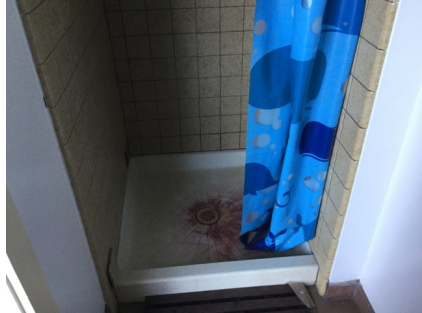
| Item No. and Name | Existing Architectural Barrier and Proposed Solution | Codes / Mitigation Info | Qty | Unit | Cost | Total |
|---|--|---|---|---|---|---|
| 724 | <ul style="list-style-type: none"> <i>As-Built Description:</i> Shower not accessible; multiple compliance violations. <i>Proposed Solution:</i> Provide accessible shower. | PCODE WF01 ADAAG 91 4.21 ADA 2010 608.1 CBC 2016 11B-608.1 Priority 4 Severity 3 | 1 | JOB | \$4,000 | \$4,000 |

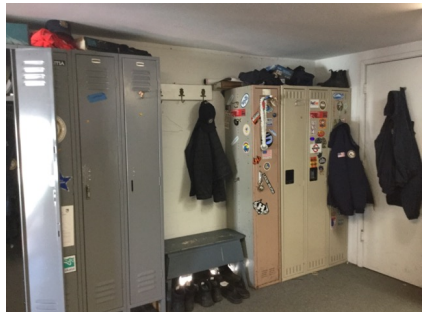
| Item No. and Name | Existing Architectural Barrier and Proposed Solution | Codes / Mitigation Info | Qty | Unit | Cost | Total |
|---|--|---|---|---|---|---|
| 732 | <ul style="list-style-type: none"> <i>As-Built Description:</i> Lockers not at proper height for disabled persons (maximum height 40" to hooks, shelves, etc.). <i>As-Built:</i> 65" high CH in locker <i>Proposed Solution:</i> Make hook/shelf height comply with 40" maximum. | PCODE GG02 ADA 2010 803.5 CBC 2007 1118B.5 CBC 2016 11B-803.5 Priority 4 Severity 3 | 1 | JOB | \$450 | \$450 |
| 733 | <ul style="list-style-type: none"> <i>As-Built Description:</i> No section of bench provided adjacent to designated accessible locker, measuring 24" deep, 48" wide, and 18" high, and fixed to a wall along the longer dimension. <i>As-Built:</i> 12" deep bench 34" wide <i>Proposed Solution:</i> Provide a new bench, fixed to a wall along the longer dimension, close to the accessible locker. | PCODE GG03 ADAAG 91 4.35.4 ADA 2010 803.4 CBC 2007 1117B.8 CBC 2016 11B-803.4 Priority 4 Severity 3 | 1 | JOB | \$750 | \$750 |
| 734 | <ul style="list-style-type: none"> <i>As-Built Description:</i> Accessible locker(s) in dressing room not provided (5% of lockers; not less than one). <i>As-Built:</i> 13 lockers <i>Proposed Solution:</i> Provide new locker(s) with accessible locking hardware that is operable with one hand and does not require grasping, pinching or twisting. | PCODE GG04 ADAAG 91 4.1.3(12)(a) ADA 2010 222.1 CBC 2007 1115B.8.5 CBC 2016 11B-222.1 Priority 4 Severity 3 | 1 | JOB | \$750 | \$750 |

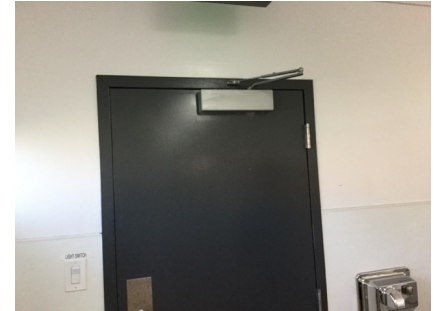
| Item No. and Name | Existing Architectural Barrier and Proposed Solution | Codes / Mitigation Info | Qty | Unit | Cost | Total |
|---|---|--|---|---|---|---|
| 761 | <ul style="list-style-type: none"> <i>As-Built Description:</i> Excessive force required to open door. <i>As-Built:</i> 15 lbs <i>Proposed Solution:</i> Adjust regular door closer to accessible standards (5 lbs. max). | <p>PCODE ID03</p> <p>ADAAG 91 4.13.11</p> <p>ADA 2010 404.2.9</p> <p>CBC 2007 1133B.2.5</p> <p>CBC 2016 11B-404.2.9</p> <p>Priority 3</p> <p>Severity 3</p> <p>Mitigation Project: <i>Laundry, public, and tenant restrooms</i></p> <p>Estimated Completion Date: <i>2020-2021</i></p> | 1 | JOB | \$25 | \$25 |

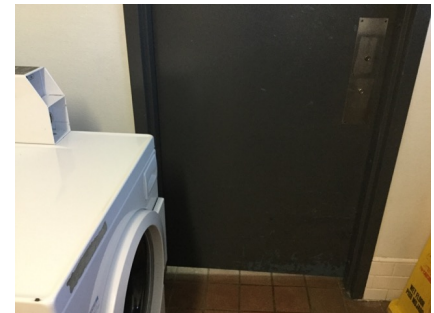
Door Swing

| 759 | <ul style="list-style-type: none"> <i>As-Built Description:</i> Front approach: At push side, door does not have clear and level maneuvering space measuring door width x 48" (door width plus 12" if door has both, latch and closer). <i>As-Built:</i> Washer in maneuvering space <i>Proposed Solution:</i> Remove or relocate furniture or storage items. | <p>PCODE ID24A</p> <p>ADAAG 91 Fig. 25(a)</p> <p>ADA 2010 404.2.4</p> <p>CBC 2007 11B-26A(a)</p> <p>CBC 2016 11B-404.2.4</p> <p>Priority 3</p> <p>Severity 4</p> <p>Mitigation Project: <i>Laundry, public, and tenant restrooms</i></p> <p>Estimated Completion Date: <i>2020-2021</i></p> | 1 | JOB | \$50 | \$50 |

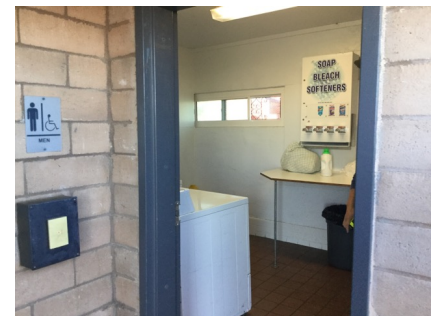
| 754 | <ul style="list-style-type: none"> <i>As-Built Description:</i> Front approach: At push side, door does not have clear and level maneuvering space measuring door width x 48" (door width plus 12" if door has both, latch and closer). <i>As-Built:</i> 11" to wall <i>Proposed Solution:</i> Provide door operator. | <p>PCODE ID24C</p> <p>ADAAG 91 Fig. 25(a)</p> <p>ADA 2010 404.2.4</p> <p>CBC 2007 11B-26A(a)</p> <p>CBC 2016 11B-404.2.4</p> <p>Priority 3</p> <p>Severity 4</p> <p>Mitigation Project: <i>Laundry, public, and tenant restrooms</i></p> <p>Estimated Completion Date: <i>2020-2021</i></p> | 1 | JOB | \$5,000 | \$5,000 |

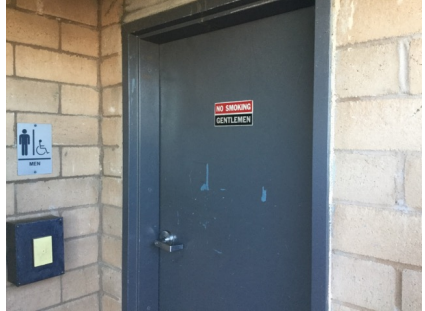
| Item No. and Name | Existing Architectural Barrier and Proposed Solution | Codes / Mitigation Info | Qty | Unit | Cost | Total |
|---|---|--|---|---|---|---|
| 752 | <ul style="list-style-type: none"> As-Built Description: Required in CA only: identification symbol centered 58" to 60" high on sanitary facility door that contrasts with the door not provided (women: 12" ø circle, men: 12" triangle, unisex: combined symbol). Proposed Solution: Provide properly mounted sanitary facility symbol when altering area. If wheelchair accessible, include International Symbol of Accessibility on sign. | <p>PCODE SA15</p> <p>CBC 2007 1115B.6</p> <p>CBC 2016 11B-703.7.2.6</p> <p>Priority 3</p> <p>Severity 3</p> <p>Mitigation Project: <i>Laundry, public, and tenant restrooms</i></p> <p>Estimated Completion Date: <i>2020-2021</i></p> | 1 | JOB | \$90 | \$90 |

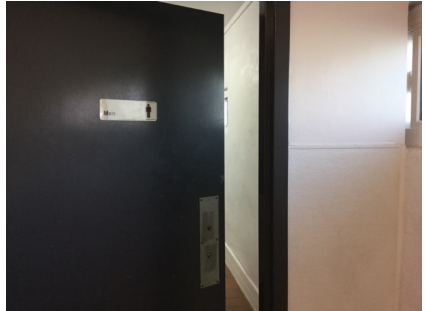
| Item No. and Name | Existing Architectural Barrier and Proposed Solution | Codes / Mitigation Info | Qty | Unit | Cost | Total |
|---|---|--|---|---|---|---|
| 760 | <ul style="list-style-type: none"> As-Built Description: Required in CA only: identification symbol centered 58" to 60" high on sanitary facility door that contrasts with the door not provided (women: 12" ø circle, men: 12" triangle, unisex: combined symbol). As-Built: Not geometric Proposed Solution: Provide properly mounted sanitary facility symbol when altering area. If wheelchair accessible, include International Symbol of Accessibility on sign. | <p>PCODE SA15</p> <p>CBC 2007 1115B.6</p> <p>CBC 2016 11B-703.7.2.6</p> <p>Priority 3</p> <p>Severity 3</p> <p>Mitigation Project: <i>Laundry, public, and tenant restrooms</i></p> <p>Estimated Completion Date: <i>2020-2021</i></p> | 1 | JOB | \$90 | \$90 |

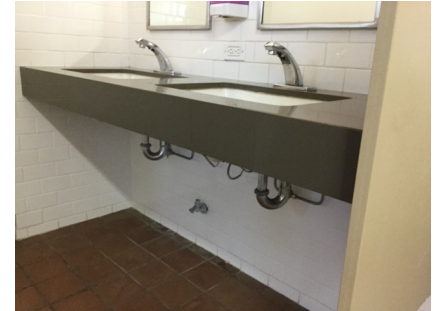
| Item No. and Name | Existing Architectural Barrier and Proposed Solution | Codes / Mitigation Info | Qty | Unit | Cost | Total |
|---|--|---|---|---|---|---|
| 765 | <ul style="list-style-type: none"> <i>As-Built Description:</i> Hot or sharp-surfaced water/drain pipe not insulated or covered. <i>Proposed Solution:</i> Insulate or cover water/drain pipe. | PCODE WD05 ADAAG 91 4.19.4 ADA 2010 606.5 CBC 2007 1115B.4.3.4 CBC 2016 11B-606.5 Priority 3 Severity 3 Mitigation Project: <i>Laundry, public, and tenant restrooms</i> Estimated Completion Date: 2020-2021 | 1 | JOB | \$120 | \$120 |

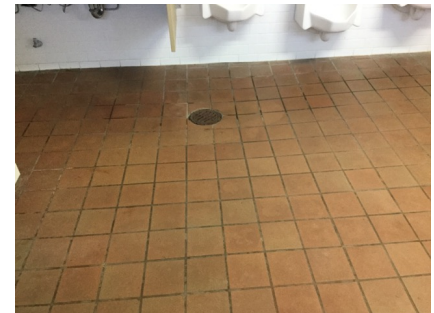
Shower

| 764 | <ul style="list-style-type: none"> <i>As-Built Description:</i> Shower: Floor surface sloped greater than 2.0% (1:48) due to drain. <i>As-Built:</i> Room sloped to drain <i>Proposed Solution:</i> Remodel floor surface in shower to compliance. | PCODE WF06A ADA 2010 608.9 CBC 2016 11B-608.9 Priority 3 Severity 3 Mitigation Project: <i>Laundry, public, and tenant restrooms</i> Estimated Completion Date: 2020-2021 | 1 | JOB | \$500 | \$500 |

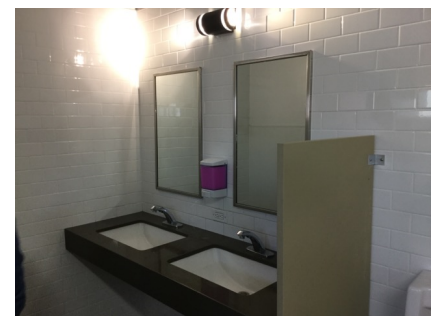
Accessories

| 768 | <ul style="list-style-type: none"> <i>As-Built Description:</i> Dispensers in sanitary facilities, such as for towels, soap, sanitary napkins, seat covers, etc., and waste receptacles more than 48" (CA only: 40") from floor to highest operating slot or control. <i>As-Built:</i> SD: 43.5" high <i>Proposed Solution:</i> Relocate existing restroom accessories. | PCODE WG01A ADAAG 91 4.23.7 ADA 2010 308.2.1 CBC 2007 1115B.8.3 CBC 2016 11B-603.5 Priority 3 Severity 4 Mitigation Project: <i>Laundry, public, and tenant restrooms</i> Estimated Completion Date: 2020-2021 | 1 | JOB | \$100 | \$100 |

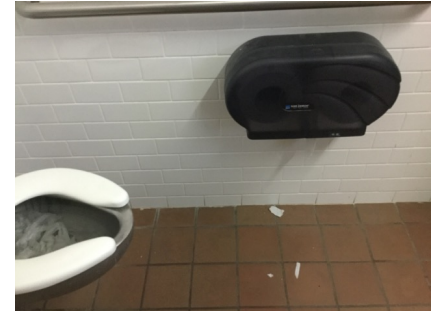
| Item No. and Name | Existing Architectural Barrier and Proposed Solution | Codes / Mitigation Info | Qty | Unit | Cost | Total |
|---|--|--|---|---|---|---|
| 776 | <ul style="list-style-type: none"> As-Built Description: Toilet paper dispenser less than 15" (CA: 19") or more than 48" above floor or not within 7" to 9" from front of water closet (Note: CA pre-2010 is allowed within 12" from front of water closet). As-Built: 12" in front Proposed Solution: Relocate or provide new toilet paper dispenser. | PCODE WG02 ADAAG 91 4.16.6 ADA 2010 604.7 CBC 2007 1115B.8.4 CBC 2016 11B-604.7 Priority 3 Severity 4 Mitigation Project: Laundry, public, and tenant restrooms Estimated Completion Date: 2020-2021 | 1 | JOB | \$75 | \$75 |

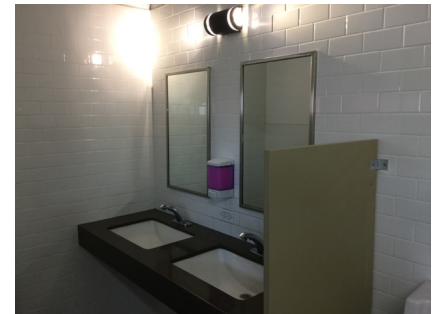
| 767 | <ul style="list-style-type: none"> As-Built Description: Bottom of flat, not tilted mirror located above lavatories or countertops more than 40" above floor. As-Built: 41.5" high mirror Proposed Solution: Relocate or provide new accessible mirror. | PCODE WG03 ADAAG 91 4.19.6 ADA 2010 603.3 CBC 2007 1115B.8.1 CBC 2016 11B-603.3 Priority 3 Severity 4 Mitigation Project: Laundry, public, and tenant restrooms Estimated Completion Date: 2020-2021 | 1 | JOB | \$150 | \$150 |

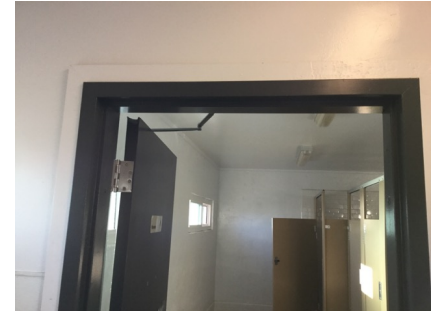
Door Swing

| Item No. and Name | Existing Architectural Barrier and Proposed Solution | Codes / Mitigation Info | Qty | Unit | Cost | Total |
|---|---|--|---|---|---|---|
| 785 | <ul style="list-style-type: none"> <i>As-Built Description:</i> Excessive force required to open door. <i>As-Built:</i> 15 lbs <i>Proposed Solution:</i> Adjust regular door closer to accessible standards (5 lbs. max). | <p>PCODE ID03</p> <p>ADAAG 91 4.13.11</p> <p>ADA 2010 404.2.9</p> <p>CBC 2007 1133B.2.5</p> <p>CBC 2016 11B-404.2.9</p> <p>Priority 3</p> <p>Severity 3</p> <p>Mitigation Project: <i>Laundry, public, and tenant restrooms</i></p> <p>Estimated Completion Date: <i>2020-2021</i></p> | 1 | JOB | \$25 | \$25 |

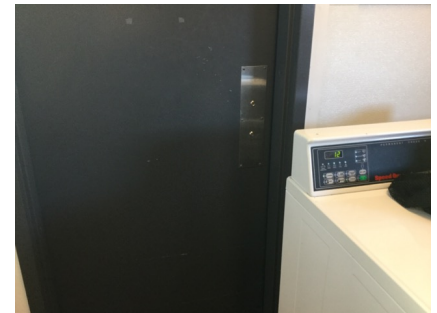
Corridor

| 782 | <ul style="list-style-type: none"> <i>As-Built Description:</i> Front approach: At push side, door does not have clear and level maneuvering space measuring door width x 48" (door width plus 12" if door has both, latch and closer). <i>As-Built:</i> Washer in maneuvering space <i>Proposed Solution:</i> Remove or relocate furniture or storage items. | <p>PCODE ID24A</p> <p>ADAAG 91 Fig. 25(a)</p> <p>ADA 2010 404.2.4</p> <p>CBC 2007 11B-26A(a)</p> <p>CBC 2016 11B-404.2.4</p> <p>Priority 3</p> <p>Severity 4</p> <p>Mitigation Project: <i>Laundry, public, and tenant restrooms</i></p> <p>Estimated Completion Date: <i>2020-2021</i></p> | 1 | JOB | \$50 | \$50 |

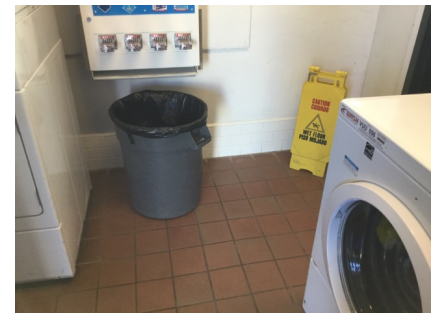
| 783 | <ul style="list-style-type: none"> <i>As-Built Description:</i> Corridor, for occupant load less than 10, less than 36" wide. <i>As-Built:</i> 38" wide <i>Proposed Solution:</i> Remove or relocate furniture and storage items. | <p>PCODE IH03A</p> <p>ADAAG 91 4.3.3</p> <p>ADA 2010 403.5.1</p> <p>CBC 2007 1133B.3.1</p> <p>CBC 2016 11B-403.5.1</p> <p>Priority 3</p> <p>Severity 4</p> <p>Mitigation Project: <i>Laundry, public, and tenant restrooms</i></p> <p>Estimated Completion Date: <i>2020-2021</i></p> | 1 | JOB | \$50 | \$50 |

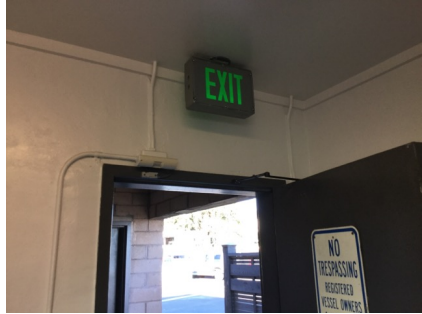
| Item No. and Name | Existing Architectural Barrier and Proposed Solution | Codes / Mitigation Info | Qty | Unit | Cost | Total |
|---|---|---|---|---|---|---|
| 781 | <ul style="list-style-type: none"> <i>As-Built Description:</i> At final exit door to exterior: Where required exit signs are installed, signs to provide exiting information for people with vision impairment are not provided. <i>Proposed Solution:</i> Provide raised letter/Braille "EXIT" sign at door. | PCODE SA10A ADAAG 91 4.1.3(16) ADA 2010 216.4.1 CBC 2007 1011.3 CBC 2016 11B-216.4.1 Priority 3 Severity 3 Mitigation Project: Laundry, public, and tenant restrooms Estimated Completion Date: 2020-2021 | 1 | JOB | \$90 | \$90 |

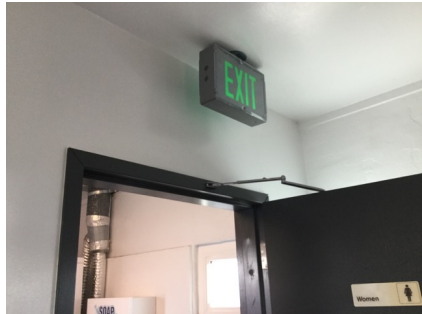
| Item No. and Name | Existing Architectural Barrier and Proposed Solution | Codes / Mitigation Info | Qty | Unit | Cost | Total |
|---|---|---|---|---|---|---|
| 787 | <ul style="list-style-type: none"> <i>As-Built Description:</i> At door leading into exit corridor: Where required exit signs are installed, signs to provide exiting information for people with vision impairment are not provided. <i>Proposed Solution:</i> Provide raised letter/Braille "EXIT ROUTE" sign at door. | PCODE SA10D ADAAG 91 4.1.3(16) ADA 2010 216.4.1 CBC 2007 1011.3 CBC 2016 11B-216.4.1 Priority 3 Severity 3 Mitigation Project: Laundry, public, and tenant restrooms Estimated Completion Date: 2020-2021 | 1 | JOB | \$90 | \$90 |

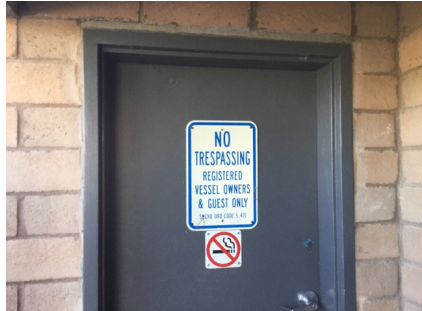
| Item No. and Name | Existing Architectural Barrier and Proposed Solution | Codes / Mitigation Info | Qty | Unit | Cost | Total |
|---|---|--|---|---|---|---|
| 778 | <ul style="list-style-type: none"> As-Built Description: Required in CA only: identification symbol centered 58" to 60" high on sanitary facility door that contrasts with the door not provided (women: 12" ø circle, men: 12" triangle, unisex: combined symbol). Proposed Solution: Provide properly mounted sanitary facility symbol when altering area. If wheelchair accessible, include International Symbol of Accessibility on sign. | <p>PCODE SA15</p> <p>CBC 2007 1115B.6</p> <p>CBC 2016 11B-703.7.2.6</p> <p>Priority 3</p> <p>Severity 3</p> <p>Mitigation Project: <i>Laundry, public, and tenant restrooms</i></p> <p>Estimated Completion Date: <i>2020-2021</i></p> | 1 | JOB | \$90 | \$90 |

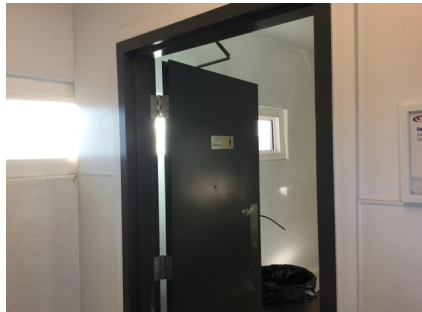
| Item No. and Name | Existing Architectural Barrier and Proposed Solution | Codes / Mitigation Info | Qty | Unit | Cost | Total |
|---|---|--|---|---|---|---|
| 784 | <ul style="list-style-type: none"> As-Built Description: Required in CA only: identification symbol centered 58" to 60" high on sanitary facility door that contrasts with the door not provided (women: 12" ø circle, men: 12" triangle, unisex: combined symbol). As-Built: Not geometric Proposed Solution: Provide properly mounted sanitary facility symbol when altering area. If wheelchair accessible, include International Symbol of Accessibility on sign. | <p>PCODE SA15</p> <p>CBC 2007 1115B.6</p> <p>CBC 2016 11B-703.7.2.6</p> <p>Priority 3</p> <p>Severity 3</p> <p>Mitigation Project: <i>Laundry, public, and tenant restrooms</i></p> <p>Estimated Completion Date: <i>2020-2021</i></p> | 1 | JOB | \$90 | \$90 |

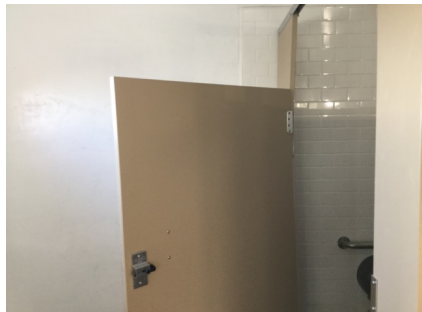
| Item No. and Name | Existing Architectural Barrier and Proposed Solution | Codes / Mitigation Info | Qty | Unit | Cost | Total |
|---|---|--|---|---|---|---|
| 791 | <ul style="list-style-type: none"> As-Built Description: Stall door to accessible compartment not self closing. Proposed Solution: Adjust closer. | <p>PCODE WB05B</p> <p>ADAAG 91 4.22.4</p> <p>ADA 2010 604.8.1.2</p> <p>CBC 2007 1115B.3.1.4.4</p> <p>CBC 2016 11B-604.8.1.2</p> <p>Priority 3</p> <p>Severity 4</p> <p>Mitigation Project: <i>Laundry, public, and tenant restrooms</i></p> <p>Estimated Completion Date: <i>2020-2021</i></p> | 1 | JOB | \$25 | \$25 |

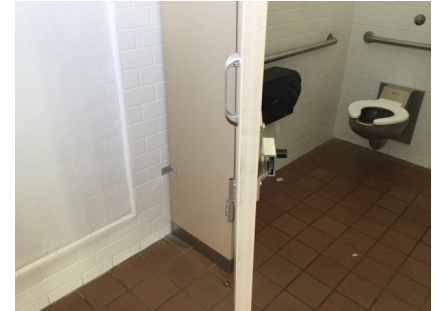
| Item No. and Name | Existing Architectural Barrier and Proposed Solution | Codes / Mitigation Info | Qty | Unit | Cost | Total |
|---|--|--|---|---|---|---|
| 792 | <ul style="list-style-type: none"> <i>As-Built Description:</i> Stall door does not have accessible operating hardware (U-pulls on both sides, flip-over or sliding lock). <i>As-Built:</i> U-pull only on one side <i>Proposed Solution:</i> Provide new accessible locking hardware that does not require grasping, pinching, or twisting and U-pulls on both sides. | <p>PCODE WB05C</p> <p>ADAAG 91 4.17.5</p> <p>ADA 2010 604.8.1.2</p> <p>CBC 2007 1115B.3.1.4.5</p> <p>CBC 2016 11B-604.8.1.2</p> <p>Priority 3</p> <p>Severity 3</p> <p>Mitigation Project: <i>Laundry, public, and tenant restrooms</i></p> <p>Estimated Completion Date: <i>2020-2021</i></p> | 1 | JOB | \$100 | \$100 |

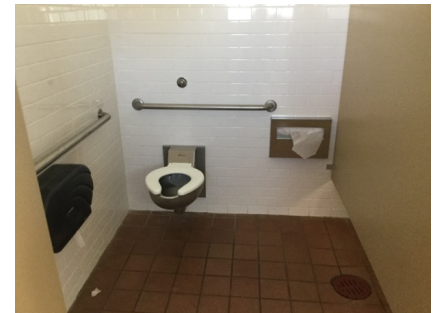
Toilet Stall

| 793 | <ul style="list-style-type: none"> <i>As-Built Description:</i> Toilet stall less than 60" wide. <i>As-Built:</i> 59" wide <i>Proposed Solution:</i> Provide new accessible stall. | <p>PCODE WB06</p> <p>ADAAG 91 4.17.3</p> <p>ADA 2010 604.8.1.1</p> <p>CBC 2007 1115B.3.1.4.1</p> <p>CBC 2016 11B-604.8.1.1</p> <p>Priority 3</p> <p>Severity 4</p> <p>Mitigation Project: <i>Laundry, public, and tenant restrooms</i></p> <p>Estimated Completion Date: <i>2020-2021</i></p> | 1 | JOB | \$1,500 | \$1,500 |

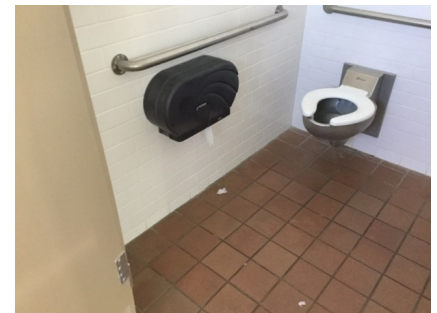
Water Closet

| 794 | <ul style="list-style-type: none"> <i>As-Built Description:</i> CA only: In single-accommodation restroom less than 48" in front of water closet provided. <i>As-Built:</i> 45" in front <i>Proposed Solution:</i> Remodel restroom to provide at least 48" in front of water closet. | <p>PCODE WB03A</p> <p>CBC 2007 1115B.3.2.1</p> <p>CBC 2016 11B-604.3.1</p> <p>Priority 3</p> <p>Severity 4</p> <p>Mitigation Project: <i>Laundry, public, and tenant restrooms</i></p> <p>Estimated Completion Date: <i>2020-2021</i></p> | 1 | JOB | \$5,000 | \$5,000 |

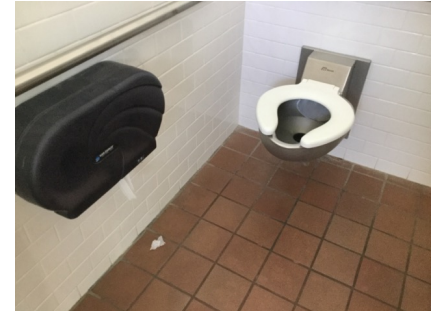
| Item No. and Name | Existing Architectural Barrier and Proposed Solution | Codes / Mitigation Info | Qty | Unit | Cost | Total |
|---|--|--|---|---|---|---|
| 795 | <ul style="list-style-type: none"> As-Built Description: Toilet paper dispenser less than 15" (CA: 19") or more than 48" above floor or not within 7" to 9" from front of water closet (Note: CA pre-2010 is allowed within 12" from front of water closet). As-Built: 15" in front Proposed Solution: Relocate or provide new toilet paper dispenser. | PCODE WG02 ADAAG 91 4.16.6 ADA 2010 604.7 CBC 2007 1115B.8.4 CBC 2016 11B-604.7 Priority 3 Severity 3 Mitigation Project: Laundry, public, and tenant restrooms Estimated Completion Date: 2020-2021 | 1 | JOB | \$75 | \$75 |

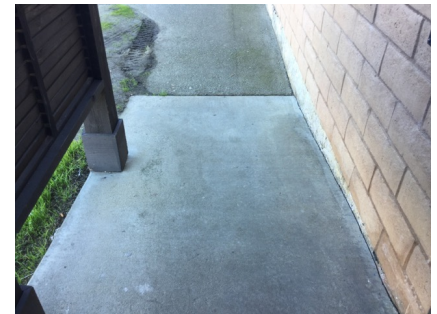
Walk

| 846 | <ul style="list-style-type: none"> As-Built Description: Walk: Slope greater than 1:20 (5.0%), and walk does not comply with requirements for ramps. As-Built: 9.6% Proposed Solution: Modify walk/sidewalk slope to 1:20 or less. | PCODE EF01 ADAAG 91 4.3.7 ADA 2010 403.3 CBC 2007 1133B.7.3 CBC 2016 11B-403.3 Priority 3 Severity 3 Mitigation Project: Laundry, public, and tenant restrooms Estimated Completion Date: 2020-2021 | 80 | SF | \$25 | \$2,000 |

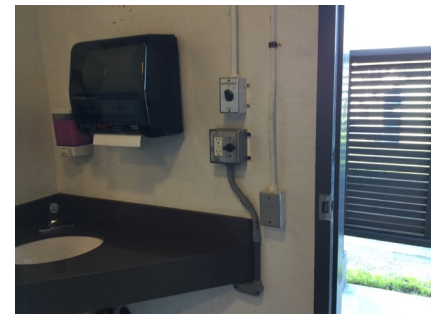
Electrical

| 840 | <ul style="list-style-type: none"> As-Built Description: Electric switch or control mounted less than 15" measured to the bottom of the outlet box or greater than 48 inches measured to the top of the outlet box. As-Built: 57" high switch Proposed Solution: Relocate light switches or control to between 15" and 48" height. | PCODE IC01 ADAAG 91 4.2.5 & 6 ADA 2010 308.2.1 & 308.2.2 CBC 2007 1117B.6.3 CBC 2016 11B-308.2.1 & 11B-308.2.2 Priority 3 Severity 3 Mitigation Project: Laundry, public, and tenant restrooms Estimated Completion Date: 2020-2021 | 1 | JOB | \$300 | \$300 |

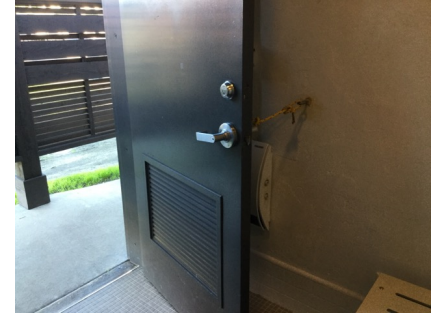
| 843 | <ul style="list-style-type: none"> • <i>As-Built Description:</i> Door lock or latch less than 34" or more than 48" above the floor (CA only: 34" to 44"). • <i>As-Built:</i> 49" high • <i>Proposed Solution:</i> Relocate or replace existing hardware. | <p><i>PCODE</i> ID17 <i>ADAAG 91</i> 4.13.9 <i>ADA 2010</i> 404.2.7 <i>CBC 2007</i> 1133B.2.5.2 <i>CBC 2016</i> 11B-404.2.7</p> <p>Priority 3 Severity 4</p> <p>Mitigation Project: <i>Laundry, public, and tenant restrooms</i></p> <p>Estimated Completion Date: 2020-2021</p> | 1 | JOB | \$300 | \$300 |

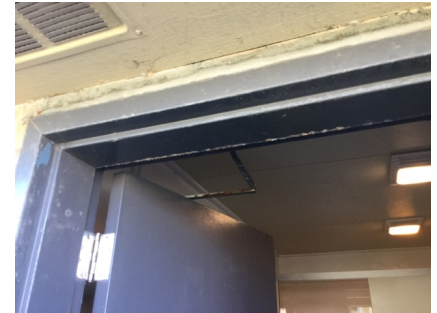
Door Closer

| 834 | <ul style="list-style-type: none"> • <i>As-Built Description:</i> Excessive force required to open door. • <i>As-Built:</i> 12 lbs • <i>Proposed Solution:</i> Adjust regular door closer to accessible standards (5 lbs. max). | <p><i>PCODE</i> ID03 <i>ADAAG 91</i> 4.13.11 <i>ADA 2010</i> 404.2.9 <i>CBC 2007</i> 1133B.2.5 <i>CBC 2016</i> 11B-404.2.9</p> <p>Priority 3 Severity 3</p> <p>Mitigation Project: <i>Laundry, public, and tenant restrooms</i></p> <p>Estimated Completion Date: 2020-2021</p> | 1 | JOB | \$25 | \$25 |

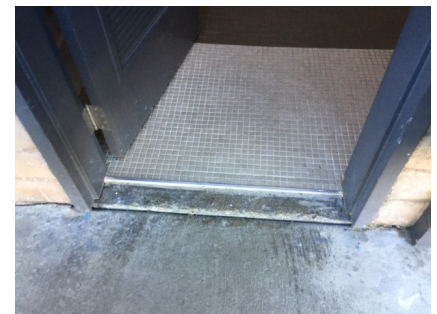
Door Threshold

| 835 | <ul style="list-style-type: none"> • <i>As-Built Description:</i> Door inaccessible due to threshold or step at door exceeding 1/2". • <i>As-Built:</i> 0.5" threshold • <i>Proposed Solution:</i> Modify threshold to be no more than 1/2" by removing existing paving at door and providing landing with edge ramping (slope 1:20 max). | <p><i>PCODE</i> ID02A <i>ADAAG 91</i> 4.13.8 <i>ADA 2010</i> 404.2.5 <i>CBC 2007</i> 1133B.2.4.1 <i>CBC 2016</i> 11B-404.2.5</p> <p>Priority 3 Severity 4</p> <p>Mitigation Project: <i>Laundry, public, and tenant restrooms</i></p> <p>Estimated Completion Date: 2020-2021</p> | 1 | JOB | \$400 | \$400 |

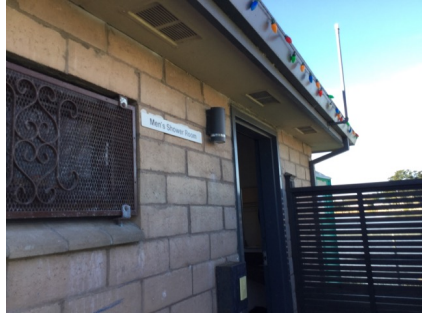
| Item No. and Name | Existing Architectural Barrier and Proposed Solution | Codes / Mitigation Info | Qty | Unit | Cost | Total |
|---|---|--|---|---|---|---|
| 832 | <ul style="list-style-type: none"> <i>As-Built Description:</i> Entrance to toilet or bathing facility not identified with ADAAG compliant signage. <i>As-Built:</i> No latch sign <i>Proposed Solution:</i> Provide ADAAG compliant sign mounted 5' high on center on nearest adjacent wall, on latch side of a single door (located not to cause a Braille reader to stand within the door swing). | <p><i>PCODE</i> SA11A <i>ADAAG 91</i> 4.1.3(16)(a) <i>ADA 2010</i> 216.8 <i>CBC 2016</i> 11B-216.8</p> <p>Priority 3 Severity 3</p> <p>Mitigation Project: <i>Laundry, public, and tenant restrooms</i></p> <p>Estimated Completion Date: <i>2020-2021</i></p> | 1 | JOB | \$90 | \$90 |

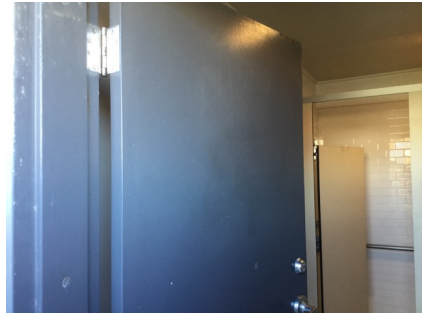
| Item No. and Name | Existing Architectural Barrier and Proposed Solution | Codes / Mitigation Info | Qty | Unit | Cost | Total |
|---|---|--|---|---|---|---|
| 833 | <ul style="list-style-type: none"> <i>As-Built Description:</i> Required in CA only: identification symbol centered 58" to 60" high on sanitary facility door that contrasts with the door not provided (women: 12" ø circle, men: 12" triangle, unisex: combined symbol). <i>Proposed Solution:</i> Provide properly mounted sanitary facility symbol when altering area. If wheelchair accessible, include International Symbol of Accessibility on sign. | <p><i>PCODE</i> SA15 <i>CBC 2007</i> 1115B.6 <i>CBC 2016</i> 11B-703.7.2.6</p> <p>Priority 3 Severity 3</p> <p>Mitigation Project: <i>Laundry, public, and tenant restrooms</i></p> <p>Estimated Completion Date: <i>2020-2021</i></p> | 1 | JOB | \$90 | \$90 |

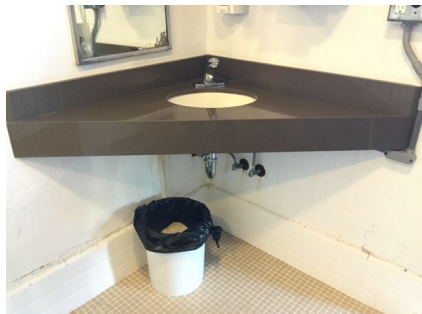
| Item No. and Name | Existing Architectural Barrier and Proposed Solution | Codes / Mitigation Info | Qty | Unit | Cost | Total |
|---|---|--|---|---|---|---|
| 837 | <ul style="list-style-type: none"> <i>As-Built Description:</i> Lavatory: Fixture rim or counter height more than 34" above floor. <i>As-Built:</i> 35.25" high <i>Proposed Solution:</i> Remount compliant fixture at accessible height. | <p><i>PCODE</i> WD02A <i>ADAAG 91</i> 4.19.2 <i>ADA 2010</i> 606.3 <i>CBC 2007</i> 1115B.4.3 <i>CBC 2016</i> 11B-606.3</p> <p>Priority 3 Severity 4</p> <p>Mitigation Project: <i>Laundry, public, and tenant restrooms</i></p> <p>Estimated Completion Date: <i>2020-2021</i></p> | 1 | JOB | \$900 | \$900 |

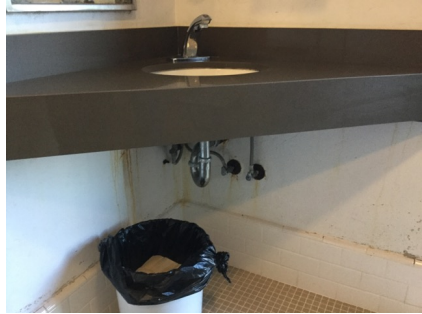
| Item No. and Name | Existing Architectural Barrier and Proposed Solution | Codes / Mitigation Info | Qty | Unit | Cost | Total |
|---|---|---|---|---|---|---|
| 842 | <ul style="list-style-type: none"> <i>As-Built Description:</i> Hot or sharp-surfaced water/drain pipe not insulated or covered. <i>Proposed Solution:</i> Insulate or cover water/drain pipe. | <p>PCODE WD05 ADAAG 91 4.19.4 ADA 2010 606.5 CBC 2007 1115B.4.3.4 CBC 2016 11B-606.5</p> <p>Priority 3 Severity 3</p> <p>Mitigation Project: Laundry, public, and tenant restrooms</p> <p>Estimated Completion Date: 2020-2021</p> | 1 | JOB | \$120 | \$120 |

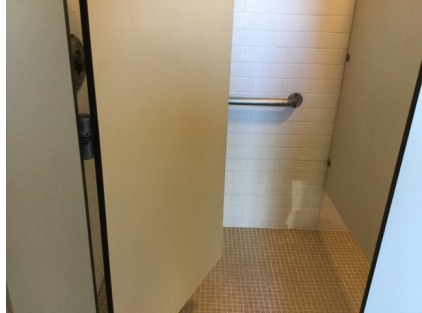
| Item No. and Name | Existing Architectural Barrier and Proposed Solution | Codes / Mitigation Info | Qty | Unit | Cost | Total |
|---|---|---|---|---|---|---|
| 844 | <ul style="list-style-type: none"> <i>As-Built Description:</i> Shower not accessible; multiple compliance violations. <i>As-Built:</i> 47" wide X 49" deep <i>Proposed Solution:</i> Provide accessible shower. Notes: Stall door swings in shower space No shower seat provided | <p>PCODE WF01 ADAAG 91 4.21 ADA 2010 608.1 CBC 2016 11B-608.1</p> <p>Priority 3 Severity 3</p> <p>Mitigation Project: Laundry, public, and tenant restrooms</p> <p>Estimated Completion Date: 2020-2021</p> | 1 | JOB | \$4,000 | \$4,000 |

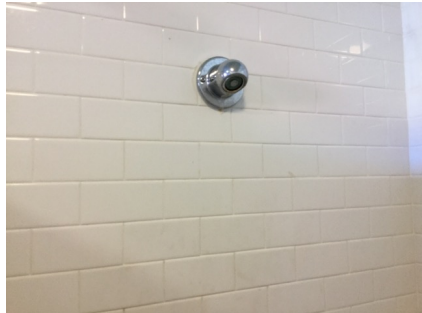
| Item No. and Name | Existing Architectural Barrier and Proposed Solution | Codes / Mitigation Info | Qty | Unit | Cost | Total |
|---|---|---|---|---|---|---|
| 845 | <ul style="list-style-type: none"> <i>As-Built Description:</i> Mounting height of shower spray bracket exceeds 48" max. height or is more than 27" from rear edge of folding seat. <i>As-Built:</i> Spray 71" high <i>Proposed Solution:</i> Provide or remount shower spray bracket within 27" from rear edge of seat and at 48" max. height. | <p>PCODE WF05B ADA 2010 608.5 CBC 2007 1115B.4.4.5.3 CBC 2016 11B-608.5</p> <p>Priority 3 Severity 1</p> <p>Mitigation Project: Laundry, public, and tenant restrooms</p> <p>Estimated Completion Date: 2020-2021</p> | 1 | JOB | \$500 | \$500 |

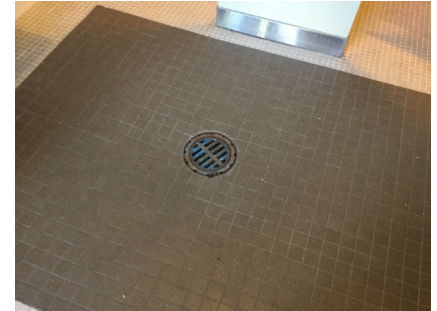
| Item No. and Name | Existing Architectural Barrier and Proposed Solution | Codes / Mitigation Info | Qty | Unit | Cost | Total |
|---|--|--|---|---|---|---|
| 836 | <ul style="list-style-type: none"> <i>As-Built Description:</i> Shower: Floor surface sloped greater than 2.0% (1:48) due to drain. <i>As-Built:</i> Sloped drain in middle of room <i>Proposed Solution:</i> Remodel floor surface in shower to compliance. | <p>PCODE WF06A ADA 2010 608.9 CBC 2016 11B-608.9</p> <p>Priority 3 Severity 3</p> <p>Mitigation Project: <i>Laundry, public, and tenant restrooms</i></p> <p>Estimated Completion Date: <i>2020-2021</i></p> | 1 | JOB | \$500 | \$500 |

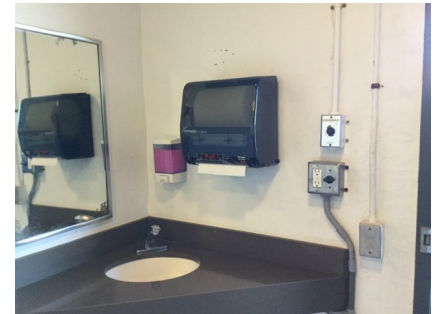
| 839 | <ul style="list-style-type: none"> <i>As-Built Description:</i> Dispensers in sanitary facilities, such as for towels, soap, sanitary napkins, seat covers, etc., and waste receptacles more than 48" (CA only: 40") from floor to highest operating slot or control. <i>As-Built:</i> PTD: 51" high SD: 47" high <i>Proposed Solution:</i> Relocate existing restroom accessories. | <p>PCODE WG01A ADAAG 91 4.23.7 ADA 2010 308.2.1 CBC 2007 1115B.8.3 CBC 2016 11B-603.5</p> <p>Priority 3 Severity 2</p> <p>Mitigation Project: <i>Laundry, public, and tenant restrooms</i></p> <p>Estimated Completion Date: <i>2020-2021</i></p> | 1 | JOB | \$100 | \$100 |

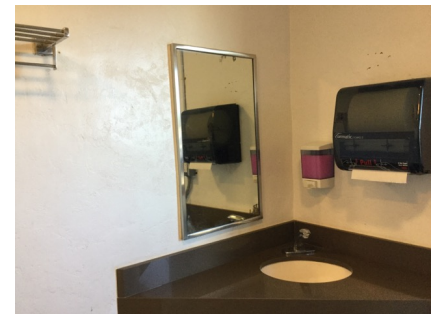
| 838 | <ul style="list-style-type: none"> <i>As-Built Description:</i> Bottom of flat, not tilted mirror located above lavatories or countertops more than 40" above floor. <i>As-Built:</i> 42" high <i>Proposed Solution:</i> Relocate or provide new accessible mirror. | <p>PCODE WG03 ADAAG 91 4.19.6 ADA 2010 603.3 CBC 2007 1115B.8.1 CBC 2016 11B-603.3</p> <p>Priority 3 Severity 4</p> <p>Mitigation Project: <i>Laundry, public, and tenant restrooms</i></p> <p>Estimated Completion Date: <i>2020-2021</i></p> | 1 | JOB | \$150 | \$150 |

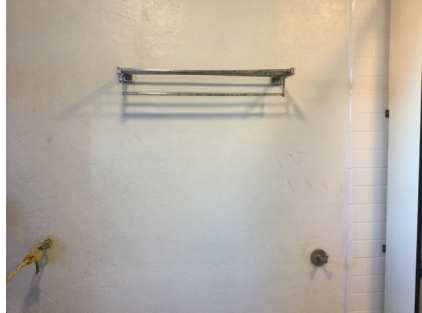
| Item No. and Name | Existing Architectural Barrier and Proposed Solution | Codes / Mitigation Info | Qty | Unit | Cost | Total |
|---|---|--|---|---|---|---|
| 841 | <ul style="list-style-type: none"> As-Built Description: Accessible coat hook not within reach range. As-Built: 67" high Proposed Solution: Adjust existing or provide new coat hook at maximum 48" height. | PCODE WG03A ADAAG 91 4.2.5 ADA 2010 603.4 CBC 2007 1118B.5 CBC 2016 11B-603.4 Priority 3 Severity 1 Mitigation Project: Laundry, public, and tenant restrooms Estimated Completion Date: 2020-2021 | 1 | JOB | \$50 | \$50 |

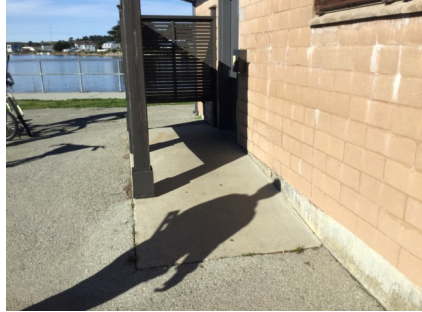
| 855 | <ul style="list-style-type: none"> As-Built Description: Walk: Slope greater than 1:20 (5.0%), and walk does not comply with requirements for ramps. As-Built: 10.3% Proposed Solution: Modify walk/sidewalk slope to 1:20 or less. | PCODE EF01 ADAAG 91 4.3.7 ADA 2010 403.3 CBC 2007 1133B.7.3 CBC 2016 11B-403.3 Priority 3 Severity 3 Mitigation Project: Laundry, public, and tenant restrooms Estimated Completion Date: 2020-2021 | 80 | SF | \$25 | \$2,000 |

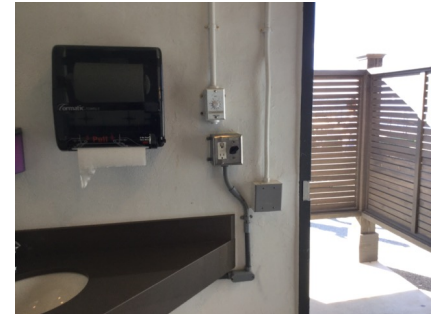
| 864 | <ul style="list-style-type: none"> • <i>As-Built Description:</i> Electric switch or control mounted less than 15" measured to the bottom of the outlet box or greater than 48 inches measured to the top of the outlet box. • <i>As-Built:</i> 57" high switch • <i>Proposed Solution:</i> Relocate light switches or control to between 15" and 48" height. | <p>PCODE IC01 ADAAG 91 4.2.5 & 6 ADA 2010 308.2.1 & 308.2.2 CBC 2007 1117B.6.3 CBC 2016 11B-308.2.1 & 11B-308.2.2</p> <p>Priority 3 Severity 3</p> <p>Mitigation Project: Laundry, public, and tenant restrooms</p> <p>Estimated Completion Date: 2020-2021</p> | 1 | JOB | \$300 | \$300 |

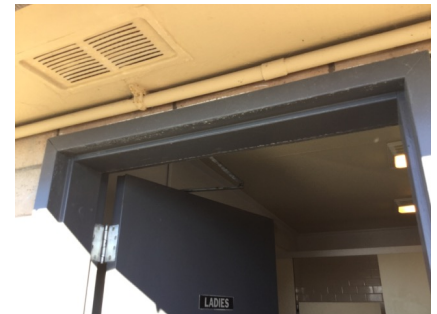
| 858 | <ul style="list-style-type: none"> • <i>As-Built Description:</i> Excessive force required to open door. • <i>As-Built:</i> 19 lbs • <i>Proposed Solution:</i> Adjust regular door closer to accessible standards (5 lbs. max). | <p>PCODE ID03 ADAAG 91 4.13.11 ADA 2010 404.2.9 CBC 2007 1133B.2.5 CBC 2016 11B-404.2.9</p> <p>Priority 3 Severity 2</p> <p>Mitigation Project: Laundry, public, and tenant restrooms</p> <p>Estimated Completion Date: 2020-2021</p> | 1 | JOB | \$25 | \$25 |

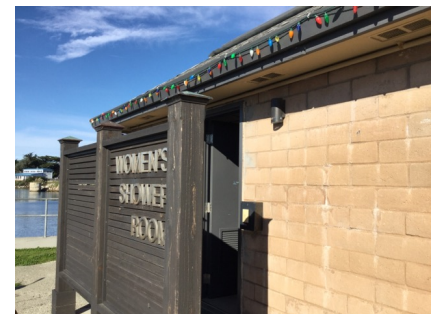
| 856 | <ul style="list-style-type: none"> • <i>As-Built Description:</i> Entrance to toilet or bathing facility not identified with ADAAG compliant signage. • <i>As-Built:</i> No latch sign • <i>Proposed Solution:</i> Provide ADAAG compliant sign mounted 5' high on center on nearest adjacent wall, on latch side of a single door (located not to cause a Braille reader to stand within the door swing). | <p>PCODE SA11A ADAAG 91 4.1.3(16)(a) ADA 2010 216.8 CBC 2016 11B-216.8</p> <p>Priority 3 Severity 3</p> <p>Mitigation Project: Laundry, public, and tenant restrooms</p> <p>Estimated Completion Date: 2020-2021</p> | 1 | JOB | \$90 | \$90 |

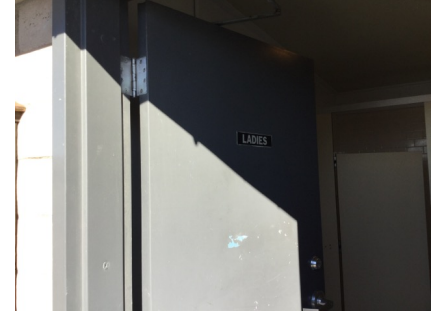
| Item No. and Name | Existing Architectural Barrier and Proposed Solution | Codes / Mitigation Info | Qty | Unit | Cost | Total |
|---|---|--|---|---|---|---|
| 857 | <ul style="list-style-type: none"> As-Built Description: Required in CA only: identification symbol centered 58" to 60" high on sanitary facility door that contrasts with the door not provided (women: 12" ø circle, men: 12" triangle, unisex: combined symbol). As-Built: Not geometric Proposed Solution: Provide properly mounted sanitary facility symbol when altering area. If wheelchair accessible, include International Symbol of Accessibility on sign. | <p>PCODE SA15</p> <p>CBC 2007 1115B.6</p> <p>CBC 2016 11B-703.7.2.6</p> <p>Priority 3</p> <p>Severity 3</p> <p>Mitigation Project: <i>Laundry, public, and tenant restrooms</i></p> <p>Estimated Completion Date: <i>2020-2021</i></p> | 1 | JOB | \$90 | \$90 |

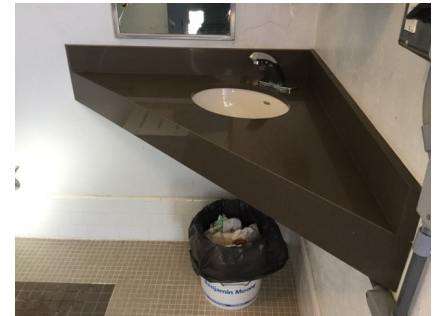
| 860 | <ul style="list-style-type: none"> As-Built Description: Lavatory: Fixture rim or counter height more than 34" above floor. As-Built: 34.25" high Proposed Solution: Remount compliant fixture at accessible height. | <p>PCODE WD02A</p> <p>ADAAG 91 4.19.2</p> <p>ADA 2010 606.3</p> <p>CBC 2007 1115B.4.3</p> <p>CBC 2016 11B-606.3</p> <p>Priority 3</p> <p>Severity 4</p> <p>Mitigation Project: <i>Laundry, public, and tenant restrooms</i></p> <p>Estimated Completion Date: <i>2020-2021</i></p> | 1 | JOB | \$900 | \$900 |

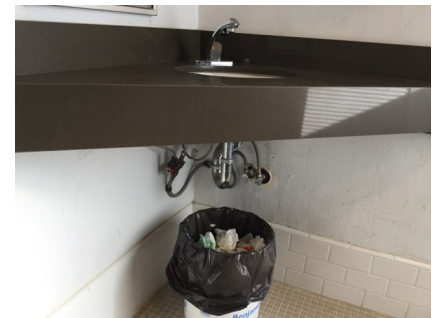
| 861 | <ul style="list-style-type: none"> As-Built Description: Hot or sharp-surfaced water/drain pipe not insulated or covered. Proposed Solution: Insulate or cover water/drain pipe. | <p>PCODE WD05</p> <p>ADAAG 91 4.19.4</p> <p>ADA 2010 606.5</p> <p>CBC 2007 1115B.4.3.4</p> <p>CBC 2016 11B-606.5</p> <p>Priority 3</p> <p>Severity 3</p> <p>Mitigation Project: <i>Laundry, public, and tenant restrooms</i></p> <p>Estimated Completion Date: <i>2020-2021</i></p> | 1 | JOB | \$120 | \$120 |

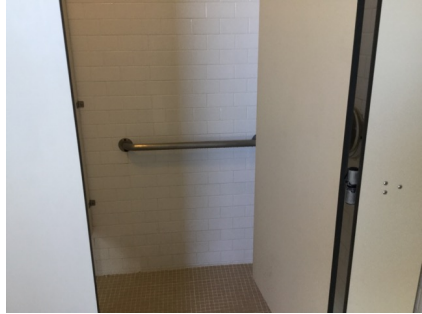
| Item No. and Name | Existing Architectural Barrier and Proposed Solution | Codes / Mitigation Info | Qty | Unit | Cost | Total |
|---|---|---|---|---|---|---|
| 866 | <ul style="list-style-type: none"> <i>As-Built Description:</i> Shower not accessible; multiple compliance violations. <i>As-Built:</i> 46.5" wide X 48" deep <i>Proposed Solution:</i> Provide accessible shower. <i>Notes:</i> Stall door swings into shower space | <p>PCODE WF01 ADAAG 91 4.21 ADA 2010 608.1 CBC 2016 11B-608.1</p> <p>Priority 3 Severity 3</p> <p>Mitigation Project: <i>Laundry, public, and tenant restrooms</i></p> <p>Estimated Completion Date: <i>2020-2021</i></p> | 1 | JOB | \$4,000 | \$4,000 |

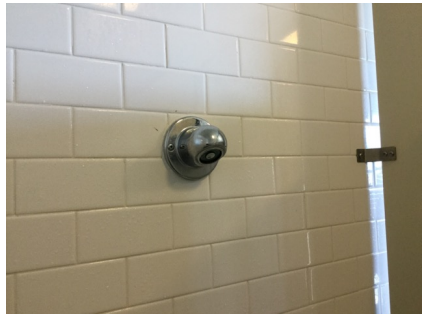
| Item No. and Name | Existing Architectural Barrier and Proposed Solution | Codes / Mitigation Info | Qty | Unit | Cost | Total |
|---|---|---|---|---|---|---|
| 867 | <ul style="list-style-type: none"> <i>As-Built Description:</i> Mounting height of shower spray bracket exceeds 48" max. height or is more than 27" from rear edge of folding seat. <i>As-Built:</i> 65" high spray <i>Proposed Solution:</i> Provide or remount shower spray bracket within 27" from rear edge of seat and at 48" max. height. <i>Notes:</i> Shower control twist to operate | <p>PCODE WF05B ADA 2010 608.5 CBC 2007 1115B.4.4.5.3 CBC 2016 11B-608.5</p> <p>Priority 3 Severity 1</p> <p>Mitigation Project: <i>Laundry, public, and tenant restrooms</i></p> <p>Estimated Completion Date: <i>2020-2021</i></p> | 1 | JOB | \$500 | \$500 |

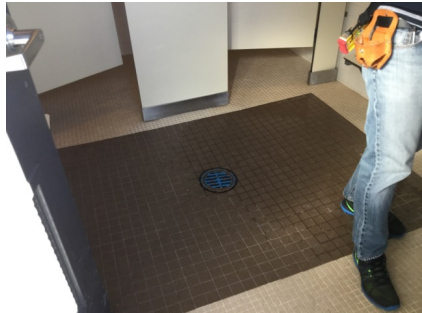
| Item No. and Name | Existing Architectural Barrier and Proposed Solution | Codes / Mitigation Info | Qty | Unit | Cost | Total |
|---|---|---|---|---|---|---|
| 859 | <ul style="list-style-type: none"> <i>As-Built Description:</i> Shower: Floor surface sloped greater than 2.0% (1:48) due to drain. <i>As-Built:</i> Sloped drain throughout room <i>Proposed Solution:</i> Remodel floor surface in shower to compliance. | <p>PCODE WF06A ADA 2010 608.9 CBC 2016 11B-608.9</p> <p>Priority 3 Severity 3</p> <p>Mitigation Project: <i>Laundry, public, and tenant restrooms</i></p> <p>Estimated Completion Date: <i>2020-2021</i></p> | 1 | JOB | \$500 | \$500 |

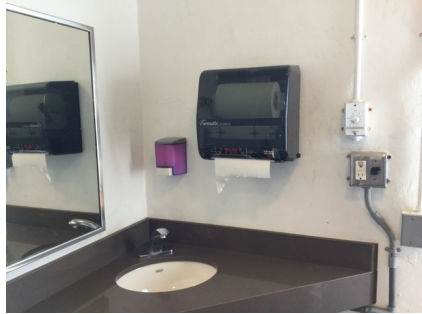
| Item No. and Name | Existing Architectural Barrier and Proposed Solution | Codes / Mitigation Info | Qty | Unit | Cost | Total |
|---|--|--|---|---|---|---|
| 863 | <ul style="list-style-type: none"> <i>As-Built Description:</i> Dispensers in sanitary facilities, such as for towels, soap, sanitary napkins, seat covers, etc., and waste receptacles more than 48" (CA only: 40") from floor to highest operating slot or control. <i>As-Built:</i> PTD: 57" high SD: 49" high <i>Proposed Solution:</i> Relocate existing restroom accessories. | <p>PCODE WG01A ADAAG 91 4.23.7 ADA 2010 308.2.1 CBC 2007 1115B.8.3 CBC 2016 11B-603.5</p> <p>Priority 3 Severity 2</p> <p>Mitigation Project: Laundry, public, and tenant restrooms</p> <p>Estimated Completion Date: 2020-2021</p> | 1 | JOB | \$100 | \$100 |

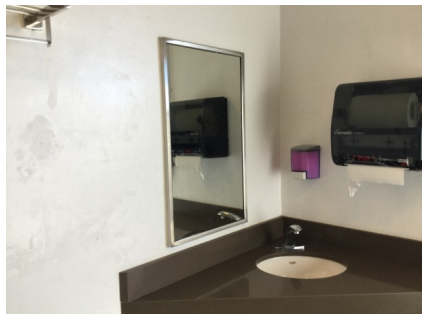
| Item No. and Name | Existing Architectural Barrier and Proposed Solution | Codes / Mitigation Info | Qty | Unit | Cost | Total |
|---|--|--|---|---|---|---|
| 862 | <ul style="list-style-type: none"> <i>As-Built Description:</i> Bottom of flat, not tilted mirror located above lavatories or countertops more than 40" above floor. <i>As-Built:</i> 41" high <i>Proposed Solution:</i> Relocate or provide new accessible mirror. | <p>PCODE WG03 ADAAG 91 4.19.6 ADA 2010 603.3 CBC 2007 1115B.8.1 CBC 2016 11B-603.3</p> <p>Priority 3 Severity 4</p> <p>Mitigation Project: Laundry, public, and tenant restrooms</p> <p>Estimated Completion Date: 2020-2021</p> | 1 | JOB | \$150 | \$150 |

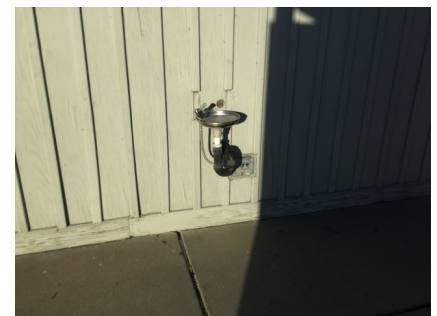
796 • *As-Built Description:*
 Drinking fountain lacks protection for visually impaired persons.
 • *Proposed Solution:*
 Provide cane-detectable rails.

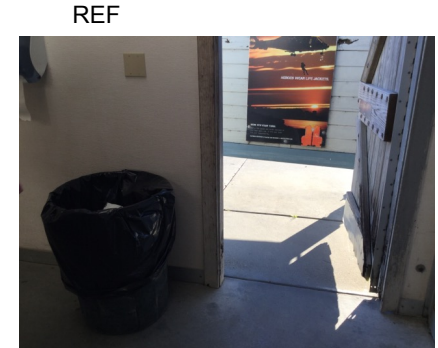
- 798
- *As-Built Description:*
Entrance to toilet or bathing facility not identified with ADAAG compliant signage.
 - *As-Built:* **Noncompliant latch sign**
 - *Proposed Solution:*
Provide ADAAG compliant sign mounted 5' high on center on nearest adjacent wall, on latch side of a single door (located not to cause a Braille reader to stand within the door swing).

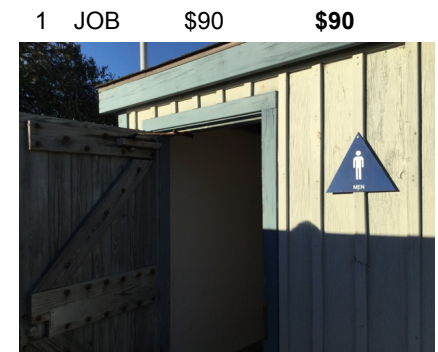
- 808
- *As-Built Description:*
The location of the stall door is not in front of the clear space (next to the water closet), with a maximum stile width of 4".
 - *As-Built:* **Stall door does not open on wide side**
 - *Proposed Solution:*
Remodel compartment.

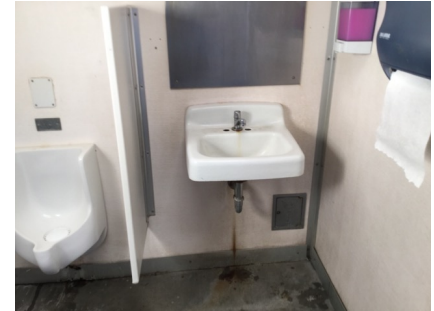
| Item No. and Name | Existing Architectural Barrier and Proposed Solution | Codes / Mitigation Info | Qty | Unit | Cost | Total |
|---|--|---|---|---|---|---|
| 802 | <ul style="list-style-type: none"> <i>As-Built Description:</i> Lavatory: Self-closing faucet at accessible lavatory does not remain open for at least 10 seconds. <i>As-Built:</i> 4 seconds <i>Proposed Solution:</i> Adjust self-closing faucet at accessible lavatory. | <p>PCODE WD07 ADAAG 91 4.19.5 ADA 2010 606.4 CBC 2007 1115B.4.3 CBC 2016 11B-606.4</p> <p>Priority 3 Severity 3</p> <p>Mitigation Project: Launch Ramp Restrooms</p> <p>Estimated Completion Date: 2018-2019</p> | 1 | JOB | \$50 | \$50 |

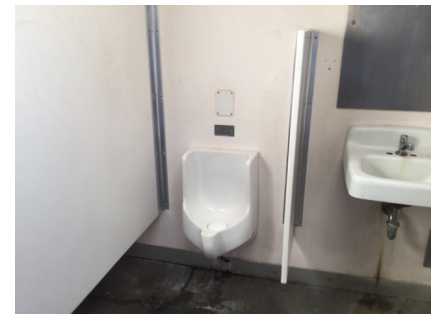
| 803 | <ul style="list-style-type: none"> <i>As-Built Description:</i> 36" wide clearance in front of accessible urinal not provided when walls or partitions project more than 24" from the front edge of 30" x 48" clear space. <i>As-Built:</i> 30" wide <i>Proposed Solution:</i> Provide 36" clear floor space in front of accessible urinal. Remodel restroom as needed. | <p>PCODE WE04A ADAAG 91 4.18.3 ADA 2010 605.3 CBC 2007 1115B.4.2.3 CBC 2016 11B-605.3</p> <p>Priority 3 Severity 2</p> <p>Mitigation Project: Launch Ramp Restrooms</p> <p>Estimated Completion Date: 2018-2019</p> | 1 | JOB | \$1,500 | \$1,500 |

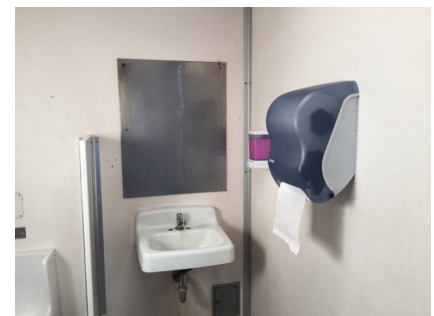
| 804 | <ul style="list-style-type: none"> <i>As-Built Description:</i> Dispensers in sanitary facilities, such as for towels, soap, sanitary napkins, seat covers, etc., and waste receptacles more than 48" (CA only: 40") from floor to highest operating slot or control. <i>As-Built:</i> SD: 48.5" high SCD: 50" high <i>Proposed Solution:</i> Relocate existing restroom accessories. | <p>PCODE WG01A ADAAG 91 4.23.7 ADA 2010 308.2.1 CBC 2007 1115B.8.3 CBC 2016 11B-603.5</p> <p>Priority 3 Severity 2</p> <p>Mitigation Project: Launch Ramp Restrooms</p> <p>Estimated Completion Date: 2018-2019</p> | 1 | JOB | \$100 | \$100 |

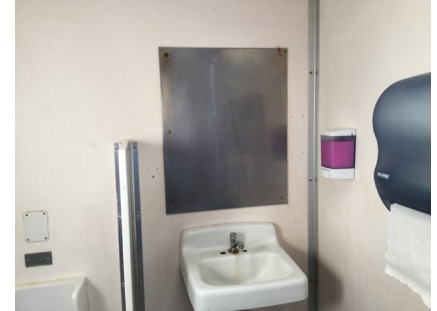
| Item No. and Name | Existing Architectural Barrier and Proposed Solution | Codes / Mitigation Info | Qty | Unit | Cost | Total |
|---|--|---|---|---|---|---|
| 801 | <ul style="list-style-type: none"> <i>As-Built Description:</i> Bottom of flat, not tilted mirror located above lavatories or countertops more than 40" above floor. <i>As-Built:</i> 40.25" high <i>Proposed Solution:</i> Relocate or provide new accessible mirror. | <p>PCODE WG03 ADAAG 91 4.19.6 ADA 2010 603.3 CBC 2007 1115B.8.1 CBC 2016 11B-603.3</p> <p>Priority 3 Severity 4</p> <p>Mitigation Project: Launch Ramp Restrooms</p> <p>Estimated Completion Date: 2018-2019</p> | 1 | JOB | \$150 | \$150 |

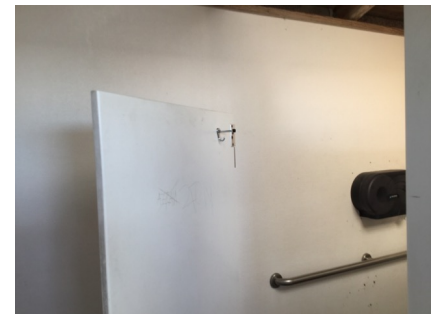
| 807 | <ul style="list-style-type: none"> <i>As-Built Description:</i> Accessible coat hook not within reach range. <i>As-Built:</i> 64" high CH <i>Proposed Solution:</i> Adjust existing or provide new coat hook at maximum 48" height. | <p>PCODE WG03A ADAAG 91 4.2.5 ADA 2010 603.4 CBC 2007 1118B.5 CBC 2016 11B-603.4</p> <p>Priority 3 Severity 2</p> <p>Mitigation Project: Launch Ramp Restrooms</p> <p>Estimated Completion Date: 2018-2019</p> | 1 | JOB | \$50 | \$50 |

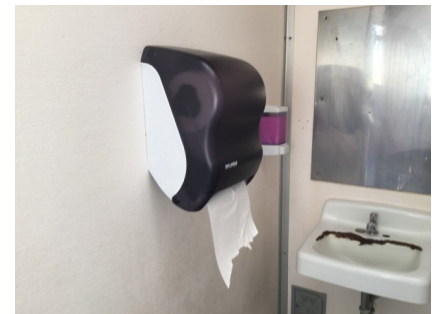
| 819 | <ul style="list-style-type: none"> <i>As-Built Description:</i> Protruding objects more than 4" from wall, when bottom of object more than 27" or less than 80" above finished floor. <i>As-Built:</i> PTD: 7" at 46" high <i>Proposed Solution:</i> Remove/relocate protruding object. Patch existing surface. | <p>PCODE EG04 ADAAG 91 4.4.1 ADA 2010 307.2 CBC 2007 1133B.8.6.1 CBC 2016 11B-307.2</p> <p>Priority 3 Severity 3</p> <p>Mitigation Project: Launch Ramp Restrooms</p> <p>Estimated Completion Date: 2018-2019</p> | 1 | JOB | \$100 | \$100 |

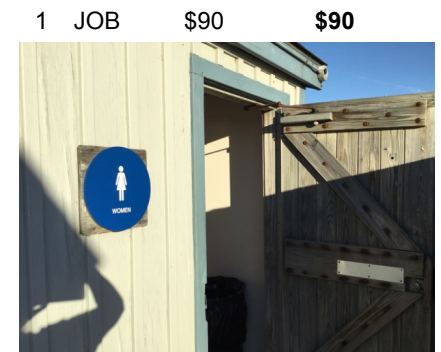
- 813
- *As-Built Description:*
Entrance to toilet or bathing facility not identified with ADAAG compliant signage.
 - *As-Built:* **Noncompliant latch sign**
 - *Proposed Solution:*
Provide ADAAG compliant sign mounted 5' high on center on nearest adjacent wall, on latch side of a single door (located not to cause a Braille reader to stand within the door swing).

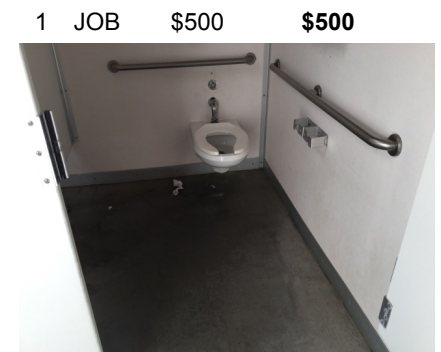
- 829
- *As-Built Description:*
The location of the stall door is not in front of the clear space (next to the water closet), with a maximum stile width of 4".
 - *As-Built:* **Stall door does not open on wide side**
 - *Proposed Solution:*
Remodel compartment.

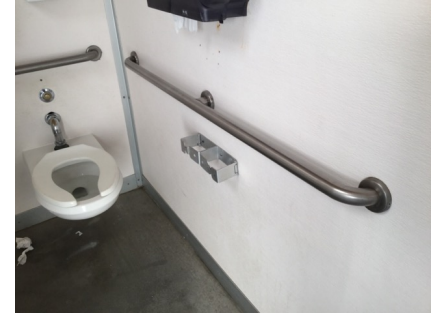
| 828 | <ul style="list-style-type: none"> • <i>As-Built Description:</i> Grab bars not at 33" to 36" from floor • <i>As-Built:</i> Interruption in RGB • <i>Proposed Solution:</i> Relocate accessible grab bars. | <p>PCODE WB07C ADAAG 91 4.16.4 ADA 2010 609.4 CBC 2007 1115B.4.1.3.1 CBC 2016 & 2 11B-609.4</p> <p>Priority 3 Severity 4</p> <p>Mitigation Project: Launch Ramp Restrooms Estimated Completion Date: 2018-2019</p> | 1 | JOB | \$260 | \$260 |

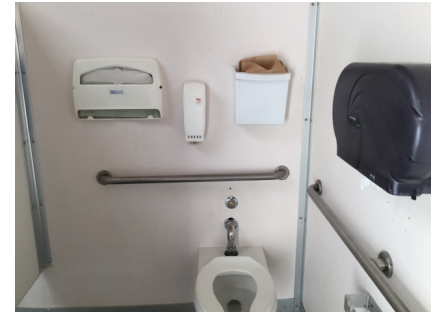
| 826 | <ul style="list-style-type: none"> • <i>As-Built Description:</i> Accessories/dispensers in accessible stall located closer than 1-1/2" below or 12" above grab bar impedes its use. • <i>As-Built:</i> TPD above GB • <i>Proposed Solution:</i> Relocate accessories/dispensers to be no closer than 1-1/2" below and 12" above grab bars (except if accessories are recessed, flush with wall, and have no sharp edges). | <p>PCODE WB07I ADAAG 91 4.26.2 ADA 2010 609.3 CBC 2007 1133B.4.2.5 CBC 2016 11B-609.3</p> <p>Priority 3 Severity 4</p> <p>Mitigation Project: Launch Ramp Restrooms Estimated Completion Date: 2018-2019</p> | 1 | JOB | \$75 | \$75 |

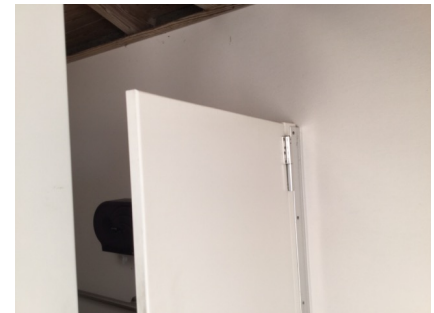
| 821 | <ul style="list-style-type: none"> • <i>As-Built Description:</i> Stall door to accessible compartment not self closing. • <i>Proposed Solution:</i> Adjust closer. | <p>PCODE WB05B ADAAG 91 4.22.4 ADA 2010 604.8.1.2 CBC 2007 1115B.3.1.4.4 CBC 2016 11B-604.8.1.2</p> <p>Priority 3 Severity 4</p> <p>Mitigation Project: Launch Ramp Restrooms Estimated Completion Date: 2018-2019</p> | 1 | JOB | \$25 | \$25 |

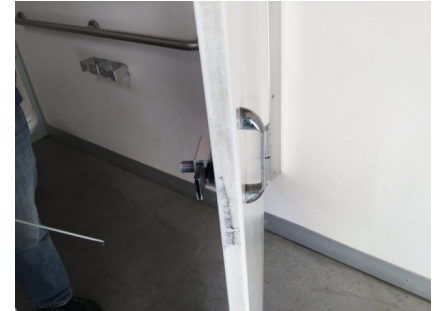
| Item No. and Name | Existing Architectural Barrier and Proposed Solution | Codes / Mitigation Info | Qty | Unit | Cost | Total |
|---|--|--|---|---|---|---|
| 822 | <ul style="list-style-type: none"> <i>As-Built Description:</i> Stall door does not have accessible operating hardware (U-pulls on both sides, flip-over or sliding lock). <i>As-Built:</i> U-pull only on one side <i>Proposed Solution:</i> Provide new accessible locking hardware that does not require grasping, pinching, or twisting and U-pulls on both sides. | <p>PCODE WB05C</p> <p>ADAAG 91 4.17.5</p> <p>ADA 2010 604.8.1.2</p> <p>CBC 2007 1115B.3.1.4.5</p> <p>CBC 2016 11B-604.8.1.2</p> <p>Priority 3</p> <p>Severity 3</p> <p>Mitigation Project: <i>Launch Ramp Restrooms</i></p> <p>Estimated Completion Date: <i>2018-2019</i></p> | 1 | JOB | \$100 | \$100 |
