SAN MATEO COUNTY HARBOR DISTRICT

ADA Self-Evaluation and Transition Plan

August 2018

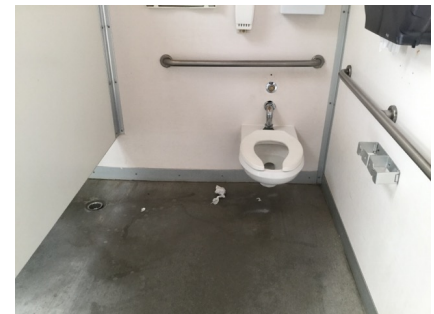
| 824 | <ul style="list-style-type: none"> <i>As-Built Description:</i> Toilet stall less than 60" wide. <i>As-Built:</i> 55" wide <i>Proposed Solution:</i> Provide new accessible stall. | <p>PCODE WB06</p> <p>ADAAG 91 4.17.3</p> <p>ADA 2010 604.8.1.1</p> <p>CBC 2007 1115B.3.1.4.1</p> <p>CBC 2016 11B-604.8.1.1</p> <p>Priority 3</p> <p>Severity 4</p> <p>Mitigation Project: <i>Launch Ramp Restrooms</i></p> <p>Estimated Completion Date: <i>2018-2019</i></p> | 1 | JOB | \$1,500 | \$1,500 |

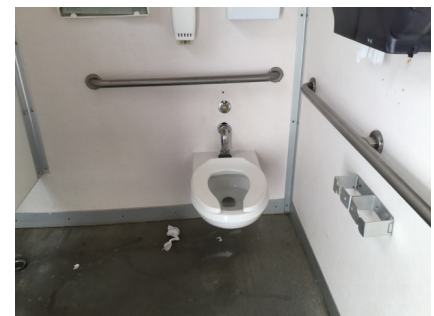
| 827 | <ul style="list-style-type: none"> <i>As-Built Description:</i> Water closet not 16"-18" (CA: 17"-18") from near side wall to center line of water closet (2010 ADAAG: 16"-18"). <i>As-Built:</i> 16" o.c. <i>Proposed Solution:</i> Relocate existing water closet and plumbing, remount with offset closet flange to provide 18" max. from side wall. | <p>PCODE WB02C</p> <p>ADAAG 91 Fig. 28</p> <p>ADA 2010 604.2</p> <p>CBC 2007 1115B.4.1.1</p> <p>CBC 2016 11B-604.2</p> <p>Priority 3</p> <p>Severity 4</p> <p>Mitigation Project: <i>Launch Ramp Restrooms</i></p> <p>Estimated Completion Date: <i>2018-2019</i></p> | 1 | JOB | \$500 | \$500 |

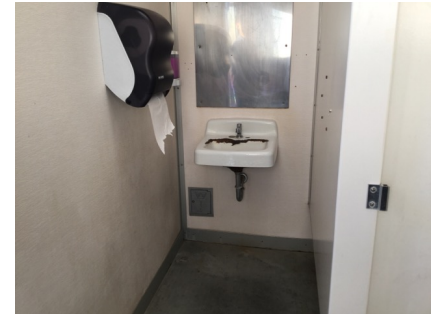
| 815 | <ul style="list-style-type: none"> <i>As-Built Description:</i> Clear passage width (except doorways) from rest room entry to accessible water closet compartment less than 36" (CA only: 44" wide). <i>As-Built:</i> 35" wide to lavatory <i>Proposed Solution:</i> Modify facility passage to be min. 44" wide. Demolish existing partition and replace. | <p>PCODE WC02A ADAAG 91 4.3.3 ADA 2010 403.5.1 CBC 2007 1115B.3.2.4 CBC 2016 11B-403.5.1</p> <p>Priority 3 Severity 2</p> <p>Mitigation Project: Launch Ramp Restrooms</p> <p>Estimated Completion Date: 2018-2019</p> | 6 | LF | \$170 | \$1,020 |

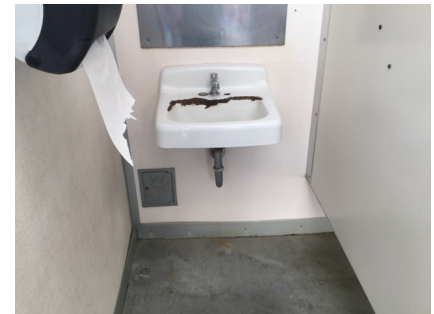
| 817 | <ul style="list-style-type: none"> <i>As-Built Description:</i> Clear floor space, 30" x 48" in front of fixture, extending 19" max. under the lavatory, not provided (CA only: Less than 18" from side wall to centerline of lavatory). <i>As-Built:</i> 17" o.c. <i>Proposed Solution:</i> Provide new accessible lavatory. Remodel restroom as needed. | <p>PCODE WD01 ADAAG 91 4.19.3 ADA 2010 606.2 CBC 2007 1115B.4.3 CBC 2016 11B-606.2, 11B-606.6</p> <p>Priority 3 Severity 2</p> <p>Mitigation Project: Launch Ramp Restrooms</p> <p>Estimated Completion Date: 2018-2019</p> | 1 | JOB | \$3,400 | \$3,400 |

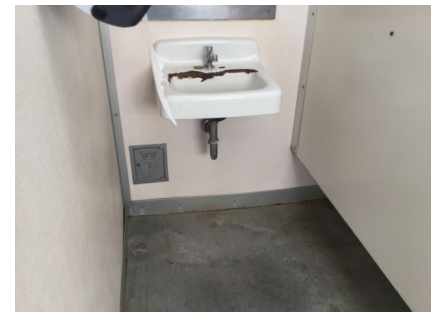
| 816 | <ul style="list-style-type: none"> <i>As-Built Description:</i> Hot or sharp-surfaced water/drain pipe not insulated or covered. <i>Proposed Solution:</i> Insulate or cover water/drain pipe. | <p>PCODE WD05 ADAAG 91 4.19.4 ADA 2010 606.5 CBC 2007 1115B.4.3.4 CBC 2016 11B-606.5</p> <p>Priority 3 Severity 3</p> <p>Mitigation Project: Launch Ramp Restrooms</p> <p>Estimated Completion Date: 2018-2019</p> | 1 | JOB | \$120 | \$120 |

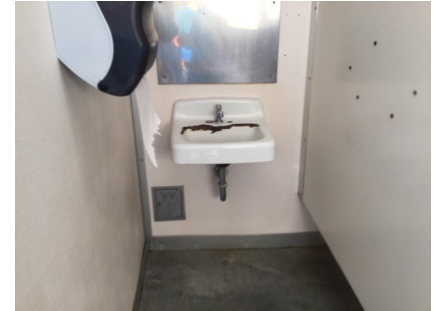
| Item No. and Name | Existing Architectural Barrier and Proposed Solution | Codes / Mitigation Info | Qty | Unit | Cost | Total |
|---|--|--|---|---|---|---|
| 820 | <ul style="list-style-type: none"> <i>As-Built Description:</i> Lavatory: Self-closing faucet at accessible lavatory does not remain open for at least 10 seconds. <i>As-Built:</i> 5 seconds <i>Proposed Solution:</i> Adjust self-closing faucet at accessible lavatory. | PCODE WD07 ADAAG 91 4.19.5 ADA 2010 606.4 CBC 2007 1115B.4.3 CBC 2016 11B-606.4 Priority 3 Severity 3 Mitigation Project: <i>Launch Ramp Restrooms</i> Estimated Completion Date: <i>2018-2019</i> | 1 | JOB | \$50 | \$50 |

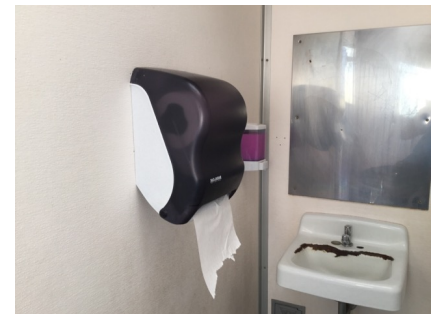
| 818 | <ul style="list-style-type: none"> <i>As-Built Description:</i> Dispensers in sanitary facilities, such as for towels, soap, sanitary napkins, seat covers, etc., and waste receptacles more than 48" (CA only: 40") from floor to highest operating slot or control. <i>As-Built:</i> SD: 47" high SCD: 57" high <i>Proposed Solution:</i> Relocate existing restroom accessories. | PCODE WG01A ADAAG 91 4.23.7 ADA 2010 308.2.1 CBC 2007 1115B.8.3 CBC 2016 11B-603.5 Priority 3 Severity 2 Mitigation Project: <i>Launch Ramp Restrooms</i> Estimated Completion Date: <i>2018-2019</i> | 1 | JOB | \$100 | \$100 |

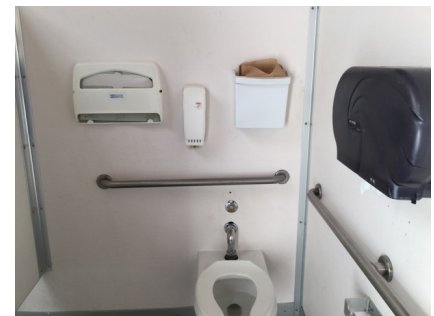
| 825 | <ul style="list-style-type: none"> <i>As-Built Description:</i> Dispensers in sanitary facilities, such as for towels, soap, sanitary napkins, seat covers, etc., and waste receptacles more than 48" (CA only: 40") from floor to highest operating slot or control. <i>As-Built:</i> FHD: 55" high <i>Proposed Solution:</i> Relocate existing restroom accessories. | PCODE WG01A ADAAG 91 4.23.7 ADA 2010 308.2.1 CBC 2007 1115B.8.3 CBC 2016 11B-603.5 Priority 3 Severity 2 Mitigation Project: <i>Launch Ramp Restrooms</i> Estimated Completion Date: <i>2018-2019</i> | 1 | JOB | \$100 | \$100 |

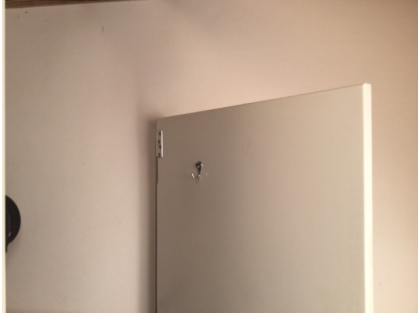
| Item No. and Name | Existing Architectural Barrier and Proposed Solution | Codes / Mitigation Info | Qty | Unit | Cost | Total |
|---|---|---|---|---|---|---|
| 823 | <ul style="list-style-type: none"> • <i>As-Built Description:</i> Accessible coat hook not within reach range. • <i>As-Built:</i> 60.5" high CH • <i>Proposed Solution:</i> Adjust existing or provide new coat hook at maximum 48" height. | <p><i>PCODE</i> WG03A</p> <p><i>ADAAG 91</i> 4.2.5</p> <p><i>ADA 2010</i> 603.4</p> <p><i>CBC 2007</i> 1118B.5</p> <p><i>CBC 2016</i> 11B-603.4</p> <p>Priority 3</p> <p>Severity 2</p> <p><u>Mitigation Project:</u> <i>Launch Ramp Restrooms</i></p> <p><u>Estimated Completion Date:</u> <i>2018-2019</i></p> | 1 | JOB | \$50 | \$50 |

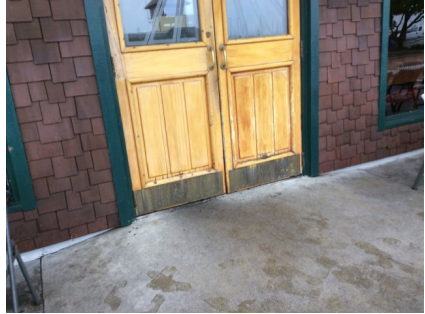
| <p>25</p> <ul style="list-style-type: none"> • <i>As-Built Description:</i> Surface of required maneuvering clearance at door slopes more than 1/4":12" (2.0%). • <i>As-Built:</i> 8.3% • <i>Proposed Solution:</i> Modify surface slope at door. • <i>Notes:</i> Reduce slope and provide automatic door opener | <p><i>PCODE</i> ID11 ADAAG 91 4.13.6 ADA 2010 404.2.4.4 CBC 2007 1133B.2.4 CBC 2016 11B-404.2.4</p> <p>Priority 1 Severity 2</p> | <p>48 SF \$40 \$1,920</p> | |

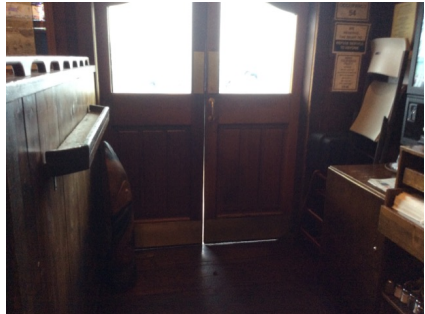
| <p>32</p> <ul style="list-style-type: none"> • <i>As-Built Description:</i> Excessive force required to open door. • <i>As-Built:</i> 10 lbs • <i>Proposed Solution:</i> Adjust regular door closer to accessible standards (5 lbs. max). | <p><i>PCODE</i> ID03 ADAAG 91 4.13.11 ADA 2010 404.2.9 CBC 2007 1133B.2.5 CBC 2016 11B-404.2.9</p> <p>Priority 1 Severity 4</p> | <p>1 JOB \$25 \$25</p> | |

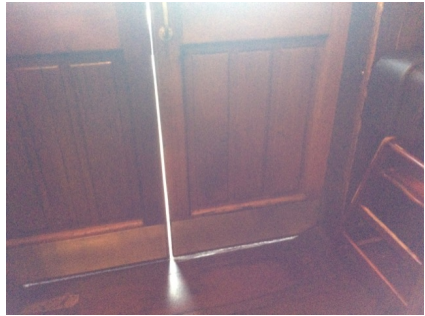
| <p>31</p> <ul style="list-style-type: none"> • <i>As-Built Description:</i> Pair of doors on accessible route has less than 32" clear opening width with one leaf open 90°. • <i>As-Built:</i> 28.5" wide • <i>Proposed Solution:</i> Provide new door leaves, unequal in width, to existing frame for pair of doors. | <p><i>PCODE</i> ID08A ADAAG 91 4.13.4 ADA 2010 404.2.2 CBC 2007 1133B.2.3.1 CBC 2016 11B-404.2.2</p> <p>Priority 1 Severity 3</p> | <p>1 JOB \$1,500 \$1,500</p> | |

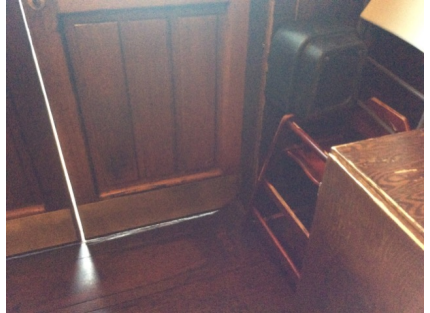
| Item No. and Name | Existing Architectural Barrier and Proposed Solution | Codes / Mitigation Info | Qty | Unit | Cost | Total |
|---|--|--|---|---|---|---|
| 30 | <ul style="list-style-type: none"> <i>As-Built Description:</i> Front approach: At push side, door does not have clear and level maneuvering space measuring door width x 48" (door width plus 12" if door has both, latch and closer). <i>As-Built:</i> Casework 4" in clear space <i>Proposed Solution:</i> Remove or relocate furniture or storage items. | PCODE ID24A ADAAG 91 Fig. 25(a) ADA 2010 404.2.4 CBC 2007 11B-26A(a) CBC 2016 11B-404.2.4 Priority 1 Severity 4 | 1 | JOB | \$50 | \$50 |

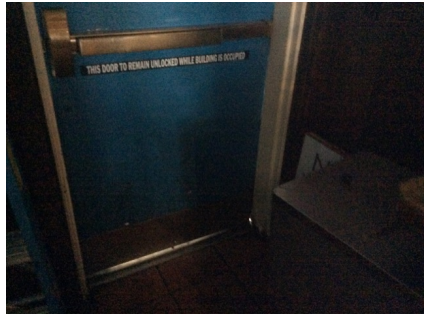
| Item No. and Name | Existing Architectural Barrier and Proposed Solution | Codes / Mitigation Info | Qty | Unit | Cost | Total |
|---|--|--|---|---|---|---|
| 49 | <ul style="list-style-type: none"> <i>As-Built Description:</i> Front approach: At push side, door does not have clear and level maneuvering space measuring door width x 48" (door width plus 12" if door has both, latch and closer). <i>As-Built:</i> Bin and counter at rear exit <i>Proposed Solution:</i> Remove or relocate furniture or storage items. | PCODE ID24A ADAAG 91 Fig. 25(a) ADA 2010 404.2.4 CBC 2007 11B-26A(a) CBC 2016 11B-404.2.4 Priority 1 Severity 4 | 1 | JOB | \$50 | \$50 |

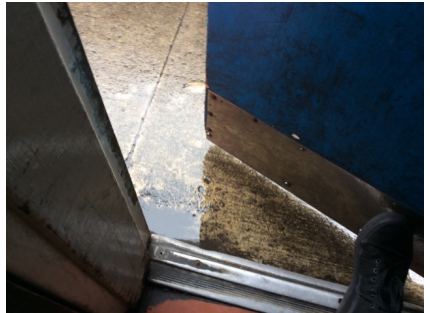
| Item No. and Name | Existing Architectural Barrier and Proposed Solution | Codes / Mitigation Info | Qty | Unit | Cost | Total |
|---|--|--|---|---|---|---|
| 50 | <ul style="list-style-type: none"> <i>As-Built Description:</i> Door inaccessible due to threshold or step at door exceeding 1/2". <i>As-Built:</i> 2" threshold <i>Proposed Solution:</i> Modify threshold to be no more than 1/2" by removing existing paving at door and providing landing with edge ramping (slope 1:20 max). | PCODE ID02A ADAAG 91 4.13.8 ADA 2010 404.2.5 CBC 2007 1133B.2.4.1 CBC 2016 11B-404.2.5 Priority 1 Severity 2 | 1 | JOB | \$400 | \$400 |

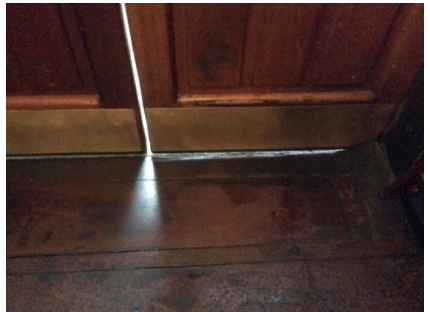
| Item No. and Name | Existing Architectural Barrier and Proposed Solution | Codes / Mitigation Info | Qty | Unit | Cost | Total |
|---|--|--|---|---|---|---|
| 26 | <ul style="list-style-type: none"> <i>As-Built Description:</i> Existing threshold at door is 1/2" high or less but without a beveled edge on both sides. <i>As-Built:</i> 3" level change with severe slope 19.6% <i>Proposed Solution:</i> Modify threshold to have beveled edge on each side. | PCODE ID02NT ADAAG 91 4.1.6(3)(d)(ii) ADA 2010 404.2.5 CBC 2007 1133B.2.4.1 CBC 2016 11B-404.2.5 Priority 1 Severity 1 | 1 | JOB | \$250 | \$250 |

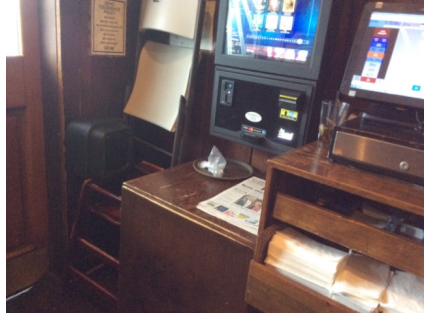
| Item No. and Name | Existing Architectural Barrier and Proposed Solution | Codes / Mitigation Info | Qty | Unit | Cost | Total |
|---|--|--|---|---|---|---|
| 28 | <ul style="list-style-type: none"> <i>As-Built Description:</i> Reach height to control or access point, where side approach is available, exceeds 48" or is less than 15" in height, or exceeds 10" in depth. <i>As-Built:</i> Juke box: 64" high and 16" deep <i>Proposed Solution:</i> Modify equipment or mounting. | <p><i>PCODE</i> IE02</p> <p>ADAAG 91 4.2.6</p> <p>ADA 2010 308.3.1</p> <p>CBC 2007 1118B.6</p> <p>CBC 2016 11B-308.3</p> <p>Priority 1</p> <p>Severity 2</p> | 1 | JOB | \$100 | \$100 |

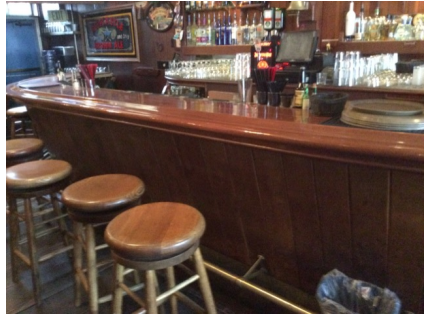
| Item No. and Name | Existing Architectural Barrier and Proposed Solution | Codes / Mitigation Info | Qty | Unit | Cost | Total |
|---|--|--|---|---|---|---|
| 34 | <ul style="list-style-type: none"> <i>As-Built Description:</i> Accessible fixed table or desk (top 28" to 34" high; knee space at least 27" high x 19" deep x 30" wide) not provided. <i>As-Built:</i> 43.5" high dining surface at bar <i>Proposed Solution:</i> Provide new fixed accessible table or desk. Notes: 11 seats Require at least 1 accessible seat at bar counter | <p><i>PCODE</i> IN02</p> <p>ADAAG 91 4.32.3 & .4</p> <p>ADA 2010 306.1 & 902.3</p> <p>CBC 2007 1122B.3 & 4</p> <p>CBC 2016 11B-306.1 & 11B-902.3</p> <p>Priority 1</p> <p>Severity 3</p> | 1 | JOB | \$2,500 | \$2,500 |

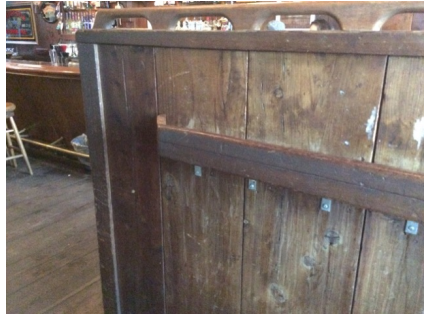
| Item No. and Name | Existing Architectural Barrier and Proposed Solution | Codes / Mitigation Info | Qty | Unit | Cost | Total |
|---|--|--|---|---|---|---|
| 29 | <ul style="list-style-type: none"> <i>As-Built Description:</i> Accessible non-fixed table or desk (top 28" to 34" high; knee space at least 27" high x 19" deep x 30" wide) not provided. <i>As-Built:</i> Drink shelf: 47.5" high <i>Proposed Solution:</i> Provide table or desk with accessible dimensions when purchasing new furniture. Notes: Verify if shelf is intended for drinks which classifies it as a dining surface and must be mounted between 28" to 34". | <p><i>PCODE</i> IN02A</p> <p>ADAAG 91 4.32.3 & .4</p> <p>ADA 2010 306.1</p> <p>CBC 2007 1122B.3 & 4</p> <p>CBC 2016 11B-306.1 & 11B-902.3</p> <p>Priority 1</p> <p>Severity 2</p> | 1 | JOB | \$1,600 | \$1,600 |

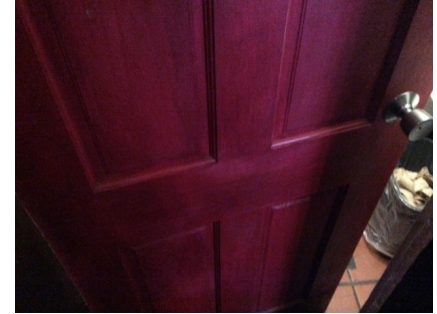
- 39
- *As-Built Description:*
Door does not have accessible operating hardware.
 - *Proposed Solution:*
Provide lever handle or other accessible hardware.

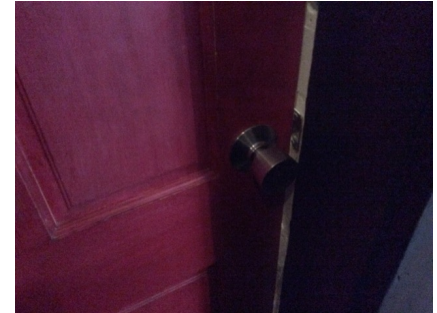
- 37
- *As-Built Description:*
Latch approach: At push side, door does not have clear and level maneuvering space measuring door width plus 24" (starting at hinge) x 42", or 48" if door has closer.
 - *As-Built:* **38"-39" from door to wall**
 - *Proposed Solution:*
Provide relocated new door and frame; remodel walls as needed.

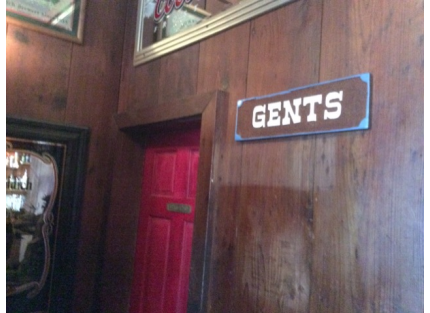
| Item No. and Name | Existing Architectural Barrier and Proposed Solution | Codes / Mitigation Info | Qty | Unit | Cost | Total |
|---|---|---|---|---|---|---|
| 35 | <ul style="list-style-type: none"> <i>As-Built Description:</i> Entrance to toilet or bathing facility not identified with ADAAG compliant signage. <i>Proposed Solution:</i> Provide ADAAG compliant sign mounted 5' high on center on nearest adjacent wall, on latch side of a single door (located not to cause a Braille reader to stand within the door swing). | PCODE SA11A ADAAG 91 4.1.3(16)(a) ADA 2010 216.8 CBC 2016 11B-216.8 Priority 3 Severity 3 | 1 | JOB | \$90 | \$90 |

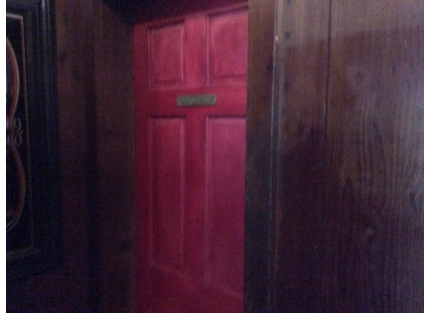
| Item No. and Name | Existing Architectural Barrier and Proposed Solution | Codes / Mitigation Info | Qty | Unit | Cost | Total |
|---|---|---|---|---|---|---|
| 36 | <ul style="list-style-type: none"> <i>As-Built Description:</i> Required in CA only: identification symbol centered 58" to 60" high on sanitary facility door that contrasts with the door not provided (women: 12" ø circle, men: 12" triangle, unisex: combined symbol). <i>Proposed Solution:</i> Provide properly mounted sanitary facility symbol when altering area. If wheelchair accessible, include International Symbol of Accessibility on sign. | PCODE SA15 CBC 2007 1115B.6 CBC 2016 11B-703.7.2.6 Priority 3 Severity 3 | 1 | JOB | \$90 | \$90 |

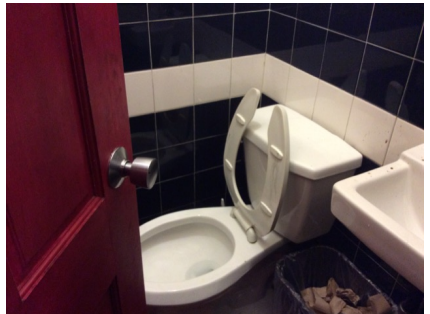
| Item No. and Name | Existing Architectural Barrier and Proposed Solution | Codes / Mitigation Info | Qty | Unit | Cost | Total |
|---|---|---|---|---|---|---|
| 38 | <ul style="list-style-type: none"> <i>As-Built Description:</i> Single accommodation restroom not accessible; multiple compliance violations. <i>Proposed Solution:</i> Remodel area to provide single-occupant accessible restroom. Notes: Remodel restroom and provide one unisex restroom. | PCODE WA01 ADAAG 91 4.22 ADA 2010 603.1 CBC 2007 1115B.3.2 CBC 2016 11B-603.1 Priority 3 Severity 2 | 1 | JOB | \$30,000 | \$30,000 |

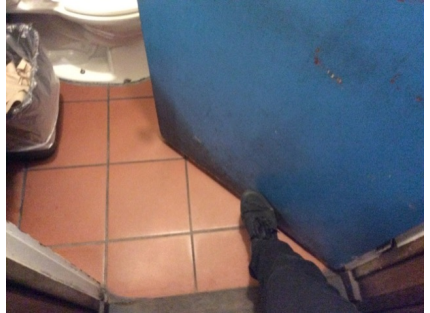
| Item No. and Name | Existing Architectural Barrier and Proposed Solution | Codes / Mitigation Info | Qty | Unit | Cost | Total |
|---|--|--|---|---|---|---|
| 47 | <ul style="list-style-type: none"> <i>As-Built Description:</i> Door on accessible route has less than 32" clear and 80" (78" min. to closer if provided) opening width when 90° open. <i>As-Built:</i> 30" wide and door does not fully open <i>Proposed Solution:</i> Provide new, larger door and frame with new accessible hardware. | <p><i>PCODE</i> ID01REF</p> <p><i>ADAAG 91</i> 4.13.5</p> <p><i>ADA 2010</i> 404.2.3</p> <p><i>CBC 2007</i> 1133B.1.1.1.1</p> <p><i>CBC 2016</i> 11B-404.2.3</p> <p>Priority 3</p> <p>Severity 3</p> | | | | |

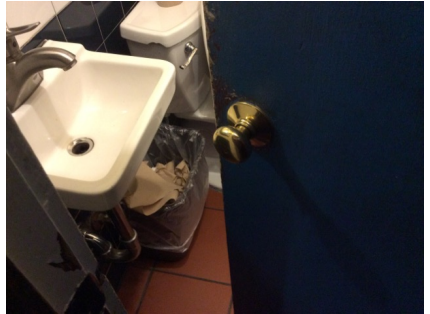
| Item No. and Name | Existing Architectural Barrier and Proposed Solution | Codes / Mitigation Info | Qty | Unit | Cost | Total |
|---|--|--|---|---|---|---|
| 45 | <ul style="list-style-type: none"> <i>As-Built Description:</i> Door does not have accessible operating hardware. <i>Proposed Solution:</i> Provide lever handle or other accessible hardware. | <p><i>PCODE</i> ID07</p> <p><i>ADAAG 91</i> 4.13.9</p> <p><i>ADA 2010</i> 404.2.7</p> <p><i>CBC 2007</i> 1133B.2.5.2</p> <p><i>CBC 2016</i> 11B-404.2.7</p> <p>Priority 3</p> <p>Severity 3</p> | 1 | JOB | \$250 | \$250 |

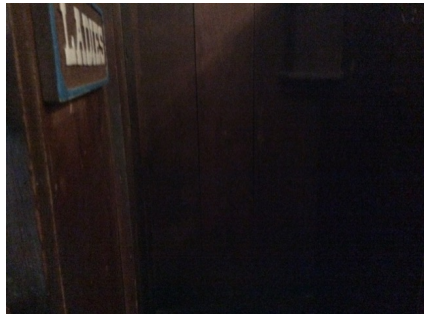
| Item No. and Name | Existing Architectural Barrier and Proposed Solution | Codes / Mitigation Info | Qty | Unit | Cost | Total |
|---|--|--|---|---|---|---|
| 43 | <ul style="list-style-type: none"> <i>As-Built Description:</i> Latch approach: At push side, door does not have clear and level maneuvering space measuring door width plus 24" (starting at hinge) x 42", or 48" if door has closer. <i>Proposed Solution:</i> Provide relocated new door and frame; remodel walls as needed. | <p><i>PCODE</i> ID28B</p> <p><i>ADAAG 91</i> Fig. 25(c)</p> <p><i>ADA 2010</i> 404.2.4</p> <p><i>CBC 2007</i> 11B-26A(c)</p> <p><i>CBC 2016</i> 11B-404.2.4</p> <p>Priority 3</p> <p>Severity 4</p> | 1 | JOB | \$2,600 | \$2,600 |

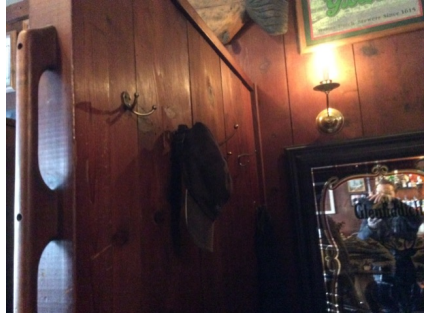
| Item No. and Name | Existing Architectural Barrier and Proposed Solution | Codes / Mitigation Info | Qty | Unit | Cost | Total |
|---|---|--|---|---|---|---|
| 44 | <ul style="list-style-type: none"> <i>As-Built Description:</i> Reach height to control or access point, exceeds 48" or is less than 15". <i>As-Built:</i> CHs: 74" high <i>Proposed Solution:</i> Modify equipment or mounting. | <p><i>PCODE</i> IE01 <i>ADAAG 91</i> 4.2.5 <i>ADA 2010</i> 308.2.1 <i>CBC 2007</i> 1118B.5 <i>CBC 2016</i> 11B-308.2.1</p> <p>Priority 3 Severity 1</p> | 1 | JOB | \$100 | \$100 |

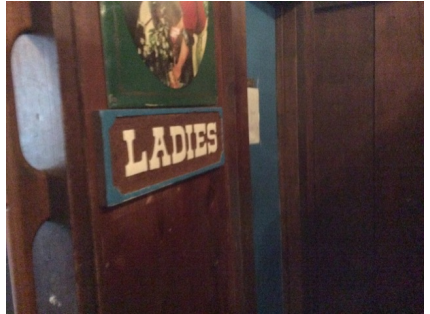
| Item No. and Name | Existing Architectural Barrier and Proposed Solution | Codes / Mitigation Info | Qty | Unit | Cost | Total |
|---|---|--|---|---|---|---|
| 41 | <ul style="list-style-type: none"> <i>As-Built Description:</i> Entrance to toilet or bathing facility not identified with ADAAG compliant signage. <i>Proposed Solution:</i> Provide ADAAG compliant sign mounted 5' high on center on nearest adjacent wall, on latch side of a single door (located not to cause a Braille reader to stand within the door swing). | <p><i>PCODE</i> SA11A <i>ADAAG 91</i> 4.1.3(16)(a) <i>ADA 2010</i> 216.8 <i>CBC 2016</i> 11B-216.8</p> <p>Priority 3 Severity 3</p> | 1 | JOB | \$90 | \$90 |

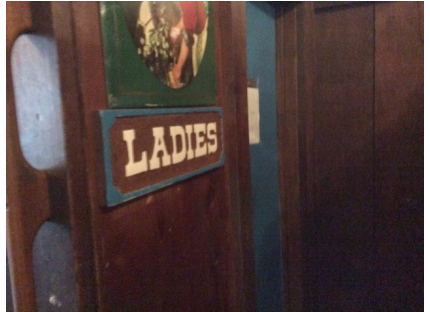
| Item No. and Name | Existing Architectural Barrier and Proposed Solution | Codes / Mitigation Info | Qty | Unit | Cost | Total |
|---|---|--|---|---|---|---|
| 42 | <ul style="list-style-type: none"> <i>As-Built Description:</i> Required in CA only: identification symbol centered 58" to 60" high on sanitary facility door that contrasts with the door not provided (women: 12" ø circle, men: 12" triangle, unisex: combined symbol). <i>Proposed Solution:</i> Provide properly mounted sanitary facility symbol when altering area. If wheelchair accessible, include International Symbol of Accessibility on sign. | <p><i>PCODE</i> SA15 <i>CBC 2007</i> 1115B.6 <i>CBC 2016</i> 11B-703.7.2.6</p> <p>Priority 3 Severity 3</p> | 1 | JOB | \$90 | \$90 |

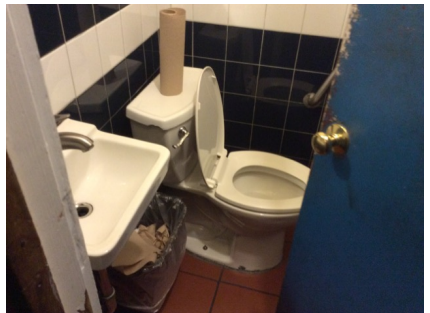
| Item No. and Name | Existing Architectural Barrier and Proposed Solution | Codes / Mitigation Info | Qty | Unit | Cost | Total |
|---|---|--|---|---|---|---|
| 46 | <ul style="list-style-type: none"> <i>As-Built Description:</i> Single accommodation restroom not accessible; multiple compliance violations. <i>Proposed Solution:</i> Remodel area to provide single-occupant accessible restroom. Notes: Modify current Men's restroom to an accessible unisex restroom by demolish existing Women's restroom. | <p><i>PCODE</i> WA01REF <i>ADAAG 91</i> 4.22 <i>ADA 2010</i> 603.1 <i>CBC 2007</i> 1115B.3.2 <i>CBC 2016</i> 11B-603.1</p> <p>Priority 3 Severity 2</p> | REF | | | |

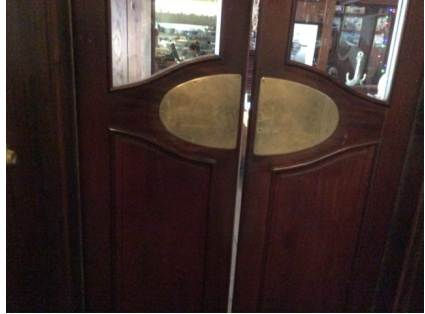
| 52 | <ul style="list-style-type: none"> • <i>As-Built Description:</i> Vision Light at door that permits viewing, does not have bottom of at least one glazed panel located 43 inches maximum above the finish floor. (Exception: More than 66" above finished floor.) • <i>As-Built:</i> 51" high • <i>Proposed Solution:</i> Provide new door with vision panel at 43" max. | <p><i>PCODE</i> ID06C <i>ADA 2010</i> 404.2.11 <i>CBC 2016</i> 11B-404.2.11</p> <p><i>Priority</i> 2 <i>Severity</i> 3</p> | 1 | JOB | \$2,500 | \$2,500 |

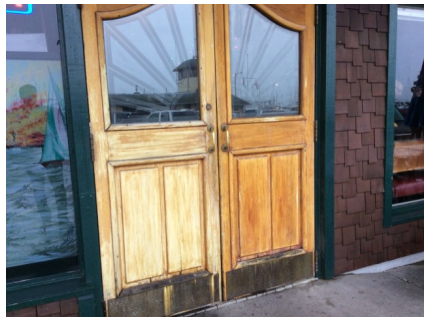
| 54 | <ul style="list-style-type: none"> • <i>As-Built Description:</i> Vision Light at door that permits viewing, does not have bottom of at least one glazed panel located 43 inches maximum above the finish floor. (Exception: More than 66" above finished floor.) • <i>As-Built:</i> Both bar and restaurant entrance 51" high • <i>Proposed Solution:</i> Provide new door with vision panel at 43" max. | <p><i>PCODE</i> ID06C <i>ADA 2010</i> 404.2.11 <i>CBC 2016</i> 11B-404.2.11</p> <p><i>Priority</i> 2 <i>Severity</i> 3</p> | 4 | JOB | \$2,500 | \$10,000 |

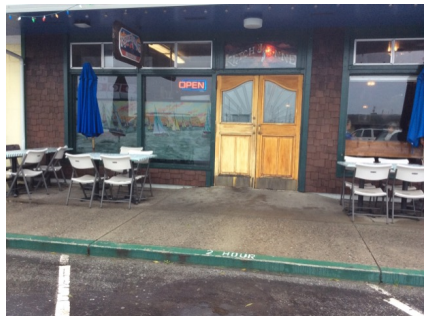
| 53 | <ul style="list-style-type: none"> • <i>As-Built Description:</i> Surface of required maneuvering clearance at door slopes more than 1/4":12" (2.0%). • <i>As-Built:</i> 7.2% • <i>Proposed Solution:</i> Modify surface slope at door. | <p><i>PCODE</i> ID11 <i>ADAAG 91</i> 4.13.6 <i>ADA 2010</i> 404.2.4.4 <i>CBC 2007</i> 1133B.2.4 <i>CBC 2016</i> 11B-404.2.4</p> <p><i>Priority</i> 2 <i>Severity</i> 2</p> | 48 | SF | \$40 | \$1,920 |

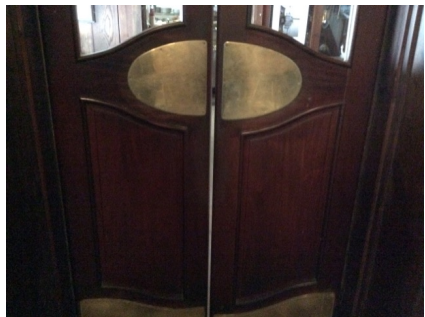
| 51 | <ul style="list-style-type: none"> • <i>As-Built Description:</i> Pair of doors on accessible route has less than 32" clear opening width with one leaf open 90°. • <i>As-Built:</i> 22" wide • <i>Proposed Solution:</i> Provide new door leaves, unequal in width, to existing frame for pair of doors. | <p><i>PCODE</i> ID08A <i>ADAAG 91</i> 4.13.4 <i>ADA 2010</i> 404.2.2 <i>CBC 2007</i> 1133B.2.3.1 <i>CBC 2016</i> 11B-404.2.2</p> <p><i>Priority</i> 2 <i>Severity</i> 1</p> | 1 | JOB | \$1,500 | \$1,500 |

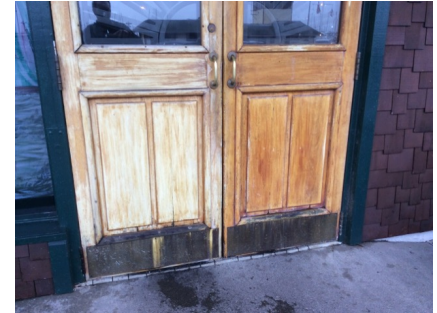
| Item No. and Name | Existing Architectural Barrier and Proposed Solution | Codes / Mitigation Info | Qty | Unit | Cost | Total |
|---|--|--|---|---|---|---|
| 56 | <ul style="list-style-type: none"> <i>As-Built Description:</i> Pair of doors on accessible route has less than 32" clear opening width with one leaf open 90°. <i>As-Built:</i> 28.75" wide <i>Proposed Solution:</i> Provide new door leaves, unequal in width, to existing frame for pair of doors. | PCODE ID08A ADAAG 91 4.13.4 ADA 2010 404.2.2 CBC 2007 1133B.2.3.1 CBC 2016 11B-404.2.2 Priority 2 Severity 3 | 1 | JOB | \$1,500 | \$1,500 |

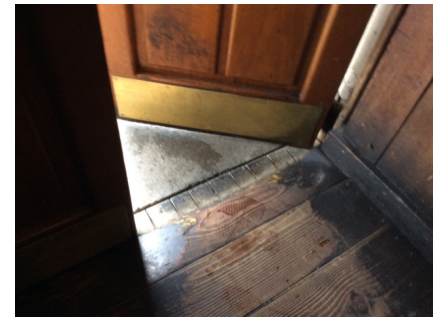
| 58 | <ul style="list-style-type: none"> <i>As-Built Description:</i> Door inaccessible due to threshold or step at door exceeding 1/2". <i>As-Built:</i> 3" bevel with 19% slope on inside <i>Proposed Solution:</i> Modify threshold to be no more than 1/2" by removing existing paving at door and providing landing with edge ramping (slope 1:20 max). | PCODE ID02ANT ADAAG 91 4.13.8 ADA 2010 404.2.5 CBC 2007 1133B.2.4.1 CBC 2016 11B-404.2.5 Priority 2 Severity 1 | 1 | JOB | \$400 | \$400 |

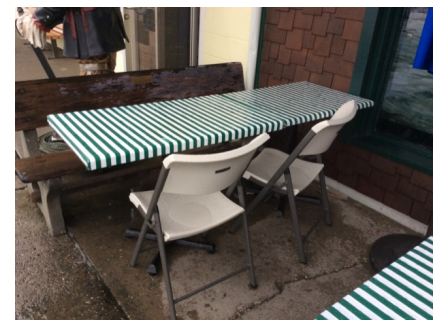
| 55 | <ul style="list-style-type: none"> <i>As-Built Description:</i> Accessible non-fixed table or desk (top 28" to 34" high; knee space at least 27" high x 19" deep x 30" wide) not provided. <i>As-Built:</i> All tables not accessible due to table legs <i>Proposed Solution:</i> Provide table or desk with accessible dimensions when purchasing new furniture. Notes: <p>Outdoor tables</p> | PCODE IN02A ADAAG 91 4.32.3 & .4 ADA 2010 306.1 CBC 2007 1122B.3 & 4 CBC 2016 11B-306.1 & 11B-902.3 Priority 2 Severity 2 | 1 | JOB | \$1,600 | \$1,600 |

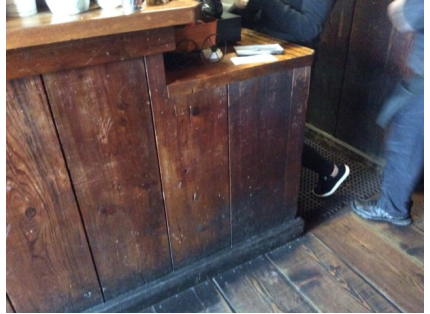
| Item No. and Name | Existing Architectural Barrier and Proposed Solution | Codes / Mitigation Info | Qty | Unit | Cost | Total |
|---|---|--|---|---|---|---|
| 59 | <ul style="list-style-type: none"> <i>As-Built Description:</i> Sales and service counter: Accessible section min. 36" length and 36" max. height (in CA: 28" to 34" high) not provided. <i>As-Built:</i> 26" long and 37" high bar counter <i>Proposed Solution:</i> Provide auxiliary shelf, clipboard, or table as equivalent facilitation. | PCODE IN03 ADAAG 91 7.2(2) ADA 2010 904.4 CBC 2007 1122B.4 CBC 2016 11B-904.4 Priority 2 Severity 4 | 1 | JOB | \$150 | \$150 |

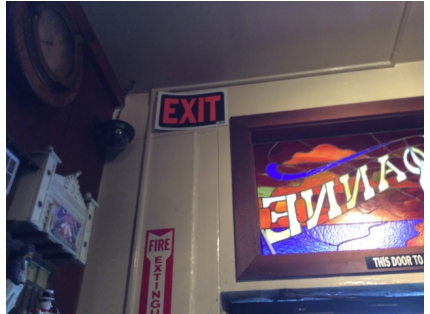
| Item No. and Name | Existing Architectural Barrier and Proposed Solution | Codes / Mitigation Info | Qty | Unit | Cost | Total |
|---|---|--|---|---|---|---|
| 57 | <ul style="list-style-type: none"> <i>As-Built Description:</i> At final exit door to exterior: Where required exit signs are installed, signs to provide exiting information for people with vision impairment are not provided. <i>Proposed Solution:</i> Provide raised letter/Braille "EXIT" sign at door. | PCODE SA10A ADAAG 91 4.1.3(16) ADA 2010 216.4.1 CBC 2007 1011.3 CBC 2016 11B-216.4.1 Priority 2 Severity 3 | 1 | JOB | \$90 | \$90 |

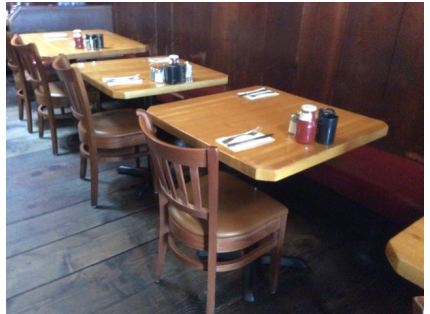
| Item No. and Name | Existing Architectural Barrier and Proposed Solution | Codes / Mitigation Info | Qty | Unit | Cost | Total |
|---|---|--|---|---|---|---|
| 61 | <ul style="list-style-type: none"> <i>As-Built Description:</i> Dining area has less than required number of wheelchair seating spaces; 5% (1 space per 20 seats), not less than one, required. <i>As-Built:</i> Tables do not provide an accessible space due to toe clearance <i>Proposed Solution:</i> Provide wheelchair seating space for dining. Notes: 6 tables for 2 seats 4 tables for 4 seats 28 seats total Require at least 2 accessible spaces | PCODE FC01 ADAAG 91 5.1 ADA 2010 226.1 CBC 2007 1104B.5.4 CBC 2016 11B-226.1 Priority 2 Severity 3 | 2 | JOB | \$100 | \$200 |

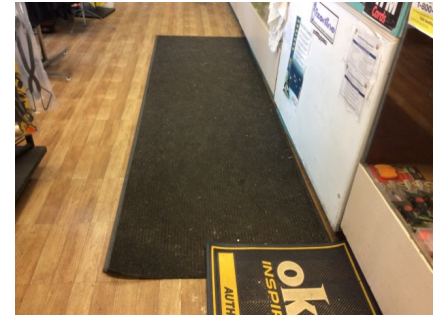
| 67 | <ul style="list-style-type: none"> • <i>As-Built Description:</i> Cross slope more than 1":48" (2.083%). • <i>As-Built:</i> 7.4% due to sunken floor • <i>Proposed Solution:</i> Modify cross slope. | <p>PCODE EF07 ADAAG 91 4.3.7 ADA 2010 403.3 CBC 2007 1133B.7.1.3 CBC 2016 11B-403.3</p> <p>Priority 1 Severity 2</p> | 4 | SF | \$25 | \$100 |

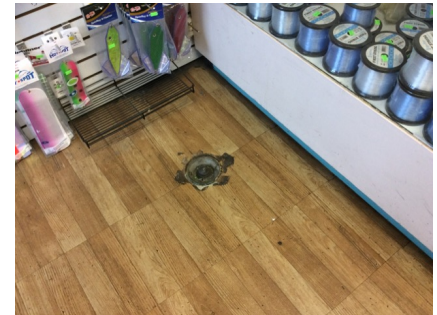
| 69 | <ul style="list-style-type: none"> • <i>As-Built Description:</i> Walk: Grating has grid openings greater than 1/2" along the line of traffic flow. • <i>As-Built:</i> 6" opening • <i>Proposed Solution:</i> Provide new grating, with grid openings 1/2" max. along the line of traffic flow. • Notes: Patch floor | <p>PCODE EF04NT ADAAG 91 4.3.6; 4.5.4 ADA 2010 403.2; 302.3 CBC 2007 1133B.7.2 CBC 2016 11B-403.2; 11B-302.3</p> <p>Priority 1 Severity 2</p> | 1 | SF | \$80 | \$80 |

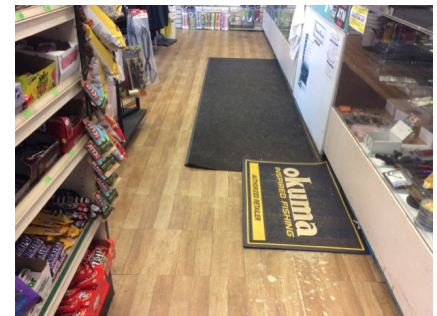
| 70 | <ul style="list-style-type: none"> • <i>As-Built Description:</i> Doormat not securely attached to ground or floor structure. • <i>Proposed Solution:</i> Attach doormat to floor surface or remove doormat. | <p>PCODE ID05A ADAAG 91 4.5.3 ADA 2010 302.2 CBC 2007 1124B.3 CBC 2016 11B-302.2</p> <p>Priority 1 Severity 3</p> | 1 | JOB | \$75 | \$75 |

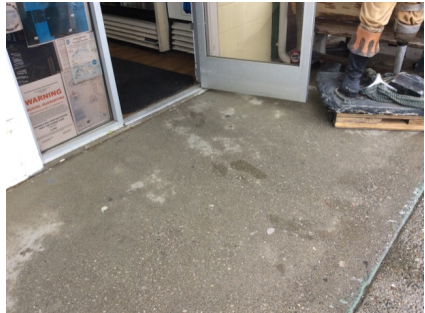
| Item No. and Name | Existing Architectural Barrier and Proposed Solution | Codes / Mitigation Info | Qty | Unit | Cost | Total | |
|---|--|---|--|---|---|---|--|
| 62 | <ul style="list-style-type: none"> <i>As-Built Description:</i> Surface of required maneuvering clearance at door slopes more than 1/4":12" (2.0%). <i>As-Built:</i> 7.4% <i>Proposed Solution:</i> Modify surface slope at door. | <p>PCODE ID11</p> <p>ADAAG 91 4.13.6</p> <p>ADA 2010 404.2.4.4</p> <p>CBC 2007 1133B.2.4</p> <p>CBC 2016 11B-404.2.4</p> <p>Priority 1</p> <p>Severity 2</p> | 48 | SF | \$40 | \$1,920 | |

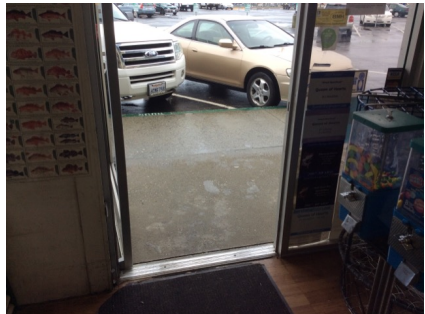
| Item No. and Name | Existing Architectural Barrier and Proposed Solution | Codes / Mitigation Info | Qty | Unit | Cost | Total | |
|---|--|---|--|---|---|---|--|
| 64 | <ul style="list-style-type: none"> <i>As-Built Description:</i> Excessive force required to open door. <i>As-Built:</i> 14 lbs <i>Proposed Solution:</i> Adjust regular door closer to accessible standards (5 lbs. max). | <p>PCODE ID03</p> <p>ADAAG 91 4.13.11</p> <p>ADA 2010 404.2.9</p> <p>CBC 2007 1133B.2.5</p> <p>CBC 2016 11B-404.2.9</p> <p>Priority 1</p> <p>Severity 3</p> | 1 | JOB | \$25 | \$25 | |

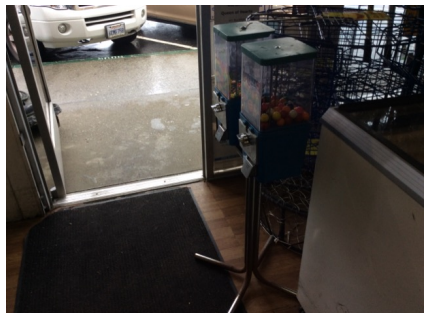
| Item No. and Name | Existing Architectural Barrier and Proposed Solution | Codes / Mitigation Info | Qty | Unit | Cost | Total | |
|---|--|---|--|---|---|---|--|
| 65 | <ul style="list-style-type: none"> <i>As-Built Description:</i> Front approach: At push side, door does not have clear and level maneuvering space measuring door width x 48" (door width plus 12" if door has both, latch and closer). <i>Proposed Solution:</i> Remove or relocate furniture or storage items. Notes: Move gum machine back out of door clearance. Door has no closer. | <p>PCODE ID24AREF</p> <p>ADAAG 91 Fig. 25(a)</p> <p>ADA 2010 404.2.4</p> <p>CBC 2007 11B-26A(a)</p> <p>CBC 2016 11B-404.2.4</p> <p>Priority 1</p> <p>Severity 4</p> | REF | | | | |

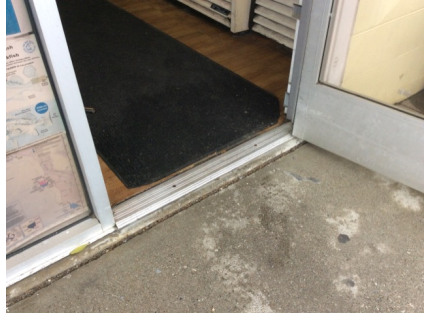
| Item No. and Name | Existing Architectural Barrier and Proposed Solution | Codes / Mitigation Info | Qty | Unit | Cost | Total |
|---|--|--|---|---|---|---|
| 63 | <ul style="list-style-type: none"> <i>As-Built Description:</i> Existing threshold at door is 1/2" high or less but without a beveled edge on both sides. <i>Proposed Solution:</i> Modify threshold to have beveled edge on each side. | <p><i>PCODE</i> ID02REF</p> <p><i>ADAAG 91</i> 4.1.6(3)(d)(ii)</p> <p><i>ADA 2010</i> 404.2.5</p> <p><i>CBC 2007</i> 1133B.2.4.1</p> <p><i>CBC 2016</i> 11B-404.2.5</p> <p>Priority 1</p> <p>Severity 4</p> | | | | |

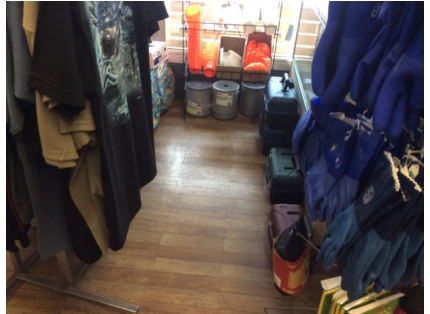
| Item No. and Name | Existing Architectural Barrier and Proposed Solution | Codes / Mitigation Info | Qty | Unit | Cost | Total |
|---|--|--|---|---|---|---|
| 68 | <ul style="list-style-type: none"> <i>As-Built Description:</i> Corridor, for occupant load less than 10, less than 36" wide. <i>As-Built:</i> Due to various items on display <i>Proposed Solution:</i> Remove or relocate furniture and storage items. | <p><i>PCODE</i> IH03A</p> <p><i>ADAAG 91</i> 4.3.3</p> <p><i>ADA 2010</i> 403.5.1</p> <p><i>CBC 2007</i> 1133B.3.1</p> <p><i>CBC 2016</i> 11B-403.5.1</p> <p>Priority 1</p> <p>Severity 4</p> | 1 | JOB | \$50 | \$50 |

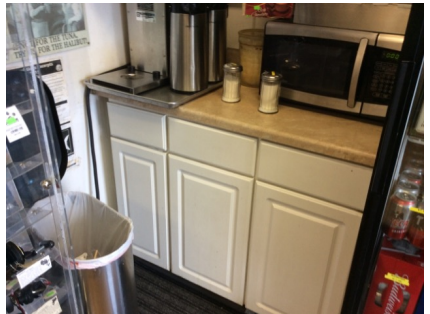
| Item No. and Name | Existing Architectural Barrier and Proposed Solution | Codes / Mitigation Info | Qty | Unit | Cost | Total |
|---|--|--|---|---|---|---|
| 71 | <ul style="list-style-type: none"> <i>As-Built Description:</i> Accessible fixed table or desk (top 28" to 34" high; knee space at least 27" high x 19" deep x 30" wide) not provided. <i>As-Built:</i> 36" high counter <i>Proposed Solution:</i> Provide new fixed accessible table or desk. Notes: Items on counter have generally high reach ranges | <p><i>PCODE</i> IN02</p> <p><i>ADAAG 91</i> 4.32.3 & .4</p> <p><i>ADA 2010</i> 306.1 & 902.3</p> <p><i>CBC 2007</i> 1122B.3 & 4</p> <p><i>CBC 2016</i> 11B-306.1 & 11B-902.3</p> <p>Priority 1</p> <p>Severity 4</p> | 1 | JOB | \$2,500 | \$2,500 |

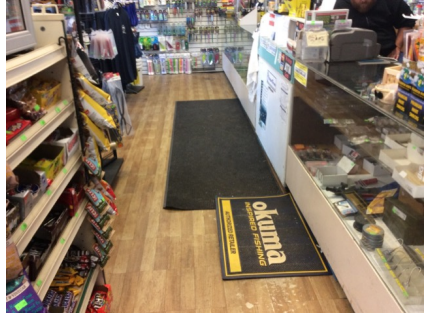
| Item No. and Name | Existing Architectural Barrier and Proposed Solution | Codes / Mitigation Info | Qty | Unit | Cost | Total |
|---|---|---|---|---|---|---|
| 66 | <ul style="list-style-type: none"> • <i>As-Built Description:</i> Sales and service counter: Accessible section min. 36" length and 36" max. height (in CA: 28" to 34" high) not provided. • <i>As-Built:</i> 40" high sales counter • <i>Proposed Solution:</i> Provide auxiliary shelf, clipboard, or table as equivalent facilitation. | <p><i>PCODE</i> IN03 <i>ADAAG 91</i> 7.2(2) <i>ADA 2010</i> 904.4 <i>CBC 2007</i> 1122B.4 <i>CBC 2016</i> 11B-904.4</p> <p>Priority 1 Severity 3</p> | 1 | JOB | \$150 | \$150 |

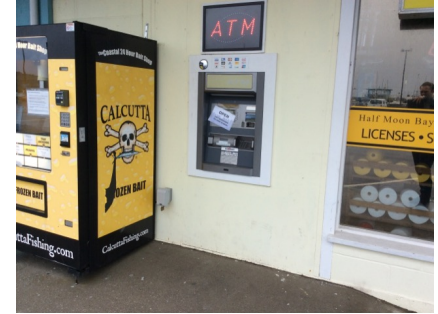
| 72 | <ul style="list-style-type: none"> <i>As-Built Description:</i> Minimum clear floor space of 30" x 48" is not provided for forward or parallel approach to ATM. <i>As-Built:</i> ATM and vending: 5.0-8.1% <i>Proposed Solution:</i> Remove obstruction(s) to provide clear floor space for wheelchair. | <p>PCODE AA02A ADAAG 91 4.34.2 ADA 2010 707.2 CBC 2007 1117B.7.4.1 CBC 2016 11B-707.2</p> <p>Priority 1 Severity 2</p> | 1 | JOB | | |

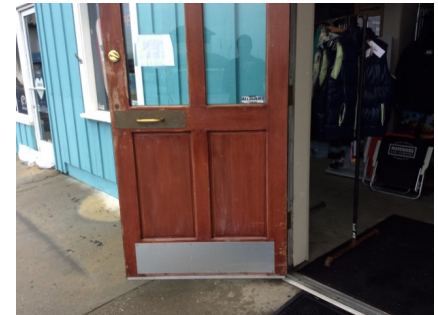
| 75 | <ul style="list-style-type: none"> <i>As-Built Description:</i> Vision Light at door that permits viewing, does not have bottom of at least one glazed panel located 43 inches maximum above the finish floor. (Exception: More than 66" above finished floor.) <i>As-Built:</i> 44" high <i>Proposed Solution:</i> Provide new door with vision panel at 43" max. | <p>PCODE ID06C ADA 2010 404.2.11 CBC 2016 11B-404.2.11</p> <p>Priority 1 Severity 3</p> | 1 | JOB | \$2,500 | \$2,500 |

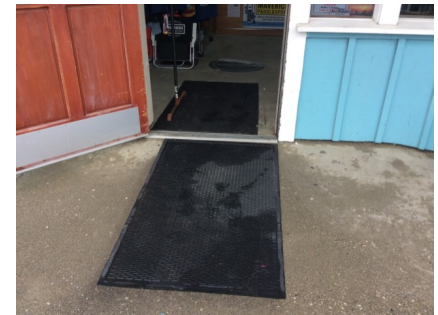
| 74 | <ul style="list-style-type: none"> <i>As-Built Description:</i> Surface of required maneuvering clearance at door slopes more than 1/4":12" (2.0%). <i>As-Built:</i> 8.0% <i>Proposed Solution:</i> Modify surface slope at door. | <p>PCODE ID11 ADAAG 91 4.13.6 ADA 2010 404.2.4.4 CBC 2007 1133B.2.4 CBC 2016 11B-404.2.4</p> <p>Priority 1 Severity 2</p> | 48 | SF | \$40 | \$1,920 |

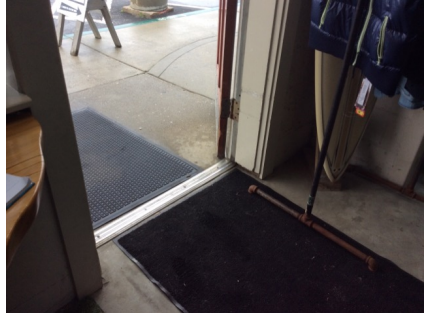
| Item No. and Name | Existing Architectural Barrier and Proposed Solution | Codes / Mitigation Info | Qty | Unit | Cost | Total |
|---|--|--|---|---|---|---|
| 76 | <ul style="list-style-type: none"> <i>As-Built Description:</i> Front approach: At push side, door does not have clear and level maneuvering space measuring door width x 48" (door width plus 12" if door has both, latch and closer). <i>As-Built:</i> Coat rack in maneuvering space <i>Proposed Solution:</i> Remove or relocate furniture or storage items. | <p>PCODE ID24A ADAAG 91 Fig. 25(a) ADA 2010 404.2.4 CBC 2007 11B-26A(a) CBC 2016 11B-404.2.4</p> <p>Priority 1 Severity 4</p> | 1 | JOB | \$50 | \$50 |

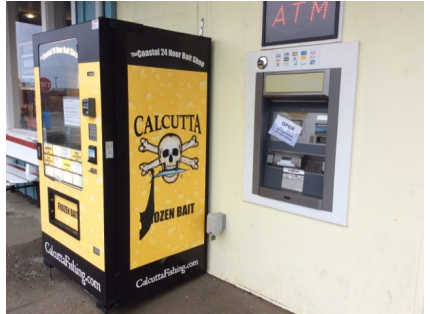
| Item No. and Name | Existing Architectural Barrier and Proposed Solution | Codes / Mitigation Info | Qty | Unit | Cost | Total |
|---|--|--|---|---|---|---|
| 73 | <ul style="list-style-type: none"> <i>As-Built Description:</i> Reach height to control or access point, exceeds 48" or is less than 15". <i>As-Built:</i> ATM: 50" high Vending: 57" high <i>Proposed Solution:</i> Modify equipment or mounting. | <p>PCODE IE01 ADAAG 91 4.2.5 ADA 2010 308.2.1 CBC 2007 1118B.5 CBC 2016 11B-308.2.1</p> <p>Priority 1 Severity 3</p> | 2 | JOB | \$100 | \$200 |

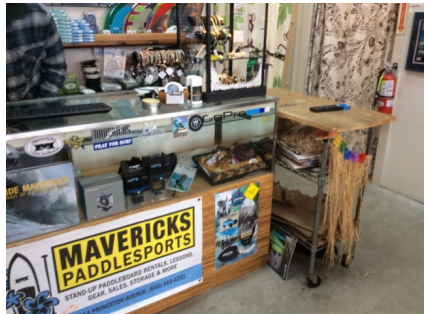
| Item No. and Name | Existing Architectural Barrier and Proposed Solution | Codes / Mitigation Info | Qty | Unit | Cost | Total |
|---|--|--|---|---|---|---|
| 77 | <ul style="list-style-type: none"> <i>As-Built Description:</i> Sales and service counter: Accessible section min. 36" length and 36" max. height (in CA: 28" to 34" high) not provided. <i>As-Built:</i> 40" high sales counter <i>Proposed Solution:</i> Provide auxiliary shelf, clipboard, or table as equivalent facilitation. | <p>PCODE IN03 ADAAG 91 7.2(2) ADA 2010 904.4 CBC 2007 1122B.4 CBC 2016 11B-904.4</p> <p>Priority 1 Severity 3</p> | 1 | JOB | \$150 | \$150 |

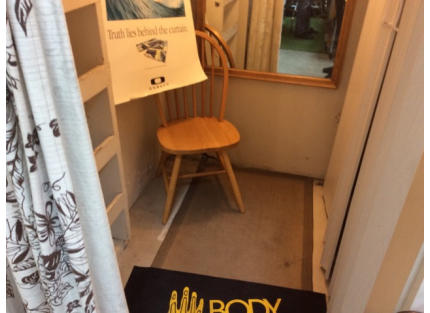
| Item No. and Name | Existing Architectural Barrier and Proposed Solution | Codes / Mitigation Info | Qty | Unit | Cost | Total |
|---|---|--|---|---|---|---|
| 78 | <ul style="list-style-type: none"> <i>As-Built Description:</i> In dressing room a clear floor space measuring 60" x 60" is not provided (ADAAG only: In dressing room with curtained opening a clear floor space of 30" x 48" is not provided; in dressing room with door a 60" diameter circle or T-shape turning space is not provided). <i>As-Built:</i> 38" x 64" dressing room <i>Proposed Solution:</i> Remodel dressing room to provide proper clear floor space. | PCODE RE03 ADAAG 91 4.35.2 ADA 2010 304.1 CBC 2007 1117B.8 CBC 2016 11B-304.1 Priority 3 Severity 3 | 1 | JOB | \$1,500 | \$1,500 |

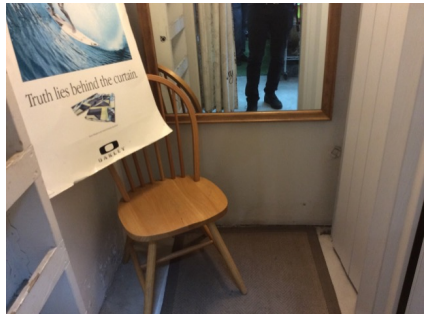
| Item No. and Name | Existing Architectural Barrier and Proposed Solution | Codes / Mitigation Info | Qty | Unit | Cost | Total |
|---|---|--|---|---|---|---|
| 79 | <ul style="list-style-type: none"> <i>As-Built Description:</i> Full-length mirror 18" x 54" not provided in accessible dressing room. Bottom more than 20" above the floor. (CA Only) <i>As-Built:</i> Mirror: 28.5" high <i>Proposed Solution:</i> Provide full-length mirror. <i>Notes:</i> Also no bench provided in dressing room | PCODE RE05 ADAAG 91 4.35.5 CBC 2007 1117B.8 CBC 2016 11B-803.6 Priority 3 Severity 3 | 1 | JOB | \$400 | \$400 |

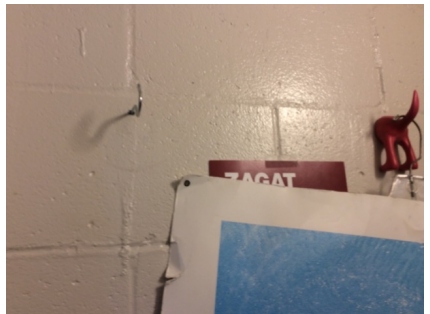
| Item No. and Name | Existing Architectural Barrier and Proposed Solution | Codes / Mitigation Info | Qty | Unit | Cost | Total |
|---|---|--|---|---|---|---|
| 80 | <ul style="list-style-type: none"> <i>As-Built Description:</i> Reach height to control or access point, exceeds 48" or is less than 15". <i>As-Built:</i> CH: 71" high <i>Proposed Solution:</i> Modify equipment or mounting. | PCODE IE01 ADAAG 91 4.2.5 ADA 2010 308.2.1 CBC 2007 1118B.5 CBC 2016 11B-308.2.1 Priority 3 Severity 1 | 1 | JOB | \$100 | \$100 |

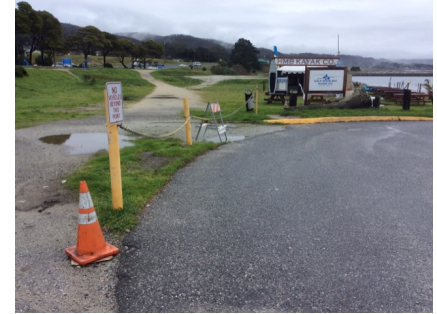
| 81 | <ul style="list-style-type: none"> <i>As-Built Description:</i> Accessible parking space(s) not located close to the nearest possible entrance on an accessible route. <i>As-Built:</i> No nearby accessible parking is provided to Kayak Rental. <i>Proposed Solution:</i> Relocate accessible parking space(s). | <p>PCODE EA06 ADAAG 91 4.6.2 ADA 2010 208.3 CBC 2007 1129B.1 CBC 2016 11B-208.3.1</p> <p>Priority 1 Severity 2</p> | 1 | JOB | \$350 | \$350 |

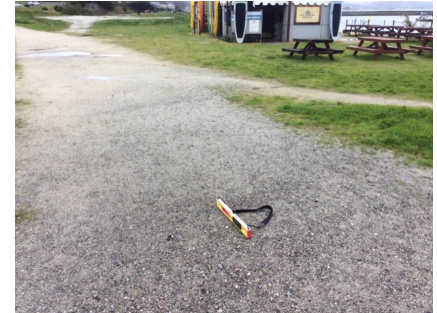
| 84 | <ul style="list-style-type: none"> <i>As-Built Description:</i> Walk: Slope greater than 1:20 (5.0%), and walk does not comply with requirements for ramps. <i>As-Built:</i> 7.1% <i>Proposed Solution:</i> Modify walk/sidewalk slope to 1:20 or less. Notes: Regrade and provide compliant surface | <p>PCODE EF01 ADAAG 91 4.3.7 ADA 2010 403.3 CBC 2007 1133B.7.3 CBC 2016 11B-403.3</p> <p>Priority 1 Severity 4</p> | 400 | SF | \$25 | \$10,000 |

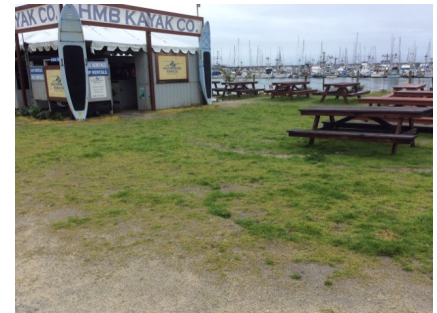
| 85 | <ul style="list-style-type: none"> <i>As-Built Description:</i> Walk: Irregular surface along compacted dirt or decomposed granite pathway. <i>As-Built:</i> Grass <i>Proposed Solution:</i> Regrade and maintain pathway to be even and smooth, provide firm, stable, and slip resistant surface. Notes: Provide complaint walkway to tables and entrance and wash station if used by customers | <p>PCODE EF10C ADAAG 91 4.5.2 ADA 2010 303.1; 302.1 CBC 2007 1133B.7.1 CBC 2016 11B-303.1; 11B-302.1</p> <p>Priority 1 Severity 3</p> | 400 | SF | \$4 | \$1,600 |

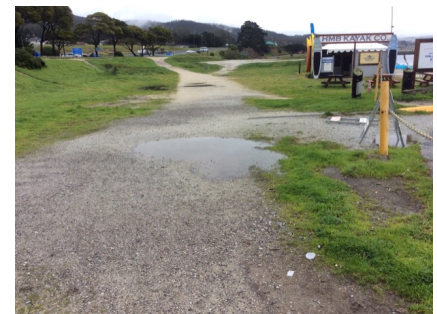
| 83 | <ul style="list-style-type: none"> <i>As-Built Description:</i> Walk: Irregular surface along compacted dirt or decomposed granite pathway. <i>Proposed Solution:</i> Maintain surface of pathway to provide smooth even surface. Notes: Maintain area around Kayak Rental as it serves as connecting paths | <p>PCODE EF10CREF ADAAG 91 4.5.2 ADA 2010 303.1; 302.1 CBC 2007 1133B.7.1 CBC 2016 11B-303.1; 11B-302.1</p> <p>Priority 1 Severity 3</p> | | REF | | |

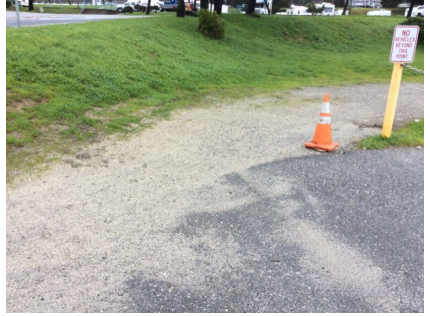
| Item No. and Name | Existing Architectural Barrier and Proposed Solution | Codes / Mitigation Info | Qty | Unit | Cost | Total |
|---|---|--|---|---|---|---|
| 82 | <ul style="list-style-type: none"> <i>As-Built Description:</i> 36" wide band of truncated domes not provided at walkway or crossing adjoining a vehicular way, if surfaces are not separated by a curb, railing, or other element. <i>Proposed Solution:</i> Provide 36" wide, contrasting color, band of truncated domes between pedestrian and vehicular area. | <p>PCODE EG09 ADAAG 91 4.29.5 CBC 2007 1133B.8.5 CBC 2016 11B-705.1.2.5</p> <p>Priority 1 Severity 3</p> | 15 | LF | \$27 | \$405 |

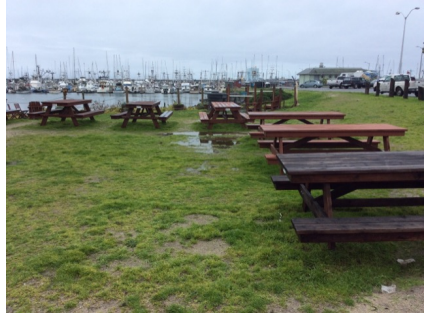
| 86 | <ul style="list-style-type: none"> <i>As-Built Description:</i> Knee clearance at minimums 27" high, 30" wide, and 19" deep is not provided. <i>As-Built:</i> 11" deep <i>Proposed Solution:</i> Modify picnic table as required to provide knee clearance. Notes: 8 tables | <p>PCODE NH11A ADAAG 91 16.5.4. ADA 2010 306.3 CBC 2007 1132B.1 CBC 2016 11B-306.3</p> <p>Priority 1 Severity 2</p> | 1 | JOB | \$850 | \$850 |

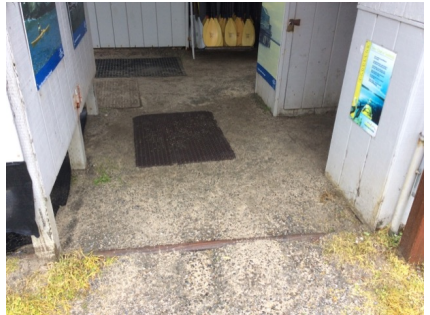
| 87 | <ul style="list-style-type: none"> <i>As-Built Description:</i> Walk: Irregular surface along compacted dirt or decomposed granite pathway. <i>Proposed Solution:</i> Regrade and maintain pathway to be even and smooth, provide firm, stable, and slip resistant surface. | <p>PCODE EF10C ADAAG 91 4.5.2 ADA 2010 303.1; 302.1 CBC 2007 1133B.7.1 CBC 2016 11B-303.1; 11B-302.1</p> <p>Priority 2 Severity 3</p> | 140 | SF | \$4 | \$560 |

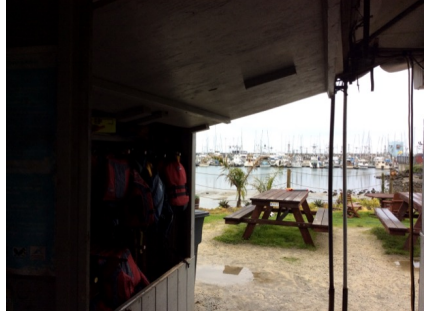
| 91 | <ul style="list-style-type: none"> • <i>As-Built Description:</i> Overhead clearance less than 80" above finished floor. • <i>As-Built:</i> Swing up door: 71"-76" high • <i>Proposed Solution:</i> Modify overhead clearance. • Notes: Remove doors | <p>PCODE EG01 ADAAG 91 4.4.2 ADA 2010 307.4 CBC 2007 1133B.8.6.2 CBC 2016 11B-307.4</p> <p>Priority 2 Severity 2</p> | 2 | JOB | \$100 | \$200 |

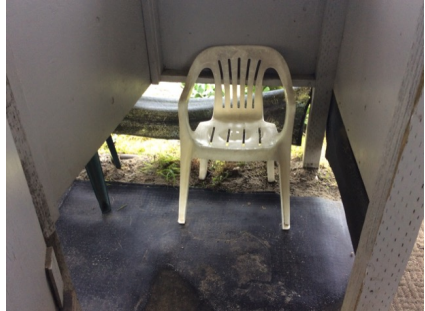
| 88 | <ul style="list-style-type: none"> • <i>As-Built Description:</i> In dressing room a clear floor space measuring 60" x 60" is not provided (ADAAG only: In dressing room with curtained opening a clear floor space of 30" x 48" is not provided; in dressing room with door a 60" diameter circle or T-shape turning space is not provided). • <i>As-Built:</i> 38" x 48" changing room • <i>Proposed Solution:</i> Remodel dressing room to provide proper clear floor space. • Notes: Noncompliant bench provided | <p>PCODE RE03 ADAAG 91 4.35.2 ADA 2010 304.1 CBC 2007 1117B.8 CBC 2016 11B-304.1</p> <p>Priority 2 Severity 3</p> | 1 | JOB | \$1,500 | \$1,500 |

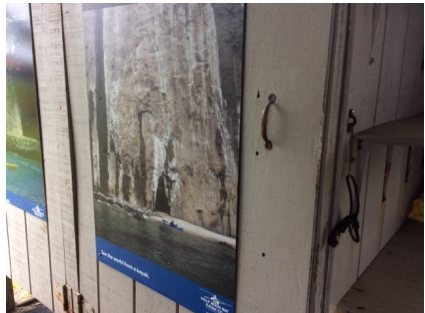
| 89 | <ul style="list-style-type: none"> • <i>As-Built Description:</i> Reach height to control or access point, exceeds 48" or is less than 15". • <i>As-Built:</i> 52" high U-pull • <i>Proposed Solution:</i> Modify equipment or mounting. | <p>PCODE IE01 ADAAG 91 4.2.5 ADA 2010 308.2.1 CBC 2007 1118B.5 CBC 2016 11B-308.2.1</p> <p>Priority 2 Severity 4</p> | 1 | JOB | \$100 | \$100 |

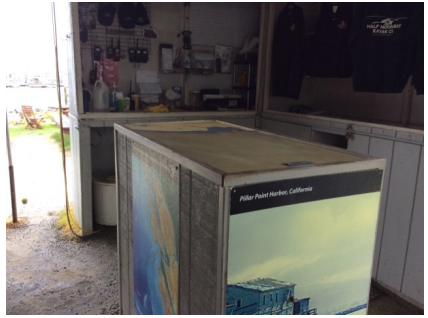
| Item No. and Name | Existing Architectural Barrier and Proposed Solution | Codes / Mitigation Info | Qty | Unit | Cost | Total |
|---|---|---|---|---|---|---|
| 90 | <ul style="list-style-type: none"> <i>As-Built Description:</i> Sales and service counter: Accessible section min. 36" length and 36" max. height (in CA: 28" to 34" high) not provided. <i>As-Built:</i> 47" high counter <i>Proposed Solution:</i> Provide auxiliary shelf, clipboard, or table as equivalent facilitation. | <p><i>PCODE</i> IN03 <i>ADAAG 91</i> 7.2(2) <i>ADA 2010</i> 904.4 <i>CBC 2007</i> 1122B.4 <i>CBC 2016</i> 11B-904.4</p> <p>Priority 2 Severity 3</p> | 1 | JOB | \$150 | \$150 |

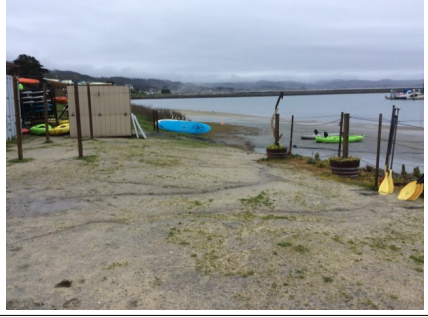
| 92 | <ul style="list-style-type: none"> <i>As-Built Description:</i> Walk: Slope greater than 1:20 (5.0%), and walk does not comply with requirements for ramps. <i>As-Built:</i> 17.7% <i>Proposed Solution:</i> Modify walk/sidewalk slope to 1:20 or less. Notes: And severe cross slopes, irregular surface | <p><i>PCODE</i> EF01 <i>ADAAG 91</i> 4.3.7 <i>ADA 2010</i> 403.3 <i>CBC 2007</i> 1133B.7.3 <i>CBC 2016</i> 11B-403.3</p> <p>Priority 2 Severity 2</p> | 480 | SF | \$25 | \$12,000 |

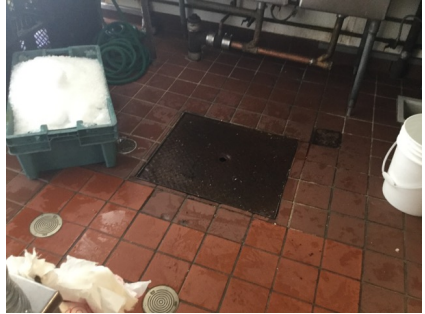
| <p>1076</p> <ul style="list-style-type: none"> <i>As-Built Description:</i> Walk: Pavement dislocation creates abrupt change in level exceeding 1/2" in accessible route. <i>As-Built:</i> Metal grate creates lip in walking area <i>Proposed Solution:</i> Remove, replace or repair area of pavement sufficient to correct abrupt change in level. <i>Notes:</i> Staff Only | <p><i>PCODE</i> EF03 <i>ADAAG 91</i> 4.3.8 <i>ADA 2010</i> 403.4 <i>CBC 2007</i> 1133B.7.4 <i>CBC 2016</i> 11B-403.4</p> <p>Priority 1 Severity 4</p> | <p>4 SF \$21 \$84</p> | |

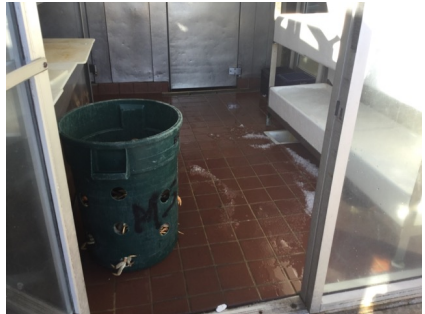
| <p>1074</p> <ul style="list-style-type: none"> <i>As-Built Description:</i> Cross slope more than 1":48" (2.083%). <i>As-Built:</i> Market room is sloped <i>Proposed Solution:</i> Modify cross slope. <i>Notes:</i> Interim solution to provide assistance as needed | <p><i>PCODE</i> EF07REF <i>ADAAG 91</i> 4.3.7 <i>ADA 2010</i> 403.3 <i>CBC 2007</i> 1133B.7.1.3 <i>CBC 2016</i> 11B-403.3</p> <p>Priority 1 Severity 4</p> | <p>REF</p> | |
