SAN MATEO COUNTY HARBOR DISTRICT

ADA Self-Evaluation and Transition Plan

August 2018

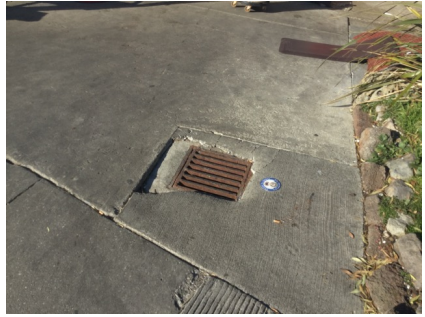
| <p>1072</p> <ul style="list-style-type: none"> <i>As-Built Description:</i> Walk: Grating has grid openings greater than 1/2" along the line of traffic flow. <i>As-Built:</i> 1" openings <i>Proposed Solution:</i> Provide new grating, with grid openings 1/2" max. along the line of traffic flow. | <p><i>PCODE</i> EF04 <i>ADAAG 91</i> 4.3.6; 4.5.4 <i>ADA 2010</i> 403.2; 302.3 <i>CBC 2007</i> 1133B.7.2 <i>CBC 2016</i> 11B-403.2; 11B-302.3</p> <p>Priority 1 Severity 2</p> | <p>2 SF \$80 \$160</p> | |

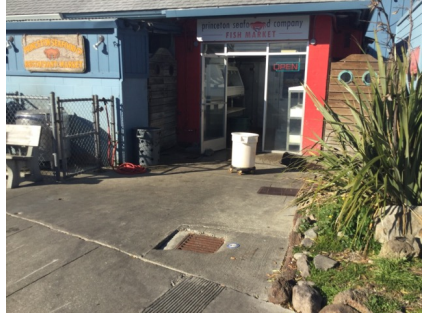
| Item No. and Name | Existing Architectural Barrier and Proposed Solution | Codes / Mitigation Info | Qty | Unit | Cost | Total |
|---|--|---|---|---|---|---|
| 1071 | <ul style="list-style-type: none"> <i>As-Built Description:</i> Walk: Slope greater than 1:20 (5.0%), and walk does not comply with requirements for ramps. <i>As-Built:</i> Sloped on POT to fish market entrance <i>Proposed Solution:</i> Modify walk/sidewalk slope to 1:20 or less. | <p>PCODE EF01REF ADAAG 91 4.3.7 ADA 2010 403.3 CBC 2007 1133B.7.3 CBC 2016 11B-403.3</p> <p>Priority 1 Severity 4</p> | | | | |

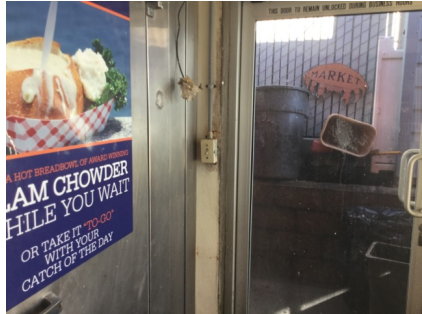
| Item No. and Name | Existing Architectural Barrier and Proposed Solution | Codes / Mitigation Info | Qty | Unit | Cost | Total |
|---|--|---|---|---|---|---|
| 1075 | <ul style="list-style-type: none"> <i>As-Built Description:</i> Electric switch or control mounted less than 15" measured to the bottom of the outlet box or greater than 48 inches measured to the top of the outlet box. <i>As-Built:</i> 52" high light switch <i>Proposed Solution:</i> Relocate light switches or control to between 15" and 48" height. Notes: Staff Only | <p>PCODE IC01 ADAAG 91 4.2.5 & 6 ADA 2010 308.2.1 & 308.2.2 CBC 2007 1117B.6.3 CBC 2016 11B-308.2.1 & 11B-308.2.2</p> <p>Priority 1 Severity 4</p> | 1 | JOB | \$300 | \$300 |

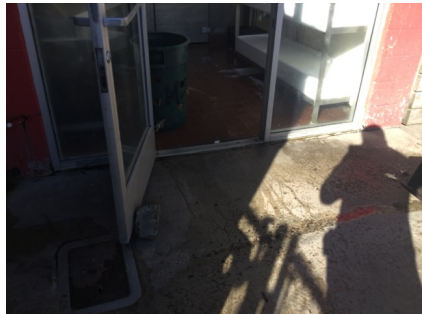
| Item No. and Name | Existing Architectural Barrier and Proposed Solution | Codes / Mitigation Info | Qty | Unit | Cost | Total |
|---|--|---|---|---|---|---|
| 1070 | <ul style="list-style-type: none"> <i>As-Built Description:</i> Surface of required maneuvering clearance at door slopes more than 1/4":12" (2.0%). <i>As-Built:</i> Sloped at door landing <i>Proposed Solution:</i> Modify surface slope at door. Notes: Also sloped on POT to entrance | <p>PCODE ID11 ADAAG 91 4.13.6 ADA 2010 404.2.4.4 CBC 2007 1133B.2.4 CBC 2016 11B-404.2.4</p> <p>Priority 1 Severity 4</p> | 20 | SF | \$40 | \$800 |

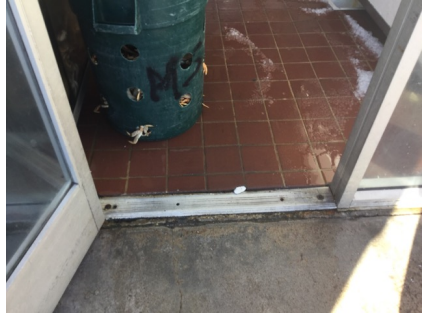
| Item No. and Name | Existing Architectural Barrier and Proposed Solution | Codes / Mitigation Info | Qty | Unit | Cost | Total |
|---|--|---|---|---|---|---|
| 1073 | <ul style="list-style-type: none"> <i>As-Built Description:</i> Door inaccessible due to threshold or step at door exceeding 1/2". <i>As-Built:</i> Lip at transition from bevel to tile flooring <i>Proposed Solution:</i> Modify threshold to be no more than 1/2" by removing existing paving at door and providing landing with edge ramping (slope 1:20 max). | <p>PCODE ID02A ADAAG 91 4.13.8 ADA 2010 404.2.5 CBC 2007 1133B.2.4.1 CBC 2016 11B-404.2.5</p> <p>Priority 1 Severity 4</p> | 1 | JOB | \$400 | \$400 |

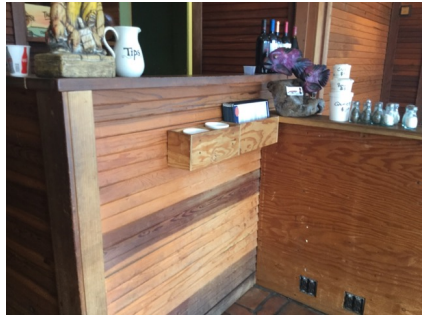
| 1081 | <ul style="list-style-type: none"> <i>As-Built Description:</i> Protruding objects more than 4" from wall, when bottom of object more than 27" or less than 80" above finished floor. <i>As-Built:</i> Shelf 5" at 38.5" high <i>Proposed Solution:</i> Remove/relocate protruding object. Patch existing surface. | <p>PCODE EG04 ADAAG 91 4.4.1 ADA 2010 307.2 CBC 2007 1133B.8.6.1 CBC 2016 11B-307.2</p> <p>Priority 2 Severity 4</p> | 1 | JOB | \$100 | \$100 |

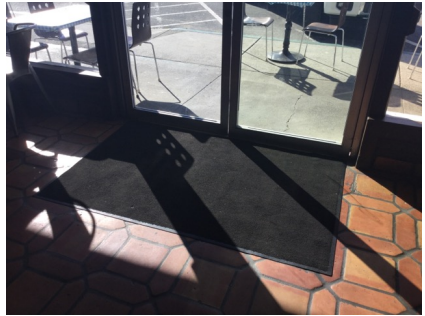
| 1077 | <ul style="list-style-type: none"> <i>As-Built Description:</i> Doormat not securely attached to ground or floor structure. <i>Proposed Solution:</i> Attach doormat to floor surface or remove doormat. | <p>PCODE ID05A ADAAG 91 4.5.3 ADA 2010 302.2 CBC 2007 1124B.3 CBC 2016 11B-302.2</p> <p>Priority 2 Severity 3</p> | 1 | JOB | \$75 | \$75 |

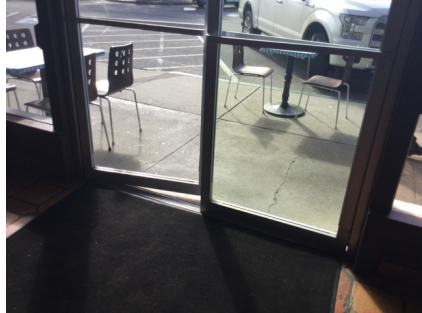
| Item No. and Name | Existing Architectural Barrier and Proposed Solution | Codes / Mitigation Info | Qty | Unit | Cost | Total |
|---|---|--|---|---|---|---|
| 1150 | <ul style="list-style-type: none"> <i>As-Built Description:</i> At push side of door on accessible route, bottom 10" does not have a smooth, uninterrupted surface. <i>As-Built:</i> 3.5" high bottom surface <i>Proposed Solution:</i> Provide 10" min. "kick plate" covering width of door when altering area. | <p><i>PCODE</i> ID06</p> <p><i>ADA 2010</i> 404.2.10</p> <p><i>CBC 2007</i> 1133B.2.6</p> <p><i>CBC 2016</i> 11B-404.2.10</p> <p>Priority 2</p> <p>Severity 3</p> | 1 | JOB | \$100 | \$100 |

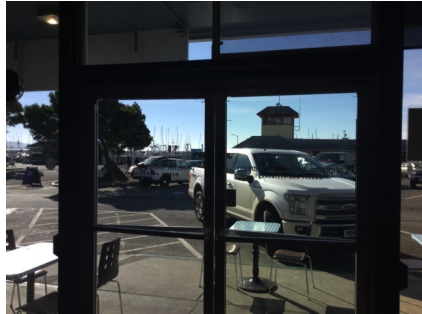
| Item No. and Name | Existing Architectural Barrier and Proposed Solution | Codes / Mitigation Info | Qty | Unit | Cost | Total |
|---|---|--|---|---|---|---|
| 1079 | <ul style="list-style-type: none"> <i>As-Built Description:</i> Excessive force required to open door. <i>As-Built:</i> 7 lbs <i>Proposed Solution:</i> Adjust regular door closer to accessible standards (5 lbs. max). | <p><i>PCODE</i> ID03</p> <p><i>ADAAG 91</i> 4.13.11</p> <p><i>ADA 2010</i> 404.2.9</p> <p><i>CBC 2007</i> 1133B.2.5</p> <p><i>CBC 2016</i> 11B-404.2.9</p> <p>Priority 2</p> <p>Severity 4</p> | 2 | JOB | \$25 | \$50 |

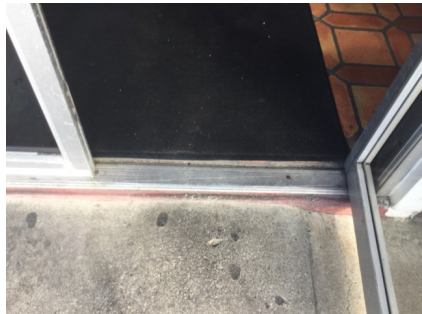
| Item No. and Name | Existing Architectural Barrier and Proposed Solution | Codes / Mitigation Info | Qty | Unit | Cost | Total |
|---|---|--|---|---|---|---|
| 1147 | <ul style="list-style-type: none"> <i>As-Built Description:</i> Door inaccessible due to threshold or step at door exceeding 1/2". <i>As-Built:</i> 1" total threshold <i>Proposed Solution:</i> Modify threshold to be no more than 1/2" by removing existing paving at door and providing landing with edge ramping (slope 1:20 max). | <p><i>PCODE</i> ID02A</p> <p><i>ADAAG 91</i> 4.13.8</p> <p><i>ADA 2010</i> 404.2.5</p> <p><i>CBC 2007</i> 1133B.2.4.1</p> <p><i>CBC 2016</i> 11B-404.2.5</p> <p>Priority 2</p> <p>Severity 4</p> | 1 | JOB | \$400 | \$400 |

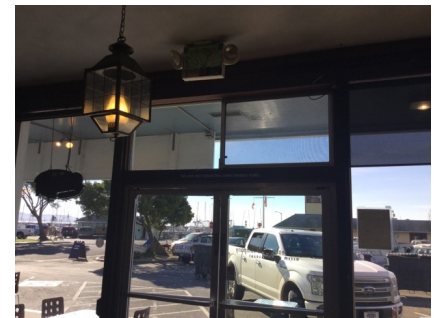
• *Notes:*
Overhead exit sign is damaged

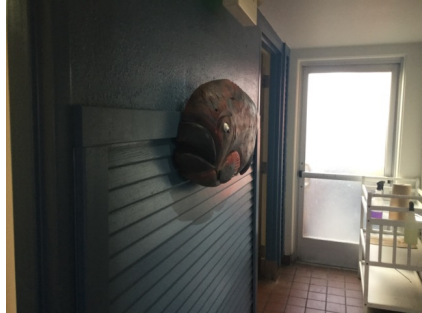
| Item No. and Name | Existing Architectural Barrier and Proposed Solution | Codes / Mitigation Info | Qty | Unit | Cost | Total |
|---|--|--|---|---|---|---|
| 1090 | <ul style="list-style-type: none"> <i>As-Built Description:</i> Protruding objects more than 4" from wall, when bottom of object more than 27" or less than 80" above finished floor. <i>As-Built:</i> Fish decoration protrudes more than 4" at 50" high <i>Proposed Solution:</i> Remove/relocate protruding object. Patch existing surface. | PCODE EG04 ADAAG 91 4.4.1 ADA 2010 307.2 CBC 2007 1133B.8.6.1 CBC 2016 11B-307.2 Priority 3 Severity 4 | 1 | JOB | \$100 | \$100 |

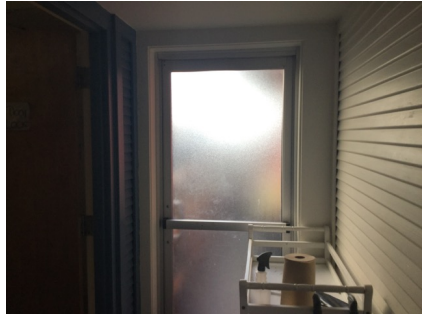
| Item No. and Name | Existing Architectural Barrier and Proposed Solution | Codes / Mitigation Info | Qty | Unit | Cost | Total |
|---|--|--|---|---|---|---|
| 1085 | <ul style="list-style-type: none"> <i>As-Built Description:</i> Door on accessible route has less than 32" clear and 80" (78" min. to closer if provided) opening width when 90° open. <i>As-Built:</i> Cannot be opened <i>Proposed Solution:</i> Provide new, larger door and frame with new accessible hardware. Notes: Door is marked as an exit door | PCODE ID01REF ADAAG 91 4.13.5 ADA 2010 404.2.3 CBC 2007 1133B.1.1.1.1 CBC 2016 11B-404.2.3 Priority 3 Severity 1 | REF | | | |

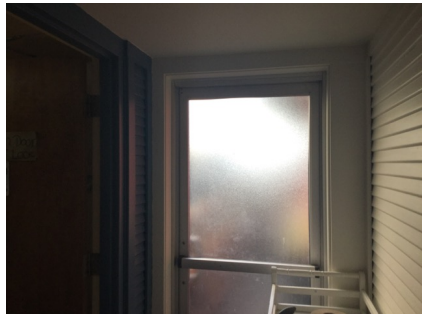
| Item No. and Name | Existing Architectural Barrier and Proposed Solution | Codes / Mitigation Info | Qty | Unit | Cost | Total |
|---|--|--|---|---|---|---|
| 1086 | <ul style="list-style-type: none"> <i>As-Built Description:</i> Front approach: At push side, door does not have clear and level maneuvering space measuring door width x 48" (door width plus 12" if door has both, latch and closer). <i>As-Built:</i> 4" to wall on push side <i>Proposed Solution:</i> Provide door operator. | PCODE ID24CREF ADAAG 91 Fig. 25(a) ADA 2010 404.2.4 CBC 2007 11B-26A(a) CBC 2016 11B-404.2.4 Priority 3 Severity 2 | REF | | | |

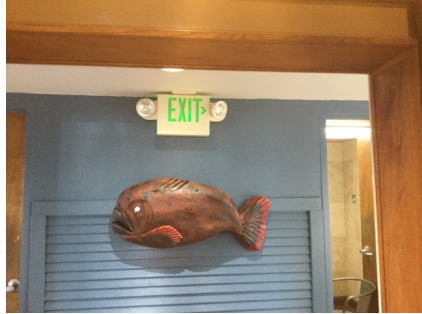
| Item No. and Name | Existing Architectural Barrier and Proposed Solution | Codes / Mitigation Info | Qty | Unit | Cost | Total |
|---|---|--|---|---|---|---|
| 1083 | <ul style="list-style-type: none"> <i>As-Built Description:</i> At door leading into exit corridor: Where required exit signs are installed, signs to provide exiting information for people with vision impairment are not provided. <i>Proposed Solution:</i> Provide raised letter/Braille "EXIT ROUTE" sign at door. <i>Notes:</i> Exit door cannot be opened | <p>PCODE SA10DREF</p> <p>ADAAG 91 4.1.3(16)</p> <p>ADA 2010 216.4.1</p> <p>CBC 2007 1011.3</p> <p>CBC 2016 11B-216.4.1</p> <p>Priority 3</p> <p>Severity 3</p> | | | | |

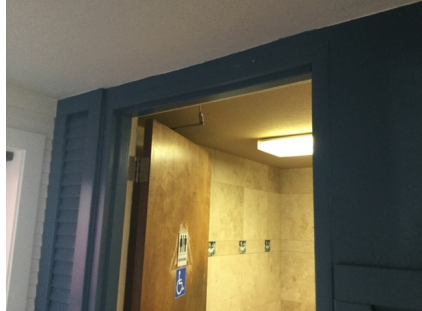
| 1089 | <ul style="list-style-type: none"> <i>As-Built Description:</i> Excessive force required to open door. <i>As-Built:</i> 10 lbs <i>Proposed Solution:</i> Adjust regular door closer to accessible standards (5 lbs. max). | <p>PCODE ID03</p> <p>ADAAG 91 4.13.11</p> <p>ADA 2010 404.2.9</p> <p>CBC 2007 1133B.2.5</p> <p>CBC 2016 11B-404.2.9</p> <p>Priority 3</p> <p>Severity 4</p> | 1 | JOB | \$25 | \$25 |

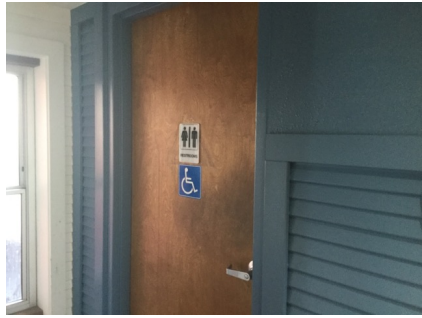
| 1088 | <ul style="list-style-type: none"> <i>As-Built Description:</i> Entrance to toilet or bathing facility not identified with ADAAG compliant signage. <i>As-Built:</i> No latch sign provided <i>Proposed Solution:</i> Provide ADAAG compliant sign mounted 5' high on center on nearest adjacent wall, on latch side of a single door (located not to cause a Braille reader to stand within the door swing). | <p>PCODE SA11A</p> <p>ADAAG 91 4.1.3(16)(a)</p> <p>ADA 2010 216.8</p> <p>CBC 2016 11B-216.8</p> <p>Priority 3</p> <p>Severity 3</p> | 1 | JOB | \$90 | \$90 |

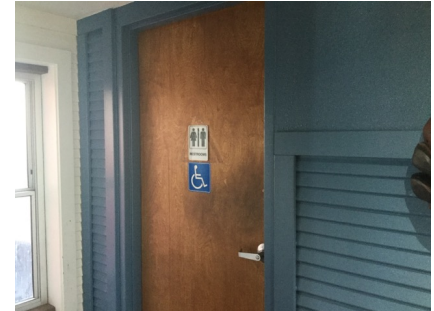
| Item No. and Name | Existing Architectural Barrier and Proposed Solution | Codes / Mitigation Info | Qty | Unit | Cost | Total |
|---|---|---|---|---|---|---|
| 1087 | <ul style="list-style-type: none"> <i>As-Built Description:</i> Required in CA only: identification symbol centered 58" to 60" high on sanitary facility door that contrasts with the door not provided (women: 12" ø circle, men: 12" triangle, unisex: combined symbol). <i>As-Built:</i> Not a geometric sign <i>Proposed Solution:</i> Provide properly mounted sanitary facility symbol when altering area. If wheelchair accessible, include International Symbol of Accessibility on sign. | <p>PCODE SA15</p> <p>CBC 2007 1115B.6</p> <p>CBC 2016 11B-703.7.2.6</p> <p>Priority 3</p> <p>Severity 3</p> | 1 | JOB | \$90 | \$90 |

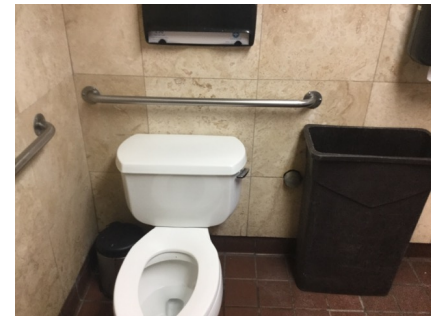
| 1097 | <ul style="list-style-type: none"> <i>As-Built Description:</i> The rear wall grab is less than 36" min. or does not extend from the centerline of the water closet 12" min. on one side and 24" min. on the other side. <i>As-Built:</i> 21.25" on wide side <i>Proposed Solution:</i> Provide or relocate accessible rear grab bar. | <p>PCODE WB07B</p> <p>ADAAG 91 4.17.6</p> <p>ADA 2010 604.5.2</p> <p>CBC 2007 1115B.4.1.3.2</p> <p>CBC 2016 11B-604.5.2</p> <p>Priority 3</p> <p>Severity 4</p> | 1 | JOB | \$340 | \$340 |

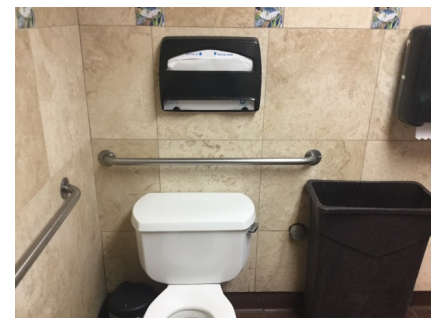
| 1098 | <ul style="list-style-type: none"> <i>As-Built Description:</i> Accessories/dispensers in accessible stall located closer than 1-1/2" below or 12" above grab bar impedes its use. <i>As-Built:</i> SCD above RGB <i>Proposed Solution:</i> Relocate accessories/dispensers to be no closer than 1-1/2" below and 12" above grab bars (except if accessories are recessed, flush with wall, and have no sharp edges). | <p>PCODE WB07I</p> <p>ADAAG 91 4.26.2</p> <p>ADA 2010 609.3</p> <p>CBC 2007 1133B.4.2.5</p> <p>CBC 2016 11B-609.3</p> <p>Priority 3</p> <p>Severity 4</p> | 1 | JOB | \$75 | \$75 |

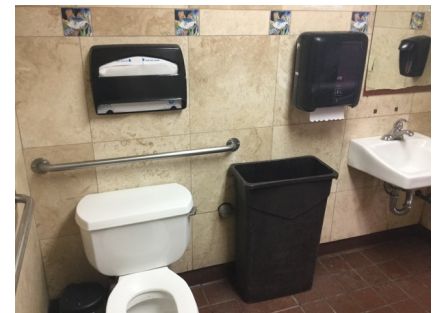
| 1099 | <ul style="list-style-type: none"> <i>As-Built Description:</i> 60" min. clearance around a water closet measured perpendicular from the side wall not provided (Fixtures are not allowed to overlap this clearance). <i>As-Built:</i> PTD within transfer space <i>Proposed Solution:</i> Remove adjacent fixture and provide new enclosure at accessible water closet. Notes: Relocate | <p>PCODE WB01ANT</p> <p>ADA 2010 604.3.1; 604.3.2</p> <p>CBC 2007 1115B.7.1.3</p> <p>CBC 2016 11B-604.3.1; 11B-604.3.2</p> <p>Priority 3</p> <p>Severity 4</p> | 1 | JOB | \$2,000 | \$2,000 |

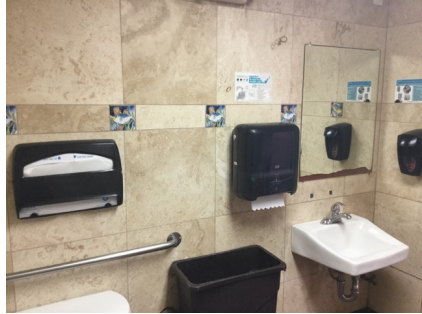
| Item No. and Name | Existing Architectural Barrier and Proposed Solution | Codes / Mitigation Info | Qty | Unit | Cost | Total |
|---|---|---|---|---|---|---|
| 1094 | <ul style="list-style-type: none"> <i>As-Built Description:</i> Dispensers in sanitary facilities, such as for towels, soap, sanitary napkins, seat covers, etc., and waste receptacles more than 48" (CA only: 40") from floor to highest operating slot or control. <i>As-Built:</i> SD and SCD: 51" high <i>Proposed Solution:</i> Relocate existing restroom accessories. | PCODE WG01A ADAAG 91 4.23.7 ADA 2010 308.2.1 CBC 2007 1115B.8.3 CBC 2016 11B-603.5 Priority 3 Severity 2 | 1 | JOB | \$100 | \$100 |

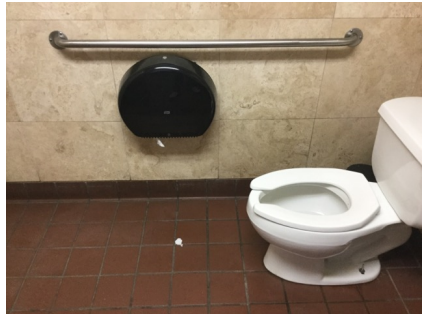
| Item No. and Name | Existing Architectural Barrier and Proposed Solution | Codes / Mitigation Info | Qty | Unit | Cost | Total |
|---|---|---|---|---|---|---|
| 1100 | <ul style="list-style-type: none"> <i>As-Built Description:</i> Toilet paper dispenser less than 15" (CA: 19") or more than 48" above floor or not within 7" to 9" from front of water closet (Note: CA pre-2010 is allowed within 12" from front of water closet). <i>As-Built:</i> 13" in front <i>Proposed Solution:</i> Relocate or provide new toilet paper dispenser. | PCODE WG02 ADAAG 91 4.16.6 ADA 2010 604.7 CBC 2007 1115B.8.4 CBC 2016 11B-604.7 Priority 3 Severity 3 | 1 | JOB | \$75 | \$75 |

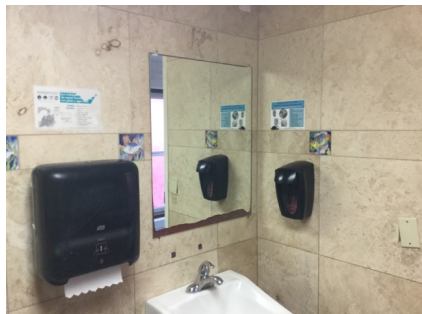
| Item No. and Name | Existing Architectural Barrier and Proposed Solution | Codes / Mitigation Info | Qty | Unit | Cost | Total |
|---|---|---|---|---|---|---|
| 1095 | <ul style="list-style-type: none"> <i>As-Built Description:</i> Bottom of flat, not tilted mirror located above lavatories or countertops more than 40" above floor. <i>As-Built:</i> 42" high <i>Proposed Solution:</i> Relocate or provide new accessible mirror. Notes: Bottom surface slightly obscured per decorative design | PCODE WG03 ADAAG 91 4.19.6 ADA 2010 603.3 CBC 2007 1115B.8.1 CBC 2016 11B-603.3 Priority 3 Severity 4 | 1 | JOB | \$150 | \$150 |

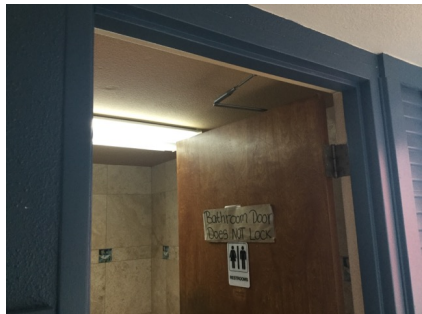
| 1104 | <ul style="list-style-type: none"> <i>As-Built Description:</i> Excessive force required to open door. <i>As-Built:</i> 9 lbs <i>Proposed Solution:</i> Adjust regular door closer to accessible standards (5 lbs. max). | PCODE ID03 ADAAG 91 4.13.11 ADA 2010 404.2.9 CBC 2007 1133B.2.5 CBC 2016 11B-404.2.9 Priority 3 Severity 4 | 1 | JOB | \$25 | \$25 |

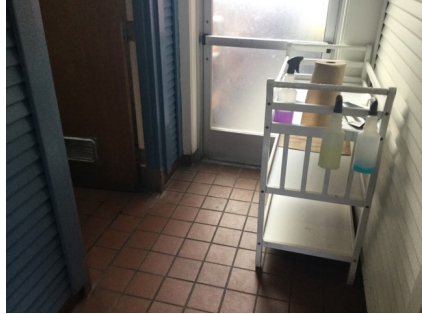
| Item No. and Name | Existing Architectural Barrier and Proposed Solution | Codes / Mitigation Info | Qty | Unit | Cost | Total | |
|---|---|--|---|---|---|---|--|
| 1103 | <ul style="list-style-type: none"> <i>As-Built Description:</i> Latch approach: At push side, door does not have clear and level maneuvering space measuring door width plus 24" (starting at hinge) x 42", or 48" if door has closer. <i>As-Built:</i> 33.5" to cleaning cart in front <i>Proposed Solution:</i> Remove or relocate furniture or storage items. | <p>PCODE ID28A ADAAG 91 Fig. 25(c) ADA 2010 404.2.4 CBC 2007 11B-26A(c) CBC 2016 11B-404.2.4</p> <p>Priority 3 Severity 4</p> | 1 | JOB | \$50 | \$50 | |

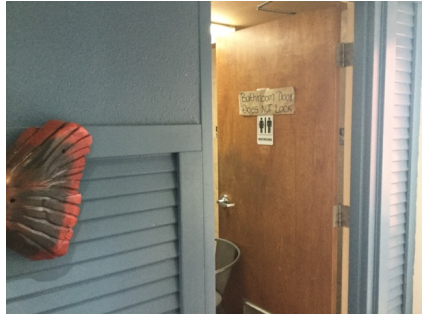
| Item No. and Name | Existing Architectural Barrier and Proposed Solution | Codes / Mitigation Info | Qty | Unit | Cost | Total | |
|---|---|--|---|---|---|---|--|
| 1101 | <ul style="list-style-type: none"> <i>As-Built Description:</i> Entrance to toilet or bathing facility identified with California signage on door leaf not identified with ADAAG compliant signage. <i>Proposed Solution:</i> Provide ADAAG compliant sign with raised letters and pictogram, mounted 5' high on center on nearest adjacent wall, on latch side of a single door. | <p>PCODE SA11AREF ADAAG 91 4.1.3(16)(a) ADA 2010 216.8 CBC 2016 11B-216.8</p> <p>Priority 3 Severity 3</p> | REF | | | | |

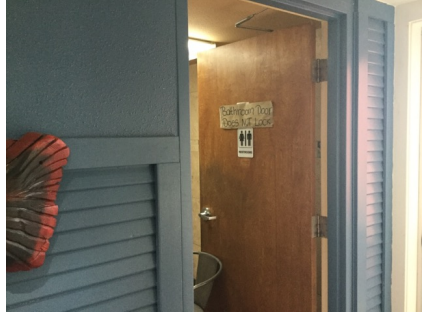
| Item No. and Name | Existing Architectural Barrier and Proposed Solution | Codes / Mitigation Info | Qty | Unit | Cost | Total | |
|---|---|--|---|---|---|---|--|
| 1102 | <ul style="list-style-type: none"> <i>As-Built Description:</i> Required in CA only: identification symbol centered 58" to 60" high on sanitary facility door that contrasts with the door not provided (women: 12" ø circle, men: 12" triangle, unisex: combined symbol). <i>Proposed Solution:</i> Provide properly mounted sanitary facility symbol when altering area. If wheelchair accessible, include International Symbol of Accessibility on sign. | <p>PCODE SA15REF CBC 2007 1115B.6 CBC 2016 11B-703.7.2.6</p> <p>Priority 3 Severity 3</p> | REF | | | | |

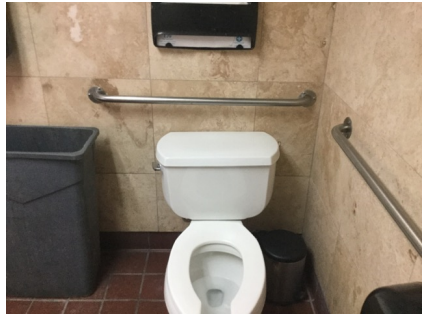
| Item No. and Name | Existing Architectural Barrier and Proposed Solution | Codes / Mitigation Info | Qty | Unit | Cost | Total | |
|---|---|--|---|---|---|---|--|
| 1112 | <ul style="list-style-type: none"> <i>As-Built Description:</i> The rear wall grab is less than 36" min. or does not extend from the centerline of the water closet 12" min. on one side and 24" min. on the other side. <i>As-Built:</i> 20.5" on wide side <i>Proposed Solution:</i> Provide or relocate accessible rear grab bar. | <p>PCODE WB07B ADAAG 91 4.17.6 ADA 2010 604.5.2 CBC 2007 1115B.4.1.3.2 CBC 2016 11B-604.5.2</p> <p>Priority 3 Severity 4</p> | 1 | JOB | \$340 | \$340 | |

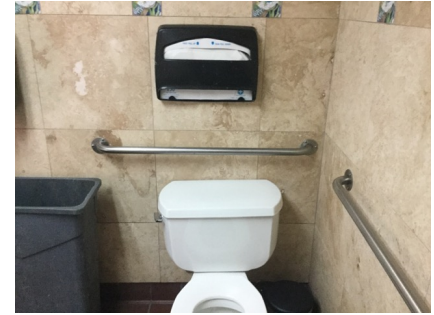
| Item No. and Name | Existing Architectural Barrier and Proposed Solution | Codes / Mitigation Info | Qty | Unit | Cost | Total |
|---|---|---|---|---|---|---|
| 1113 | <ul style="list-style-type: none"> <i>As-Built Description:</i> Accessories/dispensers in accessible stall located closer than 1-1/2" below or 12" above grab bar impedes its use. <i>As-Built:</i> SCD above RGB <i>Proposed Solution:</i> Relocate accessories/dispensers to be no closer than 1-1/2" below and 12" above grab bars (except if accessories are recessed, flush with wall, and have no sharp edges). | PCODE WB07I ADAAG 91 4.26.2 ADA 2010 609.3 CBC 2007 1133B.4.2.5 CBC 2016 11B-609.3 Priority 3 Severity 4 | 1 | JOB | \$75 | \$75 |

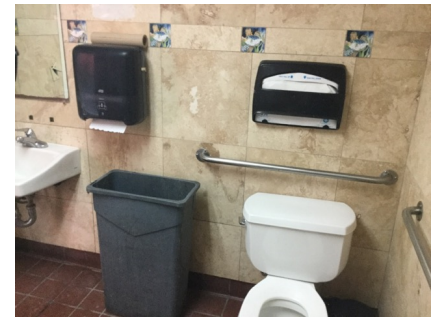
| 1114 | <ul style="list-style-type: none"> <i>As-Built Description:</i> 60" min. clearance around a water closet measured perpendicular from the side wall not provided (Fixtures are not allowed to overlap this clearance). <i>As-Built:</i> PTD within transfer space <i>Proposed Solution:</i> Remove adjacent fixture and provide new enclosure at accessible water closet. | PCODE WB01ANT ADA 2010 604.3.1; 604.3.2 CBC 2007 1115B.7.1.3 CBC 2016 11B-604.3.1; 11B-604.3.2 Priority 3 Severity 4 | 1 | JOB | \$2,000 | \$2,000 |

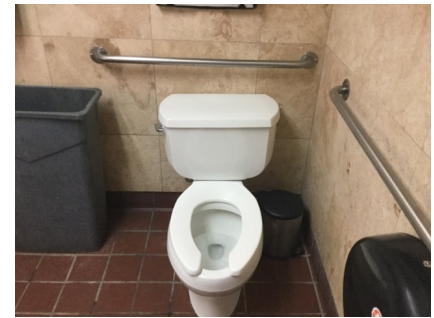
| 1110 | <ul style="list-style-type: none"> <i>As-Built Description:</i> Water closet not 16"-18" (CA: 17"-18") from near side wall to center line of water closet (2010 ADAAG: 16"-18"). <i>As-Built:</i> 18.25" o.c. <i>Proposed Solution:</i> Relocate existing water closet and plumbing, remount with offset closet flange to provide 18" max. from side wall. | PCODE WB02C ADAAG 91 Fig. 28 ADA 2010 604.2 CBC 2007 1115B.4.1.1 CBC 2016 11B-604.2 Priority 3 Severity 4 | 1 | JOB | \$500 | \$500 |

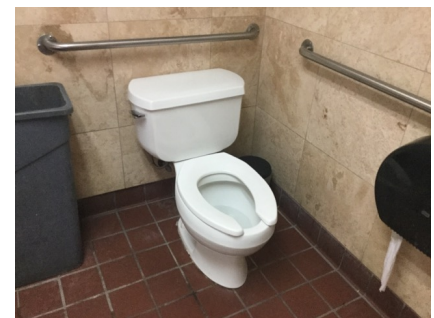
| 1111 | <ul style="list-style-type: none"> <i>As-Built Description:</i> Height of water closet seat less than 17" or more than 19" from floor. <i>As-Built:</i> 16" high <i>Proposed Solution:</i> Provide new accessible water closet. | PCODE WB08 ADAAG 91 4.16.3 ADA 2010 604.4 CBC 2007 1115B.4.1.4 CBC 2016 11B-604.4 Priority 3 Severity 4 | 1 | JOB | \$1,400 | \$1,400 |

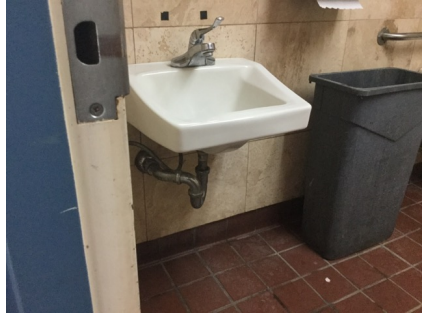
| 1106 | <ul style="list-style-type: none"> <i>As-Built Description:</i> Wheelchair clearance under lavatory apron or lavatory counter front edge less than 29" high. <i>As-Built:</i> 27.25" high apron <i>Proposed Solution:</i> Remount compliant fixture to accessible height. | <p>PCODE WD03A ADAAG 91 4.19.2 ADA 2010 606.3 CBC 2007 1115B.4.3.3 CBC 2016 11B-306.3.1</p> <p>Priority 3 Severity 3</p> | 1 | JOB | \$1,500 | \$1,500 |

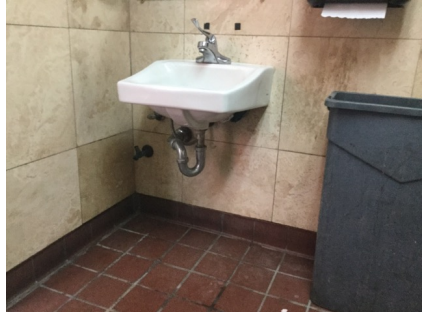
| 1107 | <ul style="list-style-type: none"> <i>As-Built Description:</i> Knee clearance 27" min. high starting 8" back from the front edge of the lavatory towards the wall is not provided. <i>As-Built:</i> 24" high knee space <i>Proposed Solution:</i> Remount compliant fixture to accessible height. | <p>PCODE WD04AREF ADAAG 91 Fig. 31 ADA 2010 306.3.3 CBC 2007 1115B.4.3 CBC 2016 11B-306.3.3</p> <p>Priority 3 Severity 2</p> | | REF | | |

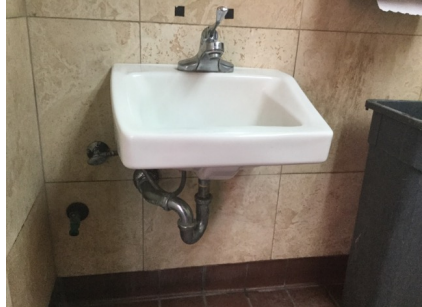
| 1105 | <ul style="list-style-type: none"> <i>As-Built Description:</i> Hot or sharp-surfaced water/drain pipe not insulated or covered. <i>Proposed Solution:</i> Insulate or cover water/drain pipe. | <p>PCODE WD05 ADAAG 91 4.19.4 ADA 2010 606.5 CBC 2007 1115B.4.3.4 CBC 2016 11B-606.5</p> <p>Priority 3 Severity 3</p> | 1 | JOB | \$120 | \$120 |

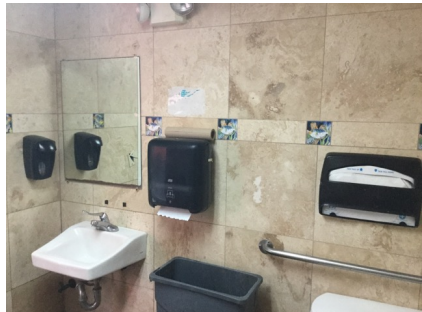
| 1108 | <ul style="list-style-type: none"> <i>As-Built Description:</i> Dispensers in sanitary facilities, such as for towels, soap, sanitary napkins, seat covers, etc., and waste receptacles more than 48" (CA only: 40") from floor to highest operating slot or control. <i>As-Built:</i> SD: 52" high SCD: 50" high <i>Proposed Solution:</i> Relocate existing restroom accessories. | <p>PCODE WG01A ADAAG 91 4.23.7 ADA 2010 308.2.1 CBC 2007 1115B.8.3 CBC 2016 11B-603.5</p> <p>Priority 3 Severity 2</p> | 1 | JOB | \$100 | \$100 |

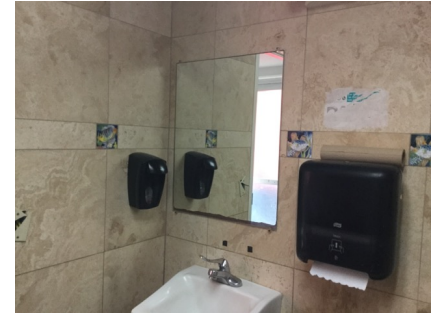
| Item No. and Name | Existing Architectural Barrier and Proposed Solution | Codes / Mitigation Info | Qty | Unit | Cost | Total |
|---|--|---|---|---|---|---|
| 1109 | <ul style="list-style-type: none"> <i>As-Built Description:</i> Bottom of flat, not tilted mirror located above lavatories or countertops more than 40" above floor. <i>As-Built:</i> 42.25" high <i>Proposed Solution:</i> Relocate or provide new accessible mirror. <i>Notes:</i> Bottom obscured per decorative design | PCODE WG03 ADAAG 91 4.19.6 ADA 2010 603.3 CBC 2007 1115B.8.1 CBC 2016 11B-603.3 Priority 3 Severity 4 | 1 | JOB | \$150 | \$150 |

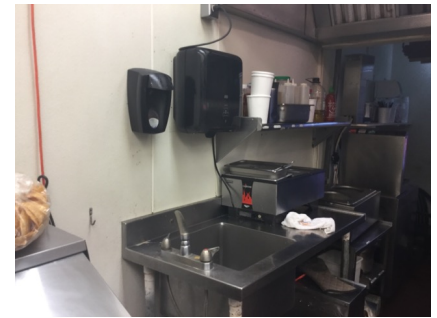
| 1121 | <ul style="list-style-type: none"> <i>As-Built Description:</i> Reach height to control or access point, exceeds 48" or is less than 15". <i>As-Built:</i> SD: 64" high PTD: 68.5" high <i>Proposed Solution:</i> Modify equipment or mounting. | PCODE IE01 ADAAG 91 4.2.5 ADA 2010 308.2.1 CBC 2007 1118B.5 CBC 2016 11B-308.2.1 Priority 4 Severity 1 | 1 | JOB | \$100 | \$100 |

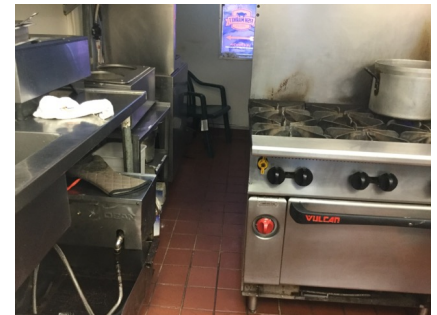
| 1118 | <ul style="list-style-type: none"> <i>As-Built Description:</i> Corridor, for occupant load less than 10, less than 36" wide. <i>As-Built:</i> Narrow walk to ice cream sales counter between sink and stove <i>Proposed Solution:</i> Remove or relocate furniture and storage items. <i>Notes:</i> Staff Only | PCODE IH03AREF ADAAG 91 4.3.3 ADA 2010 403.5.1 CBC 2007 1133B.3.1 CBC 2016 11B-403.5.1 Priority 4 Severity 4 | REF | | | |

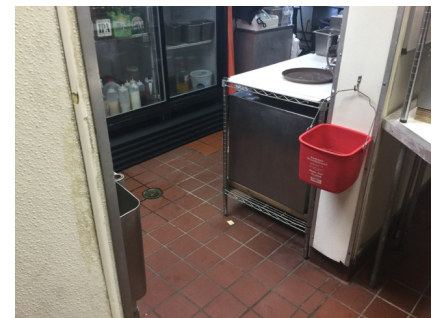
| 1116 | <ul style="list-style-type: none"> <i>As-Built Description:</i> Corridor, for occupant load less than 10, less than 36" wide. <i>As-Built:</i> 37-37.5" wide within kitchen area <i>Proposed Solution:</i> Enlarge corridor to 36" wide; relocate stud wall. | PCODE IH03REF ADAAG 91 4.3.3 ADA 2010 403.5.1 CBC 2007 1133B.3.1 CBC 2016 11B-403.5.1 Priority 4 Severity 4 | REF | | | |

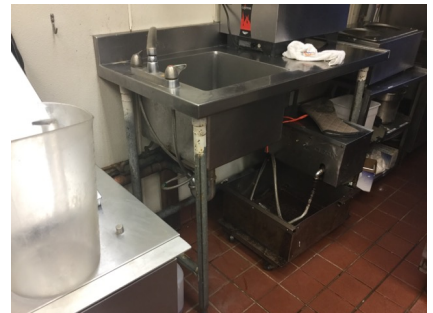
1119 • *As-Built Description:*
Sink does not have knee space min. 27" high x 19" deep x 30" wide.

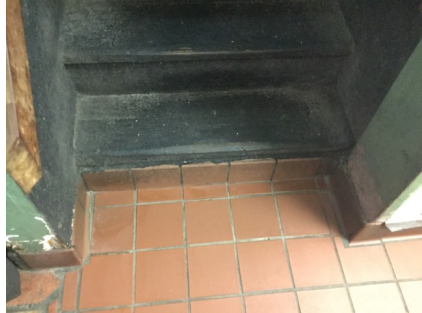
| Item No. and Name | Existing Architectural Barrier and Proposed Solution | Codes / Mitigation Info | Qty | Unit | Cost | Total |
|---|--|---|---|---|---|---|
| 1125 | <ul style="list-style-type: none"> • <i>As-Built Description:</i> Stair nosings project more than 1-1/2" past face of riser and/or are not beveled on underside 60° min. from horizontal. • <i>As-Built:</i> Nosing on first tread is damaged or missing • <i>Proposed Solution:</i> Modify stair nosings. | PCODE EC01 ADAAG 91 4.9.3 ADA 2010 504.5 CBC 2007 1133B.4.5.2 CBC 2016 11B-504.5 Priority 4 Severity 4 | 4 | LF | \$20 | \$80 |

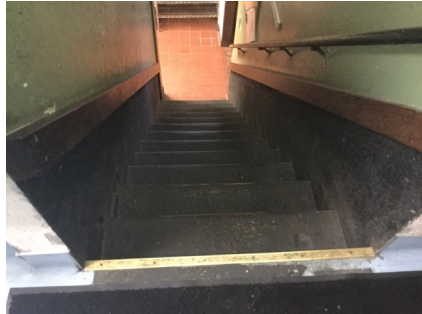
| Item No. and Name | Existing Architectural Barrier and Proposed Solution | Codes / Mitigation Info | Qty | Unit | Cost | Total |
|---|--|---|---|---|---|---|
| 1128 | <ul style="list-style-type: none"> • <i>As-Built Description:</i> Stair tread width less than 11", measured horizontally from nosing to nosing. • <i>As-Built:</i> 9" long treads • <i>Proposed Solution:</i> Rebuild stair as needed. • Notes: 13 steps | PCODE EC06 ADAAG 91 4.9.2 ADA 2010 504.2 CBC 2007 1133B.4.5.3 CBC 2016 11B-504.2 Priority 4 Severity 3 | 13 | JOB | \$300 | \$3,900 |

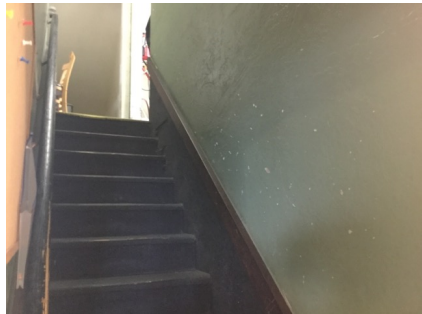
| Item No. and Name | Existing Architectural Barrier and Proposed Solution | Codes / Mitigation Info | Qty | Unit | Cost | Total |
|---|--|---|---|---|---|---|
| 1127 | <ul style="list-style-type: none"> • <i>As-Built Description:</i> Handrail not provided at stairs or ramp, required on both sides (not required at curb ramps or adjacent to seating areas). • <i>As-Built:</i> HR not provided on one side • <i>Proposed Solution:</i> Provide new handrail for each side including extensions. | PCODE ED01 ADAAG 91 4.8.5 & 4.9.4 ADA 2010 505.2 CBC 2007 1133B.4.1.1 & .5.5 CBC 2016 11B-505.2 Priority 4 Severity 2 | 15 | LF | \$95 | \$1,425 |

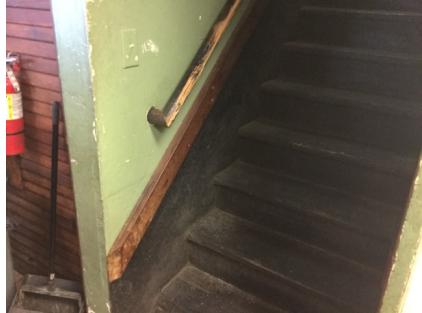
| Item No. and Name | Existing Architectural Barrier and Proposed Solution | Codes / Mitigation Info | Qty | Unit | Cost | Total |
|---|---|---|---|---|---|---|
| 1122 | <ul style="list-style-type: none"> <i>As-Built Description:</i> Stair handrail does not extend horizontally 12" minimum beyond top nosing, and one tread width sloped, plus 12" minimum horizontally beyond the bottom nosing. <i>As-Built:</i> No extensions <i>Proposed Solution:</i> Extend stair handrail at top and bottom (cost for each extension piece). <i>Notes:</i> Staff Only | <p><i>PCODE</i> ED06REF <i>ADAAG 91</i> 4.9.4(2) <i>ADA 2010</i> 505.10.2; 505.10.3 <i>CBC 2007</i> 1133B.4.2.2 <i>CBC 2016</i> 11B-505.10.2; 11B-505.10.3</p> <p>Priority 4 Severity 2</p> | | | | |

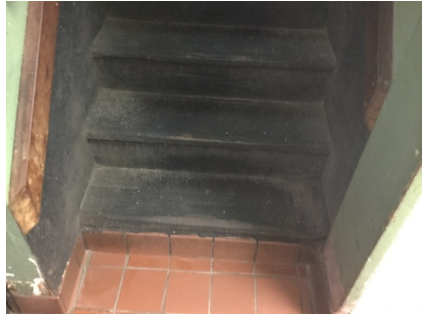
| Item No. and Name | Existing Architectural Barrier and Proposed Solution | Codes / Mitigation Info | Qty | Unit | Cost | Total |
|---|---|---|---|---|---|---|
| 1124 | <ul style="list-style-type: none"> <i>As-Built Description:</i> The leading 2" of the tread does not have visual contrast of dark-on-light or light-on-dark from the remainder of the tread. <i>Proposed Solution:</i> Provide 2" min., 4" max. wide contrasting color strip 1" max. from nosing on top & bottom treads when altering area. | <p><i>PCODE</i> II02B <i>ADA 2010</i> 504.4 <i>CBC 2007</i> 1133B.4.4 <i>CBC 2016</i> 11B-504.4.1</p> <p>Priority 4 Severity 3</p> | 8 | LF | \$14 | \$112 |

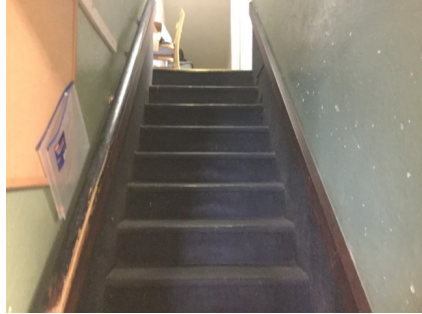
| Item No. and Name | Existing Architectural Barrier and Proposed Solution | Codes / Mitigation Info | Qty | Unit | Cost | Total |
|---|---|---|---|---|---|---|
| 1126 | <ul style="list-style-type: none"> <i>As-Built Description:</i> Stairs serving for an occupant load of less than 50 shall have a width of not less than 36". <i>As-Built:</i> 36" wide stairs <i>Proposed Solution:</i> Rebuild stair as needed. <i>Notes:</i> Staff Only areas | <p><i>PCODE</i> II02IREF <i>CBC 2016</i> 1009.4 Exception 1</p> <p>Priority 4 Severity 3</p> | | | | |

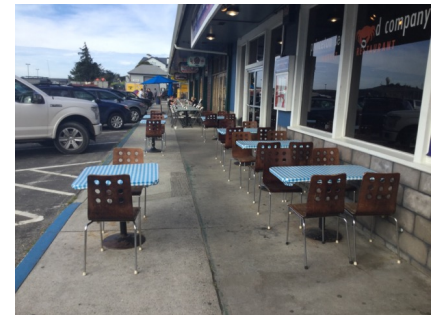
- 1146 • *As-Built Description:*
Dining area has less than required number of wheelchair seating spaces; 5% (1 space per 20 seats), not less than one, required.
- *As-Built:* **No tables provided that can accommodate a wheelchair space due to tables support bases**
- *Proposed Solution:*
Provide wheelchair seating space for dining.
- **Notes:**
10 tables
4 picnic tables
44 seats
0 wheelchair seating spaces

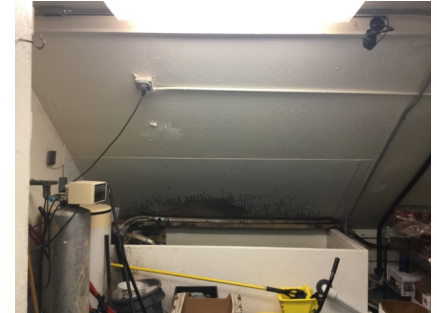
| 1131 | <ul style="list-style-type: none"> <i>As-Built Description:</i> Overhead clearance less than 80" above finished floor. <i>As-Built:</i> Slanted ceiling <i>Proposed Solution:</i> Provide cane-detectable railing to mark area of low clearance. <i>Notes:</i> Staff Only Technically infeasible to resolve | PCODE EG01AREF | | | | |

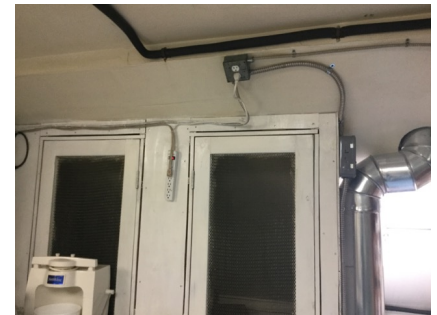
| 1133 | <ul style="list-style-type: none"> <i>As-Built Description:</i> Electric switch or control mounted less than 15" measured to the bottom of the outlet box or greater than 48 inches measured to the top of the outlet box. <i>As-Built:</i> 61" and higher outlets <i>Proposed Solution:</i> Relocate light switches or control to between 15" and 48" height. | PCODE IC01 | 1 | JOB | \$300 | \$300 |

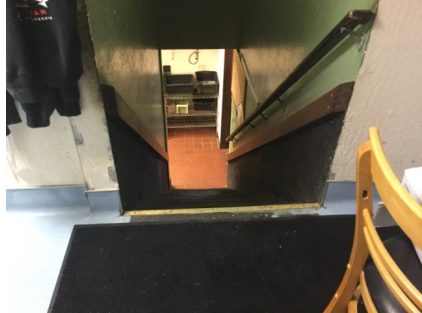
| Item No. and Name | Existing Architectural Barrier and Proposed Solution | Codes / Mitigation Info | Qty | Unit | Cost | Total |
|---|--|---|---|---|---|---|
| 1129 | <ul style="list-style-type: none"> <i>As-Built Description:</i> Elevator not provided in multistory building. <i>As-Built:</i> Only stairs provided for access to second floor <i>Proposed Solution:</i> Provide new elevator with two stops. <i>Notes:</i> Staff Only | <p>PCODE IK01REF</p> <p>ADAAG 91 4.1.3(5)</p> <p>ADA 2010 402.2</p> <p>CBC 2007 1007.2.1</p> <p>CBC 2016 11B-402.2</p> <p>Priority 4</p> <p>Severity 3</p> | | | | |

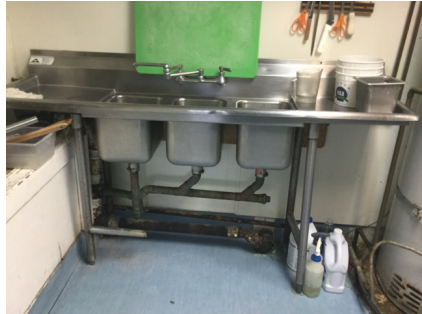
| Item No. and Name | Existing Architectural Barrier and Proposed Solution | Codes / Mitigation Info | Qty | Unit | Cost | Total |
|---|--|---|---|---|---|---|
| 1136 | <ul style="list-style-type: none"> <i>As-Built Description:</i> Sink rim higher than 34" above floor. <i>As-Built:</i> 37.75" high <i>Proposed Solution:</i> Remodel sink cabinet to lower sink. <i>Notes:</i> Staff Only | <p>PCODE IN06</p> <p>ADAAG 91 4.24.2</p> <p>ADA 2010 606.3</p> <p>CBC 2007 1115B.4.7.1</p> <p>CBC 2016 11B-606.3</p> <p>Priority 4</p> <p>Severity 4</p> | 1 | JOB | \$1,750 | \$1,750 |

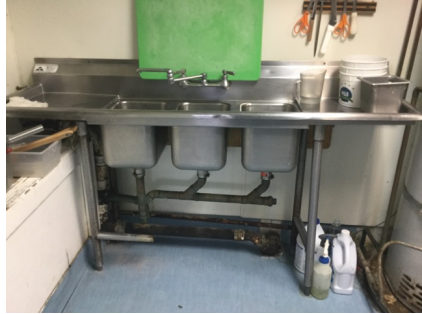
| Item No. and Name | Existing Architectural Barrier and Proposed Solution | Codes / Mitigation Info | Qty | Unit | Cost | Total |
|---|--|---|---|---|---|---|
| 1135 | <ul style="list-style-type: none"> <i>As-Built Description:</i> Sink does not have knee space min. 27" high x 19" deep x 30" wide. <i>Proposed Solution:</i> Remodel sink cabinet. | <p>PCODE IN06AREF</p> <p>ADAAG 91 4.24.3</p> <p>ADA 2010 606.2</p> <p>CBC 2007 1115B.4.7.1</p> <p>CBC 2016 11B-606.2</p> <p>Priority 4</p> <p>Severity 2</p> | | | | |

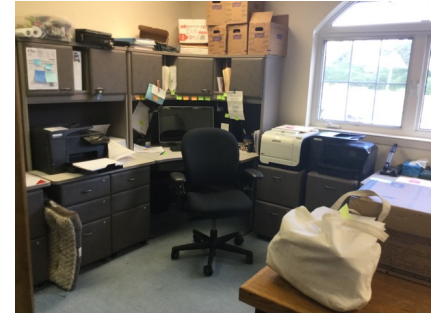
Non-Fixed Desk

- 1145
- *As-Built Description:*
Accessible non-fixed table or desk (top 28" to 34" high; knee space at least 27" high x 19" deep x 30" wide) not provided.
 - *As-Built:* **No knee spaces provided at desks**
 - *Proposed Solution:*
Provide table or desk with accessible dimensions when purchasing new furniture.
 - **Notes:**
Staff Only
4 computer desks

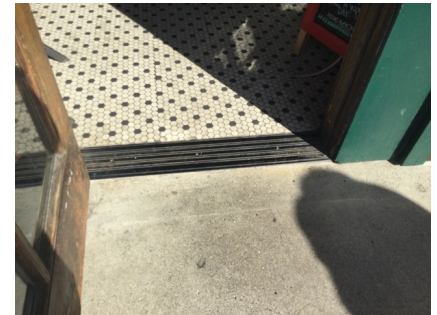
Door Threshold

- 1151
- *As-Built Description:*
Door inaccessible due to threshold or step at door exceeding 1/2".
 - *As-Built:* **1" threshold**
 - *Proposed Solution:*
Modify threshold to be no more than 1/2" by removing existing paving at door and providing landing with edge ramping (slope 1:20 max).

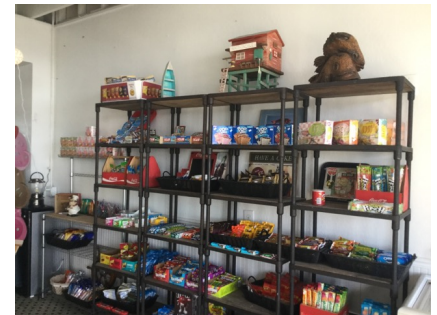
Reach Range

- 1155
- *As-Built Description:*
Reach height to control or access point, exceeds 48" or is less than 15".
 - *As-Built:* **51-64.75" high shelves**
 - *Proposed Solution:*
Modify equipment or mounting.
 - **Notes:**
Interim solution to provide assistance as needed

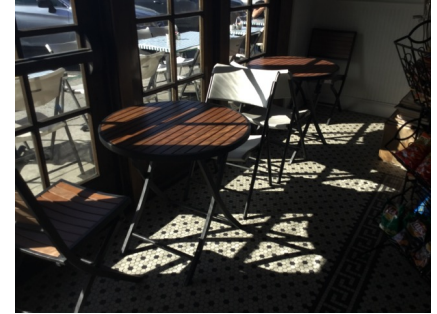
Non-Fixed Desk

| 1153 | <ul style="list-style-type: none"> <i>As-Built Description:</i> Accessible non-fixed table or desk (top 28" to 34" high; knee space at least 27" high x 19" deep x 30" wide) not provided. <i>As-Built:</i> No knee space at tables due to support base <i>Proposed Solution:</i> Provide table or desk with accessible dimensions when purchasing new furniture. <i>Notes:</i> 2 tables 4 seats | <p><i>PCODE</i> IN02A <i>ADAAG 91</i> 4.32.3 & .4 <i>ADA 2010</i> 306.1 <i>CBC 2007</i> 1122B.3 & 4 <i>CBC 2016</i> 11B-306.1 & 11B-902.3</p> <p>Priority 2 Severity 2</p> | 1 | JOB | \$1,600 | \$1,600 |

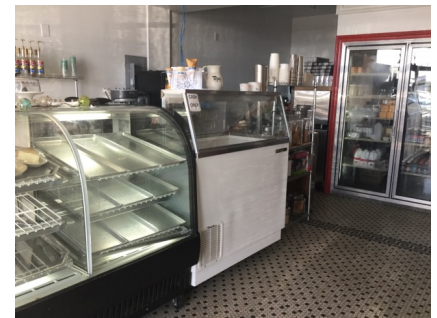
Public Counter

| 1154 | <ul style="list-style-type: none"> <i>As-Built Description:</i> Sales and service counter: Accessible section min. 36" length and 36" max. height (in CA: 28" to 34" high) not provided. <i>As-Built:</i> 57" high sales counter <i>Proposed Solution:</i> Provide auxiliary shelf, clipboard, or table as equivalent facilitation. <i>Notes:</i> Interim solution to provide Auxillary clipboards for sales as needed | <p><i>PCODE</i> IN03 <i>ADAAG 91</i> 7.2(2) <i>ADA 2010</i> 904.4 <i>CBC 2007</i> 1122B.4 <i>CBC 2016</i> 11B-904.4</p> <p>Priority 2 Severity 1</p> | 1 | JOB | \$150 | \$150 |

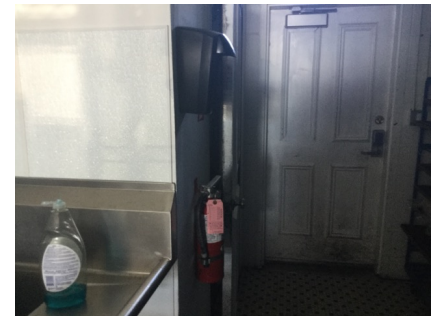
Protrusion Limits

| 1161 | <ul style="list-style-type: none"> <i>As-Built Description:</i> Protruding objects more than 4" from wall, when bottom of object more than 27" or less than 80" above finished floor. <i>As-Built:</i> SD and FE protrude into walk <i>Proposed Solution:</i> Remove/relocate protruding object. Patch existing surface. | <p><i>PCODE</i> EG04 <i>ADAAG 91</i> 4.4.1 <i>ADA 2010</i> 307.2 <i>CBC 2007</i> 1133B.8.6.1 <i>CBC 2016</i> 11B-307.2</p> <p>Priority 4 Severity 4</p> | 1 | JOB | \$100 | \$100 |

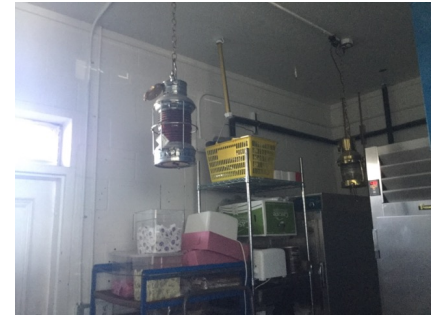
| 1164 | <ul style="list-style-type: none"> • <i>As-Built Description:</i> Overhead clearance less than 80" above finished floor. • <i>As-Built:</i> 77.5" high lights • <i>Proposed Solution:</i> Modify overhead clearance. • <i>Notes:</i> Staff Only | <p><i>PCODE</i> EG01REF <i>ADAAG 91</i> 4.4.2 <i>ADA 2010</i> 307.4 <i>CBC 2007</i> 1133B.8.6.2 <i>CBC 2016</i> 11B-307.4</p> <p>Priority 4 Severity 2</p> | | | | |

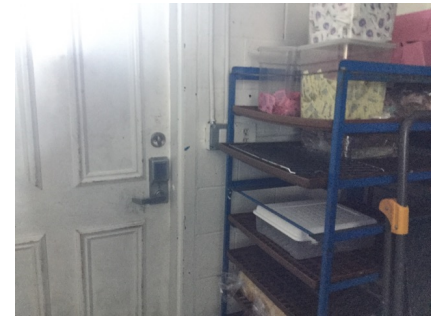
Electrical

| 1171 | <ul style="list-style-type: none"> • <i>As-Built Description:</i> Electric switch or control mounted less than 15" measured to the bottom of the outlet box or greater than 48 inches measured to the top of the outlet box. • <i>As-Built:</i> 50.5" high light switch • <i>Proposed Solution:</i> Relocate light switches or control to between 15" and 48" height. | <p><i>PCODE</i> IC01 <i>ADAAG 91</i> 4.2.5 & 6 <i>ADA 2010</i> 308.2.1 & 308.2.2 <i>CBC 2007</i> 1117B.6.3 <i>CBC 2016</i> 11B-308.2.1 & 11B-308.2.2</p> <p>Priority 4 Severity 4</p> | 1 | JOB | \$300 | \$300 |

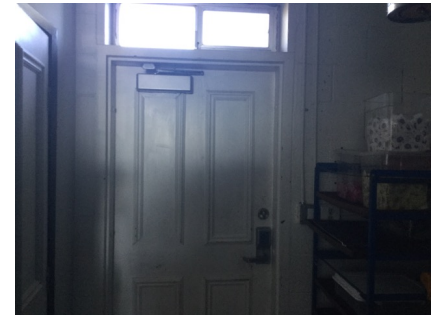
Door Closer

| 1163 | <ul style="list-style-type: none"> • <i>As-Built Description:</i> Excessive force required to open door. • <i>As-Built:</i> 15 lbs • <i>Proposed Solution:</i> Adjust regular door closer to accessible standards (5 lbs. max). | <p><i>PCODE</i> ID03 <i>ADAAG 91</i> 4.13.11 <i>ADA 2010</i> 404.2.9 <i>CBC 2007</i> 1133B.2.5 <i>CBC 2016</i> 11B-404.2.9</p> <p>Priority 4 Severity 3</p> | 1 | JOB | \$25 | \$25 |

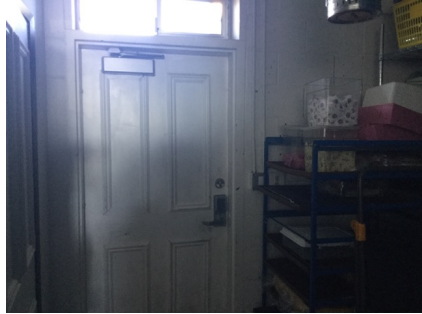
| Item No. and Name | Existing Architectural Barrier and Proposed Solution | Codes / Mitigation Info | Qty | Unit | Cost | Total |
|---|---|--|---|---|---|---|
| <u>Door Swing</u> | | | | | | |

| Item No. and Name | Existing Architectural Barrier and Proposed Solution | Codes / Mitigation Info | Qty | Unit | Cost | Total |
|---|---|--|---|---|---|---|
| 1162 | <ul style="list-style-type: none"> • <i>As-Built Description:</i> Front approach: At push side, door does not have clear and level maneuvering space measuring door width x 48" (door width plus 12" if door has both, latch and closer). • <i>As-Built:</i> 6" to food tray shelf • <i>Proposed Solution:</i> Remove or relocate furniture or storage items. | <p>PCODE ID24A ADAAG 91 Fig. 25(a) ADA 2010 404.2.4 CBC 2007 11B-26A(a) CBC 2016 11B-404.2.4</p> <p>Priority 4 Severity 4</p> | 1 | JOB | \$50 | \$50 |

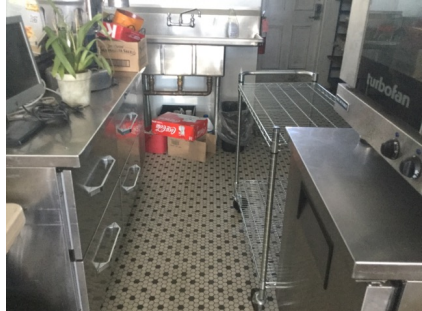
| Item No. and Name | Existing Architectural Barrier and Proposed Solution | Codes / Mitigation Info | Qty | Unit | Cost | Total |
|---|---|--|---|---|---|---|
| 1156 | <ul style="list-style-type: none"> • <i>As-Built Description:</i> Corridor, for occupant load less than 10, less than 36" wide. • <i>As-Built:</i> 25" wide • <i>Proposed Solution:</i> Remove or relocate furniture and storage items. • Notes: Staff Only | <p>PCODE IH03A ADAAG 91 4.3.3 ADA 2010 403.5.1 CBC 2007 1133B.3.1 CBC 2016 11B-403.5.1</p> <p>Priority 4 Severity 4</p> | 1 | JOB | \$50 | \$50 |
| 1157 | <ul style="list-style-type: none"> • <i>As-Built Description:</i> Corridor, for occupant load less than 10, less than 36" wide. • <i>As-Built:</i> 25.5" wide • <i>Proposed Solution:</i> Remove or relocate furniture and storage items. | <p>PCODE IH03A ADAAG 91 4.3.3 ADA 2010 403.5.1 CBC 2007 1133B.3.1 CBC 2016 11B-403.5.1</p> <p>Priority 4 Severity 4</p> | 1 | JOB | \$50 | \$50 |

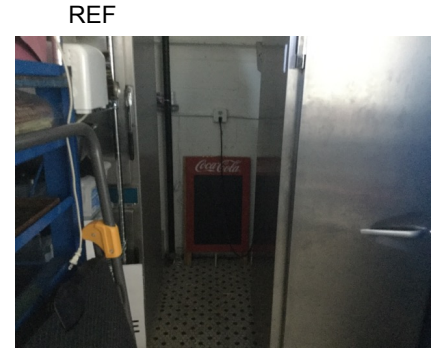
| Item No. and Name | Existing Architectural Barrier and Proposed Solution | Codes / Mitigation Info | Qty | Unit | Cost | Total |
|---|--|--|---|---|---|---|
| 1165 | <ul style="list-style-type: none"> <i>As-Built Description:</i> Corridor, for occupant load less than 10, less than 36" wide. <i>As-Built:</i> 22.5" wide <i>Proposed Solution:</i> Remove or relocate furniture and storage items. <i>Notes:</i> Staff Only | PCODE IH03AREF ADAAG 91 4.3.3 ADA 2010 403.5.1 CBC 2007 1133B.3.1 CBC 2016 11B-403.5.1 Priority 4 Severity 4 | | | | |

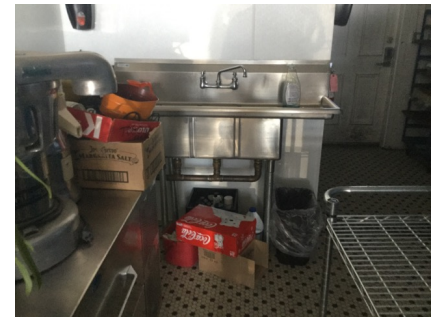
| 1159 | <ul style="list-style-type: none"> <i>As-Built Description:</i> Sink rim higher than 34" above floor. <i>As-Built:</i> 39" high <i>Proposed Solution:</i> Remodel sink cabinet to lower sink. | PCODE IN06 ADAAG 91 4.24.2 ADA 2010 606.3 CBC 2007 1115B.4.7.1 CBC 2016 11B-606.3 Priority 4 Severity 4 | 1 | JOB | \$1,750 | \$1,750 |

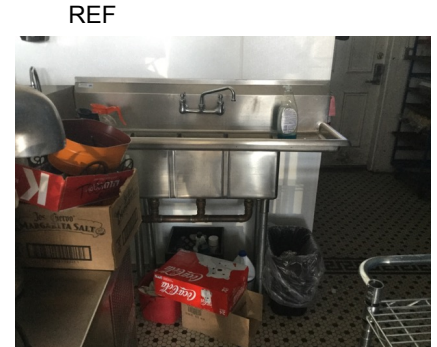
| 1158 | <ul style="list-style-type: none"> <i>As-Built Description:</i> Sink does not have knee space min. 27" high x 19" deep x 30" wide. <i>Proposed Solution:</i> Remodel sink cabinet. | PCODE IN06AREF ADAAG 91 4.24.3 ADA 2010 606.2 CBC 2007 1115B.4.7.1 CBC 2016 11B-606.2 Priority 4 Severity 2 | | | | |

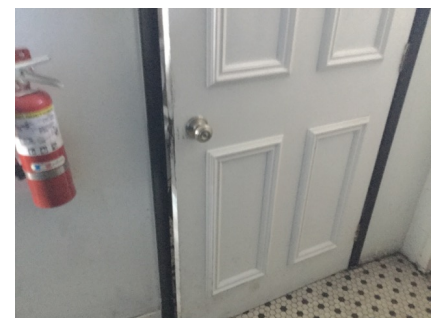
Door Hardware

| 1166 | <ul style="list-style-type: none"> <i>As-Built Description:</i> Door does not have accessible operating hardware. <i>Proposed Solution:</i> Provide lever handle or other accessible hardware. | PCODE ID07 ADAAG 91 4.13.9 ADA 2010 404.2.7 CBC 2007 1133B.2.5.2 CBC 2016 11B-404.2.7 Priority 4 Severity 3 | 1 | JOB | \$250 | \$250 |

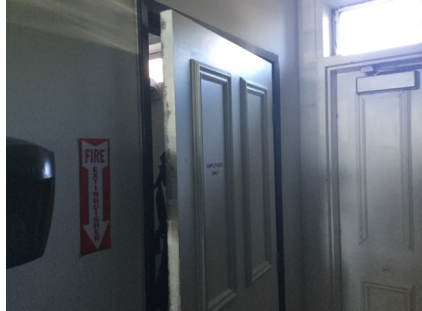
| Item No. and Name | Existing Architectural Barrier and Proposed Solution | Codes / Mitigation Info | Qty | Unit | Cost | Total |
|---|---|--|---|---|---|---|
| 1167 | <ul style="list-style-type: none"> <i>As-Built Description:</i> Entrance to toilet or bathing facility identified with California signage on door leaf not identified with ADAAG compliant signage. <i>Proposed Solution:</i> Provide ADAAG compliant sign with raised letters and pictogram, mounted 5' high on center on nearest adjacent wall, on latch side of a single door. Notes: Accessible restroom provided in adjacent Princeton Seafood restaurant | PCODE SA11AREF ADAAG 91 4.1.3(16)(a) ADA 2010 216.8 CBC 2016 11B-216.8 Priority 4 Severity 3 | | | | REF |

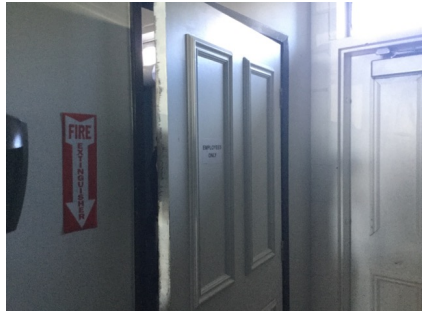
| Item No. and Name | Existing Architectural Barrier and Proposed Solution | Codes / Mitigation Info | Qty | Unit | Cost | Total |
|---|---|--|---|---|---|---|
| 1168 | <ul style="list-style-type: none"> <i>As-Built Description:</i> Required in CA only: identification symbol centered 58" to 60" high on sanitary facility door that contrasts with the door not provided (women: 12" ø circle, men: 12" triangle, unisex: combined symbol). <i>Proposed Solution:</i> Provide properly mounted sanitary facility symbol when altering area. If wheelchair accessible, include International Symbol of Accessibility on sign. | PCODE SA15REF CBC 2007 1115B.6 CBC 2016 11B-703.7.2.6 Priority 4 Severity 3 | | | | REF |

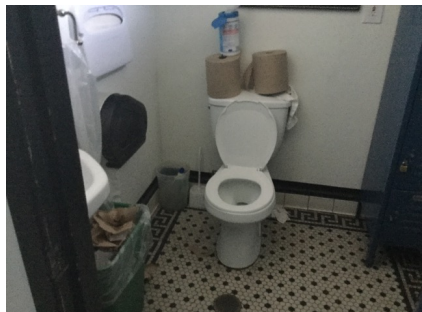
| Item No. and Name | Existing Architectural Barrier and Proposed Solution | Codes / Mitigation Info | Qty | Unit | Cost | Total |
|---|---|--|---|---|---|---|
| 1169 | <ul style="list-style-type: none"> <i>As-Built Description:</i> Single accommodation restroom not accessible; multiple compliance violations. <i>As-Built:</i> Multiple compliance violations <i>Proposed Solution:</i> Remodel area to provide single-occupant accessible restroom. Notes: Accessible restroom provided in adjacent Princeton Seafood restaurant | PCODE WA01REF ADAAG 91 4.22 ADA 2010 603.1 CBC 2007 1115B.3.2 CBC 2016 11B-603.1 Priority 4 Severity 2 | | | | REF |

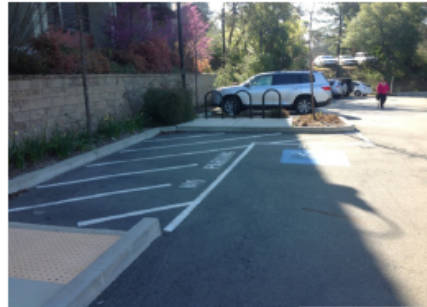
| Item No. and Name | Existing Architectural Barrier and Proposed Solution | Codes / Mitigation Info | Qty | Unit | Cost | Total |
|---|---|---|--|---|---|---|
| 102 | <ul style="list-style-type: none"> <i>As-Built Description:</i> Accessible parking space does not have 5' wide access aisle; 8' wide for van accessible aisle. <i>As-Built:</i> 16'-6" long to built up curb <i>Proposed Solution:</i> Modify parking aisle(s) to create accessible space by restriping. <i>Notes:</i> Overall length 21'-3" curb to curb | PCODE EA02B ADAAG 4.6.3 ADA-2010 502.3 CSAS 1129B.3.1 Priority 1 Severity 4 City Hall Exterior Upgrades 4/9/2014 | 1 | JOB | \$200 | \$200 |

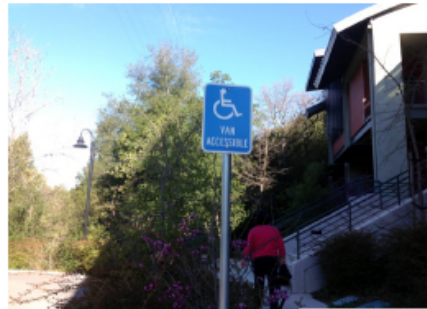
| Item No. and Name | Existing Architectural Barrier and Proposed Solution | Codes / Mitigation Info | Qty | Unit | Cost | Total |
|---|---|---|--|---|---|---|
| 101 | <ul style="list-style-type: none"> <i>As-Built Description:</i> CA only: Additional Sign or additional language below the symbol of accessibility stating "Minimum Fine \$250" not provided. <i>Proposed Solution:</i> Provide compliant parking signage that includes fine information. | PCODE EA04G CSAS 1129B.4 Priority 5 Severity 4 City Hall Exterior Upgrades 4/9/2014 | 1 | JOB | \$100 | \$100 |
