SAN MATEO COUNTY HARBOR DISTRICT  
STRATEGIC BUSINESS PLAN  
**EXISTING INFRASTRUCTURE &  
FACILITIES ASSESSMENT**  
DRAFT, DECEMBER 2014

**A.3. MARINE INFRASTRUCTURE & HARBOR FACILITIES ASSESSMENT –  
PILLAR POINT HARBOR**

**A.4. MARINE INFRASTRUCTURE & HARBOR FACILITIES ASSESSMENT –  
OYSTER POINT MARINA PARK**

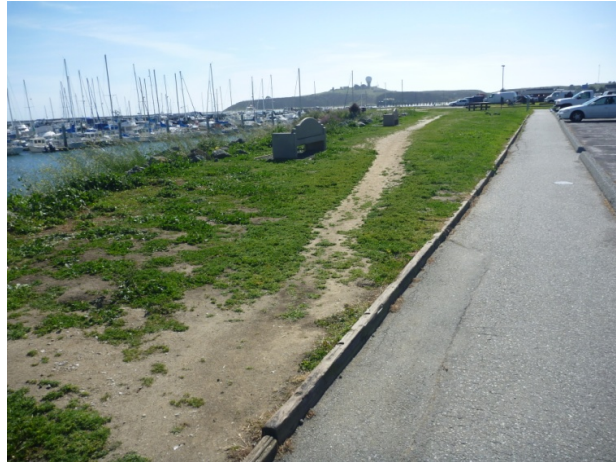
*PHOTOGRAPH 16: LANDSCAPED AREA BETWEEN PARKING LOT & HARBOR WATERS*

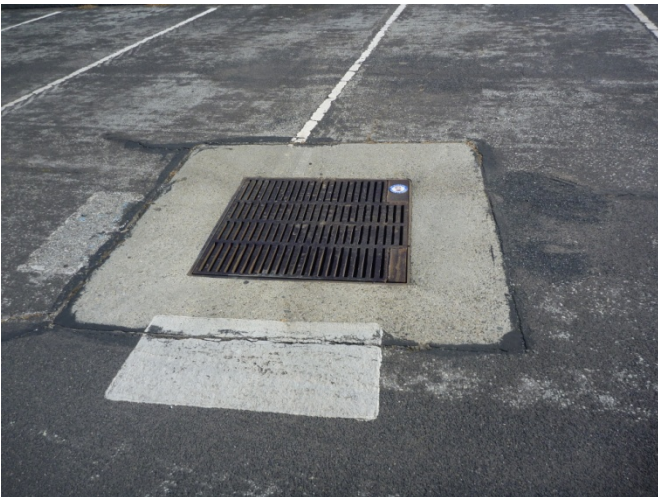
*PHOTOGRAPH 15: STORM DRAIN DROP INLET*

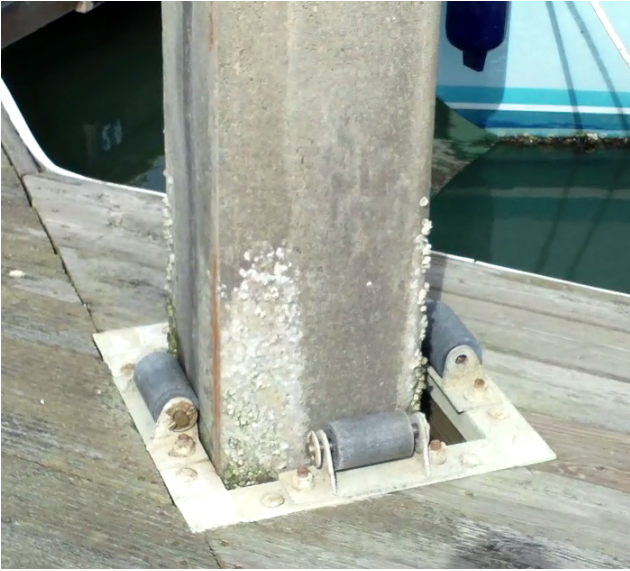
PHOTOGRAPH 1: TYPICAL PILE GUIDE -GOOD  
CONDITION (DOCK)

The pile guides at all the docks consist of steel angles bolted to the dock surface. Photograph 1 in Attachment A shows a typical pile guide in good condition. The pile guides are generally in good condition, with a few exceptions. The following pile guides should be replaced within the next two years due to missing bolts or corrosion, four pile guides at Dock 1 (Photograph 1 and Photograph 2,) one at Dock 2, and one at Dock 3.

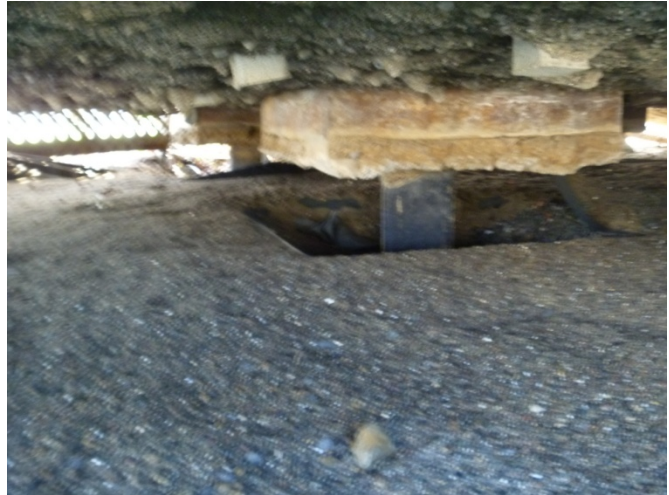
PHOTOGRAPH 3: HARBOR MASTER'S OFFICE BUILDING

This one story 1,220 square foot building was constructed in the early 1980s and structurally appears to be in fair condition. The roof consists of 1/2" plywood over 2x6 decking with heavy timber framing supported by timber pole columns. The foundation consists of a 12" thick reinforced concrete mat over nine 12" square by 125 foot long concrete pilings. The lateral force resisting system appears to be conventional wood framed shear walls. The finishes consist of wood shake roofing, exterior T1-11 wood siding and interior gypsum board. It is evident that the ground has settled significantly below this building (Photograph 3). The stability of the building is not compromised by this condition due to the deep foundations. It was reported that during high tides of +6.9 or greater the access road to this building and its parking lot are below water.

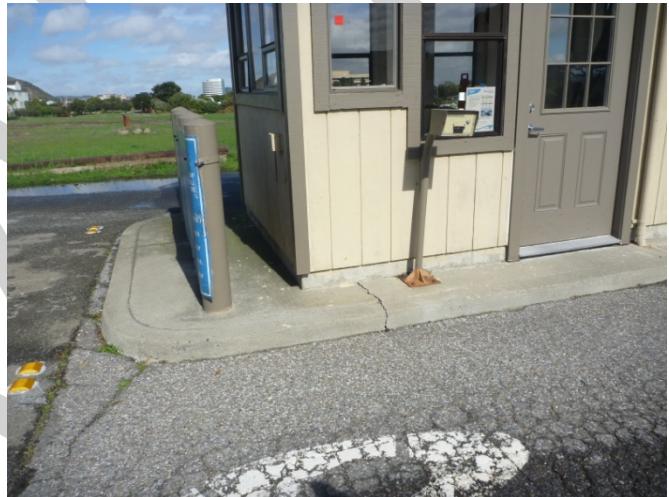
PHOTOGRAPH 4: KIOSK BUILDING

This is a small one story 100 square foot building constructed in the early 1980s and structurally appears to be in fair condition. The roof consists of conventional wood framing over stud walls with a 4" thick slab on grade. The finishes consist of wood shake roofing, exterior T1-11 wood siding and interior gypsum board. The raised concrete pad beyond the kiosk's foundation appears to have settlement cracks (Photograph 4).

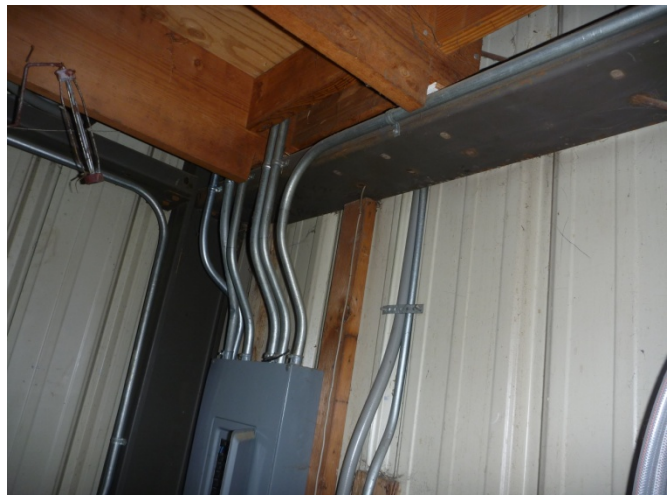
PHOTOGRAPH 5: MAINTENANCE BUILDING

This one story 2,300 square foot prefabricated metal building was constructed in the early 1980s and structurally appears to be in fair condition. The roof consists of standing seam metal panels over cold formed steel purlins over rigid steel frames. The exterior has metal siding with horizontal wall girts between frame columns. The foundation consists of a slab on grade with a masonry retaining wall on the south side of the building. The interior space has been in filled with partition walls with gypsum board finishes. A wood framed mezzanine has been added to the west end of the building. The mezzanine is supported by wood posts at its center and supported by wall girts on its north side and a masonry wall on its south side. It appears that the mezzanine's load on the wall girt may have bowed out the wall at the northwest corner of the building (Photograph 5).
