San Mateo County Harbor District

West Trail Repair – Phase 1 Conceptual Alternatives Analysis

September 2016

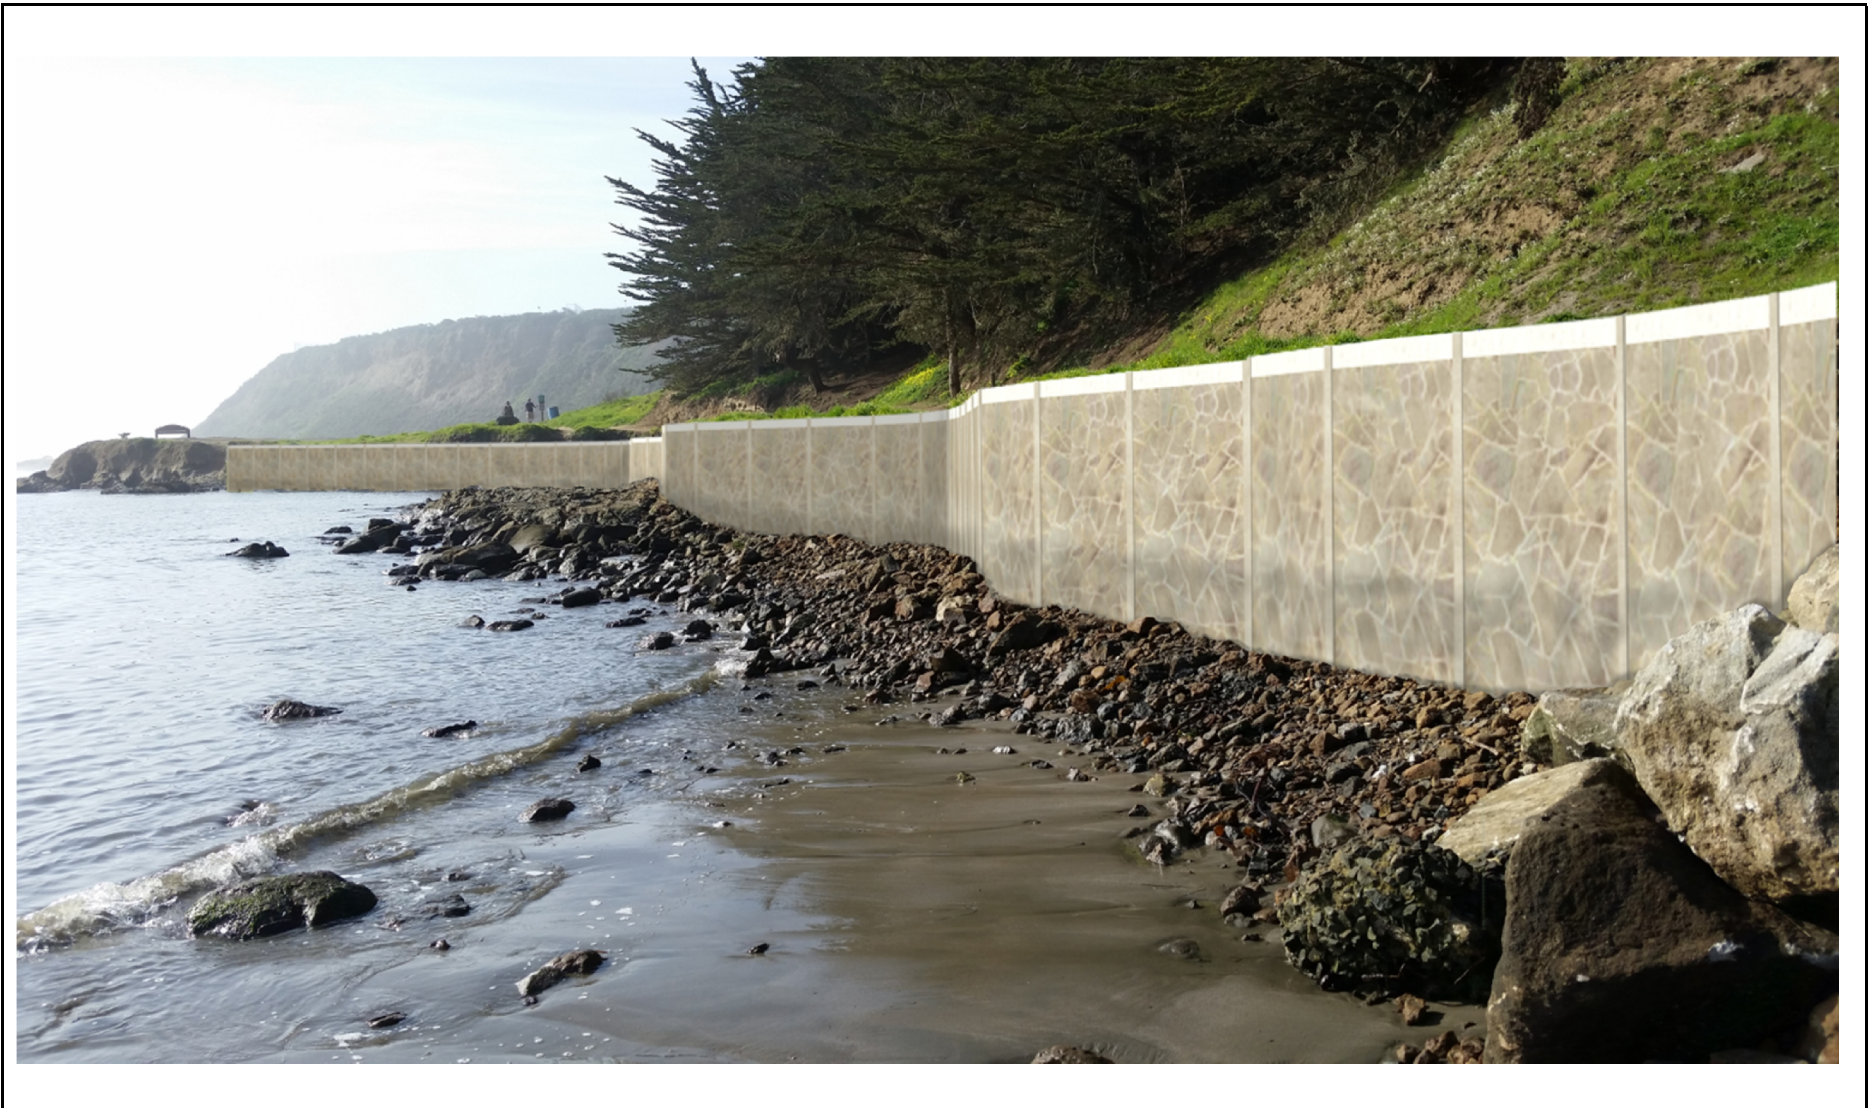
Figure 4A

SAN MATEO COUNTY HARBOR DISTRICT
PILLAR POINT HARBOR
WEST TRAIL REPAIR - PHASE 1
SOLDIER PILE WALL RENDERINGS
VIEW FROM BEACH

The soldier pile wall would consist of precast reinforced concrete lagging placed between steel soldier piles. The concrete lagging would be textured to be more aesthetically pleasing and blend better with the surrounding area as shown in Figures 4A and 4B, from two vantage points. The lagging would need to be secured at the top to prevent adverse movement due to wave action and may be built to an elevation of 12.7 feet to provide a consistent six inch high curb along the trail.

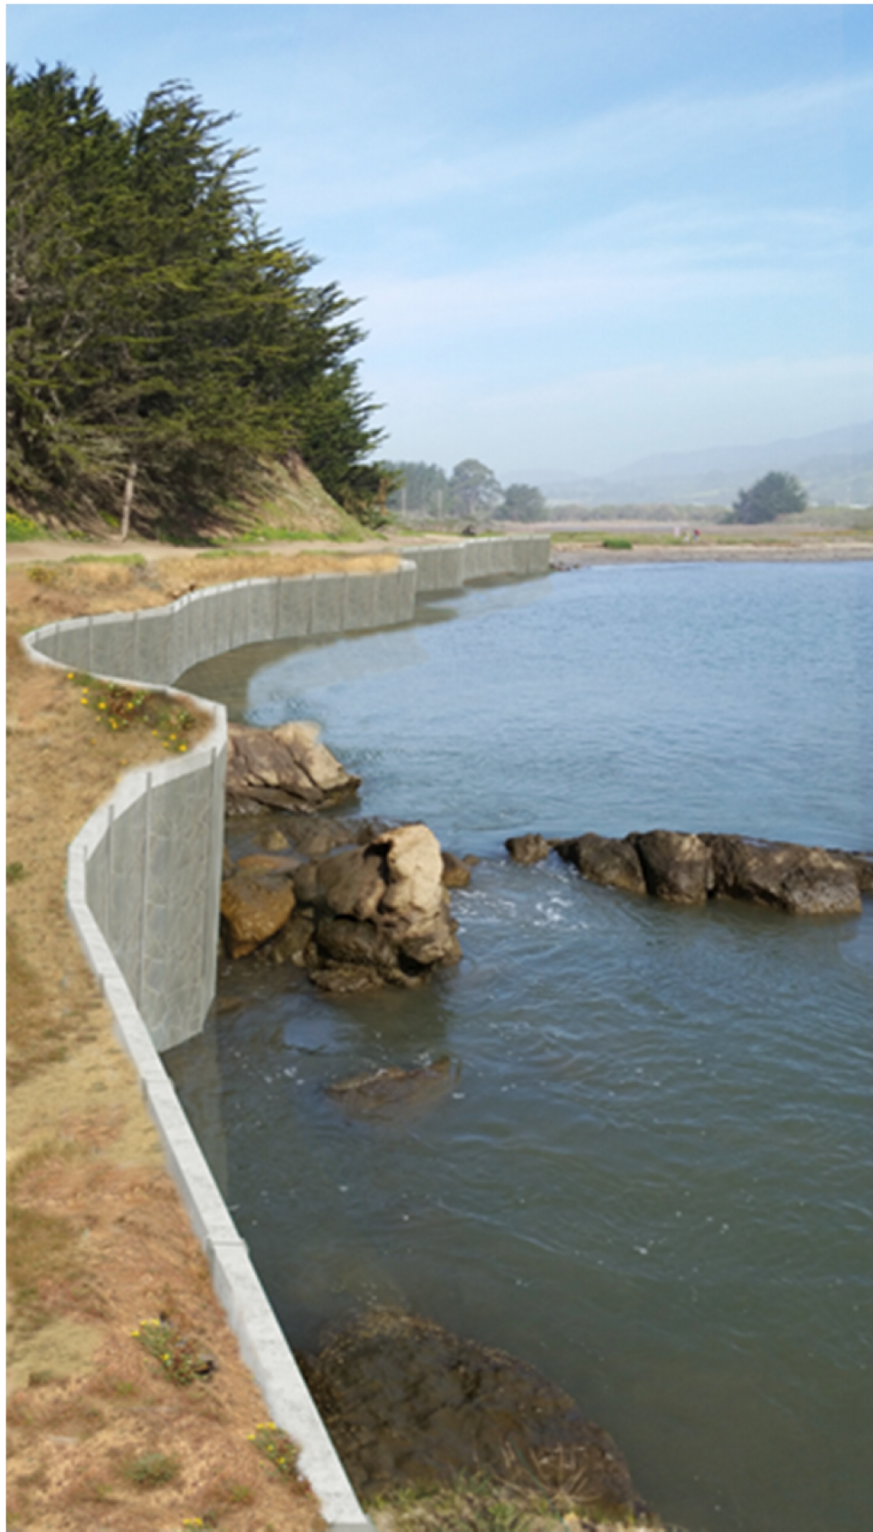
Figure 4B

SAN MATEO COUNTY HARBOR DISTRICT
PILLAR POINT HARBOR
WEST TRAIL REPAIR - PHASE 1
SOLDIER PILE WALL RENDERINGS
VIEW FROM LABYRINTH

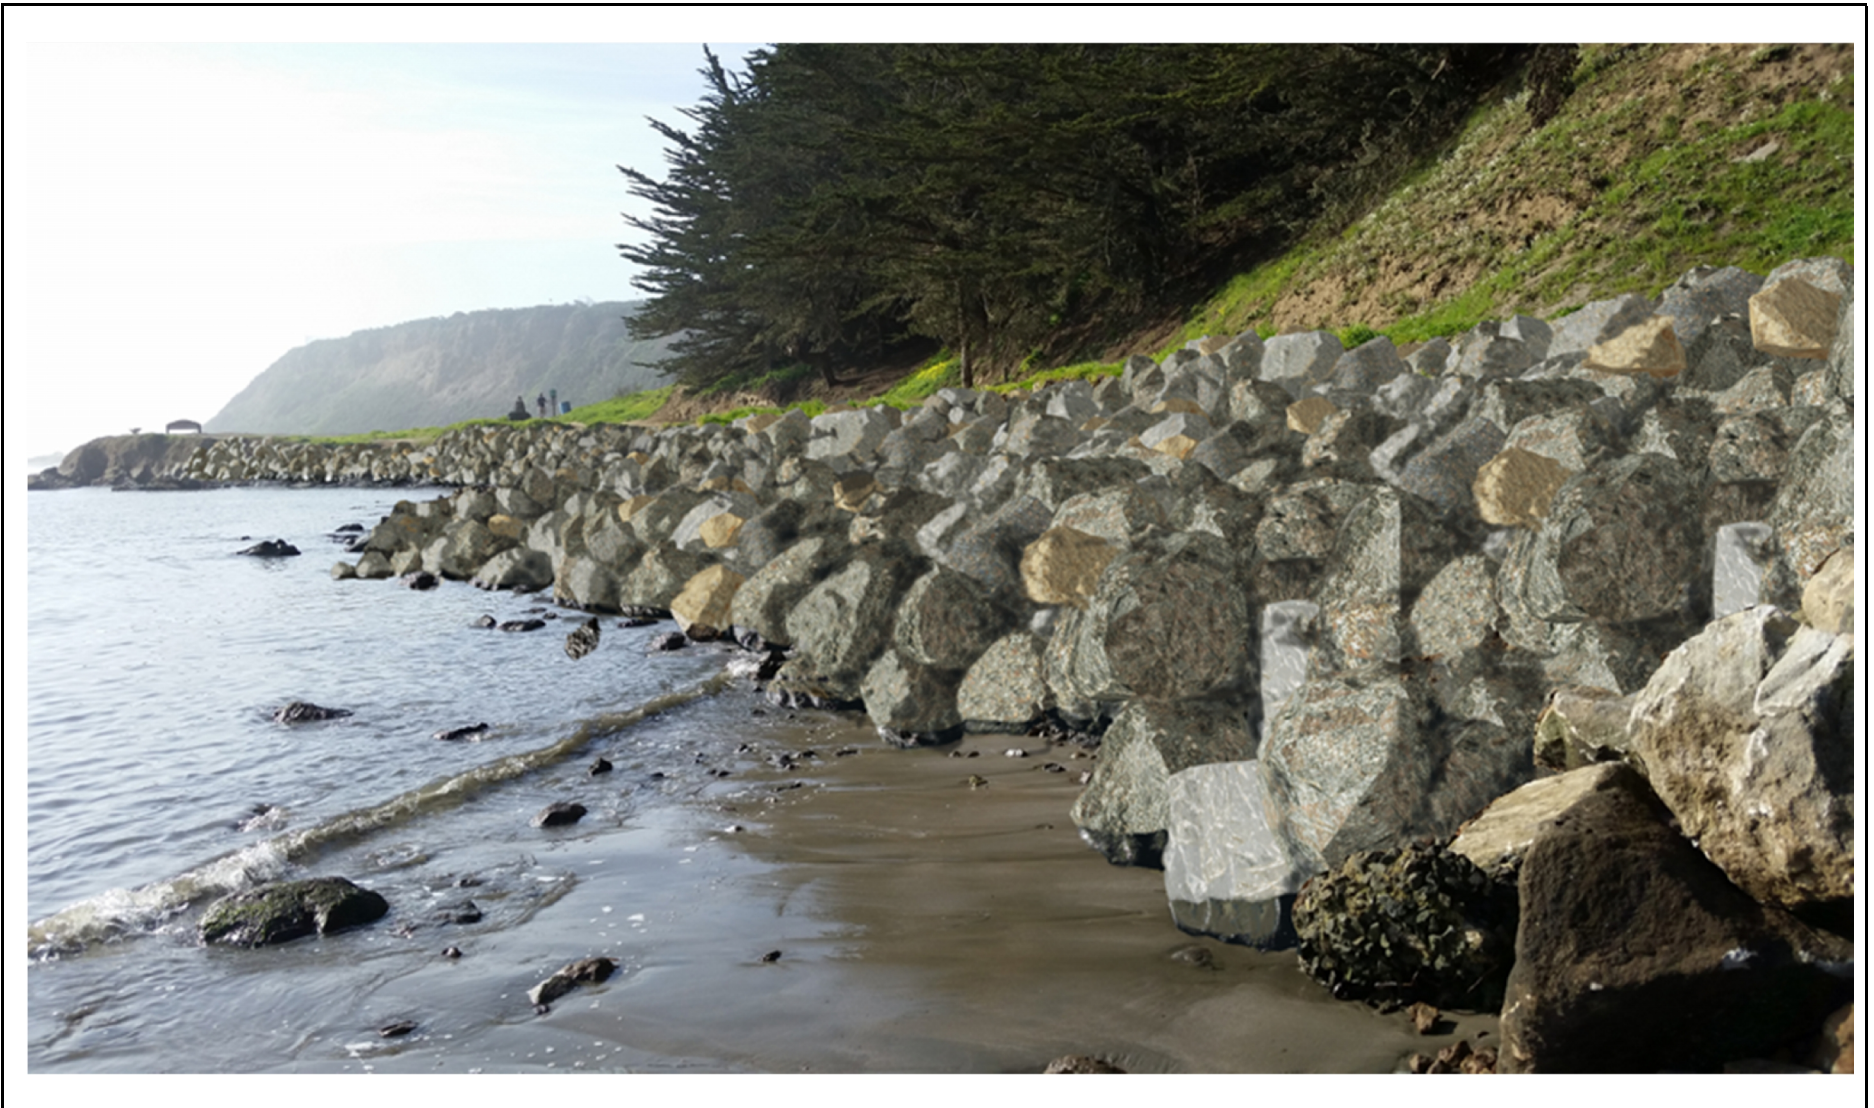
Figure 5A

SAN MATEO COUNTY HARBOR DISTRICT
PILLAR POINT HARBOR
WEST TRAIL REPAIR - PHASE 1
ROCK SLOPE PROTECTION RENDERING
VIEW FROM BEACH

Rock slope protection, alternatively called RSP or rip rap revetment, would consist of placing large rock boulders against the bank and at a 1.5H:1V transition to the shore. As recommended by Fisher's Geotechnical Study (2012), a toe key or trench would be excavated to a depth of three feet below grade to provide stability of the revetment. The geotechnical study also anticipates exposed bedrock along the majority of the key. Geotextile fabric would be sandwiched between the existing slope and the revetment for approximately 300 feet. Rip rap would have a maximum diameter of 2.8 feet with voids filled with smaller rock. Figures 5A and 5B provide conceptual views of this alternative from two vantage points.

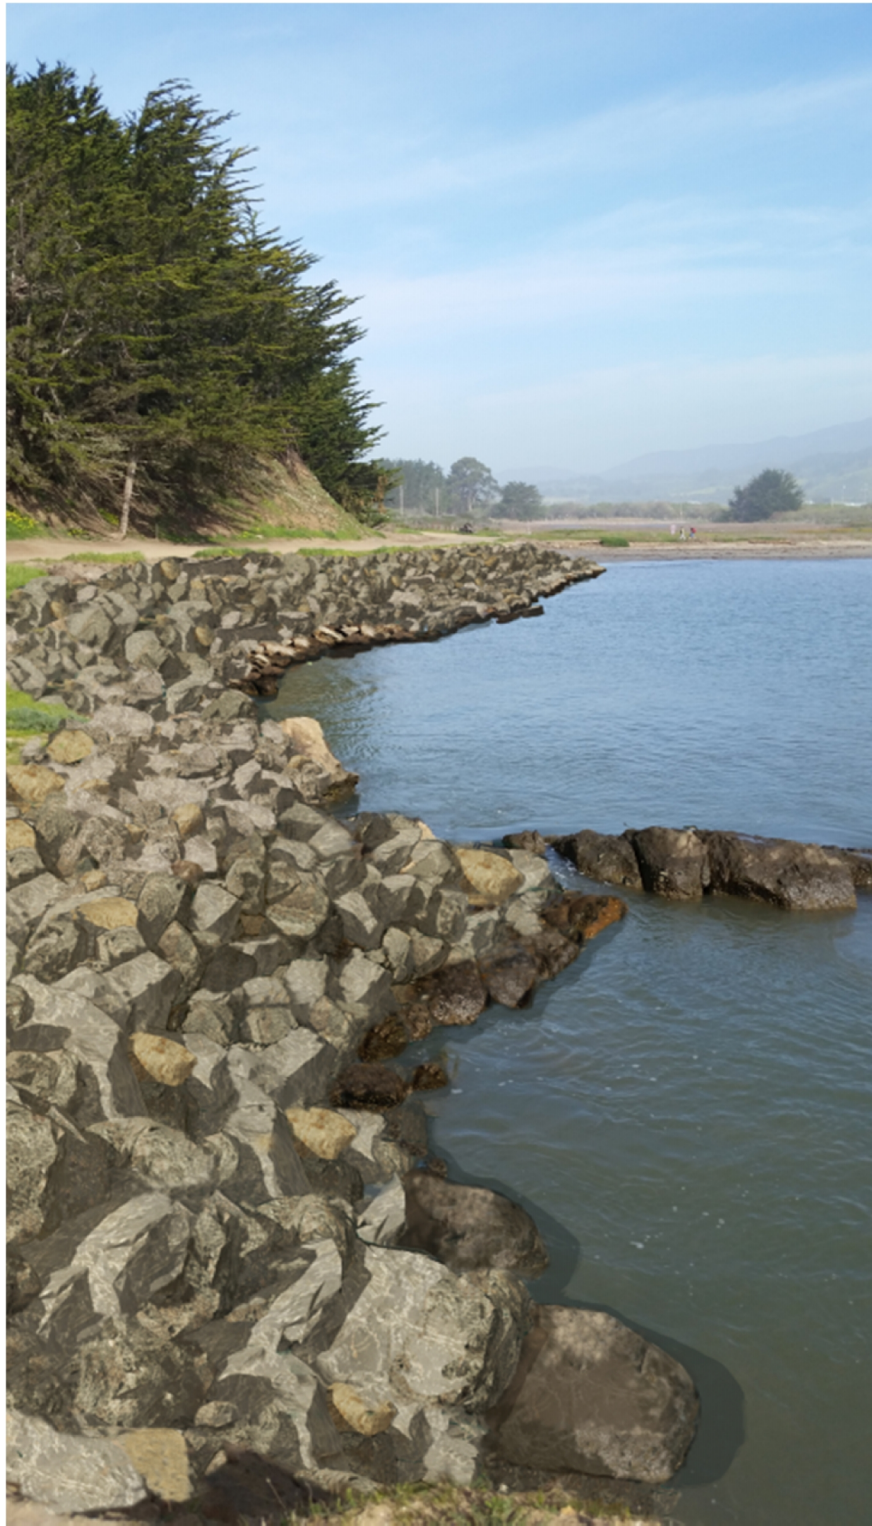
Figure 5B

SAN MATEO COUNTY HARBOR DISTRICT
PILLAR POINT HARBOR
WEST TRAIL REPAIR - PHASE 1
ROCK SLOPE PROTECTION RENDERING
VIEW FROM LABYRINTH

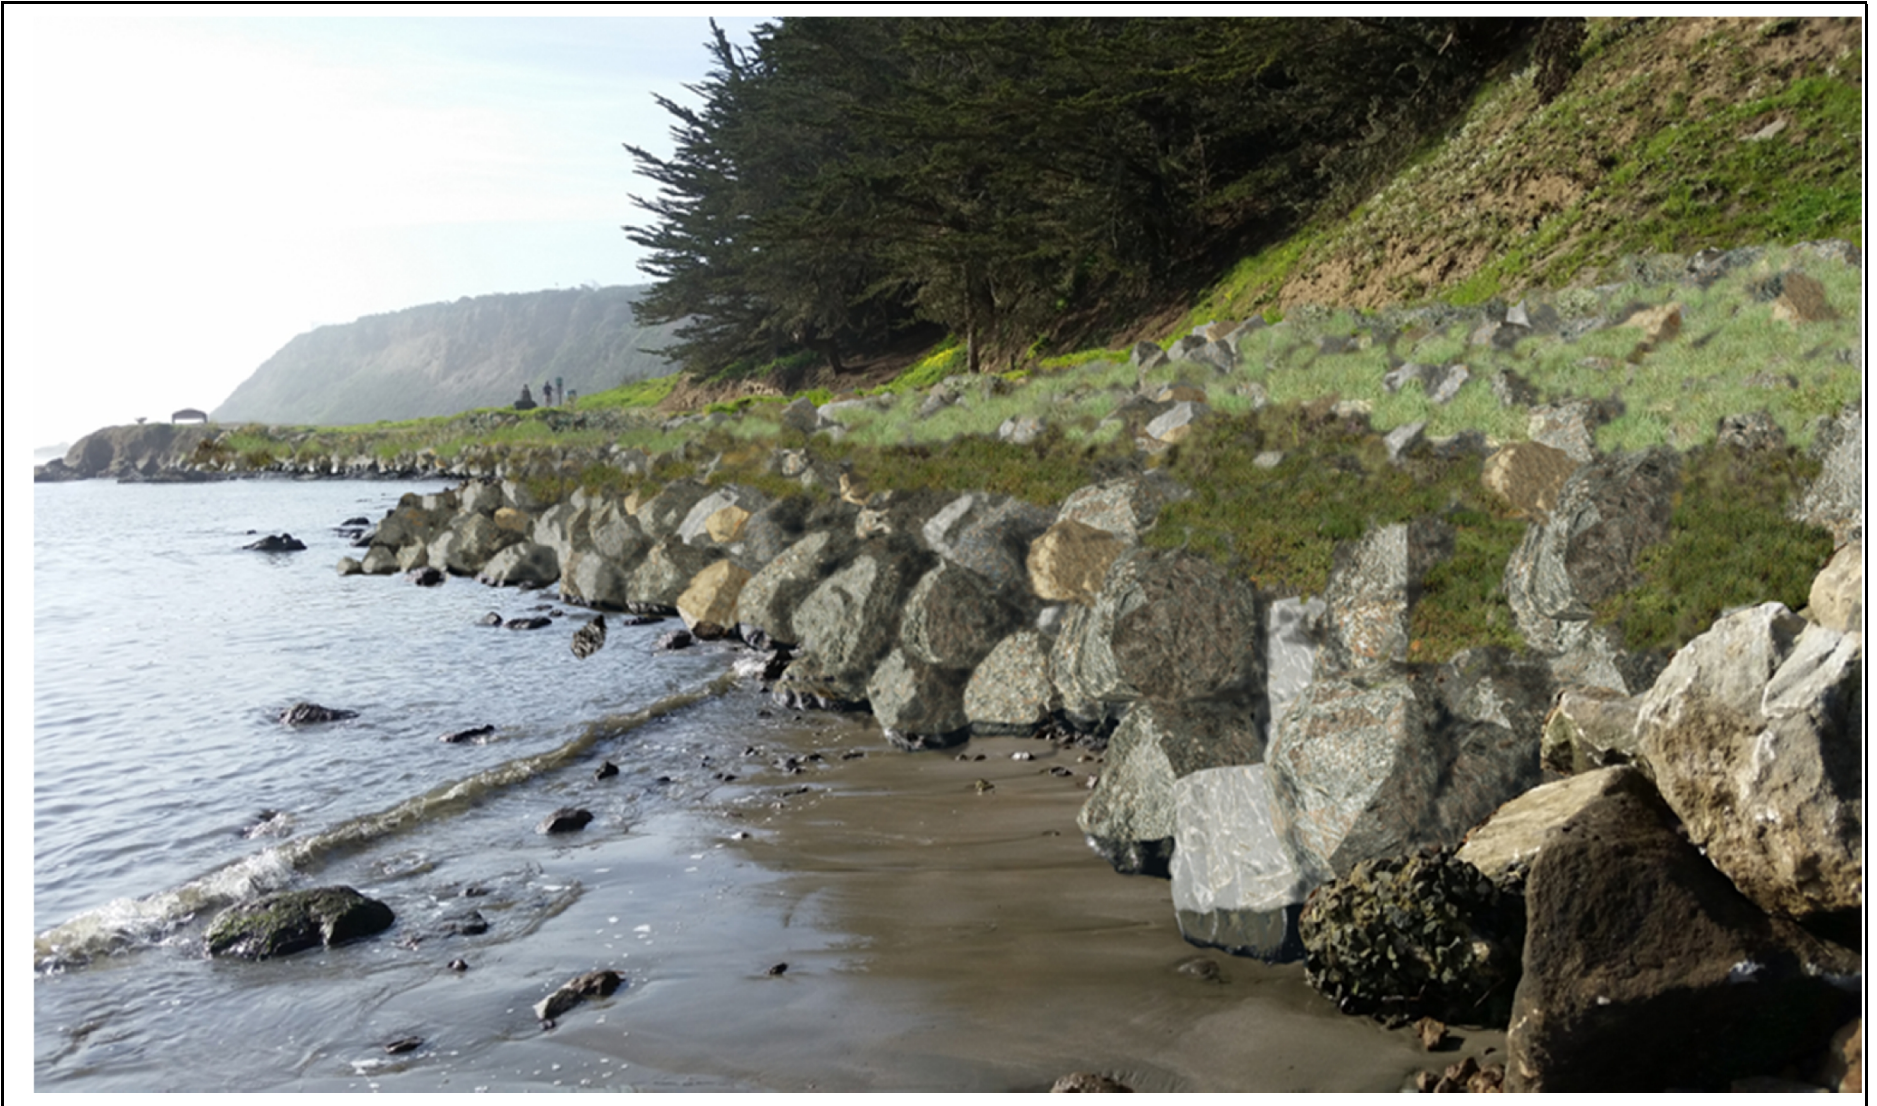
SAN MATEO COUNTY HARBOR DISTRICT
PILLAR POINT HARBOR
WEST TRAIL REPAIR - PHASE 1
ROCK SLOPE PROTECTION WITH VEGETATION RENDERING
VIEW FROM BEACH

AUG 2016
Figure 6A

Rock slope protection with vegetation is similar to Alternative 2 described above. However, instead of smaller rock being placed between the voids of the larger rocks, vegetation can be planted. The selection of planting proposed is dependent on the tidal elevations. Proposed plantings above wave action include California sagebrush, coyote bush, maritime brome, tufted hair grass, and bluff lettuce. Plantings within the area most vulnerable to wave action, but above the mean high tide, include beach saltbush, and salt grass. In the lower zone, still susceptible to wave action through to low tide, alkali heath, pickleweed, and fleshy jaumea are proposed. No planting is proposed below low tide. Figure 7A and 7B provide conceptual views of the proposed plantings per zone from two vantage points. Figure 7C provides a schematic rendering of rock slope protection with vegetation.

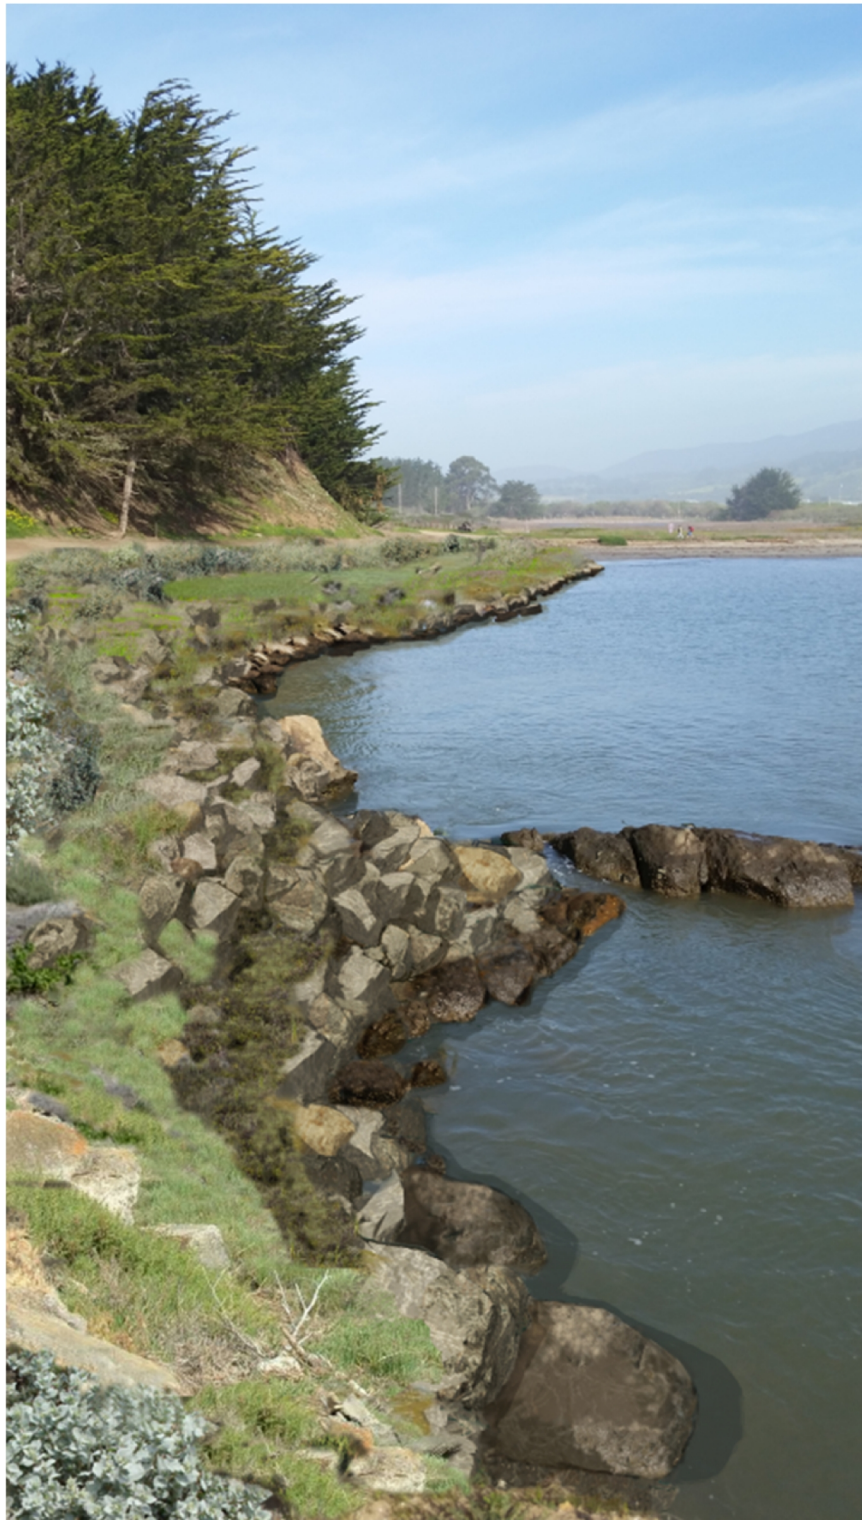
Figure 6B

SAN MATEO COUNTY HARBOR DISTRICT
PILLAR POINT HARBOR
WEST TRAIL REPAIR - PHASE 1
ROCK SLOPE PROTECTION WITH VEGETATION RENDERING
VIEW FROM LABYRINTH

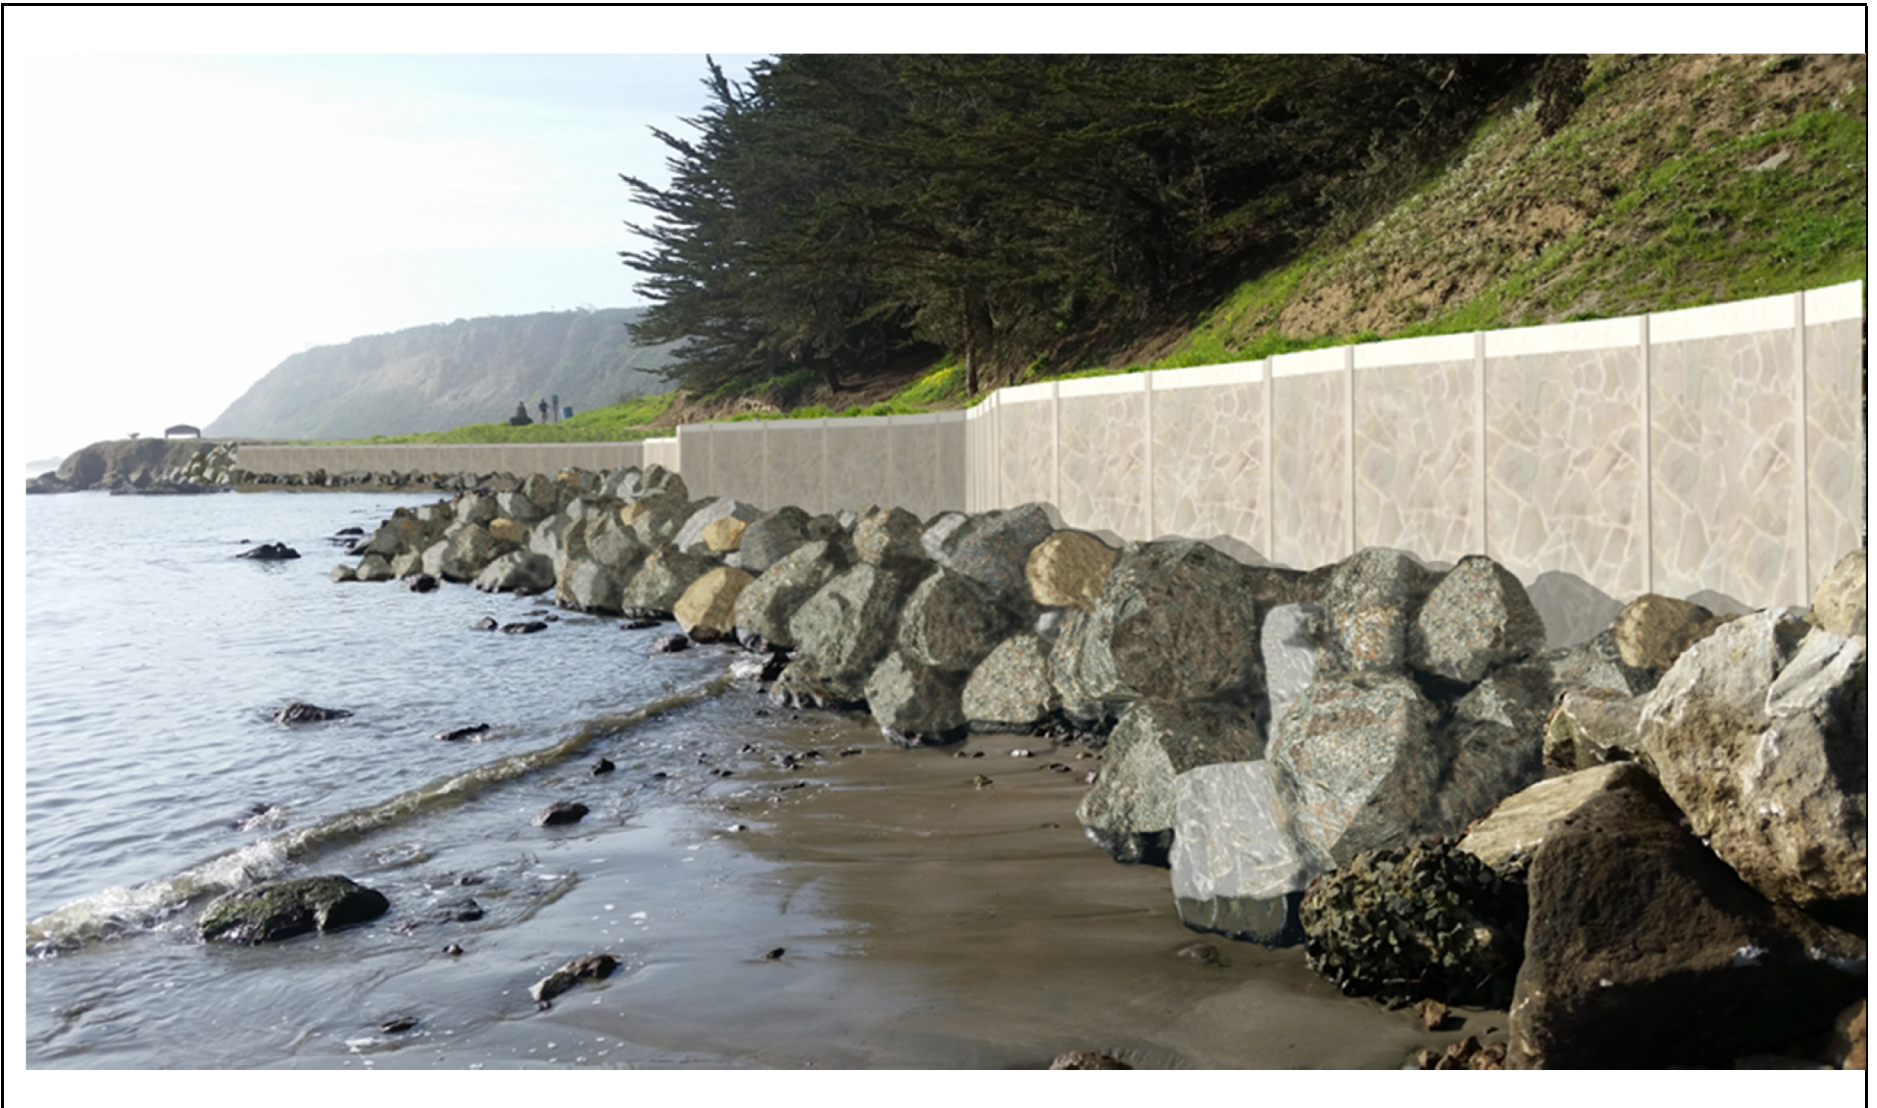
Figure 7A

SAN MATEO COUNTY HARBOR DISTRICT
PILLAR POINT HARBOR
WEST TRAIL REPAIR - PHASE 1
HYBRID ALTERNATIVE RENDERING - COMBINING ALTERNATIVES 1 & 2
VIEW FROM BEACH

Figures 6A and 6B provide a hybrid alternative combining Alternatives 1 and 2, utilizing both a soldier pile wall and rock slope protection. The hybrid alternative provides more aesthetic appeal, but there would be no cost savings with this alternative. Concepts are provided for reference should the District wish to explore this option.

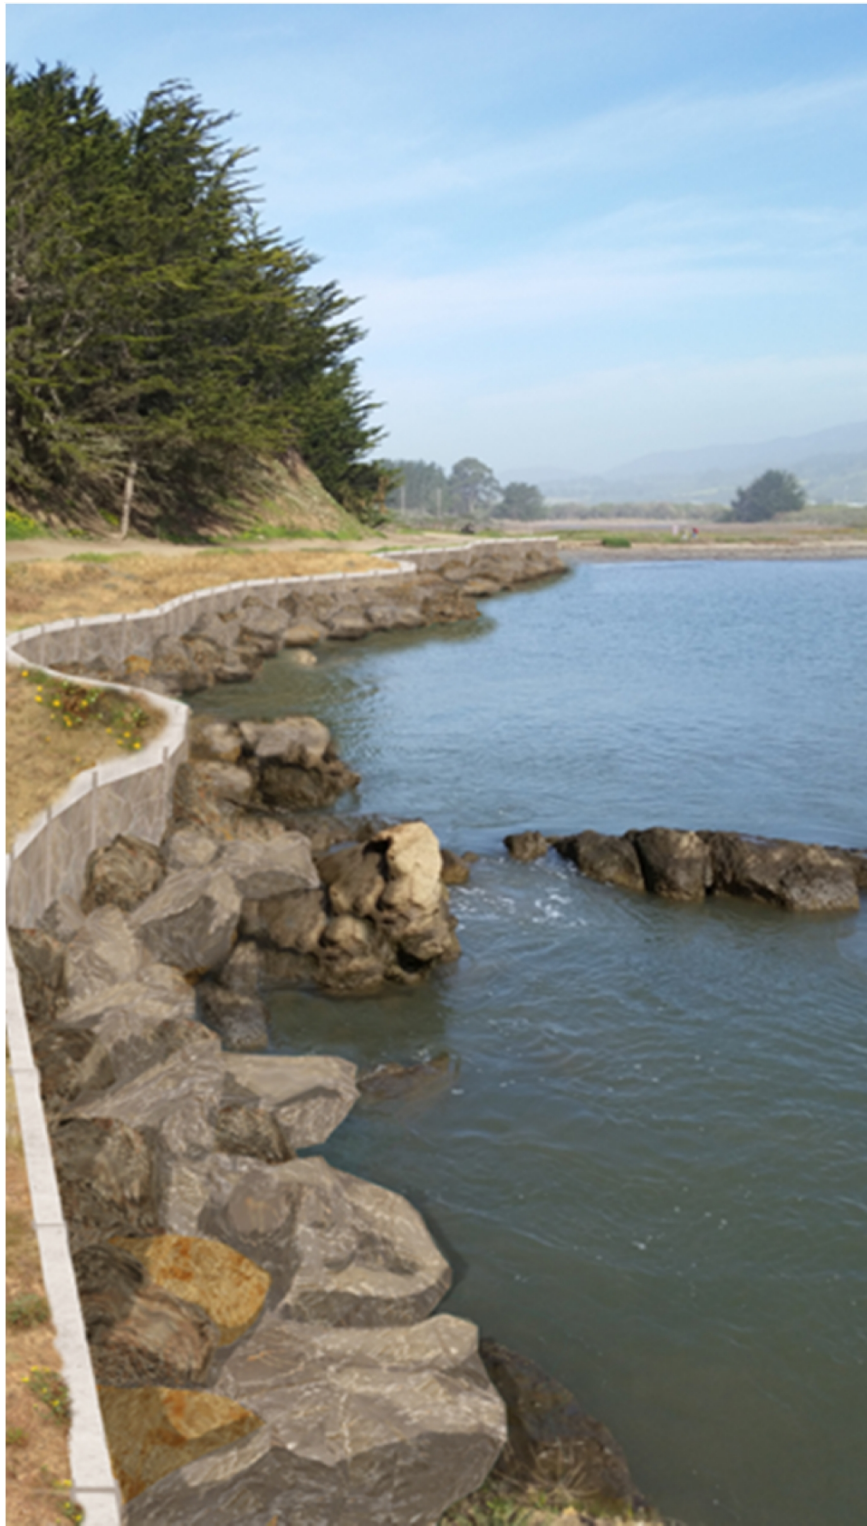
Figure 7B

SAN MATEO COUNTY HARBOR DISTRICT
PILLAR POINT HARBOR
WEST TRAIL REPAIR - PHASE 1
HYBRID ALTERNATIVE RENDERING - COMBINING ALT. 1 & 2
VIEW FROM LABYRINTH

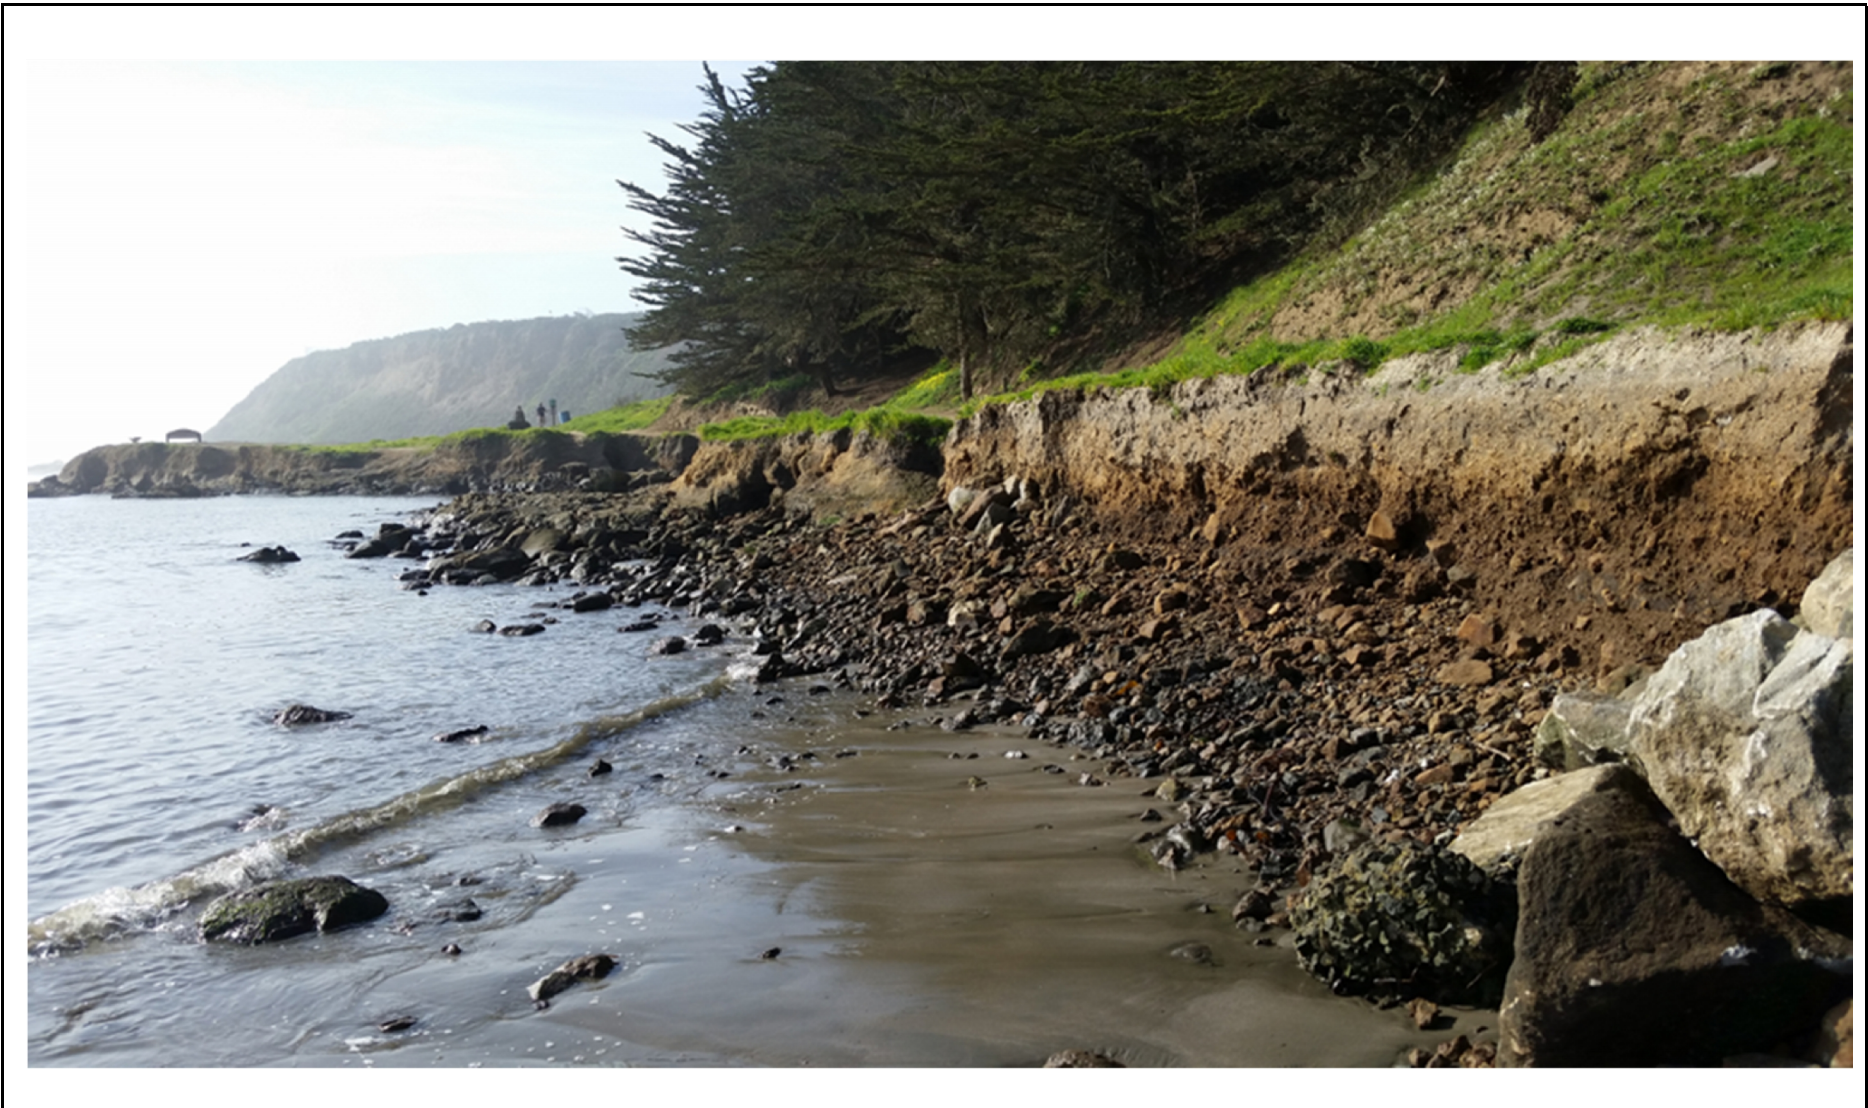
SAN MATEO COUNTY HARBOR DISTRICT
PILLAR POINT HARBOR
WEST TRAIL REPAIR - PHASE 1
DO NOTHING ALTERNATIVE
VIEW FROM BEACH
